ATLAS Silicon Microstrip Tracker Operation and Performance

TIPP 2011

ATLAS Semiconductor Tracker (SCT)

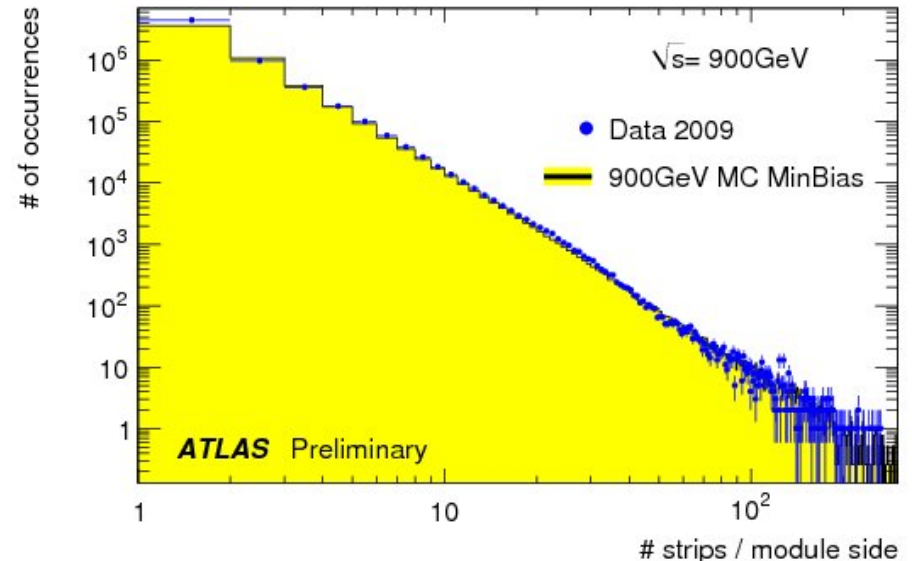
SCT Modules Sensor Performance

- Occupancy
 - 900GeV run compared with a 900GeV minimum bias MC sample and solenoid on
 - Good agreement is obtained for a wide range of number of strips

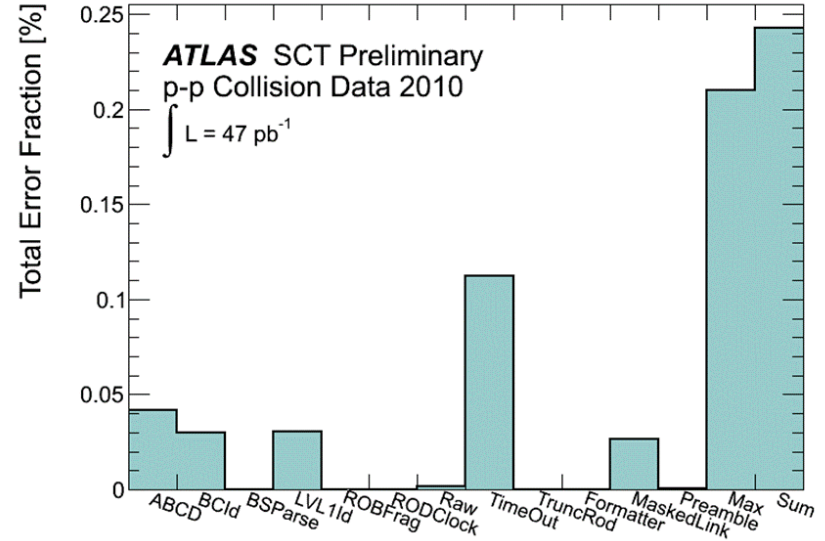
Module Errors

- Overall, the error rate is very low
- The total fraction of data with errors in the run period was less than 0.25%

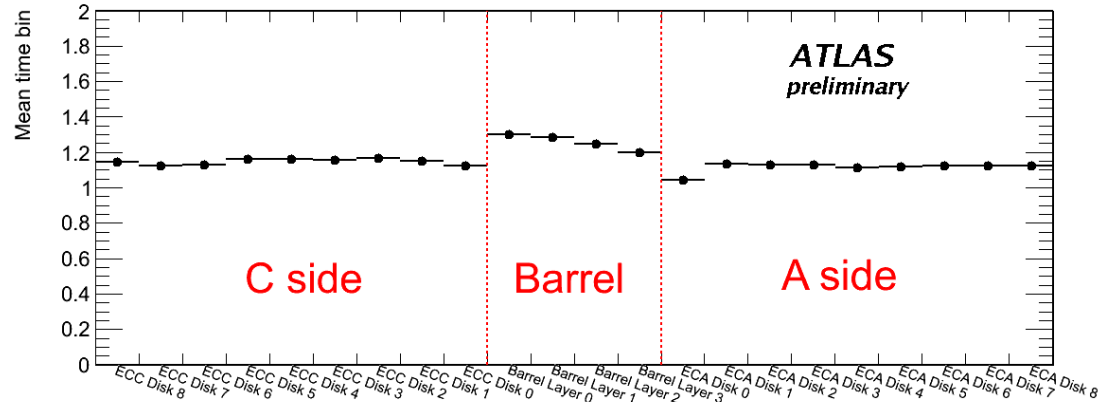
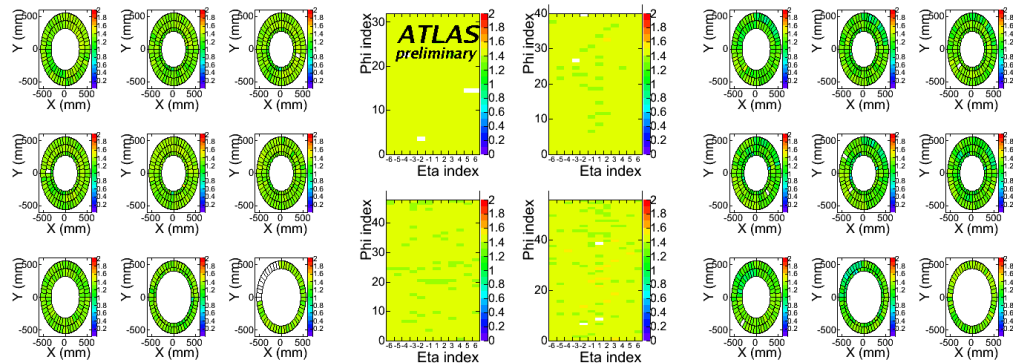
Trigger and Timing

- The SCT reads out 3 25ns time bins (BCs) around LVL1 accept
 - Trigger is delayed to account for length of optical fibers and time of flight from IP
 - Hits should arrive in the middle bin (010 or 011)
 - In 2010 running SCT was in XXX mode
 - In 2011 we have moved to X1X
 - In 25ns operation (compressed mode) we will run 01X

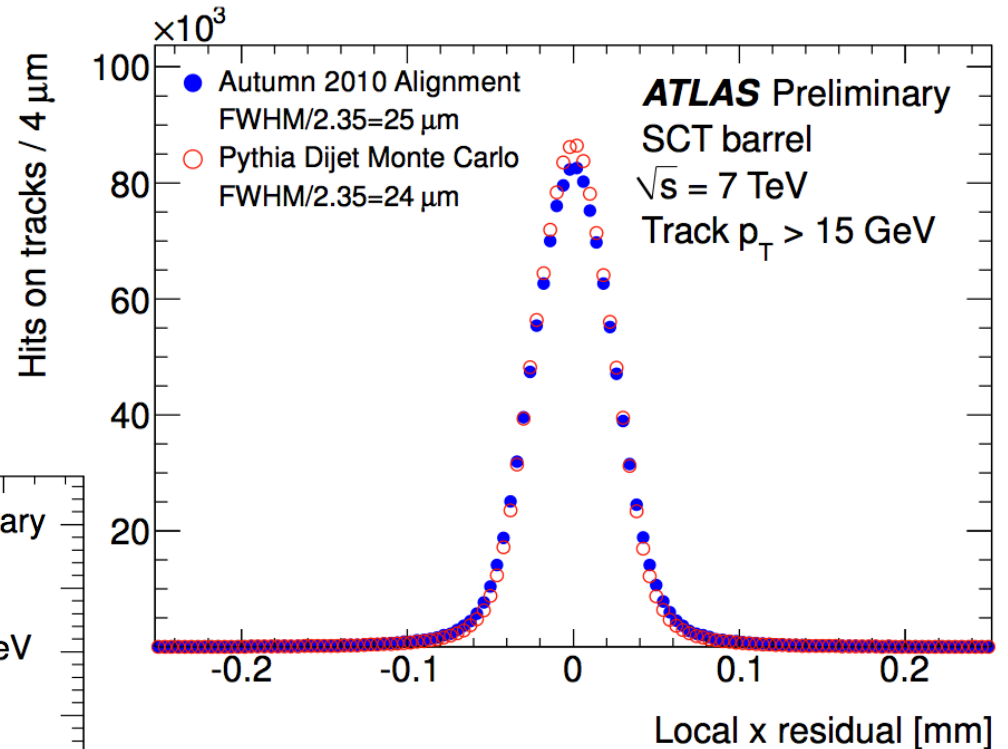
SCT Track-Based Alignment

- Precision alignment allows on-line track reconstruction and invariant mass determination

- Residual = Measured hit position – expected position from track extrapolation
- Track $p_T > 2 \text{ GeV}$ and more than 6 Si hits

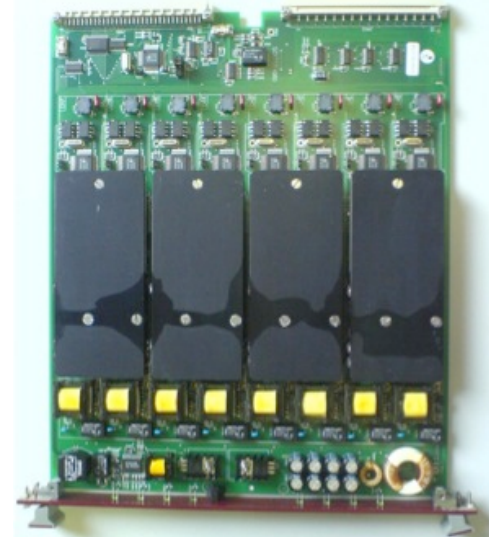
Powering the SCT

- Each detector module is served by its own independent power supply
- Low voltage (LV) cards supply
 - Detector Module ASICs (ABCD chips)
 - On-detector optical communication components (VPIN and VCSEL)
- High voltage (HV) cards provide
 - Bias voltage (up to 470V) for the module sensors
- 88 power supply crates in 22 racks
 - Each holds 12x 4-channel LV cards and 6x 8-channel HV cards serving up to 48 modules
