Materials for BLMs

Viatcheslav (Slava) Grishin on behalf of CERN (BI-BL section) and IHEP (Protvino)

DEVELOPMENT, PRODUCTION AND TESTING OF 4500 BEAM LOSS MONITORS

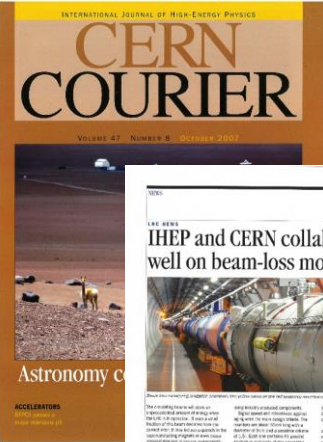
To support the investigations of the LHC limitation and anticipate other possible similar future problems, we have produced **the proportional chamber**. The PC has the same outside geometry as IC but the sensitivity is 10- 100 times higher in comparison to the existing LHC IC.

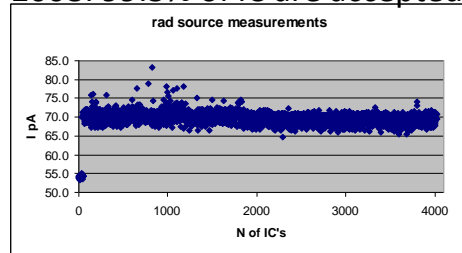
2008: 99.5% of IC are accepted

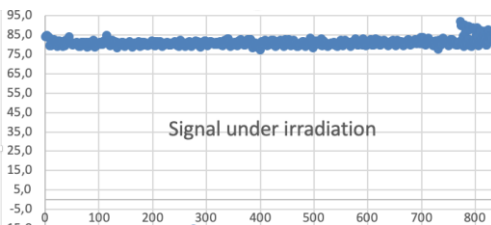
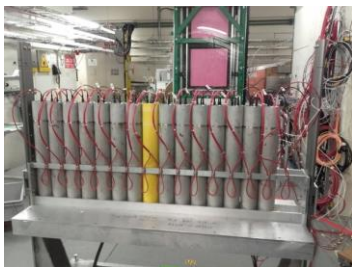
2017: 97 % of IC are accepted

One of the reasons for high (out of specs) signal is the migration of water and other nasty things from the ceramics.

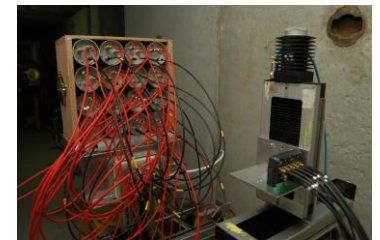
Calibration of 250 SEM detectors in a mixed radiation field corrected for systematic position errors.

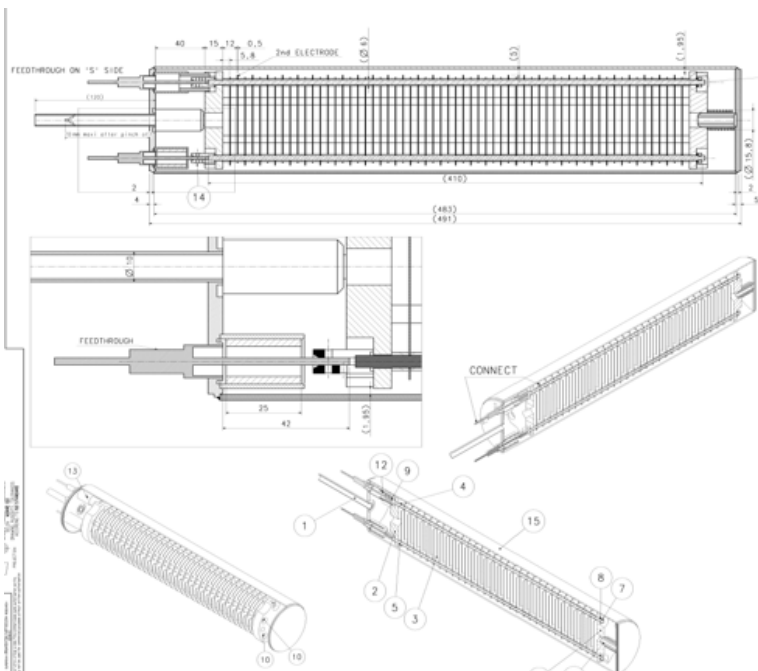
- Material: tubes 1.4435 ss 88.9 x 2.0 x 6 mt
- Tube inox 316L 483x88.9x2.0 LHCBLM_0040, IC
- Tube inox 316L 105x88.9x2 LHCBLM_0038
- Ceramics LHCBLM_0005 v.AC, IC

- Material AW6082
- Al electrodes production LHCBLM_0004 0.5X82, IC
- electrode spacer LHCBLM_0007 type A
- electrode spacer LHCBLM_0007 type C
- bottom cover disk LHCBLM_0006

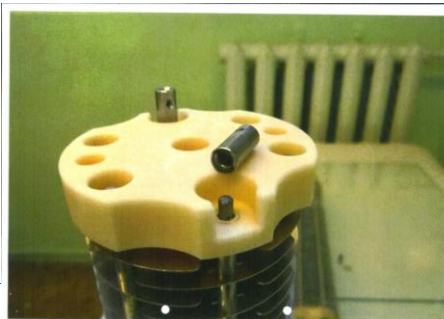
MÉTROLOGIE EN MM-MM
CERTIFICAT DE CONTRÔLE

pièce 15: Ø41 (+0.30) 4.20, Ø6 (+0.05) 5.98, Δ (E14) A 0.040, Δ (E14) B 0.022, Δ (E14) C 0.178, Ra 1.6 0.42

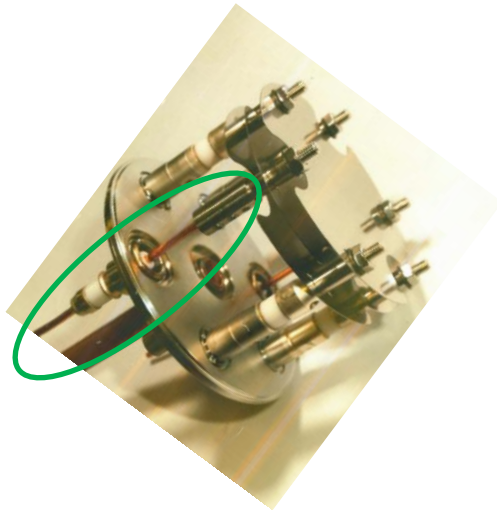
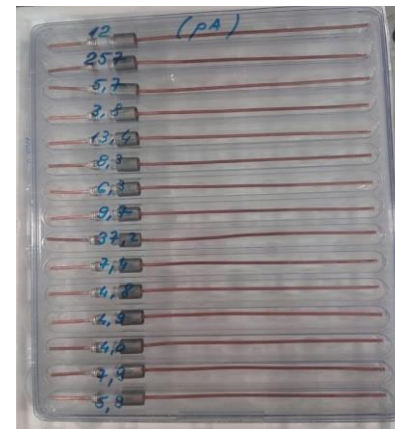
UHV current feed through

- glazing of the ceramics on both sides, including the vacuum side
- outside: stainless steel
- current lead: copper
- leak rate: $<10^{-10}$ mbar l/s
- UHV application.
- not outgas.
- withstand baking at 300 C.

Feedthroughs testing is done at CERN after reception and in IHEP just before chambers assembly. The acceptance criteria for leakage current is set below 1 pA in air at 2000 V.

Only 15 out of 1700 feedthroughs were not accepted.

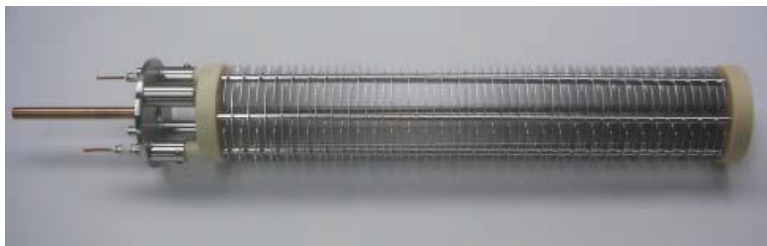
Electrodes

- no burr
- the flatness
- no edge curvature
- no surface scratches
- no oil
- large number

2 types of FIC electrode plates from st steel 316L and Al by 2 different technologies: water and laser.

In both cases we have the burrs, but in case of laser cutting the burrs are more smaller than water cutting plate.

The flatness in both case is good.

The defects of the metal drops adhering to the surface, trace from the laser on the edge of some plates, a small notch.

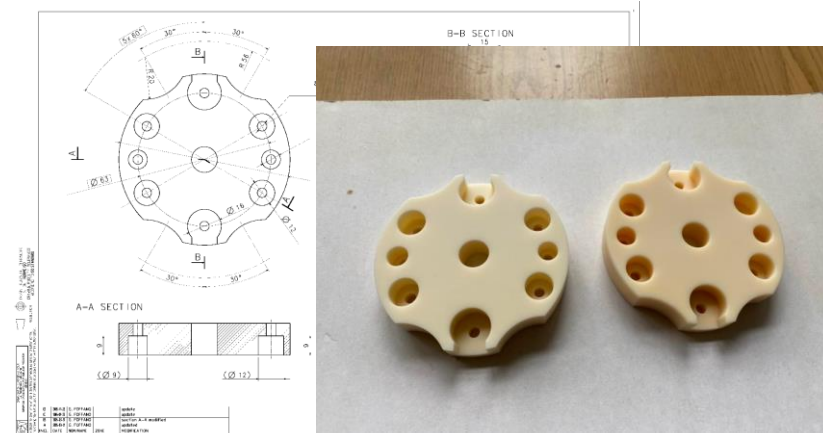
Various investigations on the ceramic insulators include vacuum, chemical, electrical, cleaning, and heating tests. Some of these tests (e.g. heating and cleaning) leads to improved quality of the ceramics from Friatec.

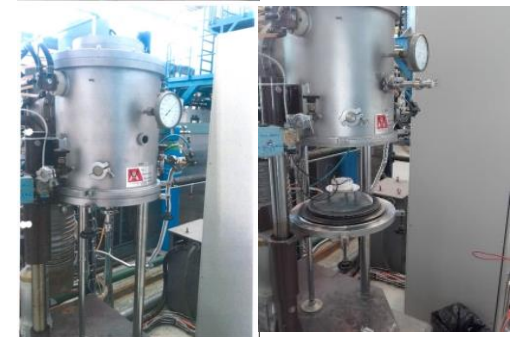
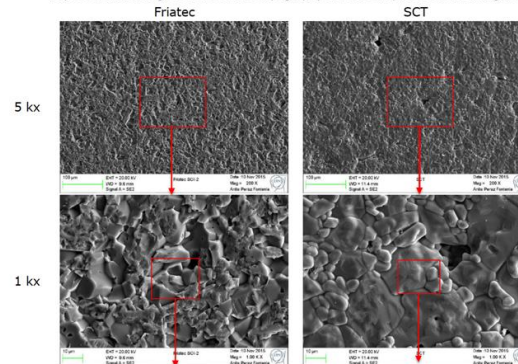
Surface morphology study of two ceramic plates by Scanning Electron Microscopy (SEM)

The aim of this investigation is to compare the surface morphology of two plates from different providers: New ceramics from Friatec that presented an unacceptable low electrical resistivity, and ceramics from SCT that presented the low current expected during the resistivity tests. Higher conductivity of the Friatec samples could be due to a higher adsorption of water at the surface.

Representative Images of the surface topography of both samples is shown in Figure 2.

The surface differences of SCT and Friatec ceramics are visible with electronic scope (atomic level).

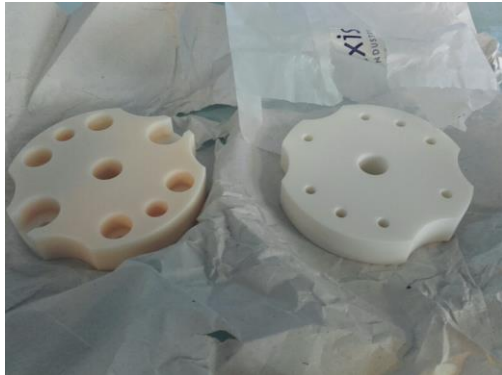
The results of our investigation, the production of "white" ceramics

The problem isn't caused by **the material resistivity of our ceramics, but by the surface resistivity.**

1. It may be that the morphology of our ceramic surface (it is grinded) in combination with carbon impurities or water causes problems, so an oxidizing heat treatment may help.
2. Oxygen defects in the surface layer may play a role, so an aging process under UV light may help.

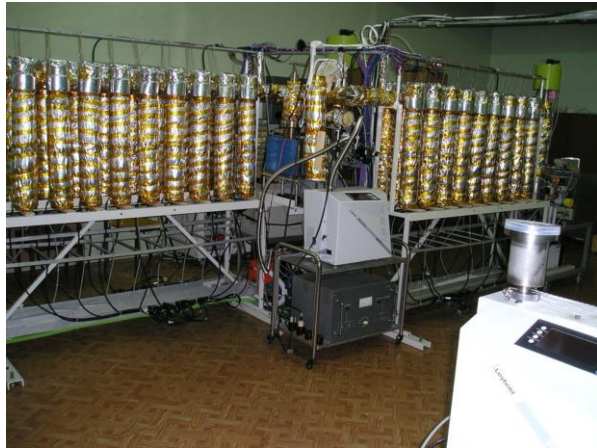
After annealing the ceramics are acceptable but very important is the ageing effects.

On the vacuum stand, we heat the ceramics during 22h with pumping out and there is no water vapor (we control the spectra) until nitrogen filled (the partial pressure was not recorded by the analyzer below 10^{-11} mbar).

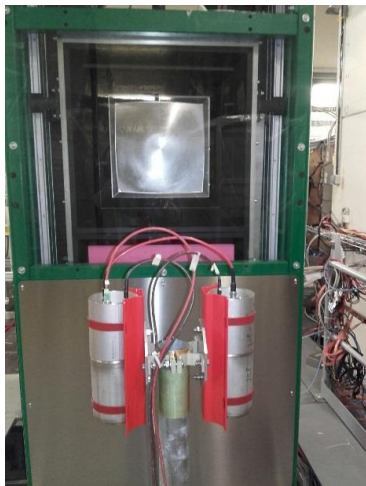
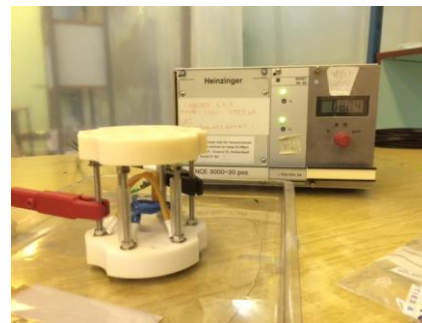
Proposal test of the ceramics on stand

Leakage current							
	SCT 1	SCT 2	Firatec 1	Firatec 2	Firatec 3	Firatec 4	Firatec 5	Firatec 6
13.03.2020	<1 pA	<1 pA	7 pA	7 pA	40 pA	9 pA	1311 pA	10 pA
25.01.2021	<1 pA	<1 pA	<1 pA	<1 pA	2 pA	2.5 pA	1234 pA	5 pA
