# Commissioning of the CMS GE1/1 Detector

Brendan Regnery

on behalf of the CMS Collaboration

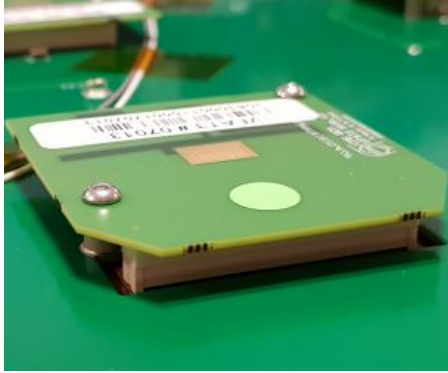
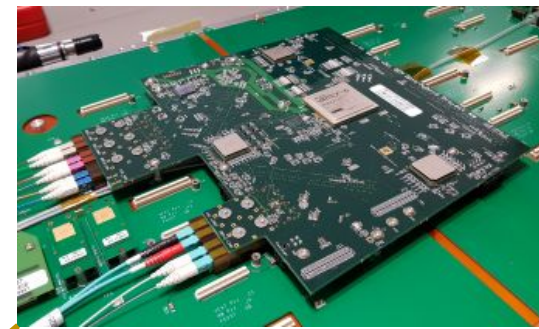
# GE1/1 Readout Electronics

- Communication between VFATs and backend electronics via gigabit transceivers (GBTX's)
- Sends slow control commands to front-end electronics (via SCA)
- Transfers tracking and trigger data to backend and CSCs

- 128 readout channels
- Data path w/ full granularity
- Sends trigger data via 8 parallel lines
- Can deliver calibration pulses

- Radiation hard DC-DC converters delivering a precise output voltage

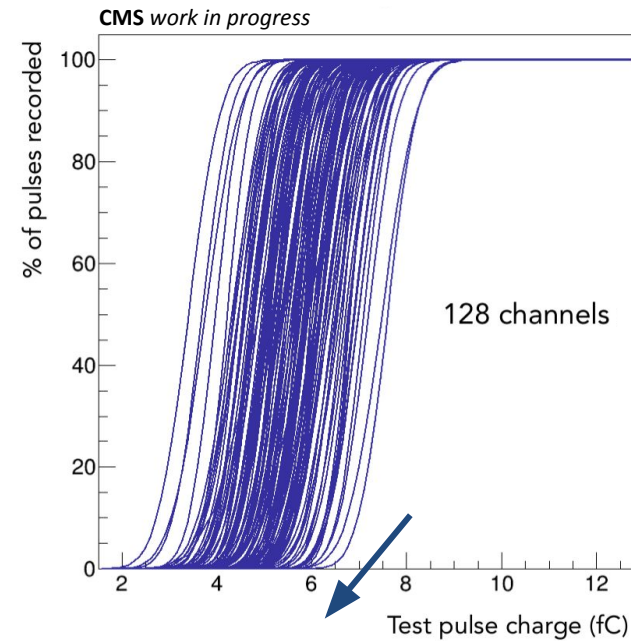
Curve width defines the intrinsic noise level

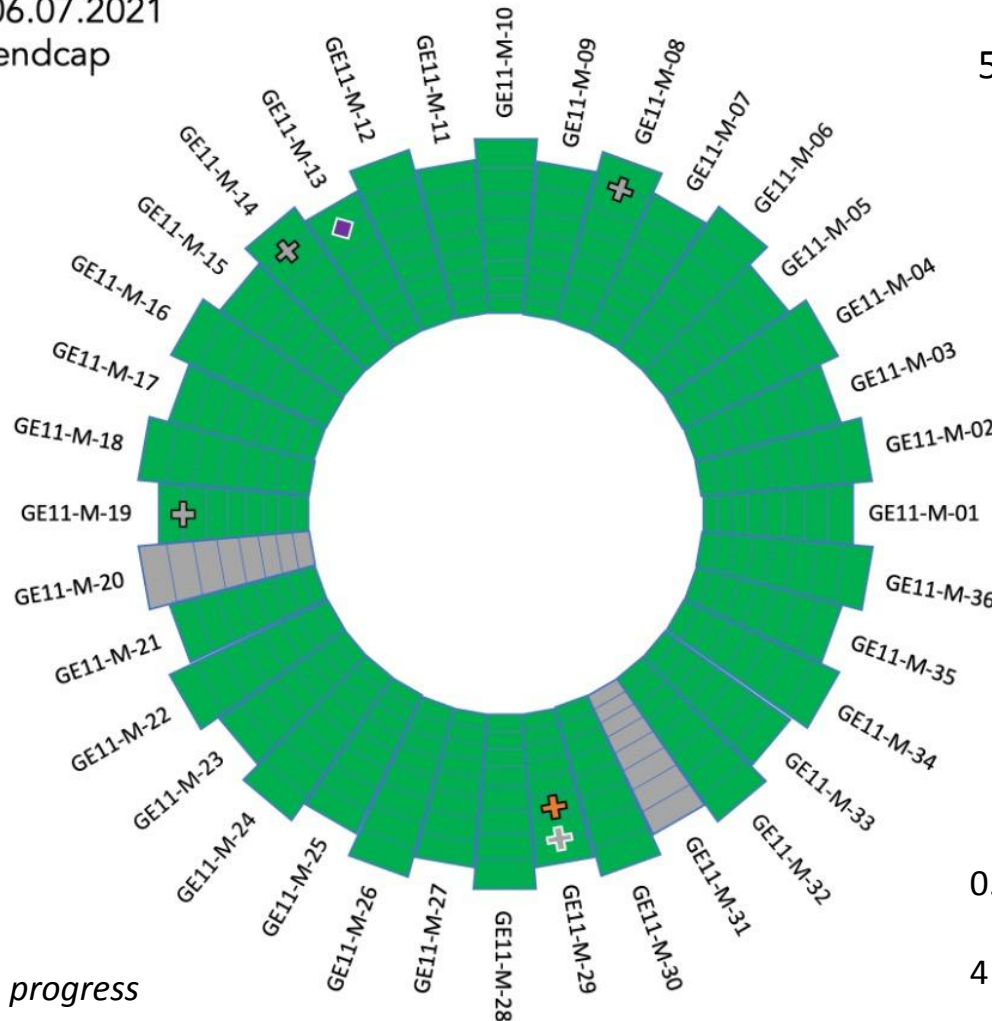
Updated 06.07.2021  
Negative endcap

5 GBT Communication Issues

0.043% of trigger lines not working properly

4 of 1728 VFATs with communication issues

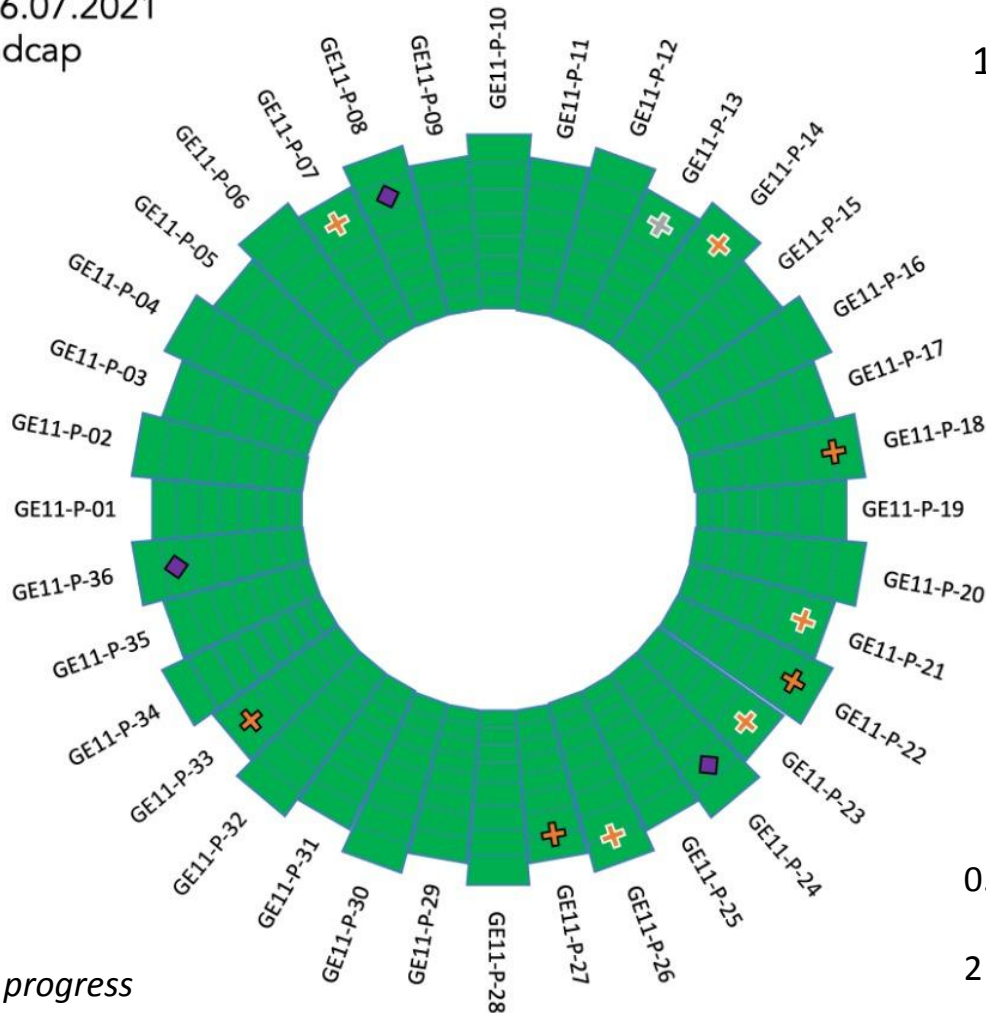
Updated 06.07.2021  
Positive endcap

10 GBT Communication Issues

- Green trapezoid: GE1/1 super chamber
- Grey trapezoid: Substituted – no test yet
- Purple diamond: Short circuit in GEM foil
- Orange cross: GBT unlocked
- Orange cross: GBT unstable
- Grey circle: Issue is on layer 1
- Grey circle: Issue is on layer 2

0.043% of trigger lines not working properly

2 of 1728 VFATs with communication issues

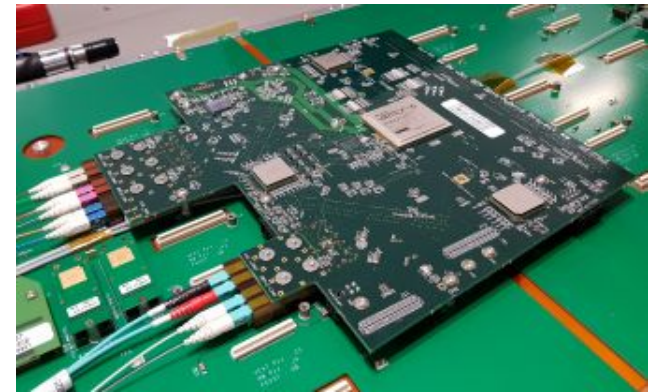
- GigaBit Transceivers (GBT) send information on optical fibers via a versatile link (VTRx)
  - Send data from the detector
  - Receive slow control information
- Around 15 of 144 GBTs have communication issues
  - The affected GBTs change, but the number remains around 15

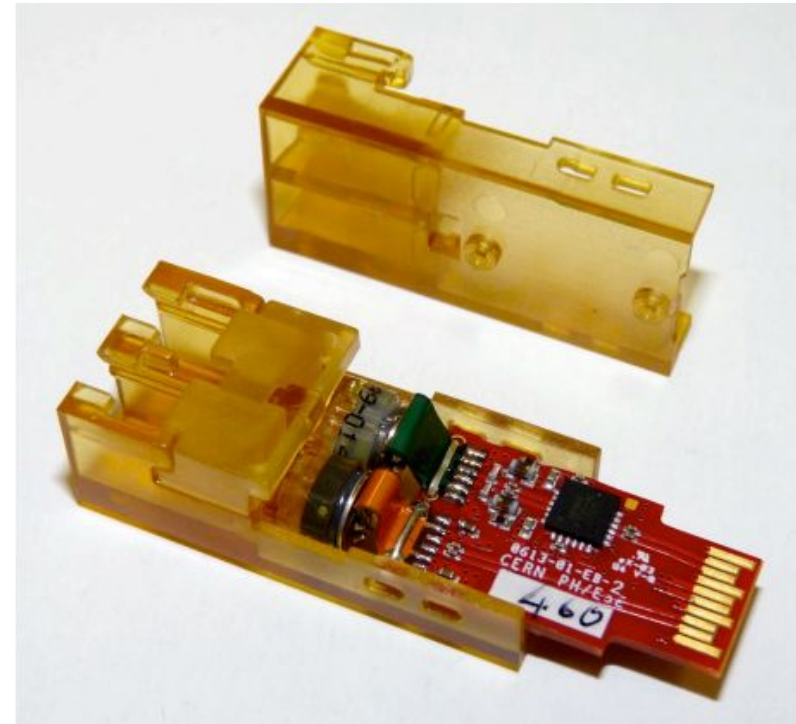
- VTRx
  - Photodiode for receiving
  - Laser for transmitting
- Photodiode attached with epoxy which is outgassing
- Deposits cloud the optical fiber causing the instability
- Electronics team has a long term plan defined for baking the VTRx's
- During run 3, GE1/1 will carefully monitor the instabilities

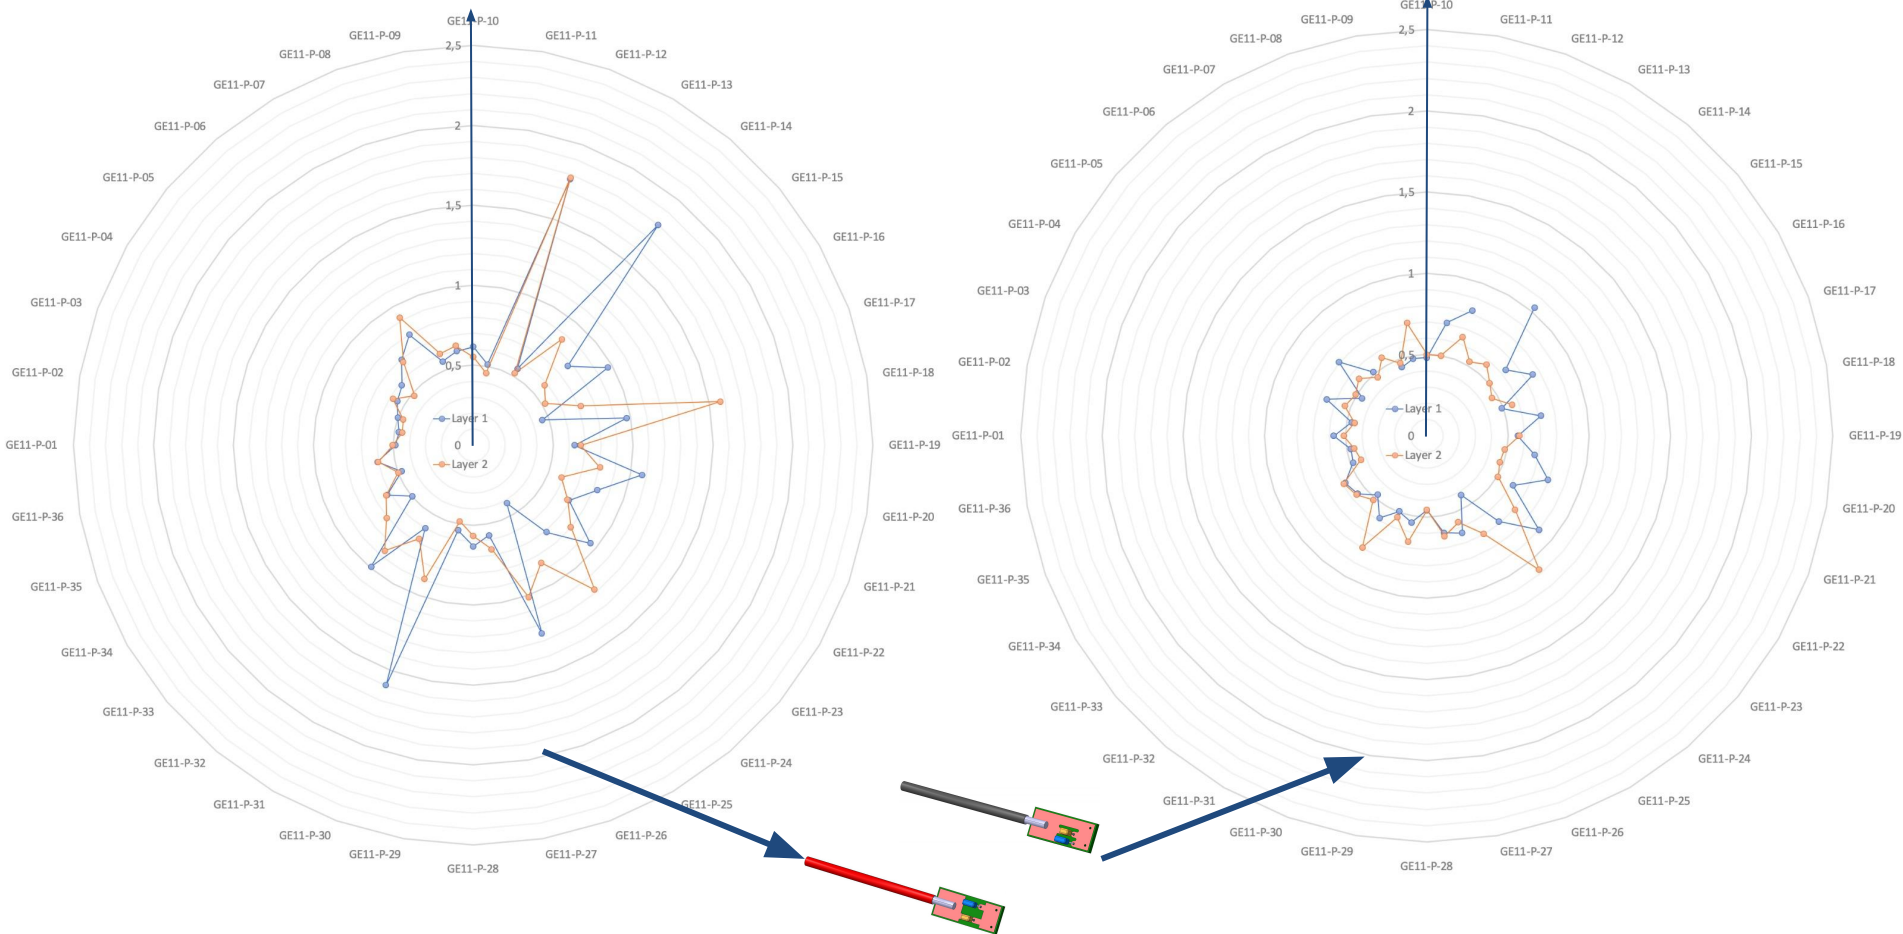
Before LV filters

After LV filters

Missing chambers due to GBT instabilities

- **Problem:** The noise level in point 5 was quite high after initial commissioning
- **Solution:** Designed LV filters to mitigate noise in readout electronics
  - 144 chamber-side filters installed at the beginning of May
- Detailed noise scans taken throughout the process

- Designed to mitigate noise in readout electronics
- 144 chamber-side filters installed at the beginning of May
- Noise levels decreased in most chambers
- LV filters also installed on LV boards

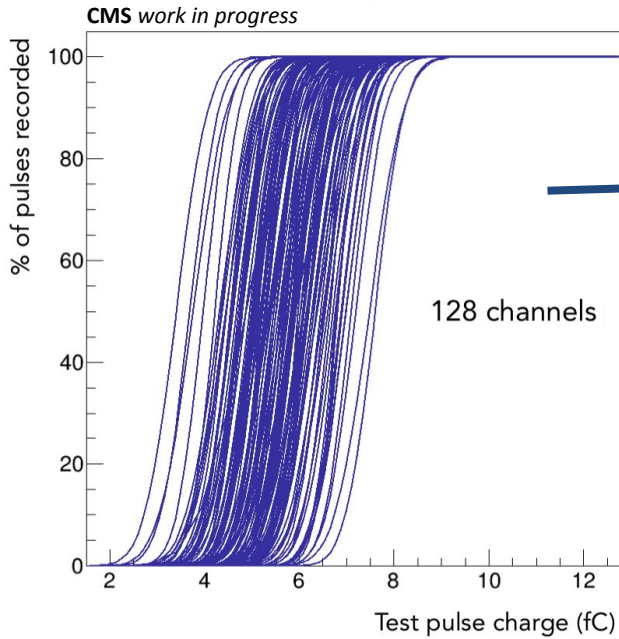
Curve width defines the intrinsic noise level

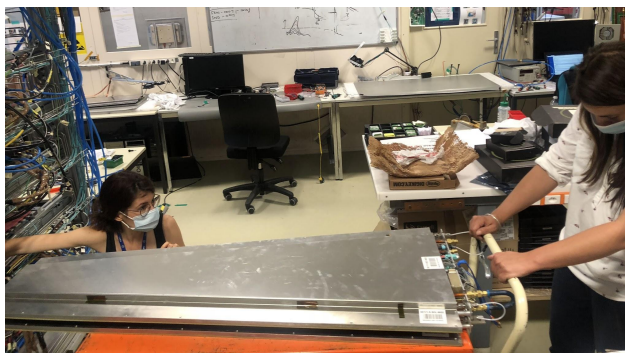
- 15 super chamber slots with 2 layers of scintillators (90Hz trigger)
- 92k readout channels with CMS-like DAQ based on  $\mu$ TCA backend (with CTP7s)
- CMS like environment (LV, HV, cooling, DAQ system, and dedicated DCS)
- Gas mixture Ar/CO<sub>2</sub> 70/30% (with CO<sub>2</sub> and pure air lines available)

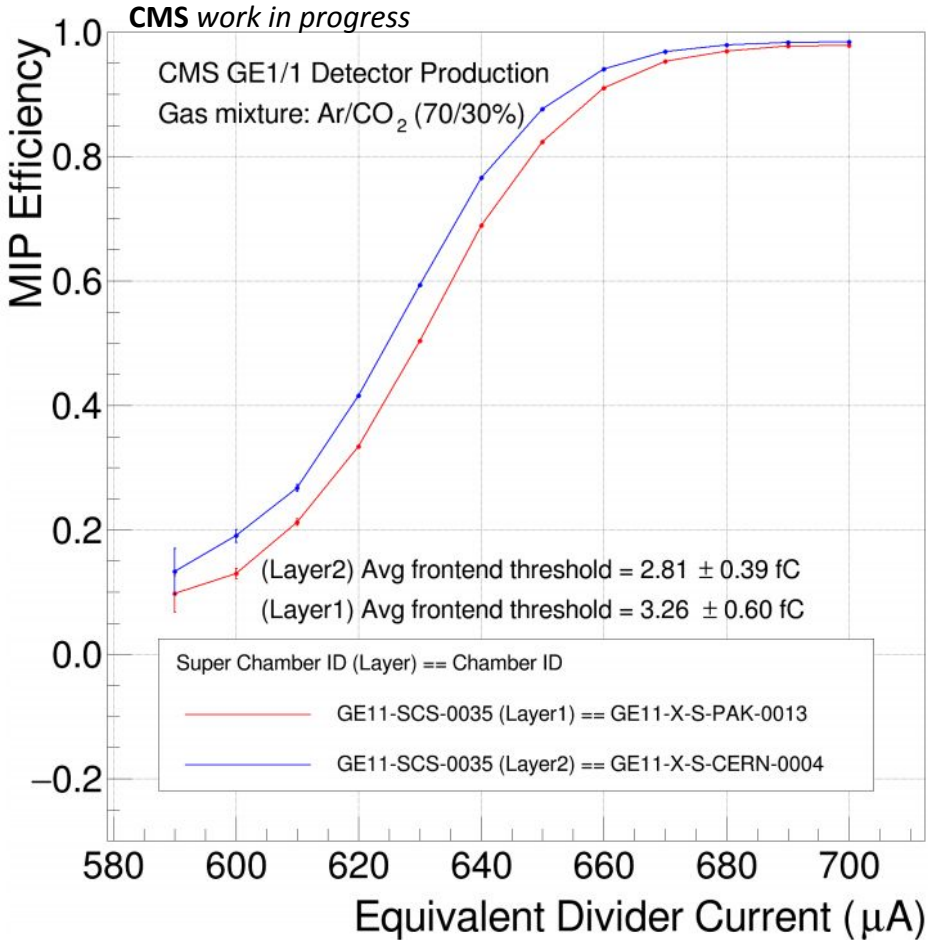
## Efficiency vs HV Set Point

- HV scan with cosmic ray muons (12h runs for each HV point)
- Analyze efficiency with CMSSW

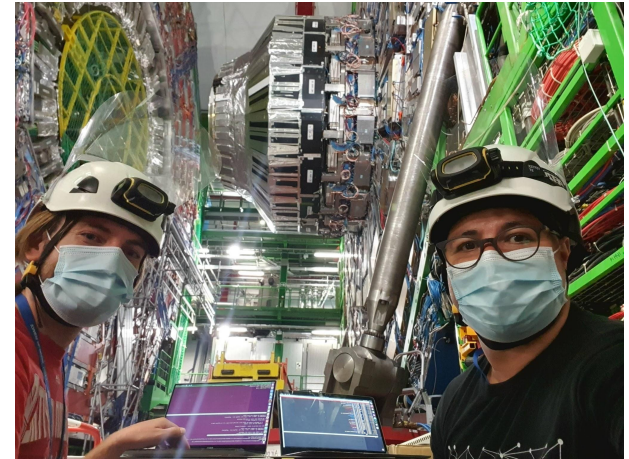
**Objective:** test front-end connections after transportation to CMS cavern

- Before Installation
- 20 minutes test of tracking and triggering path

```
VFAT 0 - TU line 0 -- Unexpected number of Sbits : 9
All sbits: 0 0
All sbits: 5 0
All sbits: 5 1
All sbits: 5 2
All sbits: 5 3
All sbits: 5 4
All sbits: 5 5
All sbits: 5 6
All sbits: 5 7
```

Identified 5 problematic chambers that were able to be repaired before installation

- 5 Chambers returned for repairs
  - 1 due to high LV current drawn
  - 3 due to “broken” SBIT lines
  - 1 due to VFAT communication problem
- All 5 super chambers were repaired
- All 36 super chambers now installed in positive end-cap!

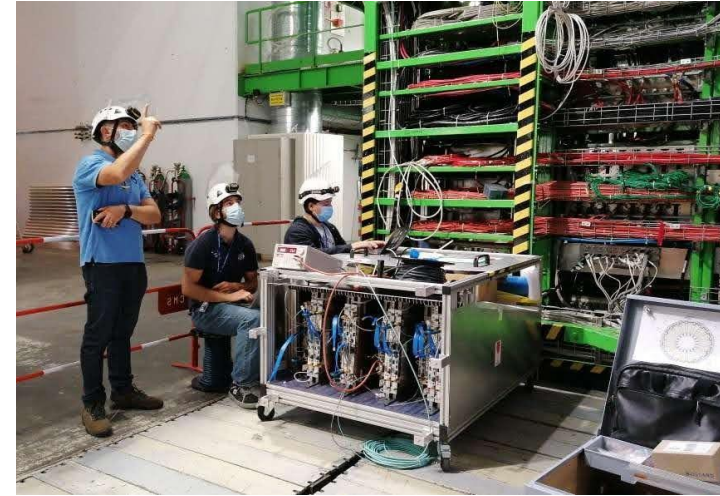
**Objective:** test front-end connections after transportation to CMS cavern

- Procedure:
  - Test communication
  - Write common calibration values
  - Look for any disconnections in trigger path
  - Scan for any disconnections in the tracking path
- Test designed to be as short as possible
