CDF Run-II Silicon Detector: Operation and Aging

Michelle Stancari

Fermi National Accelerator Laboratory

Vertex2011
Rust, Austria | 19-24 June 2011

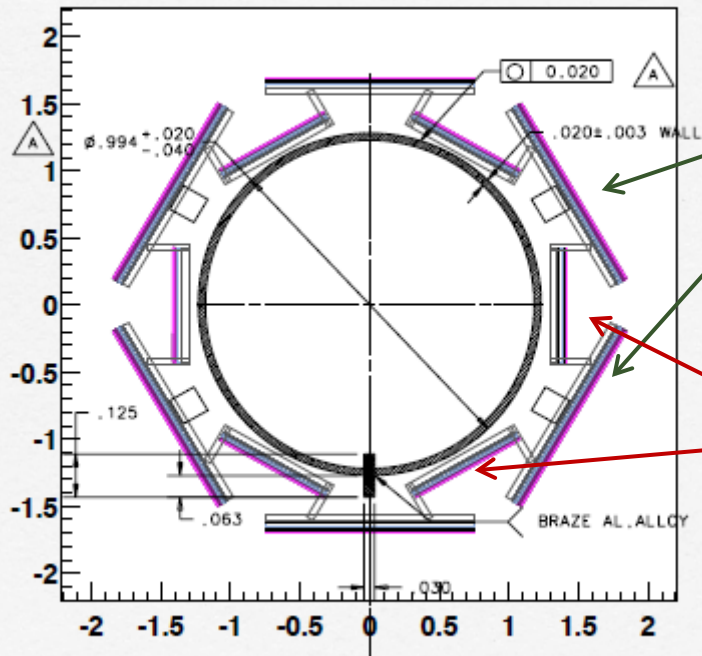
L00 geometry

x-y view of Layer 00

“Wides” at $r=1.62$ cm
made by Hamamatsu

“Narrows” at $r=1.35$ cm
made by SGS Thomsen
** 2 of 12 are special
oxygenated sensors from
Micron for R&D

SVX-L0 $r=2.54$ cm

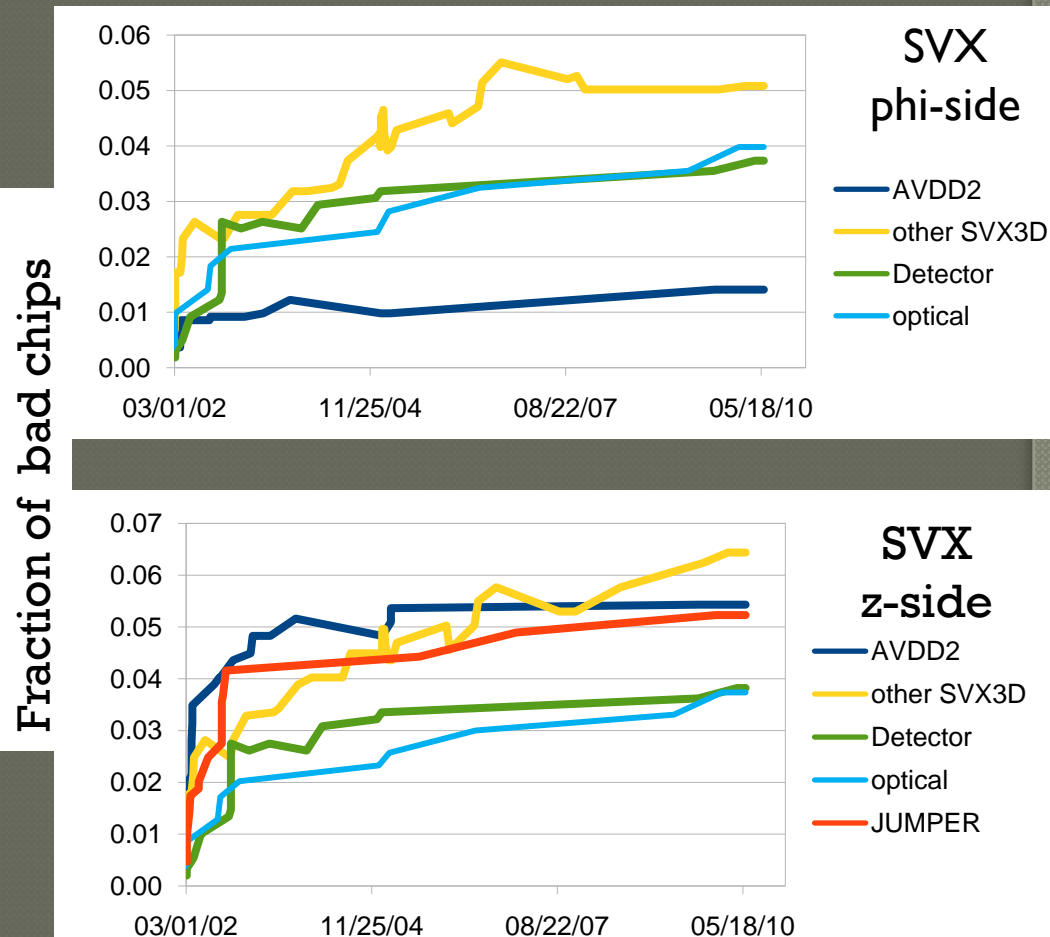
Chip Accounting - SVX

Common failure modes:

Detector includes port cards, junction cards, cables, power supplies, and the sensors themselves.

Optical is bit errors and failures from the internal DOIM data transmitters

Jumper is SVX3D chip failures due to wire bond resonances

AVDD2 is a SVX3D chip failure mode caused by beam incidents and thermal cycles

Other SVX3D includes all other chip failure modes (internal)

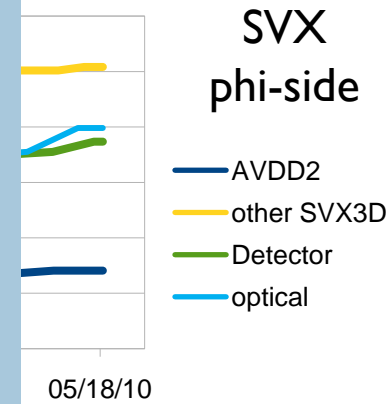
Chip Accounting - SVX

- Optical transmitter (DOIM) failure rate is very very small
- Rate of “Internal chip failures” is stable
 - Radiation damage or time?
 - Mitigated by sparsing out chip (readout threshold=max counts)
 - Symptoms: Stuck or random buffer ID, general garbage data, bit errors local to chip
- Other causes have been identified and addressed

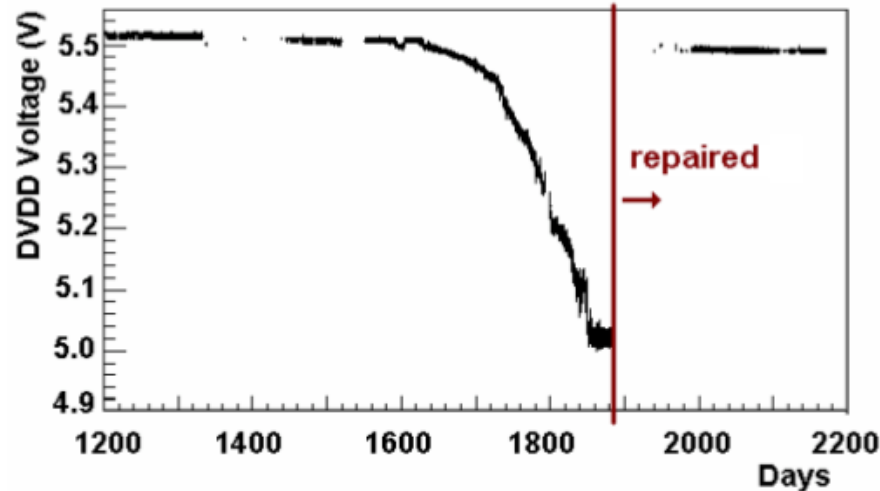
Radiation Damage to Electronics

- **Power supplies – radiation soft components**
 - Soft transistor required overvoltage protection (crowbars) for L00
 - Capacitors loose their “C” after $3\text{-}5 \text{ fb}^{-1}$ and need to be replaced.

- Takes 4 hours to replace all 36 caps , plus 2 days of testing
- Limited spare pool
- Opening the CDF detector blocks access to supplies

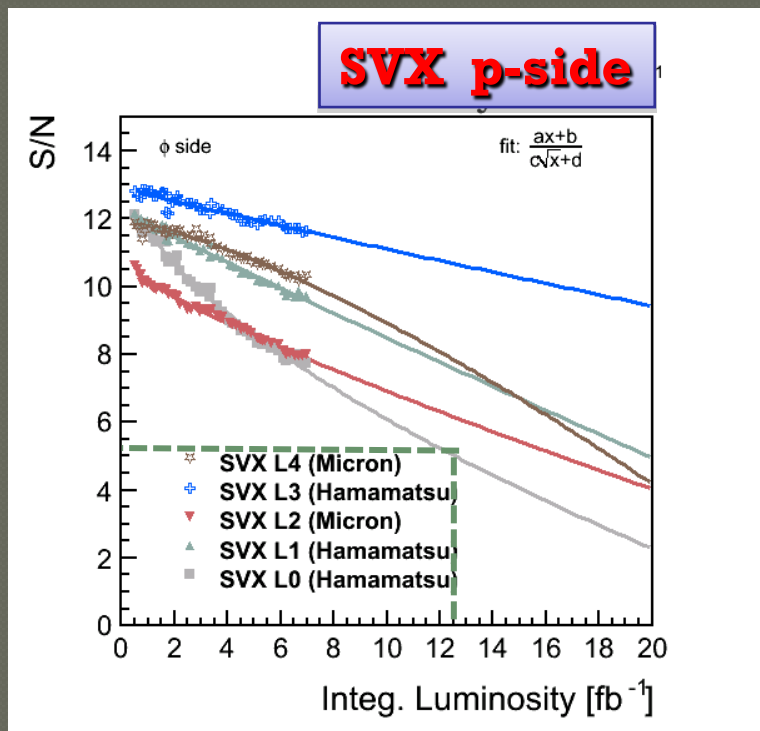
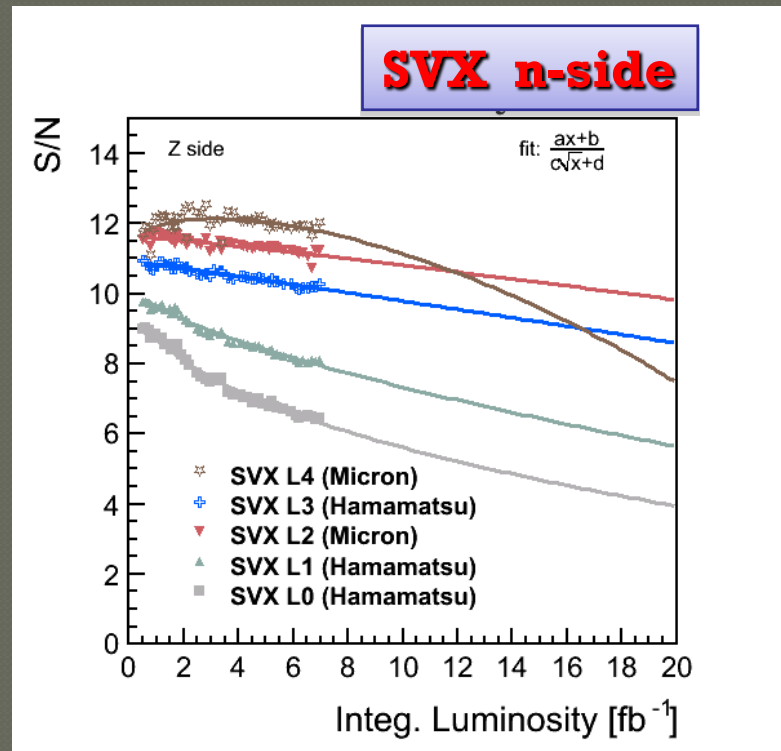
Signal / Noise Measurements

- Signal from $J/\psi \rightarrow \mu^+\mu^-$ tracks
- Noise measured with bi-weekly calibrations
- Extrapolations assume fully depleted sensors

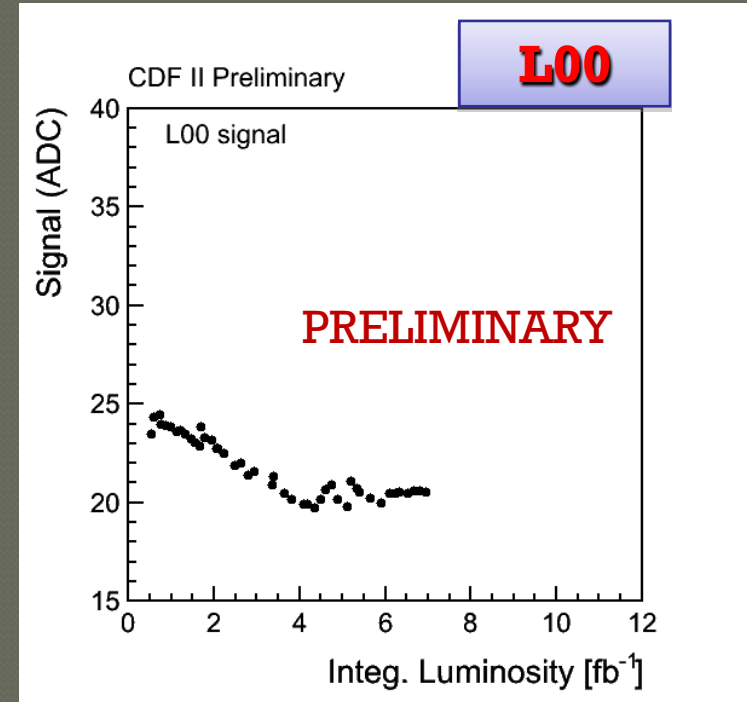
Unexpected signal decrease

No significant decrease in the signal (total cluster charge) was foreseen.

- The S/N predictions differ from the measured data (20% signal loss for innermost sensors)
- Slightly underdepleted sensors still give good data on both sides of the sensor.

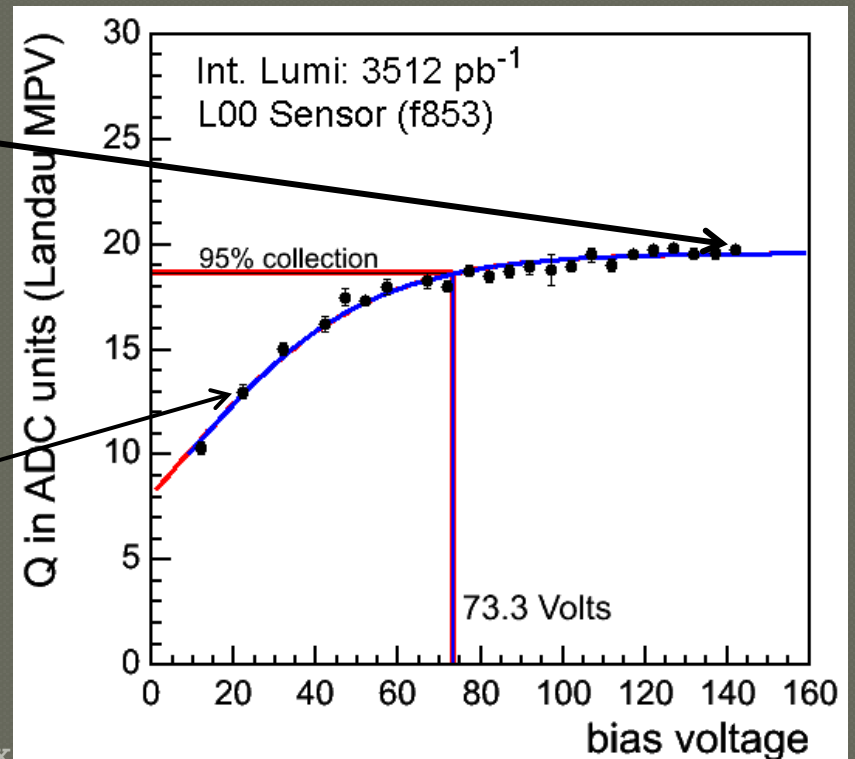
Depletion Voltage Measurement

- Plot peak charge for offline clusters as a function of bias voltage
- CDF defines depletion voltage as **the minimum voltage that collects 95% of the charge at the plateau**

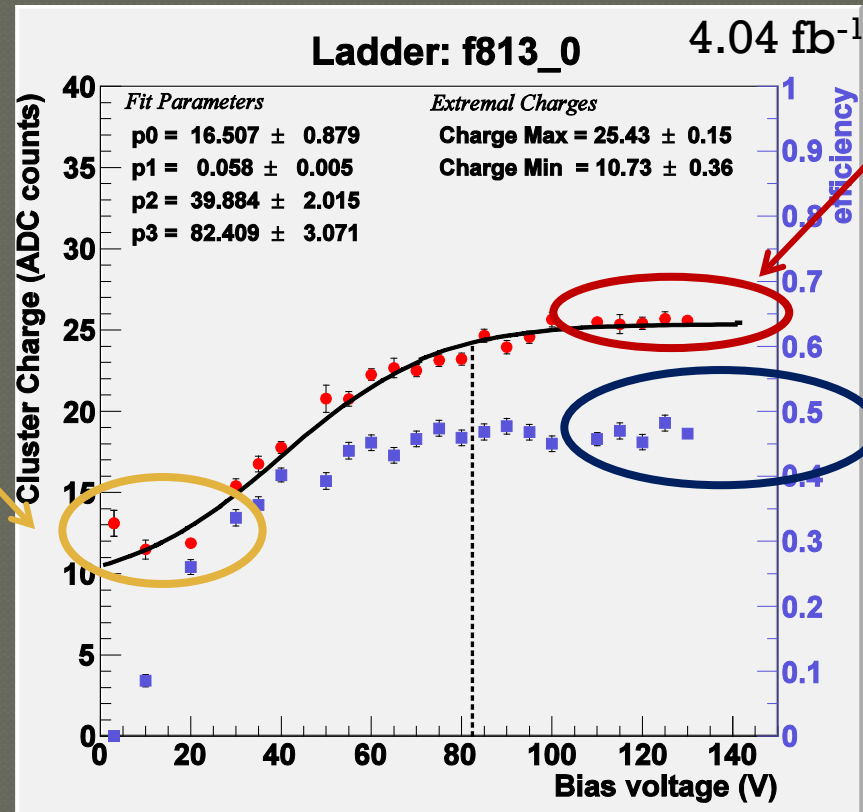
Operational Perspective

Standard offline clustering threshold (depends on measured noise of individual strips)

“S” portion of S/N

Probability to find a cluster for a given track

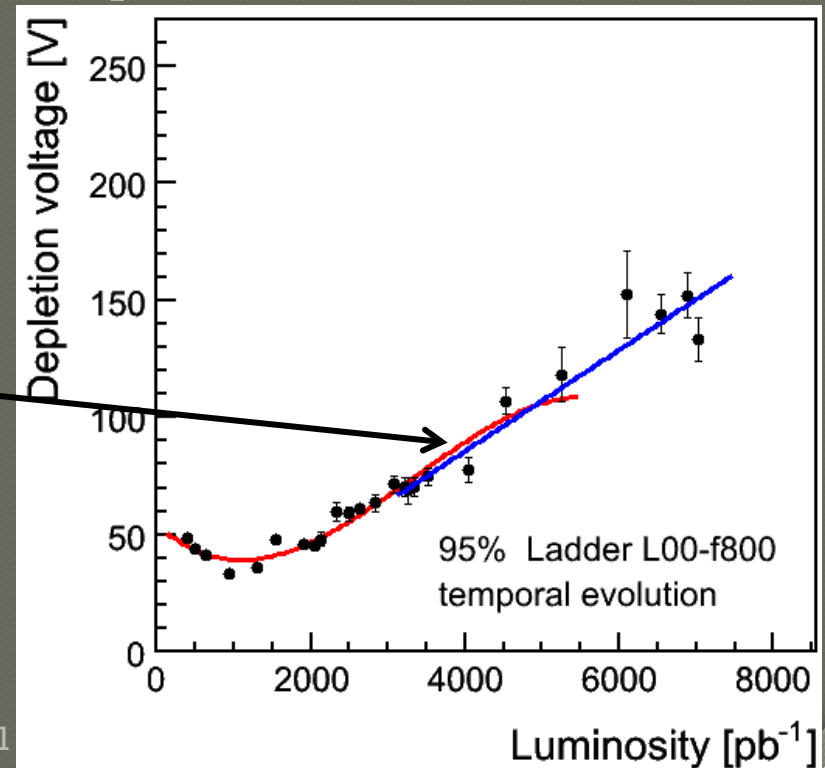
Depletion Voltage Measurement

- Plot collected charge for different bias voltages
- Determine depletion voltage as **the minimum voltage that collects 95% of the charge at the plateau**
- Extrapolate into the future
3rd order polynomial fit around the inversion point, **linear fit** after

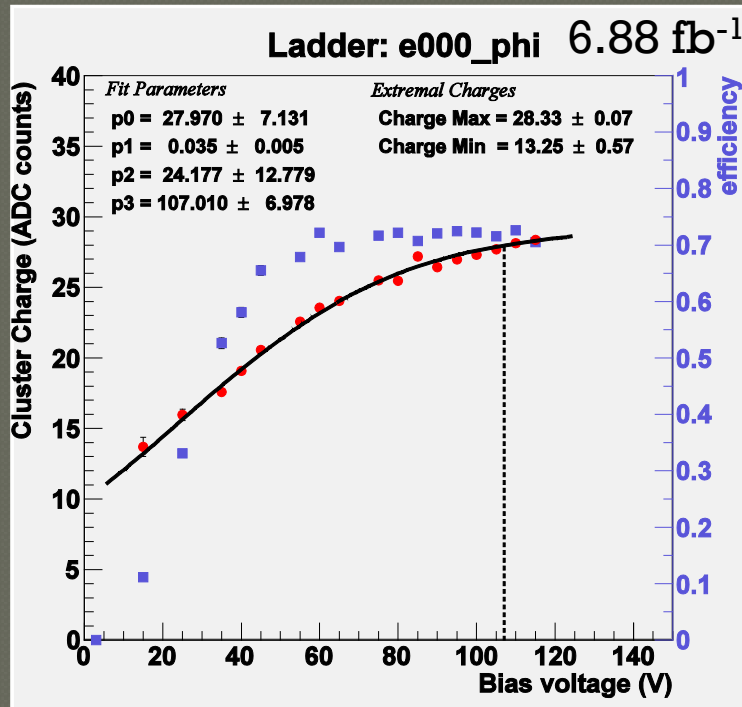
Underdepleted ladders

Underdepletion is NOT instant death for the p-side!
Instead, a slow process of decreasing efficiency.

Qualitative observation

- The (heavily irradiated) sensors are depleting from the two sides toward the center
- Consistent with a doubly-peaked electric field

Qualitative confirmation of double-peaked electric field inside heavily irradiated sensors

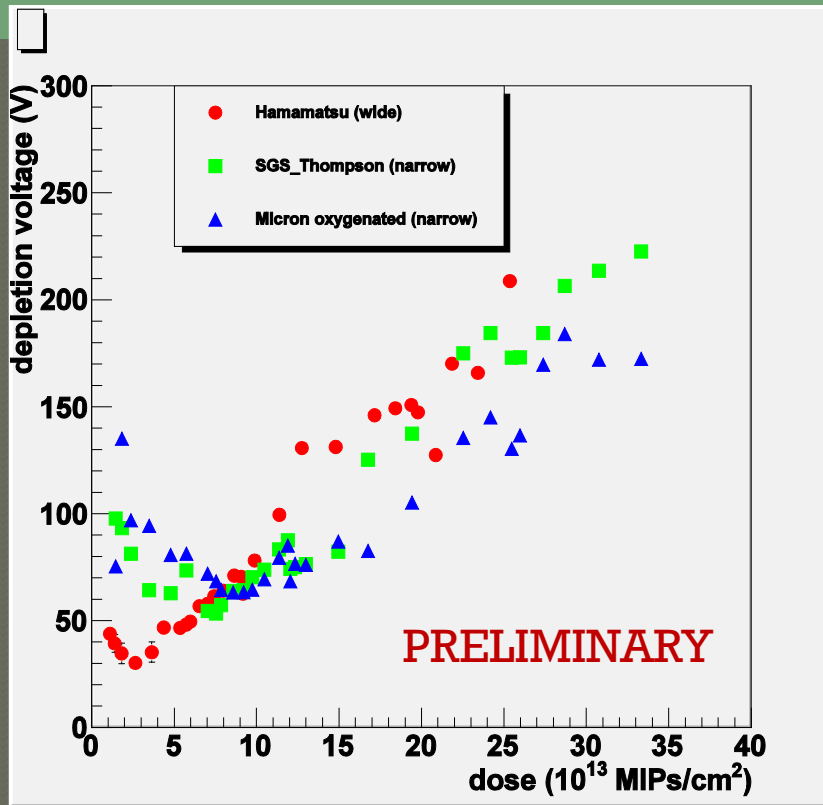
Future Plans

- Depletion voltage is averaged over all sensors in a layer
- Assume interaction region is at the center of the detector
- Conversion from luminosity to MIPs/cm² comes from the TLD measurement of CDF radiation field (NIM **A514** (2003) 188), assuming the contribution of photons and low energy neutrons to the TLD measured values is negligible.

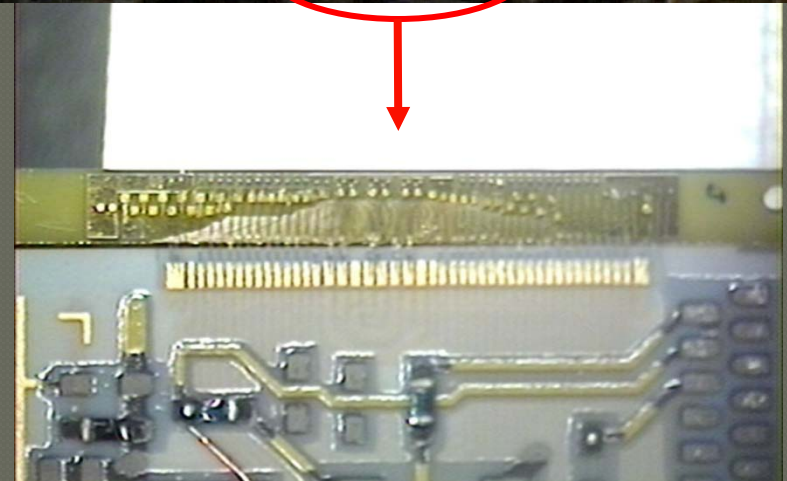
Wire Bond Resonances

- Jumper wires are the path for control, power and data to pass from one face of the hybrid to the other
- When this breaks, the chips for the z-side of the sensor have no power

- Limit the L1A rate to 35 kHz (hard) and 30 kHz (soft)
- “Ghostbuster” monitors for resonance conditions and halts the DAQ.

- Encapsulant (silicone elastomer) placed by hand over the foot of the bond (Bolla, VERTEX2003)

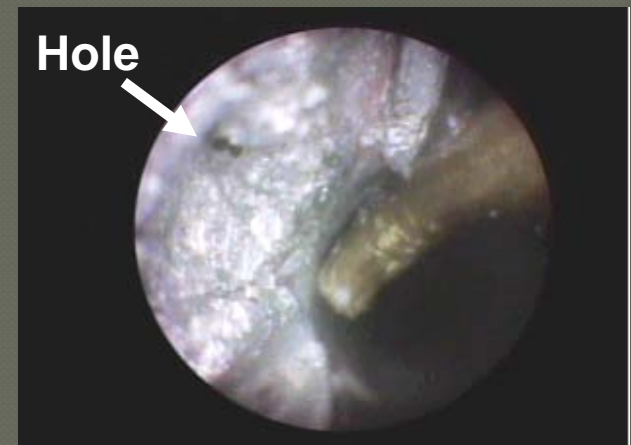
ISL Cooling System: The Saga of 2007

- In 2007, bad vacuum in ISL indicates presence of leaks. Eventually, east side bad enough to interfere with detector operations.
- Found high acidity in coolant, **pH = 2**, like lemon juice
- Formic acid had formed out of the glycol/water mixture (after warming up during the 2006 shutdown)
- Corrosion affected vulnerable parts (Al-alloys welding, brass e-valves)

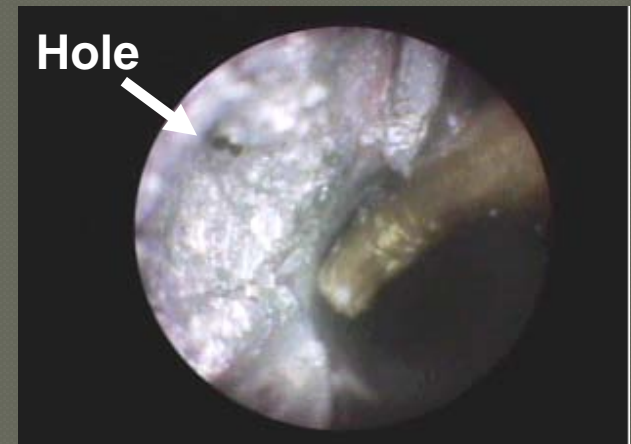
ISL Cooling System: The Saga of 2007

- Internal walls of pipes were probed using boroscopes and catheters (~1 m inside CDF detector)
- Port Card manifold-pipe junctions **were coated with epoxy**
- Brass e-valves were replaced (mounted on CDF detector)
- The ISL coolant was replaced with deionized water
- Expanded monitoring of **pH and conductivity**
- Frequent replacement of deionizer (DI) resin filters

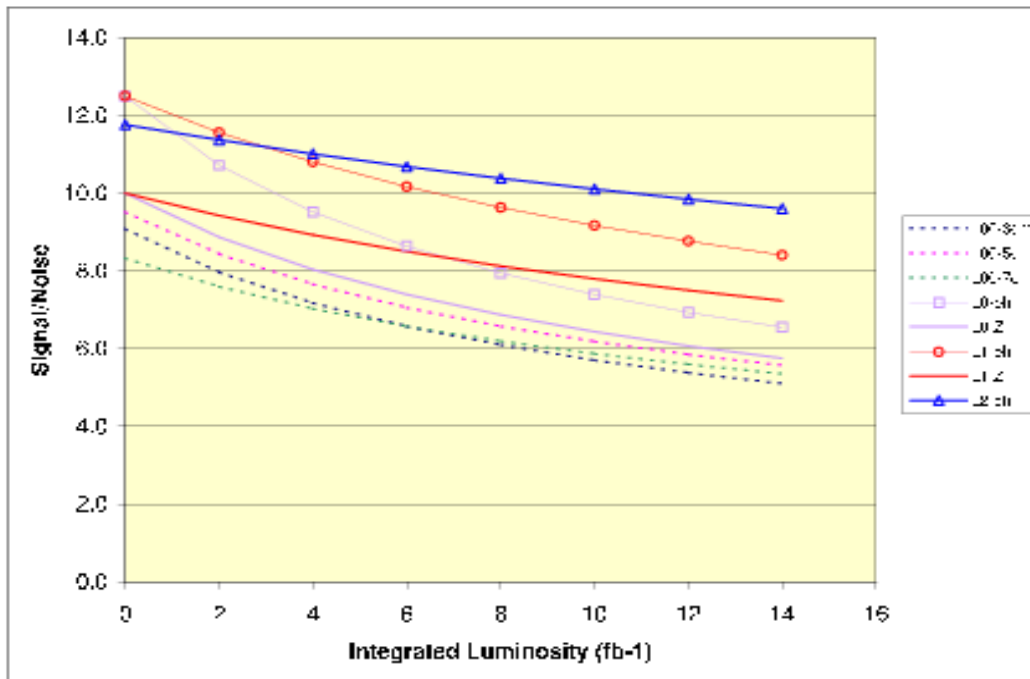
Expected S/N

CDF note 6673 (2003)
S/N predictions assumed
increase in noise and no
change in signal

L0 (dashed lines) and SVX-L0 (grey lines) predictions roughly match data?

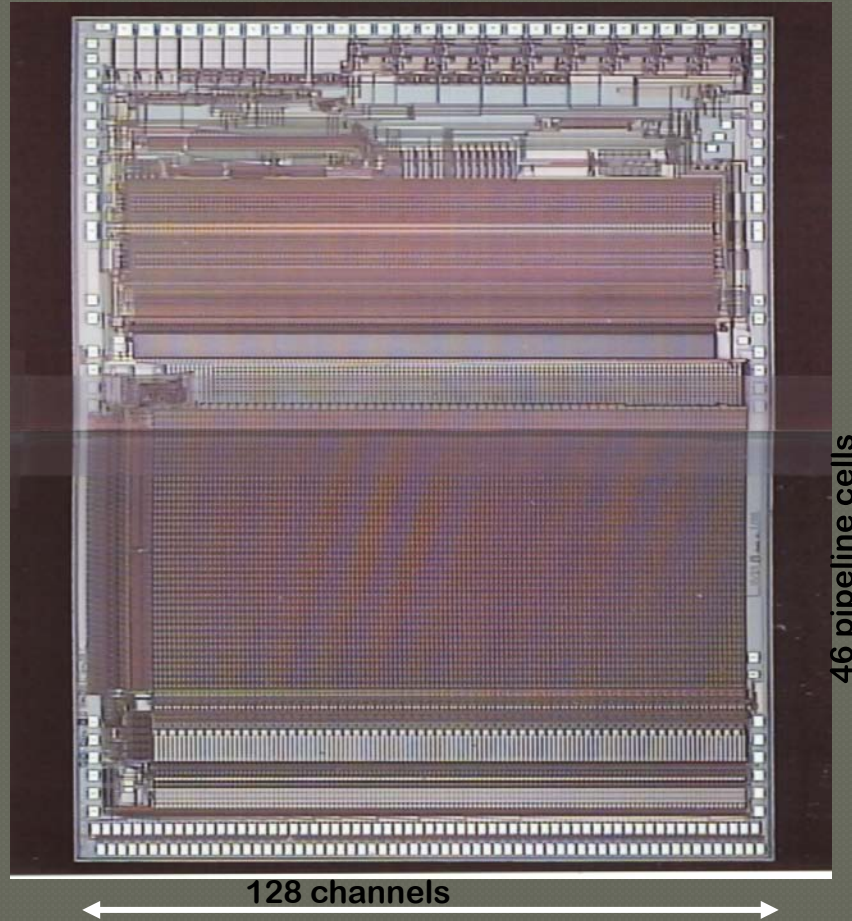
SVX3d chip

○ Analog Front End and Digital Back End

- Compatible with 396/132 nsec bunch spacing
- FE has relatively low noise integrator with 128 channels and 46 cell analog pipeline with 4 buffer cells
- BE has a comparator, 8-bit Wilkinson ADC, and sparse readout with nearest-neighbors

Fabricated in the Honeywell 0.8 μ m rad.hard process
