# Commissioning and preliminary performance of the MEG II drift chamber

Marco Chiappini (INFN Pisa, speaker) Gianluigi Chiarello (INFN Pisa) VCI2022

22 February 2022

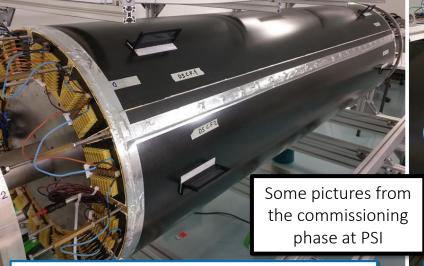
➤ CDCH temporarily sealed with CF + Al tape

➤ Nitrogen flux

> 216 FE cards mounted

Final CDCH length experimentally found through systematic HV tests at different lengths/wires elongations

CDCH length adjusted through geometry survey campaigns with a laser tracker (20 μm accuracy)

Final length set to +5.2 mm of wires elongation

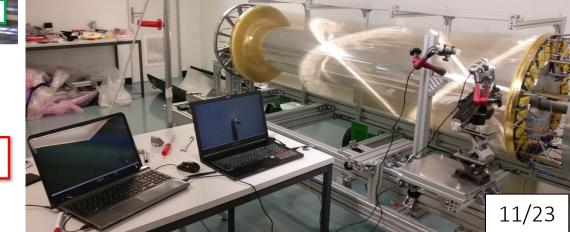
- > Each broken wire piece can randomly put to ground big portion of the chamber
- > They must be removed from the chamber
  - Very delicate and time-consuming operation
- > We developed a safe procedure to extract the broken wires from inside CDCH
  - Exploiting the radial projective geometry given by the stereo wire configuration

Example of extraction with Setup for broken wires extraction 2 mm a broken wire hooked by a stainless steel rod

Precision mount with fine axes control

2 cameras for stereo view

- Enter with a small tool inside the chamber (few mm space)
- Hook the wire piece as close as possible to the wire-PCB
- Extract the wire segment
- Pull it perpendicularly in the radial direction to break it at the soldering pad

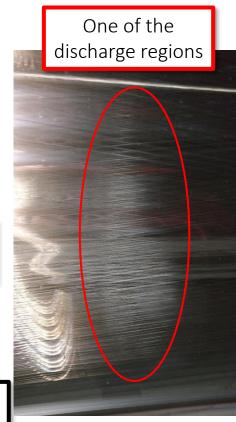
- ➤ We performed HV tests with CDCH closed with a transparent shell and filled with the standard He:IsoB 90:10 gas mixture to spot the discharges
- ➤ We saw corona-like discharges in correspondence of 6 whitish regions
- Gas mixture optimization: <u>different additives to the standard mixture</u> to test the CDCH stability and try to recover the normal operation
  - Up to 5% CO<sub>2</sub> and 10% synthetic air (80% Nitrogen + 20% Oxygen)
  - 2000-4000 ppm of H<sub>2</sub>O (≈10% Relative Humidity inside CDCH)
  - 1-1.5% Isopropyl alcohol

- From 500 ppm to 2% of O<sub>2</sub>
  - o Also in combination with H<sub>2</sub>O and Isopropyl alcohol
- Oxygen proved to be effective in reducing high currents (plasma cleaning?)
- Isopropyl alcohol crucial to keep stable the current level

Accelerated ageing tests on prototypes returned no issues or discharges
