Refurbishment of the CMS Pixel detector during LS2 and projected lifetime in Run 3

Atanu Modak

On behalf of the CMS Collaboration

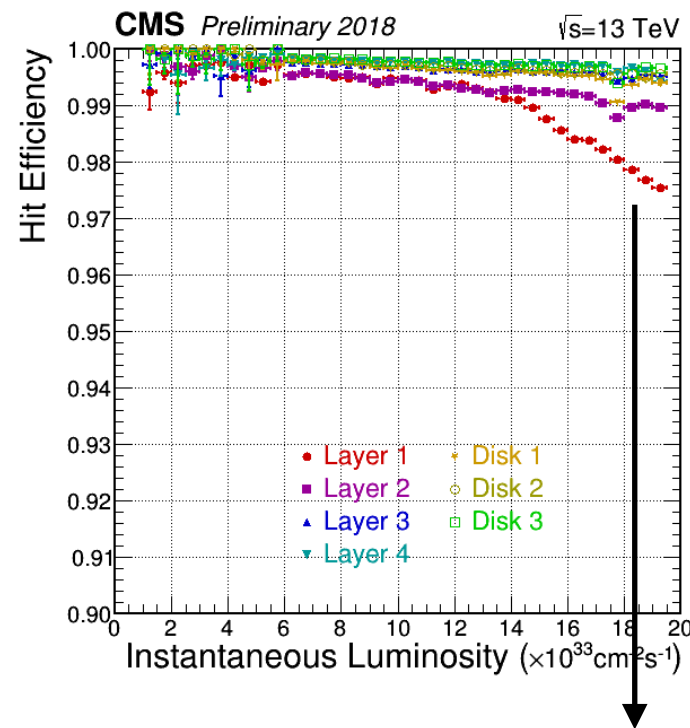
Dynamic Inefficiency,
addressed in new ROC

- Features a new readout chip (PROC600v4)
 - Fixed dynamic inefficiency issue, reduce crosstalk noise
- New Token-Bit-Manager (TBM10d) with delay and power reset option
- New HDI design to eliminate HV issues

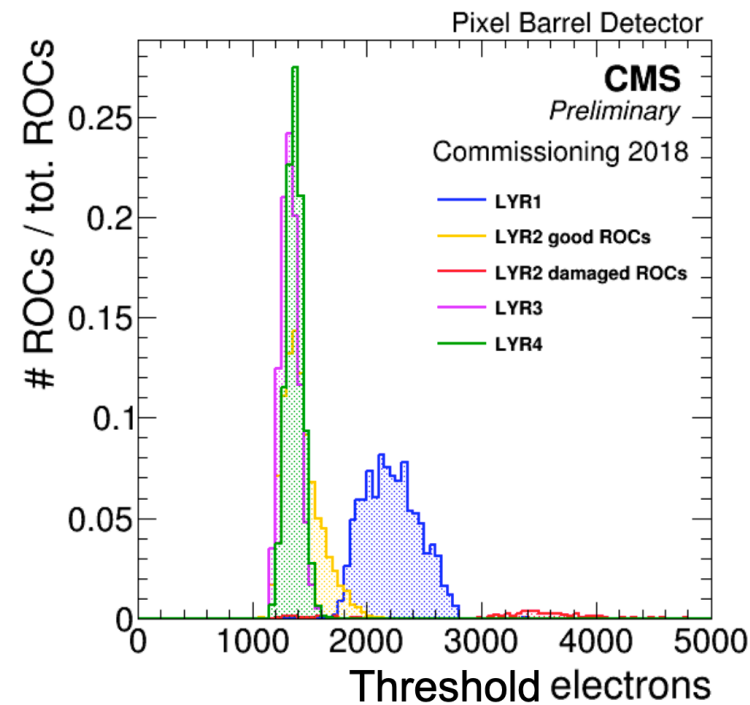
High threshold for L1
due to crosstalk noise.

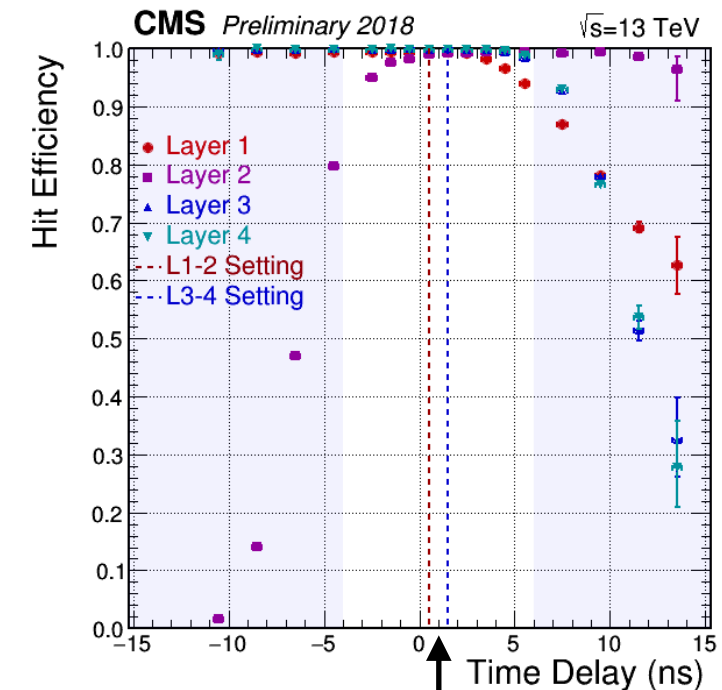
Delay chips shared by L1 and L2. Optimal range very narrow. New TBM10d offers a relative delay for L1.

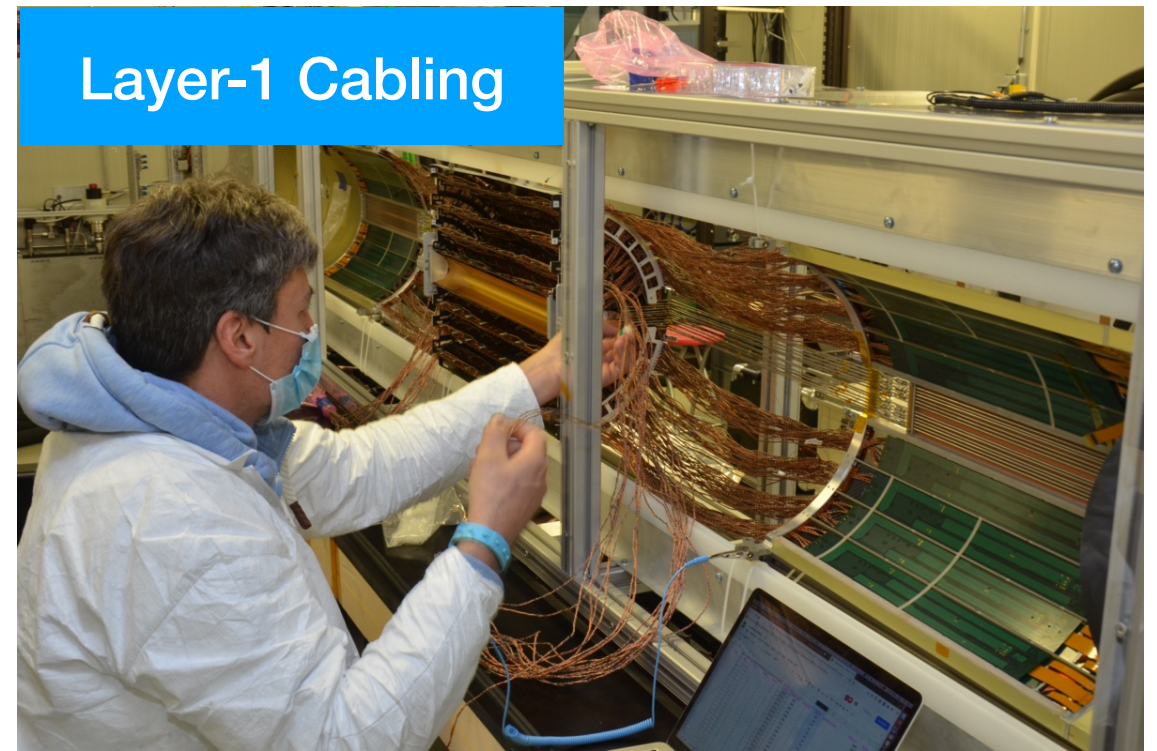
Layer-1 Cabling

- Layer 1 was delivered at CERN/P5 in Oct 2020
- Detector integration and testing started in early 2021

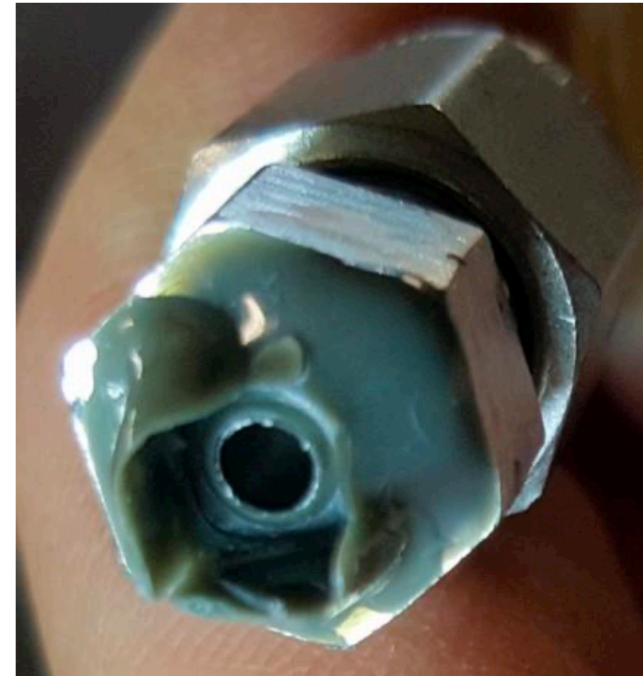
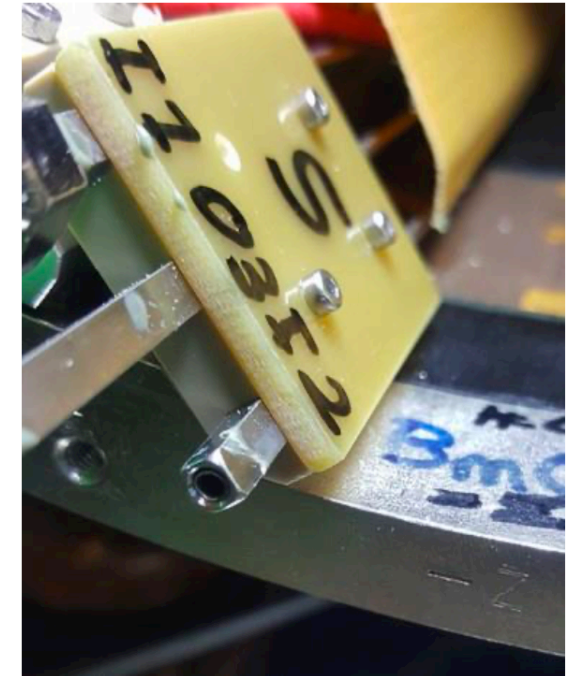
Forward Pixel CO2 cooling inlets

- ❑ Broke one connection during lab checkout
- ❑ Minimum mechanical torque needed to break off the fixed nut
- ❑ Risk was high to damage other connections during handling
 - ❑ Total 24 CO₂ inlet connections in Forward Pixel
- ❑ **The plan was to consolidate all the connections to ensure operational stability**

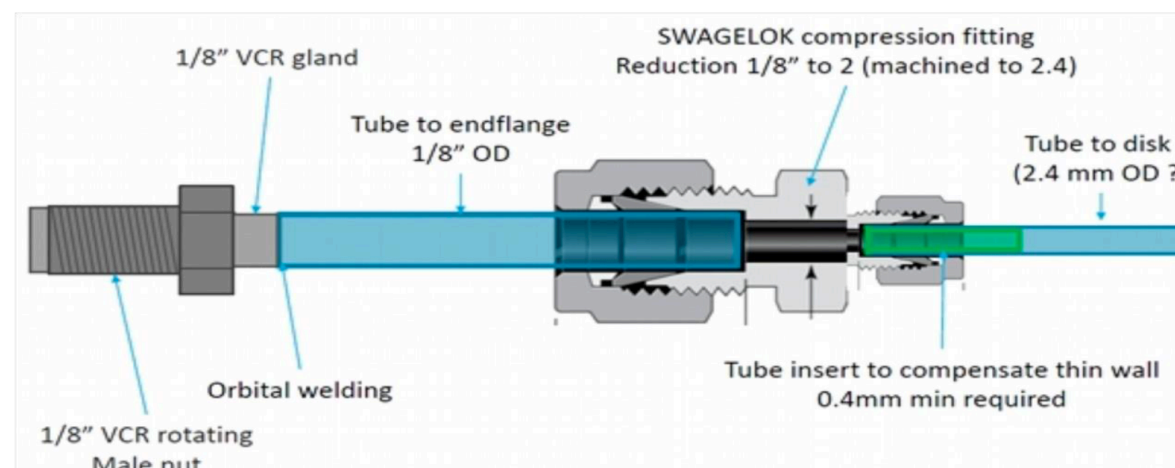
Rotating VCR nut
at end flange

Custom VCR
fitting solution

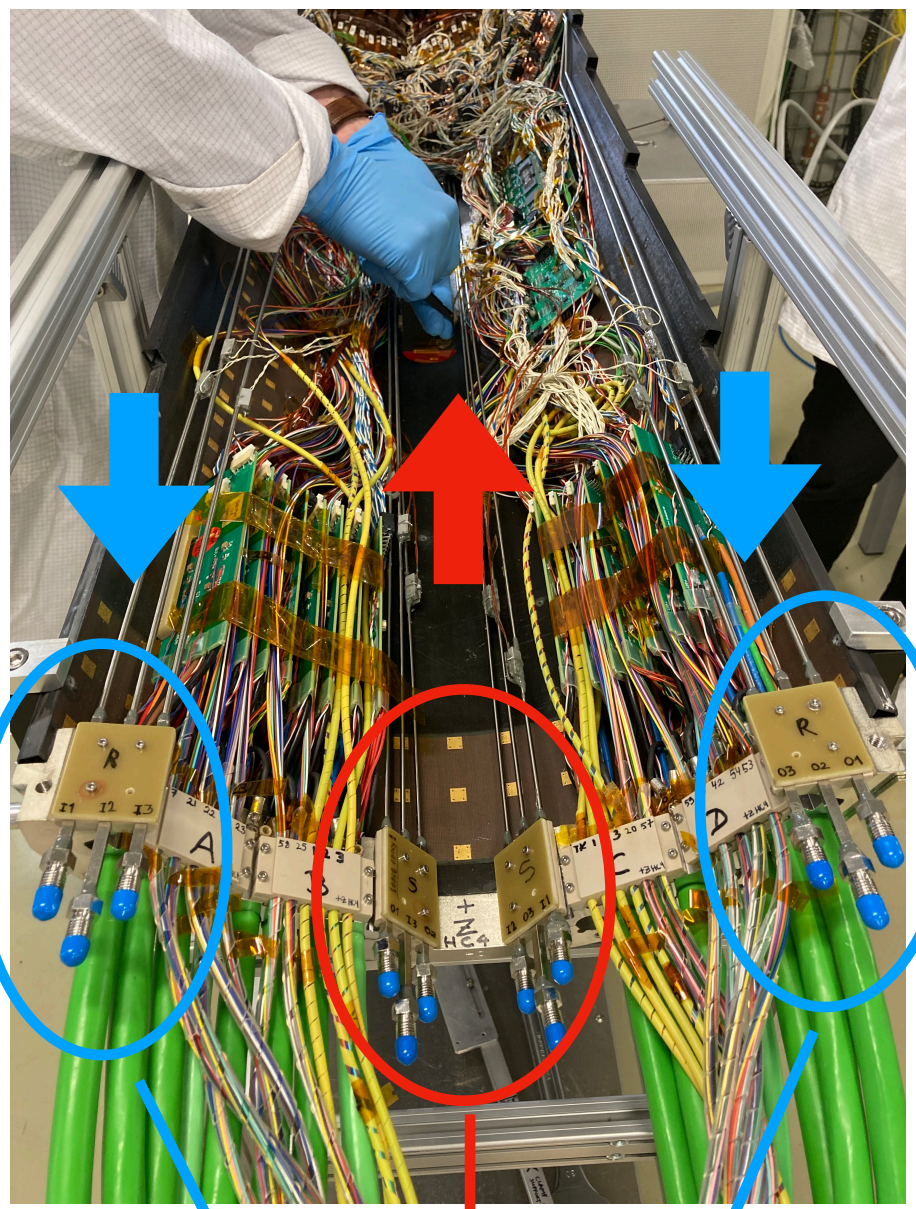
Cooling Inlets

Cooling Outlets

This is 1/4 th of FPix

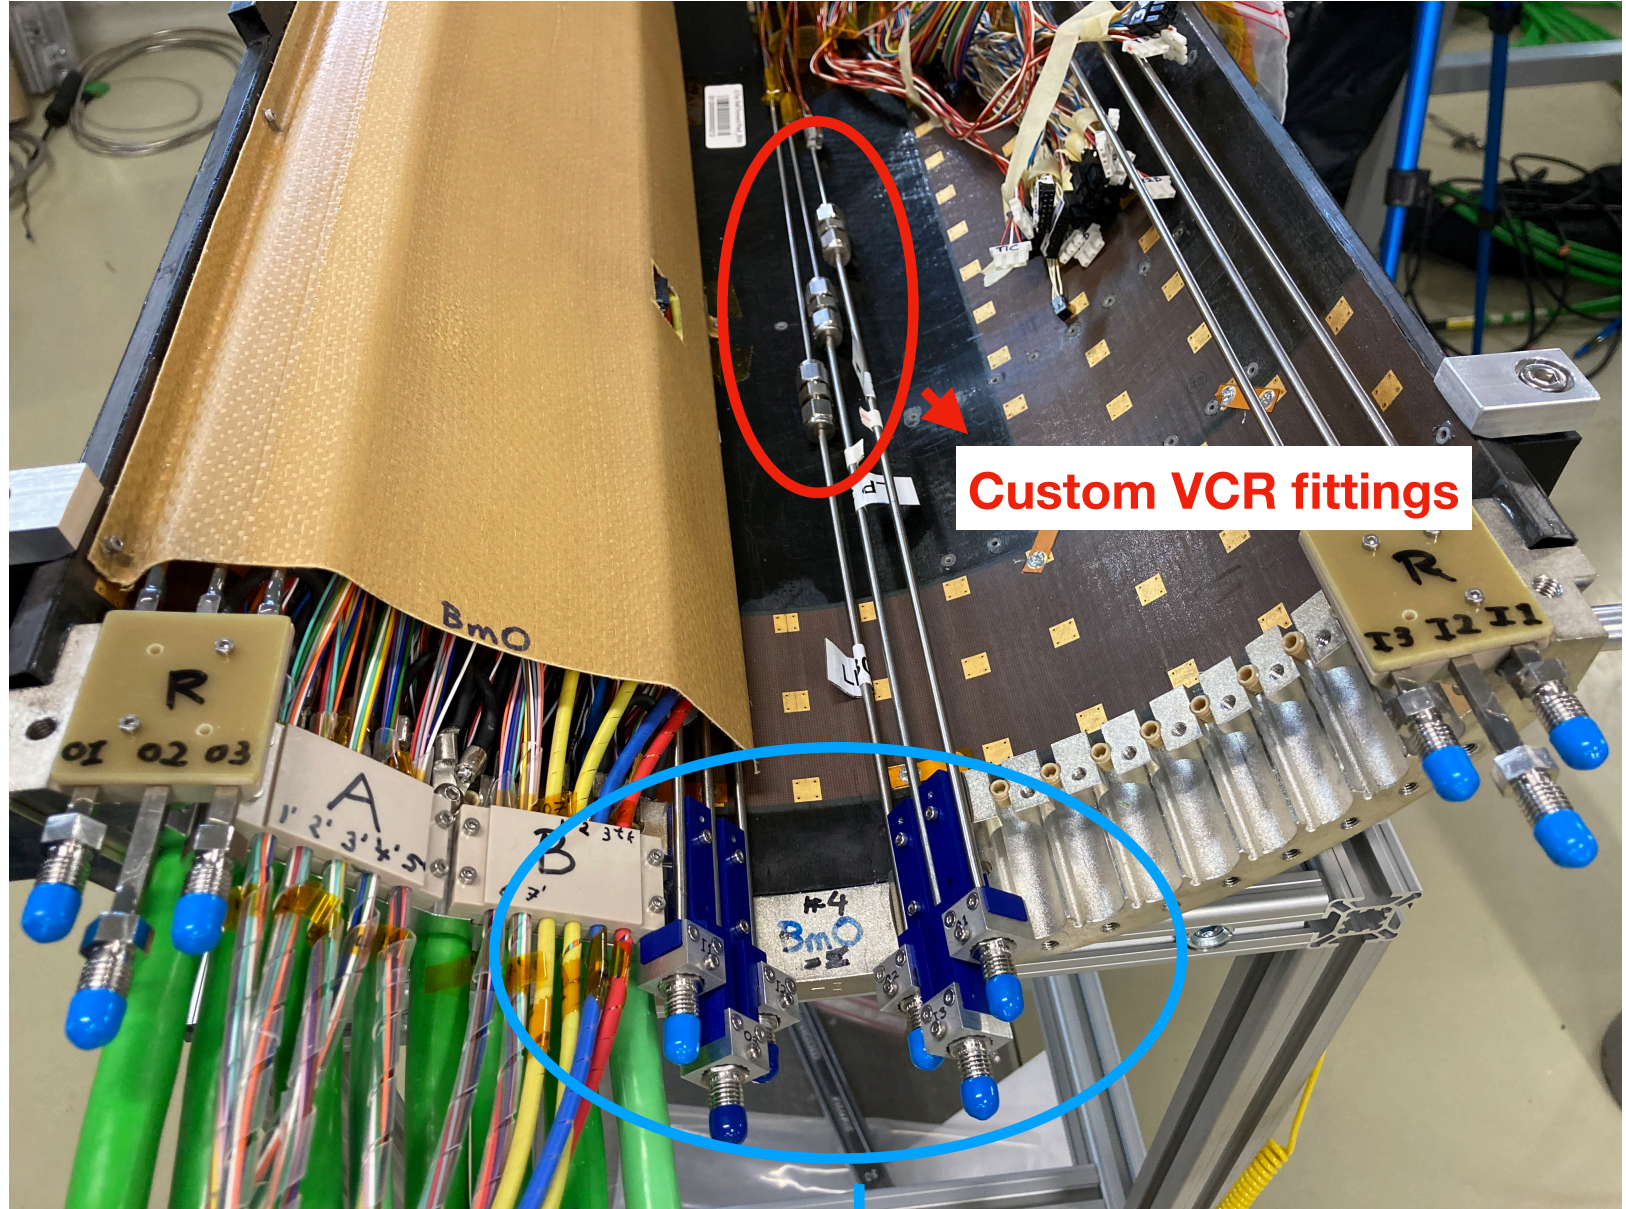
Custom VCR fittings

Newly installed supply inlets with redesigned mounts

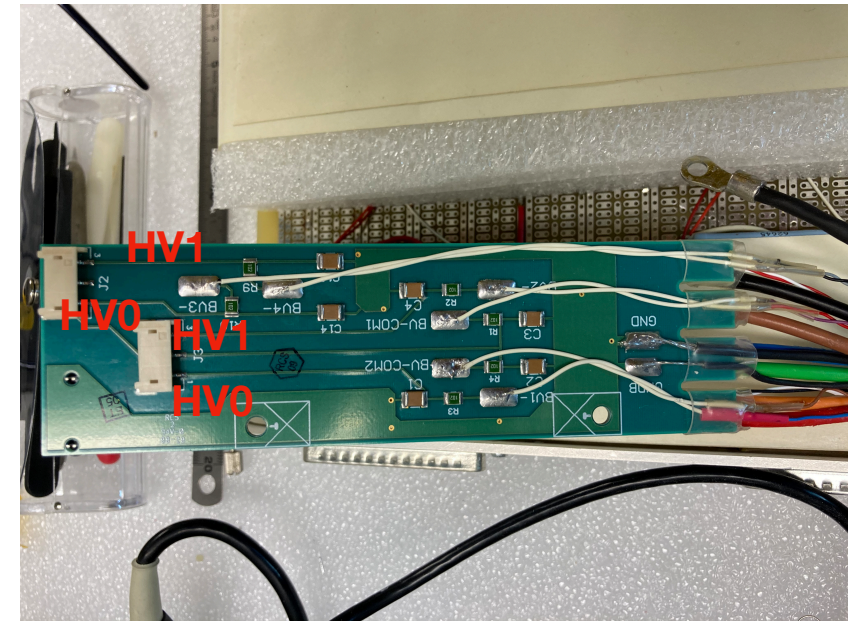
New board

4 independent HV lines
instead of two per power group

To better match the LV/HV granularity!

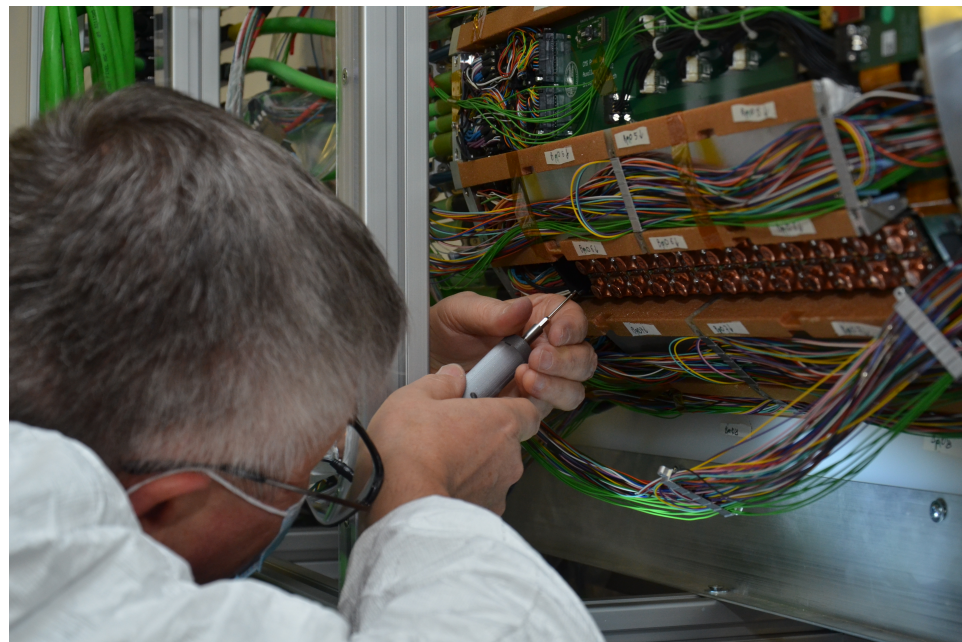
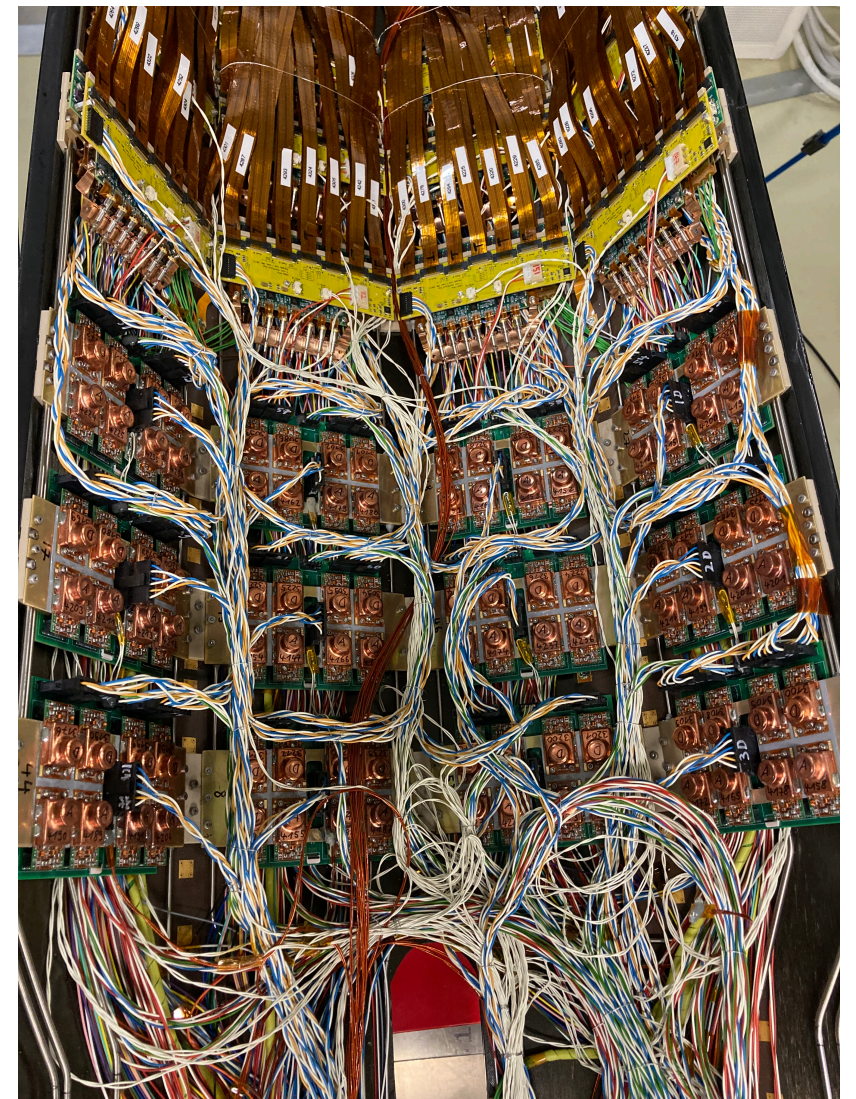
- New set of DCDC converters produced with the revised ASIC (FEASTv2.3)
- Fixed the failure mechanism in disabled state

Installed 1216 new converters for Run3 detector

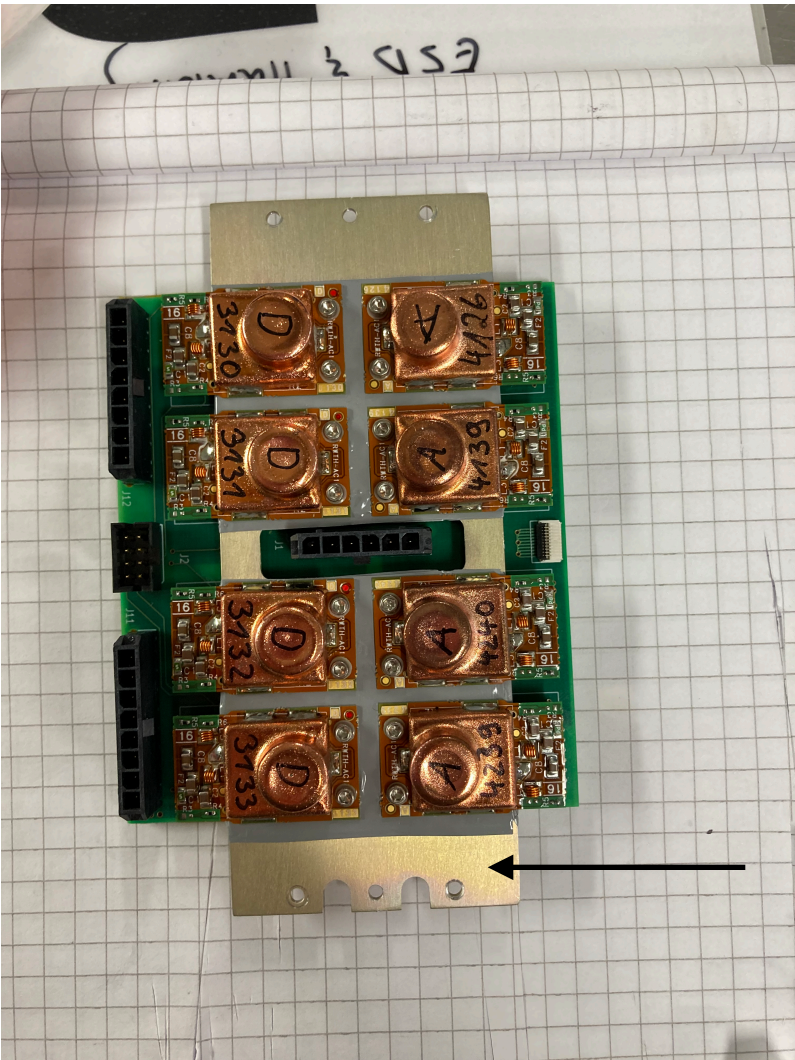
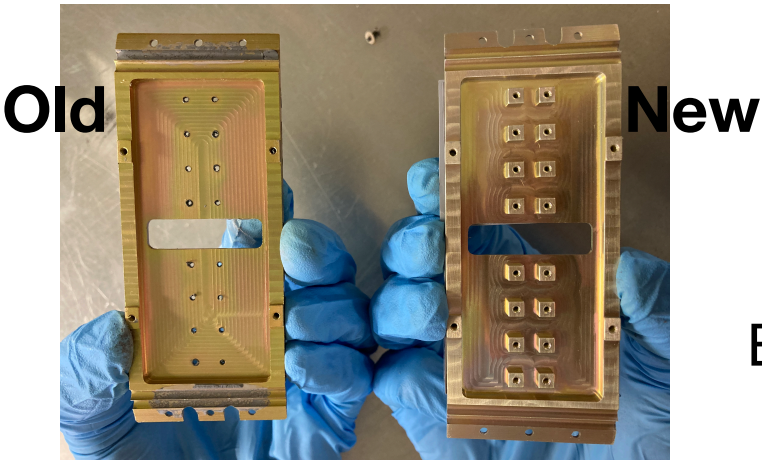
FPix Cooling Bridge Replacement

Aluminum Cooling Bridge

Better thread better thermal contact between DCDC and cooling bridge

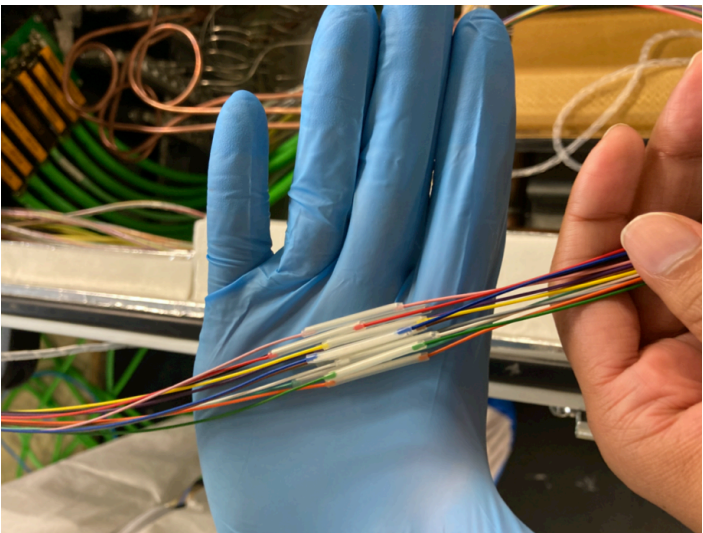
Splice the fiber bundle and replace with a new MTP

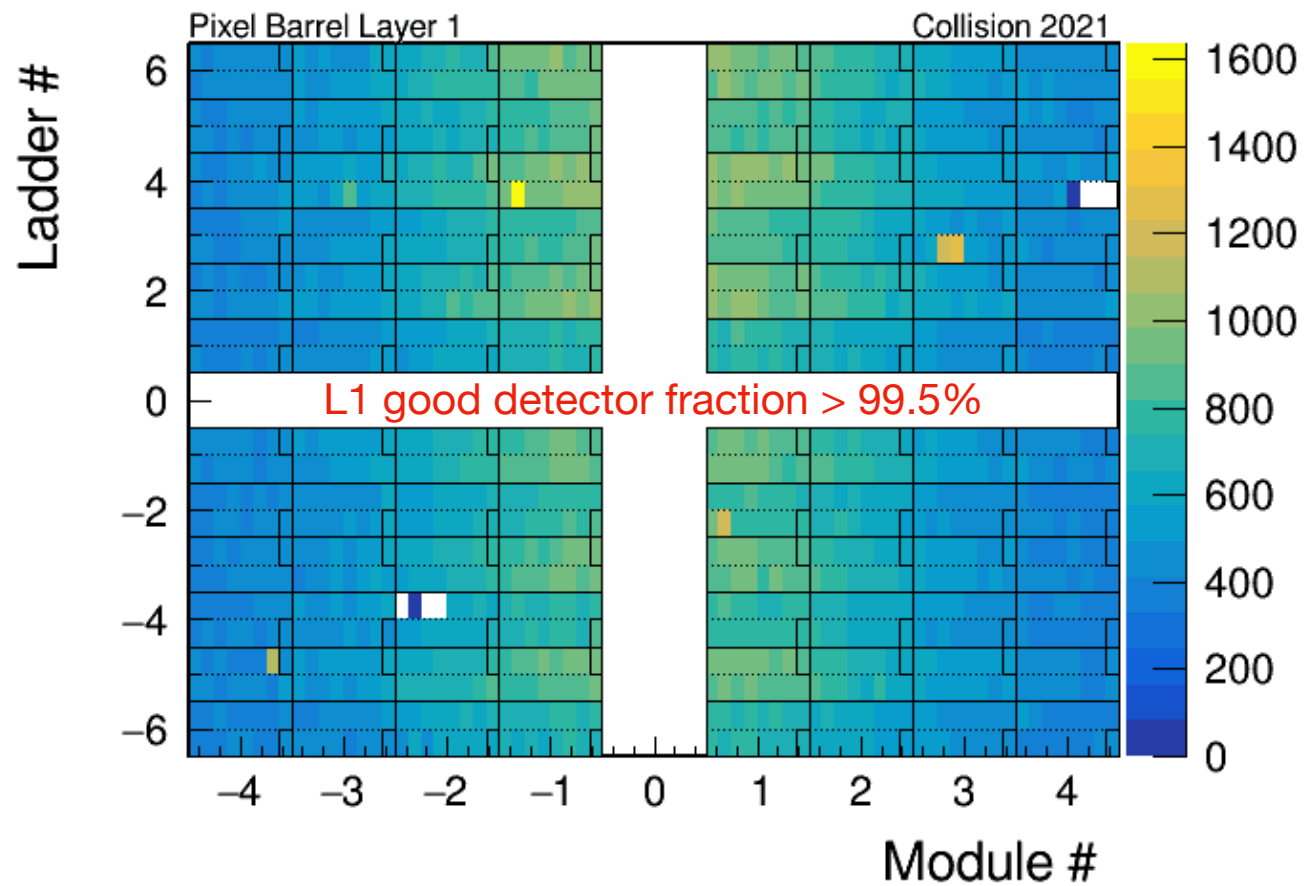
Layer 1 occupancy during pilot beam

Active Detector fraction:
BPix 99% and FPix 98%

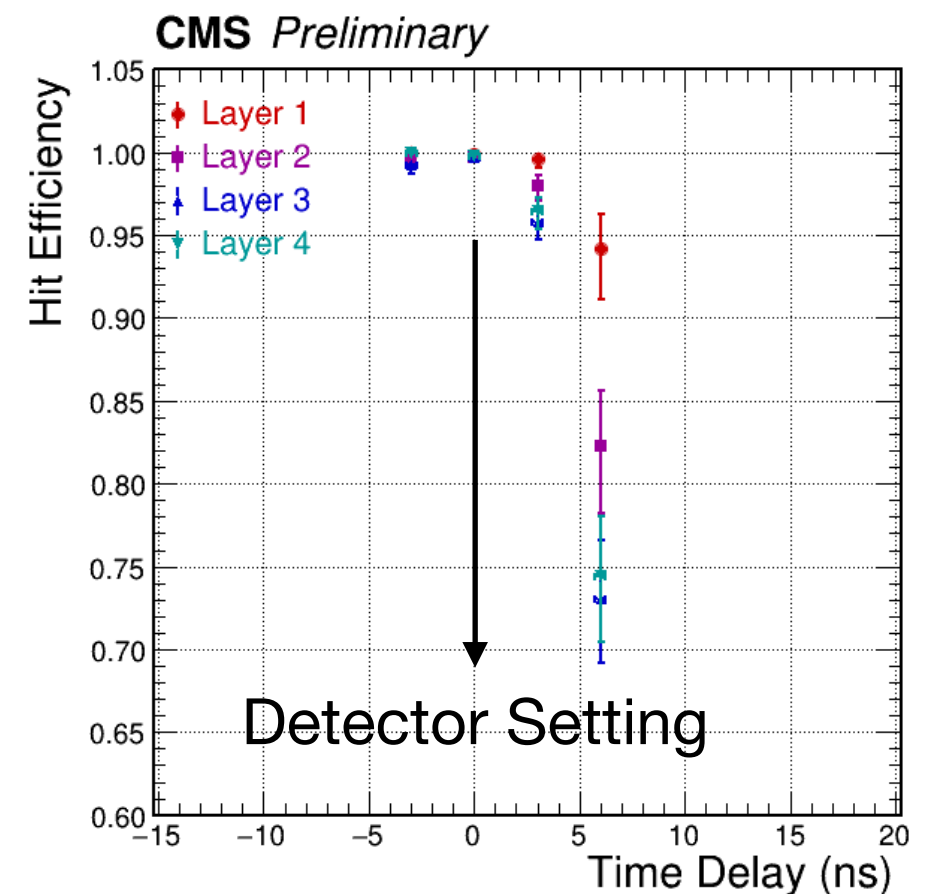
Coarse Timing Scan

New Layer 1 and rest of
the detector placed at
optimal delay

Utilized new TBM feature to set a
relative delay between L1 and L2

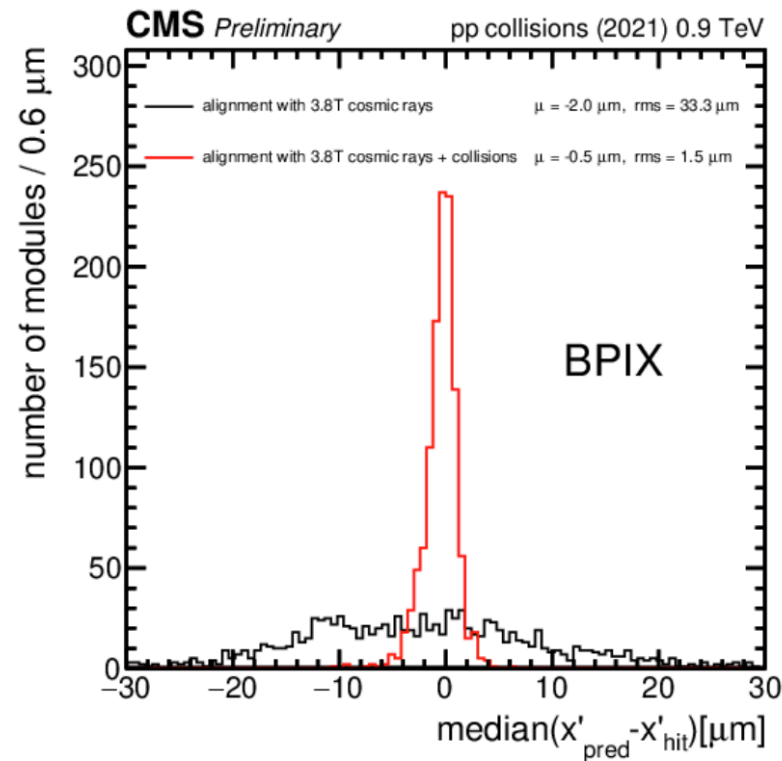
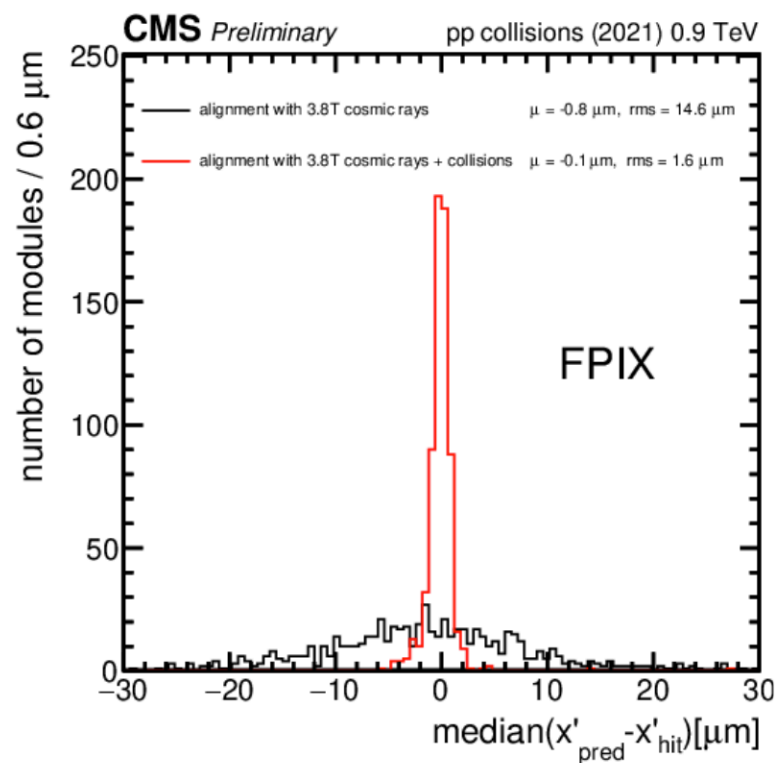
Refurbished detector newly realigned after the installation

Improved
residuals with
collision data

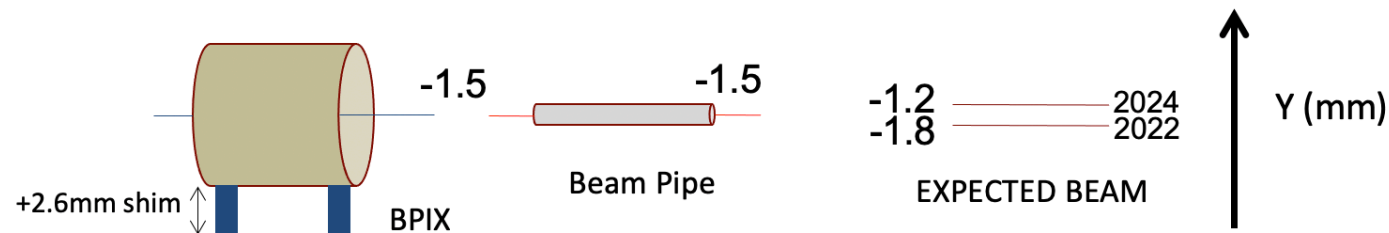
Where we wanted it for Run3 after re-installation in 2021

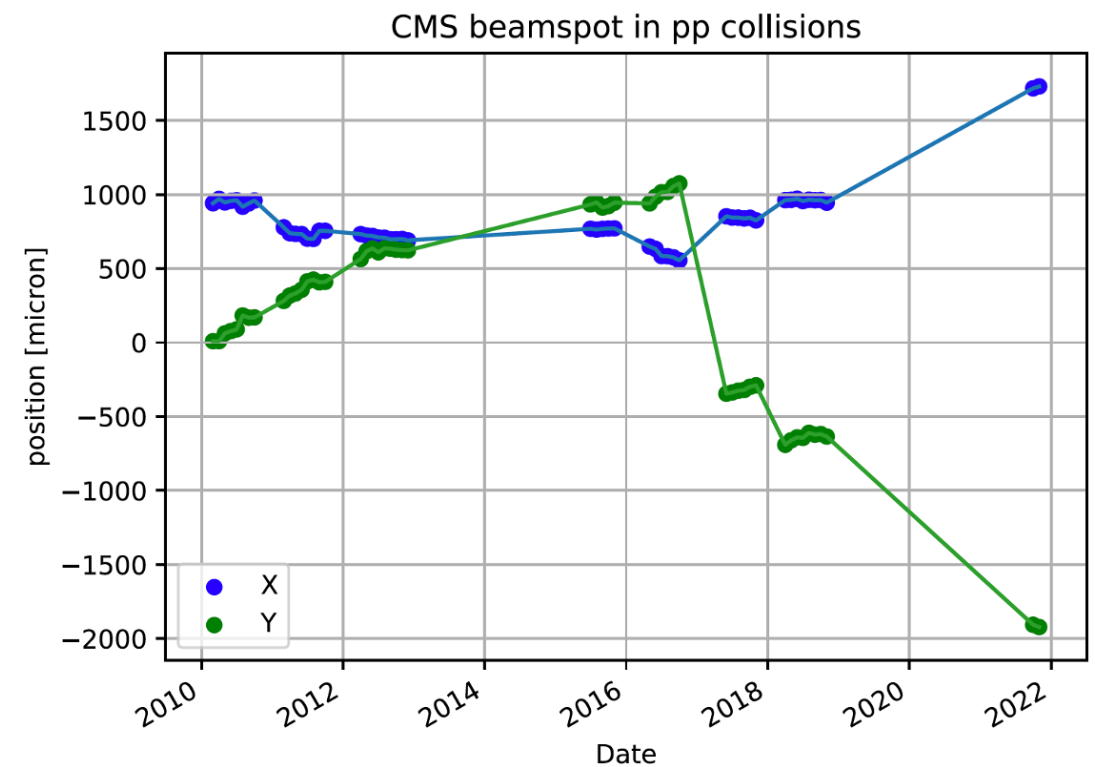
2021 pilot beam alignment data suggest that Pixel is perfectly positioned in Y coordinate
