Recent Test - CERN Pulsed DC Large Electrode System

2nd September 2021

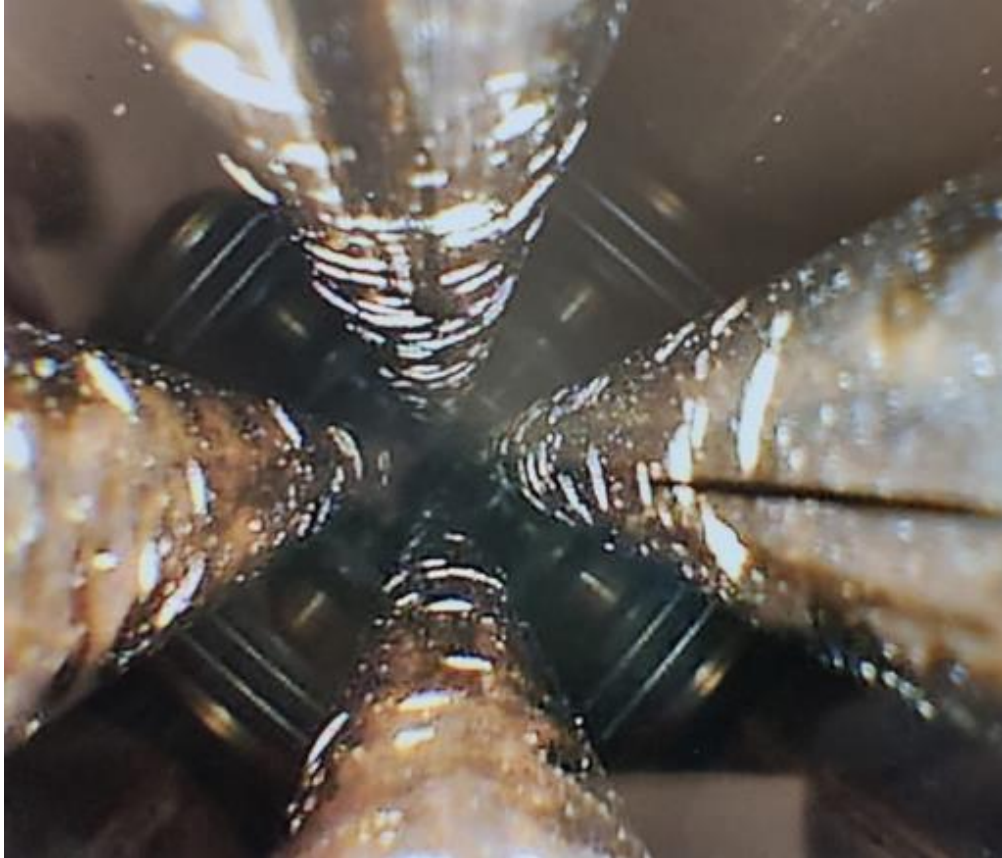
Breakdown rate (BDR) in RFQ

BDR: $\sim 10^{-4}$

Surface field: ~ 35 MV/m

RF pulse 1 ms
Rep rate 1 Hz

- A **replacement** RFQ is being manufactured
- Need to understand origin of enhanced breakdown rate, and find a mitigation
- Could **breakdowns** be **correlated with beam losses** ?

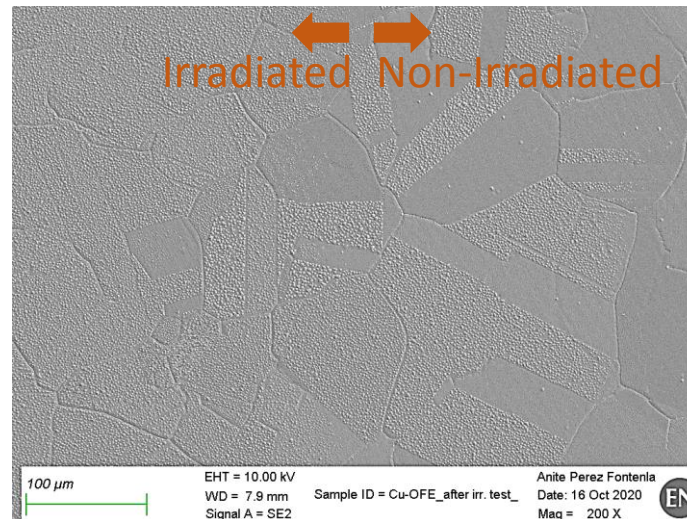
Pre-Test Scanning Electron Microscope (SEM) Analyses

SEM analyses of the surface displayed clusters of blisters in the 'C' shape of the beam and a visible transition between the irradiated and non-irradiated areas.

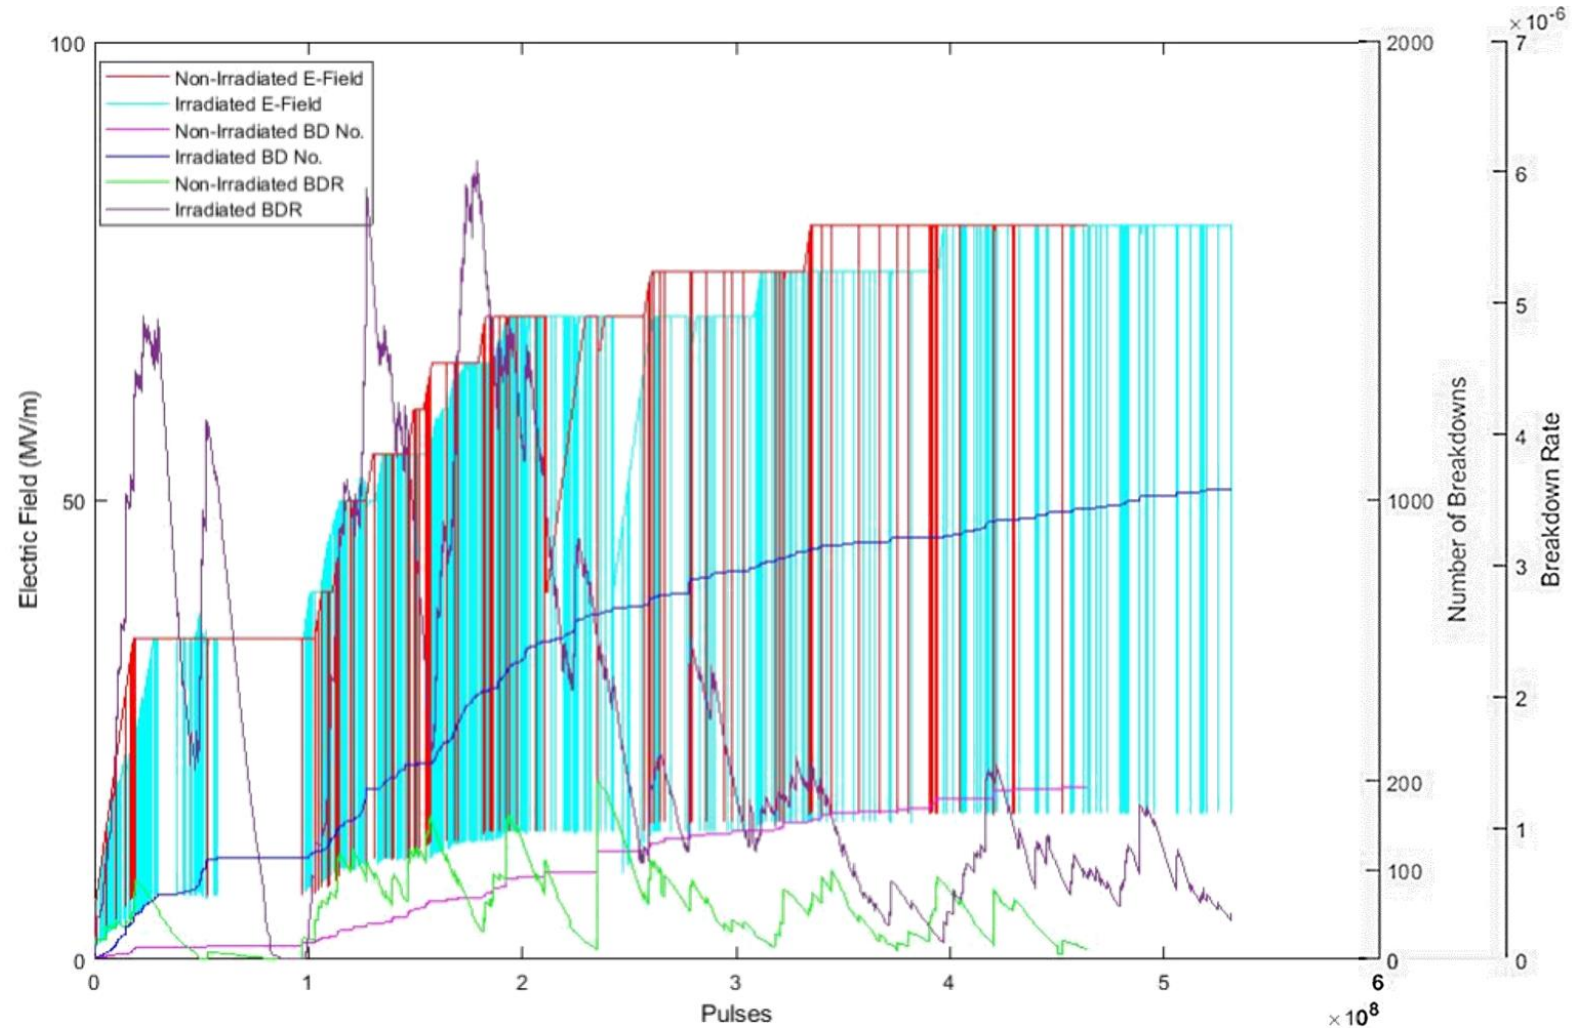
Irradiated vs. Non-Irradiated Cu BD Locations Conditioning

- Conditioning is a process where the electric field is gradually increased to achieve a higher operating field.
- 2 pairs of electrodes were tested, one with an irradiated electrode and the other without.
- Conditioning was done as similarly as possible.
- There is a large number of breakdowns in the initial stages of conditioning with the Irradiated cathode.
- The Irradiated electrodes appeared to have a reduced breakdown rate at higher voltages suggesting that the imperfections had been conditioned away.
- **Maximum stable E-Field 80MV/m**

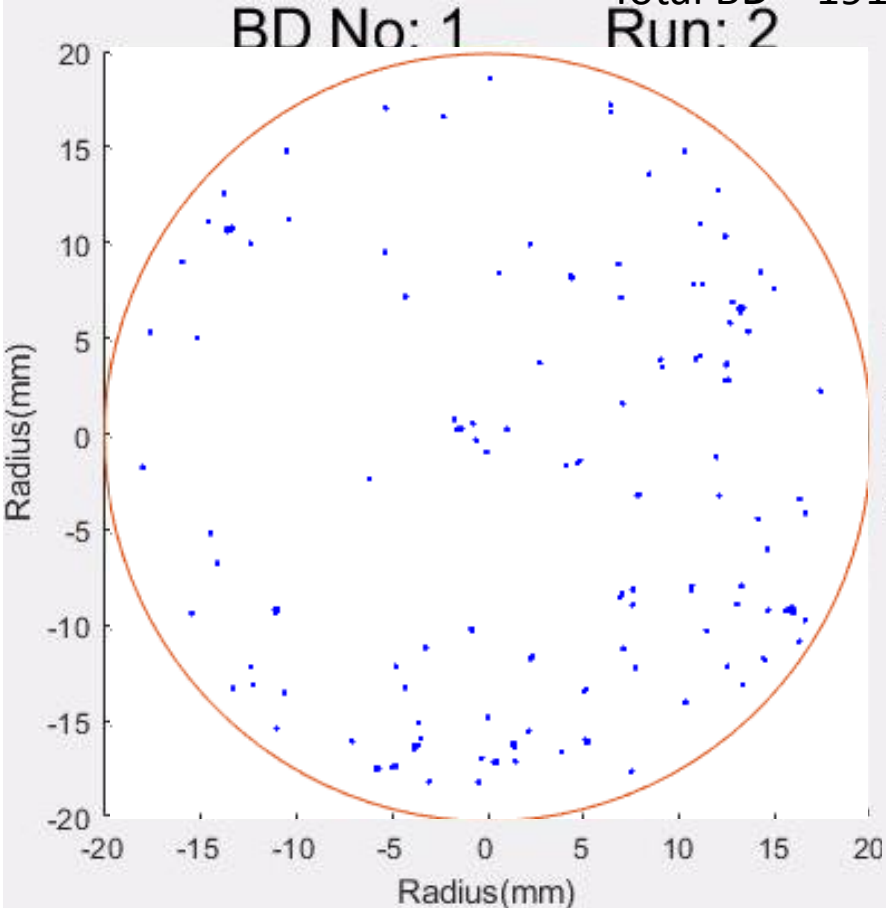
Non-Irradiated Electrode

Total BD = 191

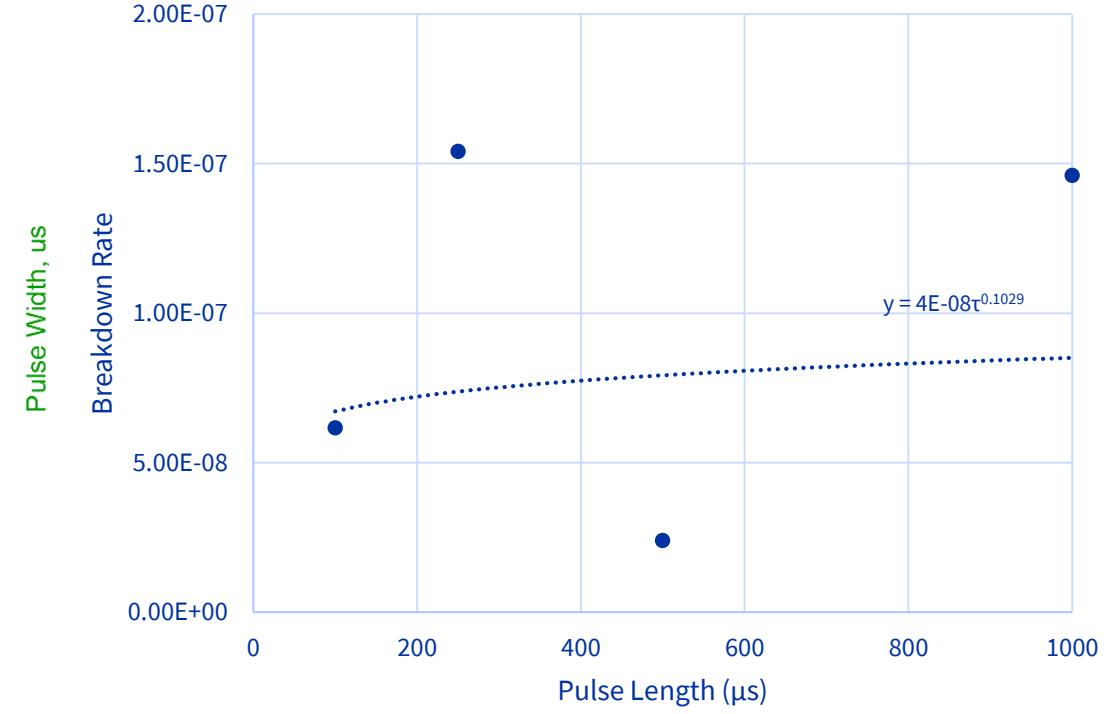
Pulse Length Dependence in the 1us to 1ms range

For small pulse lengths (50-800ns) the dependence is τ^5

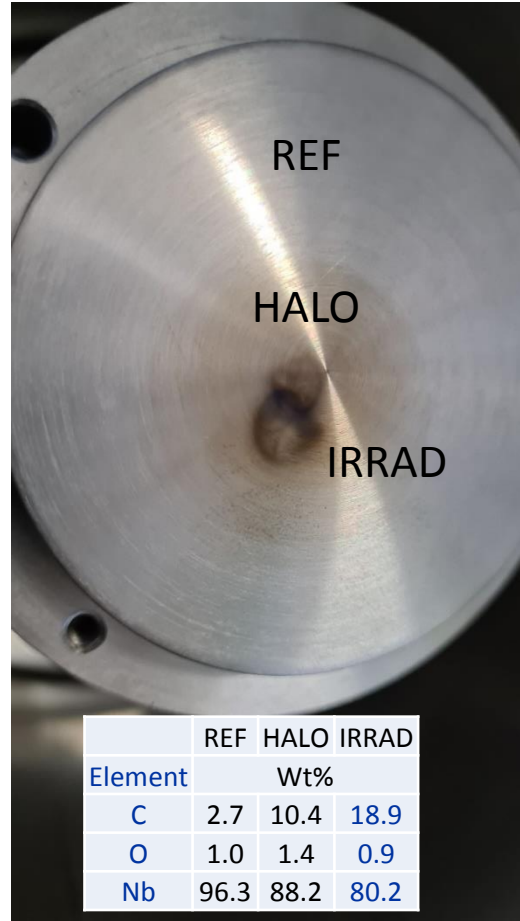
Irradiated Niobium

- 2 irradiation spots due to issues with measuring current during the first attempt.
- No physical changes to the surface from irradiation (e.g. no blisters or melting).
- Increased amounts of carbon in the halo and further increase the irradiated areas.
- Possibly cutting fluid contamination causing the discoloration during irradiation

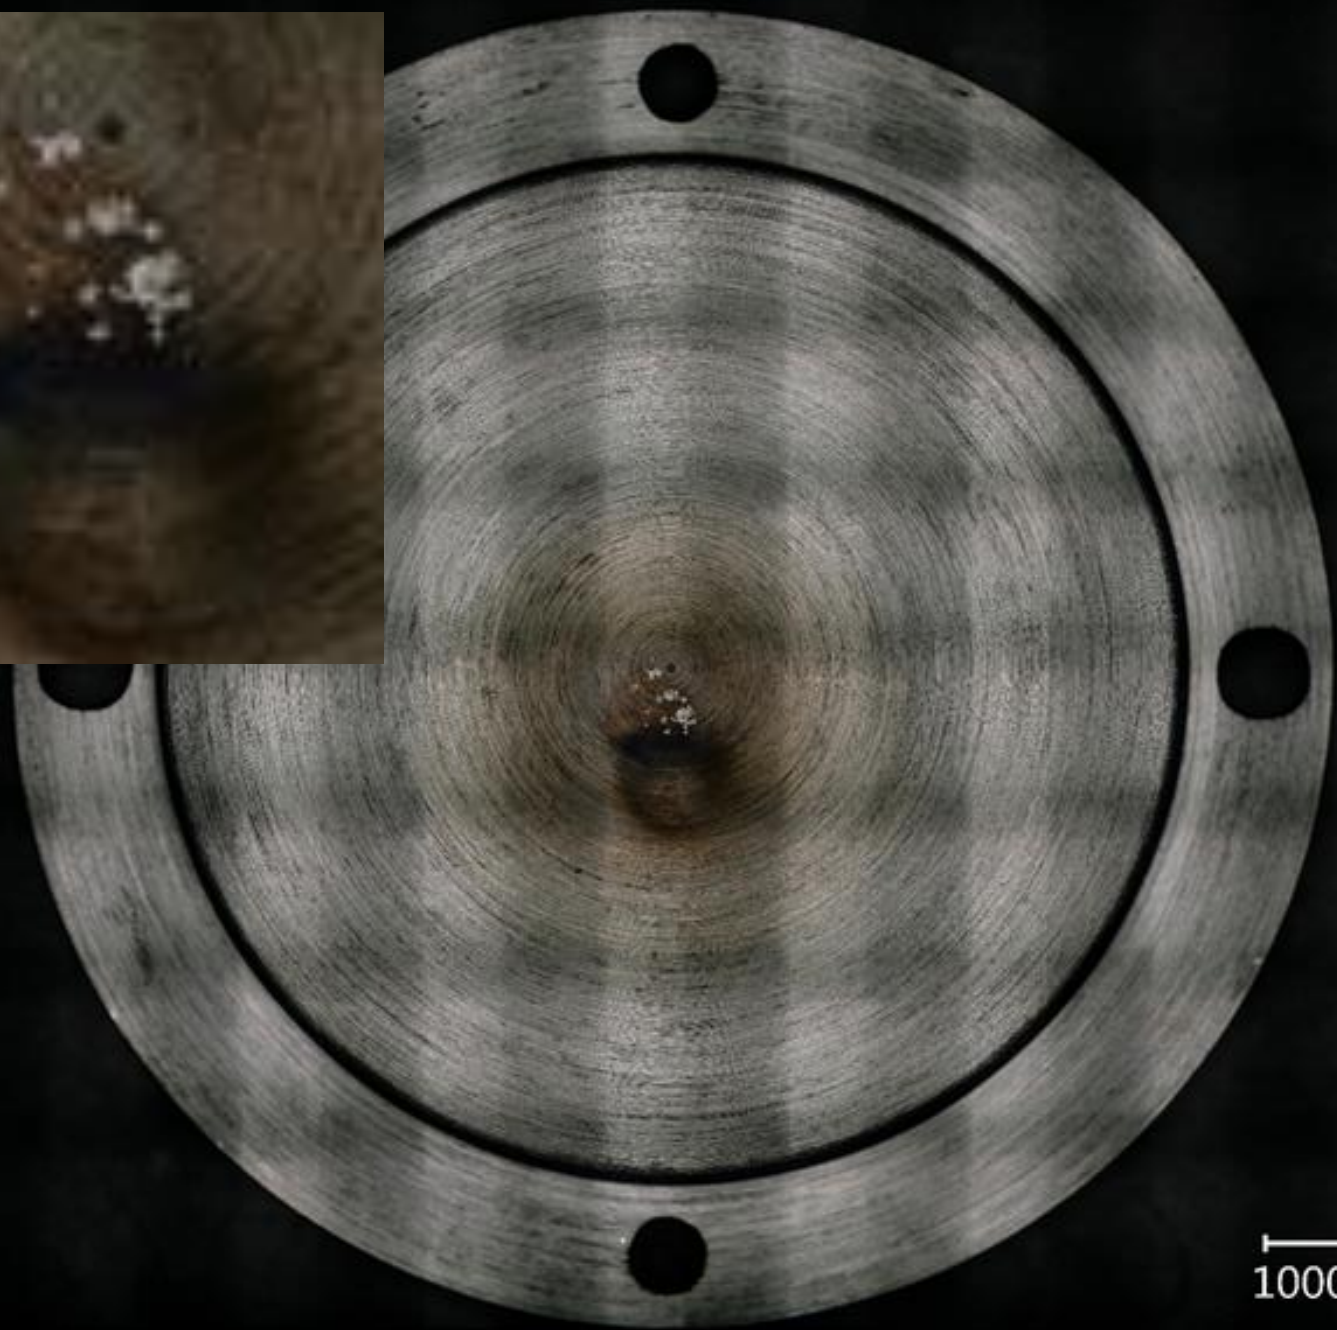
Irradiated Niobium

Max E-Field - 23MV/m

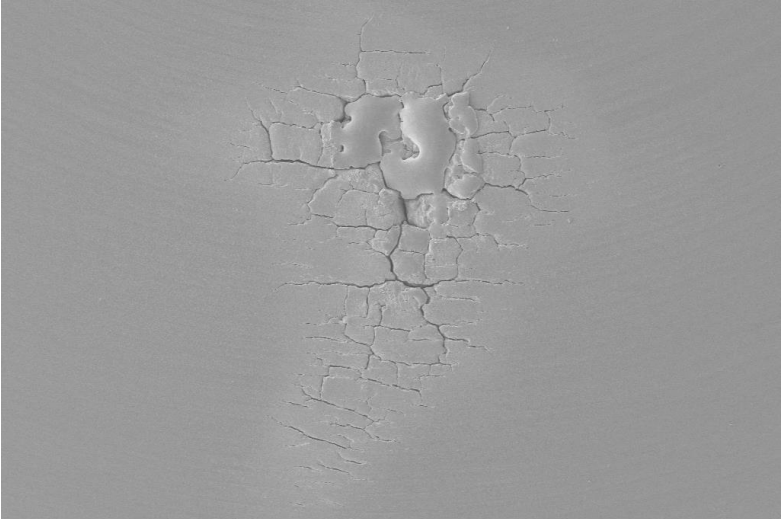
SEM Images after Irradiation (CuCrZr)

- Melting in the area of the beam spot during irradiation
- No tests done as the electrode was sent for re-machining
- Testing copper disks to determine beam parameters for next irradiation

300 µm EHT = 10.00 kV WD = 16.4 mm Signal A = SE2 Sample ID = CuCr1Zr_irrad_ Anite Perez Fontenla Date: 8 Feb 2021 Mag = 42 X EN
