39th CERN RD50 Workshop, 17-19 November 2021, Valencia

THICKNESS DEPENDENCE OF THE SEB BIAS THRESHOLD IN FS-LASER BASED MORTALITY STUDY ON LGAD FROM DIFFERENT PRODUCERS

Study on irradiated LGADs - Fall 2021 campaign at ELI

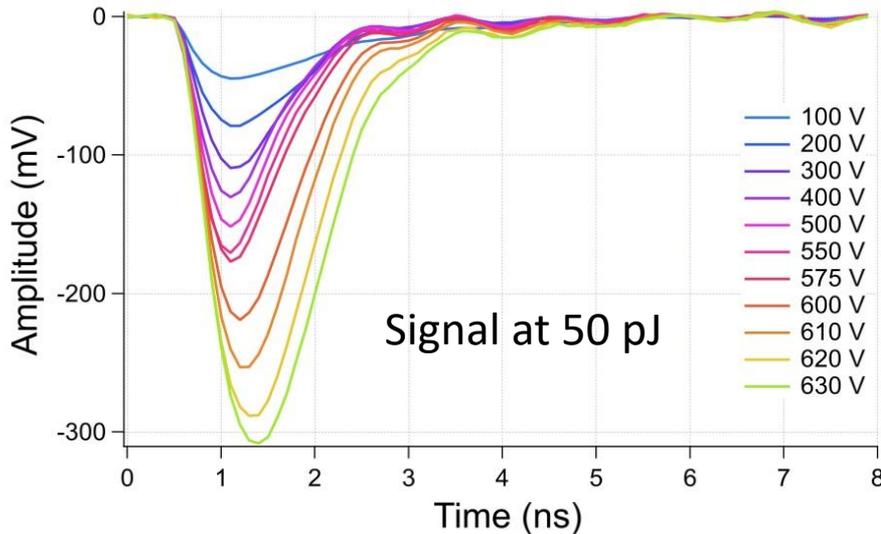
HPK-P2 W36 LGAD (1.5e15 50 um 2x2 array) Front SPA, 800 nm

Breakdown in the “safe” region as defined in previous study

- ✓ higher leak current at the same bias & higher amplitude signal at the same laser power for bias > 600 V (the most probable due to higher capacity – 2x2 LGAD area)
- ✓ **breakdown at lower laser power and bias (30 pJ/635 V vs 50 pJ/645 V previously)**
- ✓ **no visible damage on the pad after breakdown**
- ✓ **- it has to be inspected by microscope and further investigate in order to demonstrate that sensor died from the same mechanism as before (SEB and the same triggered conditions)**

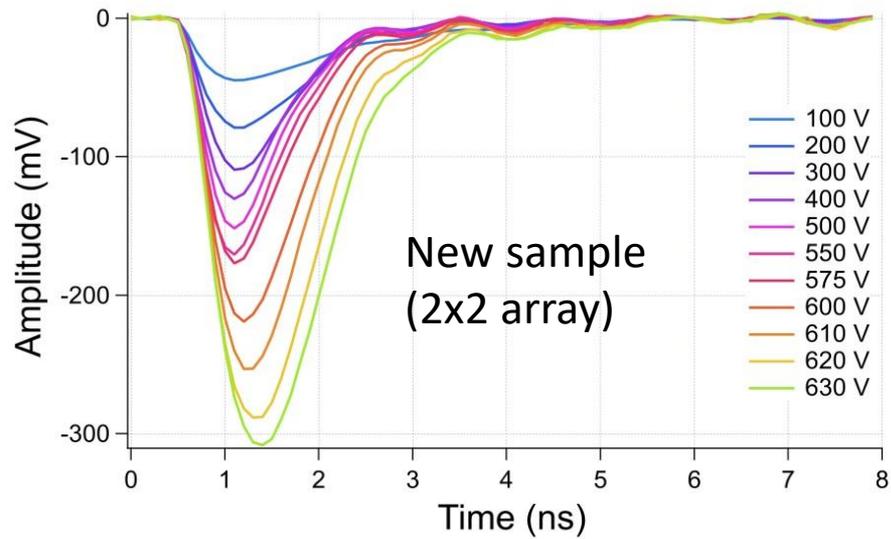
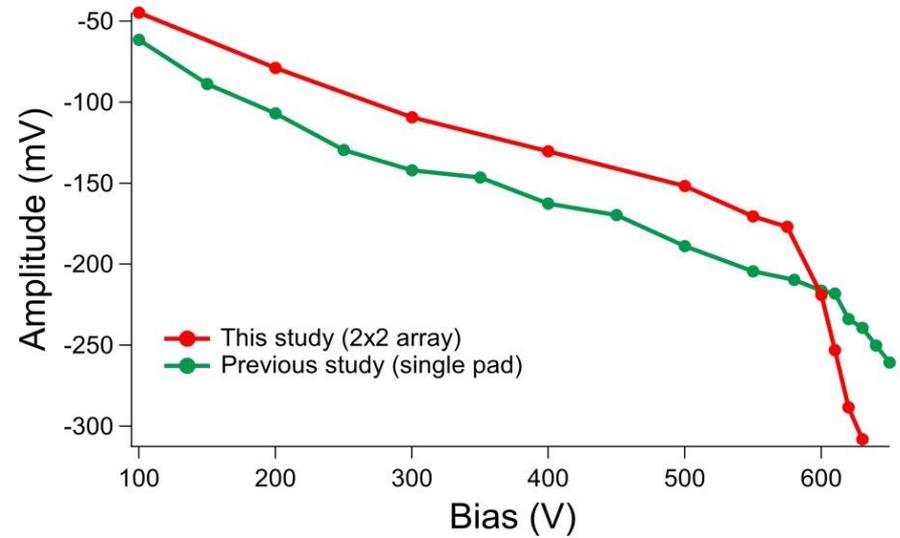
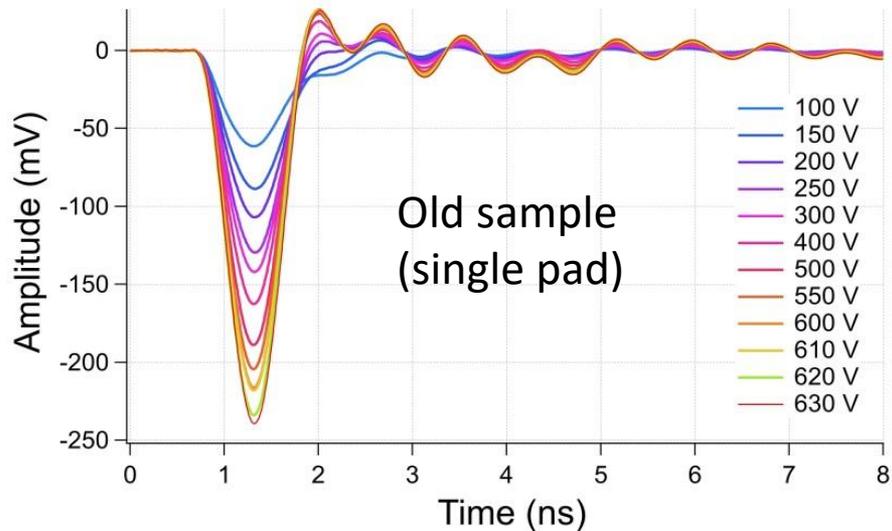
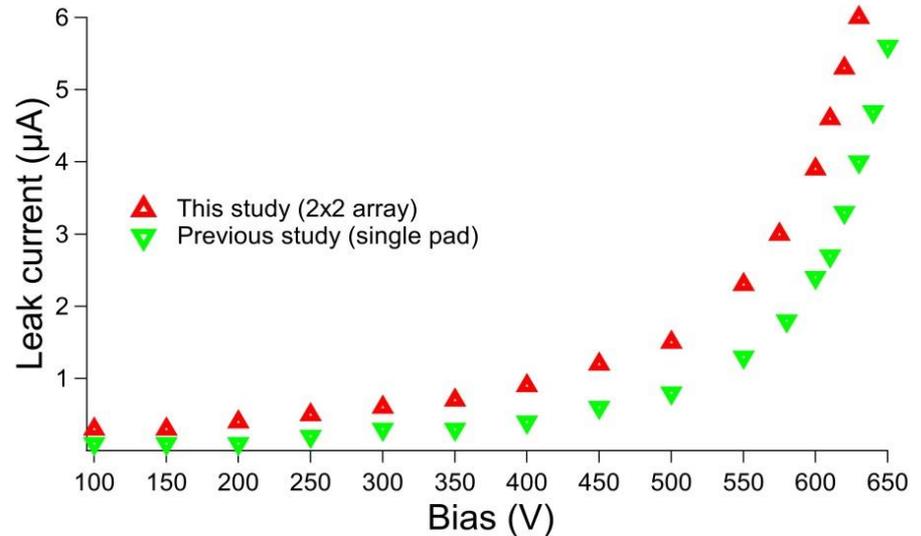
HPK-P2 W36 LGAD (1.5e15 50 um)

Comparison of new sample (2x2 array) with previous one (single pad)

□ Difference due to higher capacity of LGADs

Above 600 V waveforms for new sample are significantly broadened

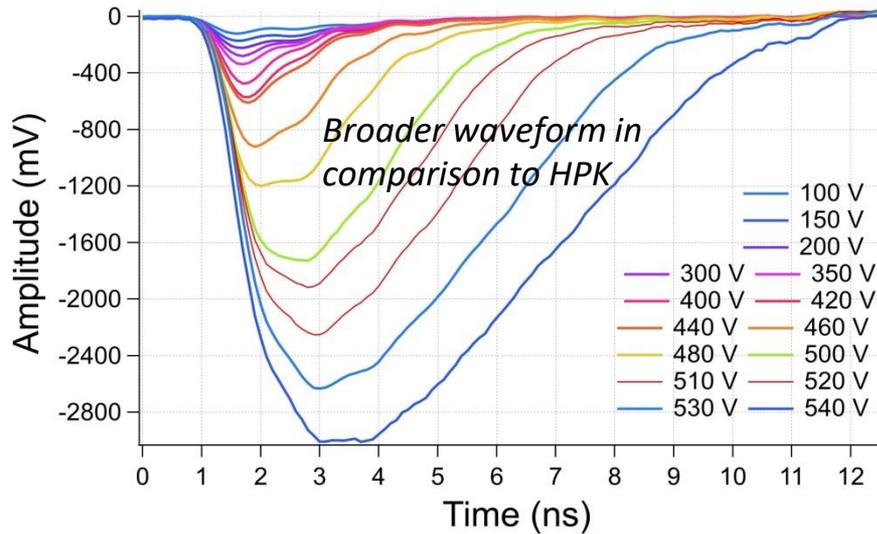
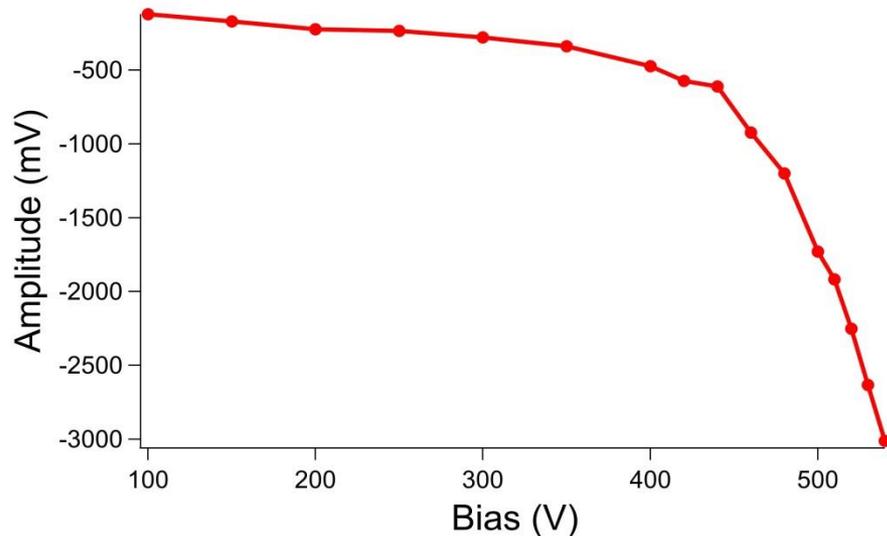
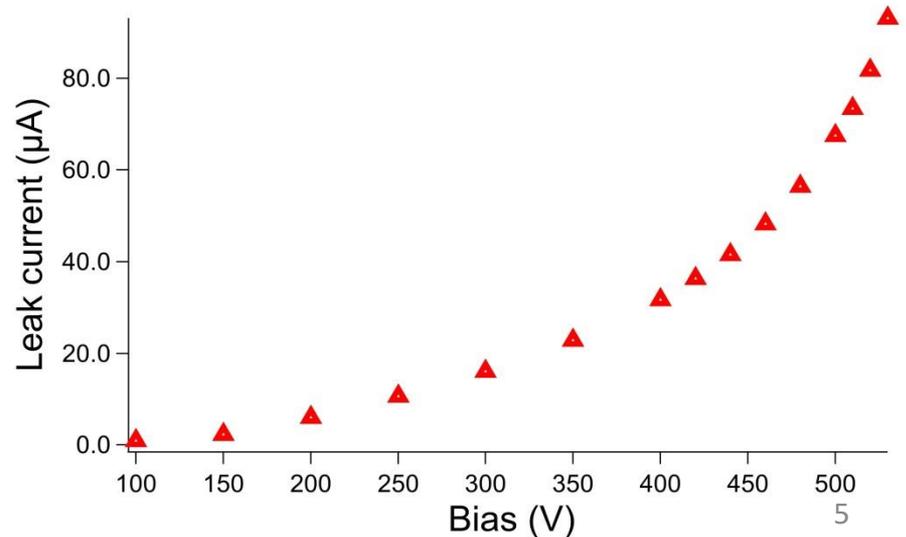
FBK UFSD3.2 W18 LGAD (1.5e15 45 um 2x2 array)

Signal at 50 pJ

- this sensor has nominal max. bias ~550 V
- waveforms start broadening significantly above 450 V but the signal is stable (no jumping) in all studied range
- Leak current is stable below 550 V
- Leak current jumps rapidly above 0.5 mA at 550V but not irreversible damage happens
- sensor works normally after decreasing bias below 550 V
- **rapid jump of current at 550 V occurs also for low pulse energies < 10 pJ**

(0.5 mA is a safety limit of our HV power supply so further increase of bias is not possible)

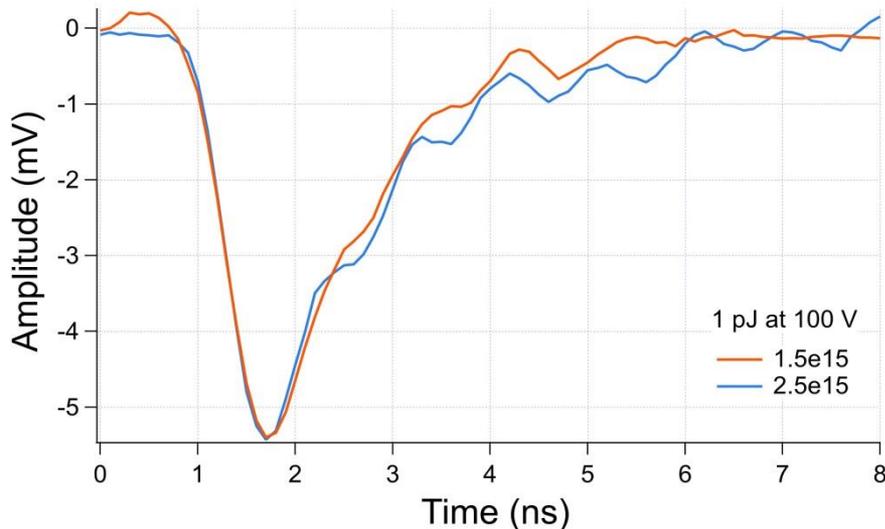
FBK UFSD3.2 W18 LGAD (2.5e15 45 um 2x2 array)

Irreversible damage of the sensor
at 545V for 1 pJ pulse energy.

Only one result we managed to get for this sample is single waveform we registered during alignment. Below it's comparison with the first FBK sample (1.5e15). The waveforms for both samples are very similar.

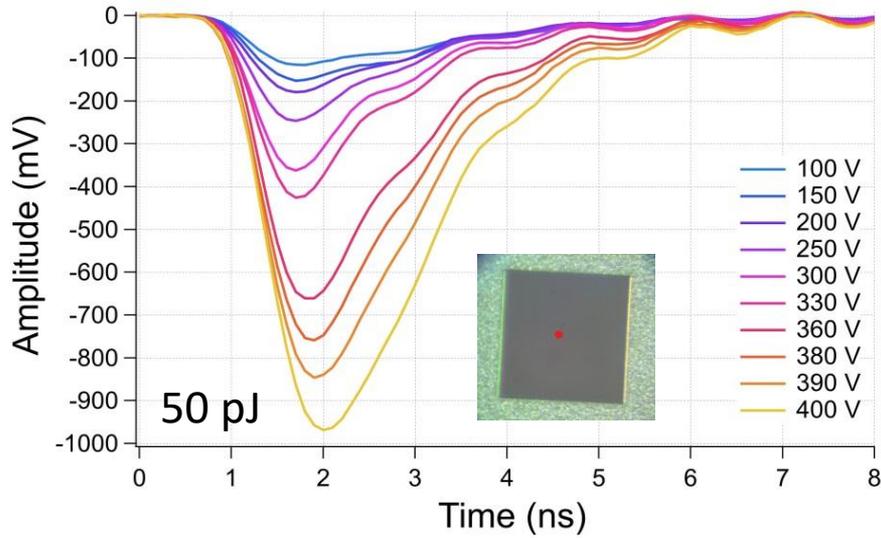
Opening window

- this sensor has nominal max. bias ~ 400 V
- the measurements in this range were performed for opening window and for the interpad region
- the results are nearly identical

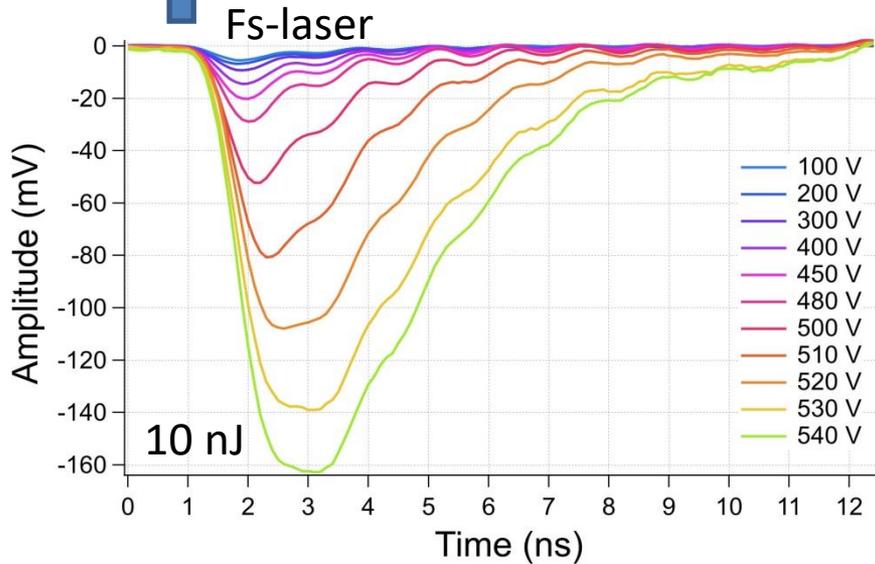
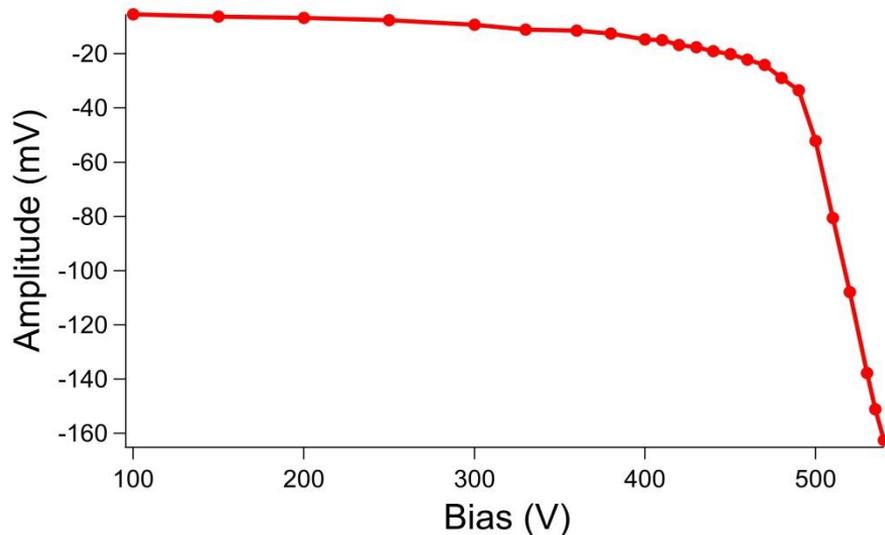
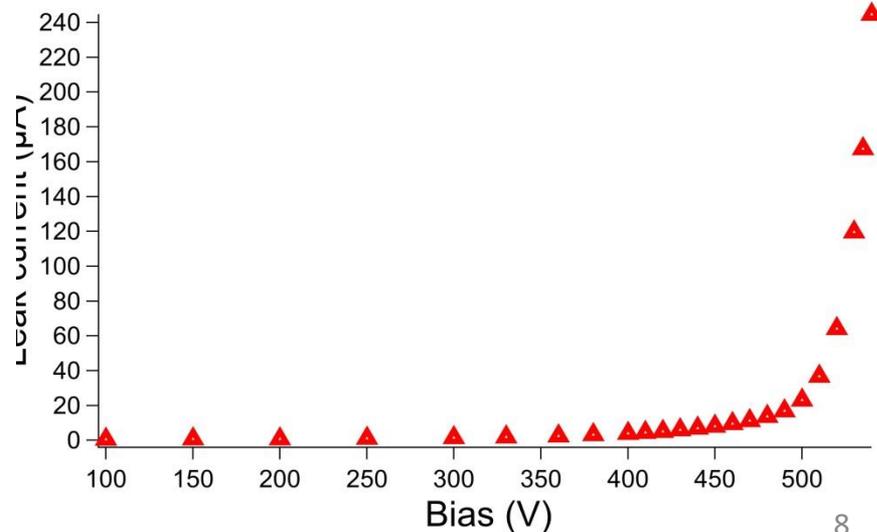
HPK-P1 W4 LGAD (1.5e15 35 um 2x2 array) (backside illumination)

- to get a reasonable signal by illumination from the backside much higher pulse energy is necessary
- **more or less one order of magnitude higher pulse energy gives the signal comparable with front illuminated sensor (10 nJ vs 10 pJ)**
- although nominal max. bias for this sensor is ~400 V it turned out that it **can survive significantly higher voltage (at least 544 V)**
- the signal became slightly instable (small jumping of amplitude) above 500 V
- leak current jumps rapidly above 0.5 mA at 544V but not irreversible damage happens

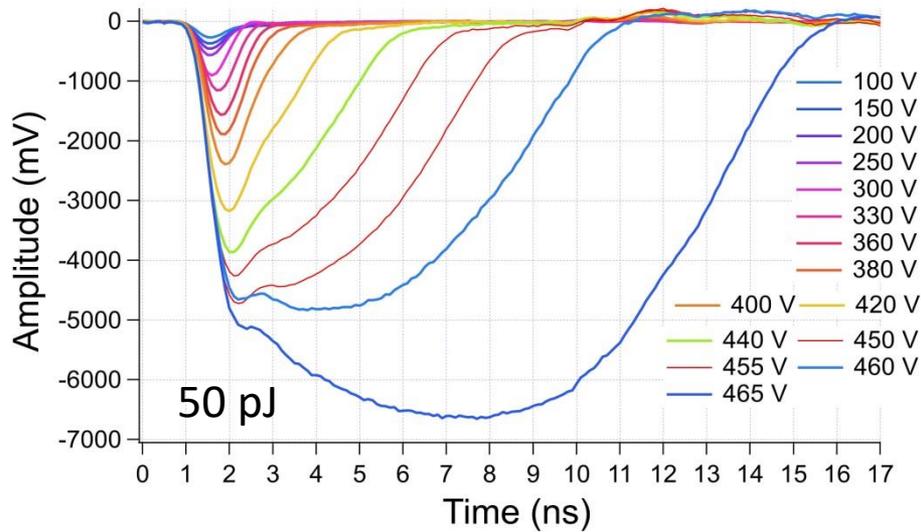
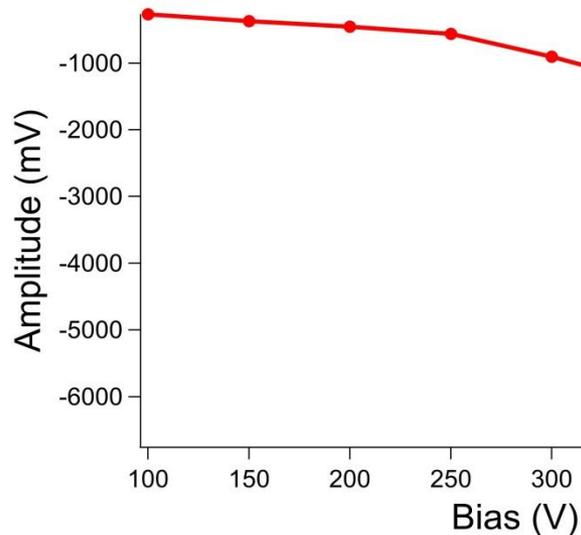
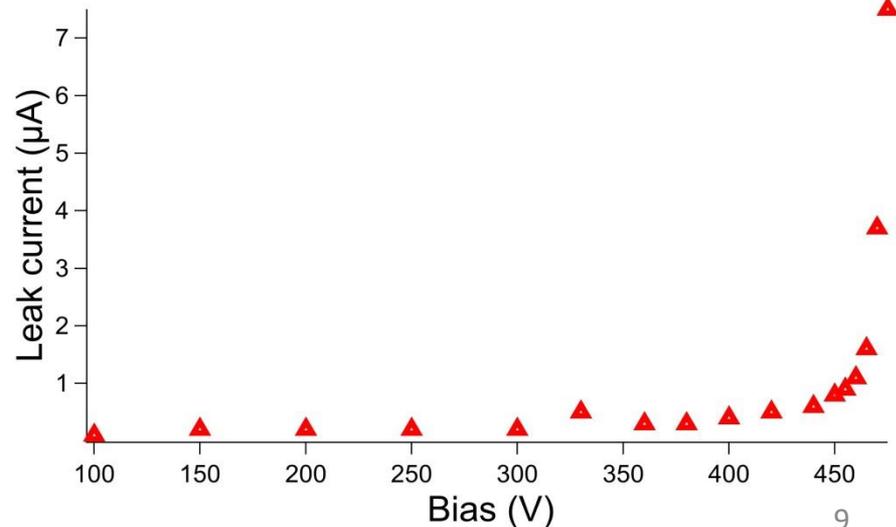
HPK-P1 W4 LGAD (2.25e15 35 um single pad) Frontside

- although nominal max. bias for this sensor is ~400 V it turned out that it can survive higher voltage (at least 505 V)
- the signal became very broad above 420 V
- the signal became slightly instable (small jumping of amplitude) at 450 V
- the signal is highly deformed and extended at 470 V (see next slide)
- above 470 V the signal is too high to be measured
- leak current becomes unstable at 505 V

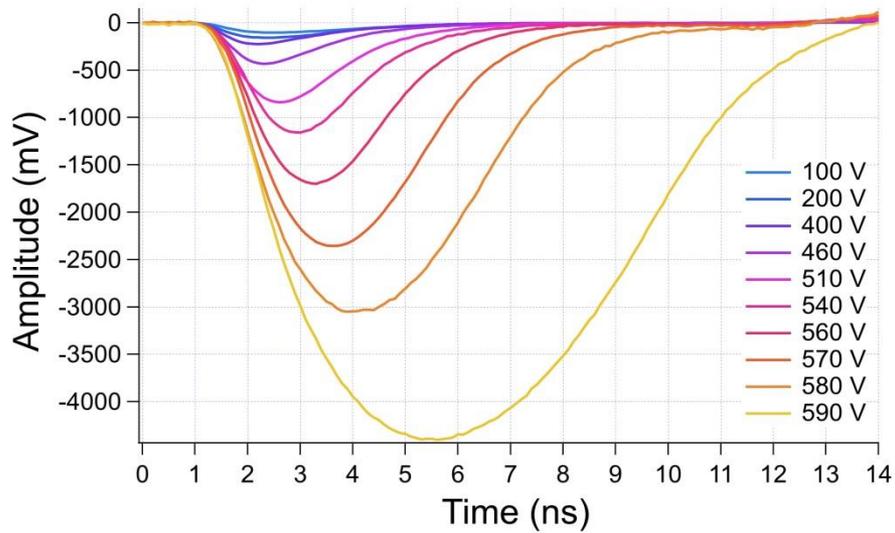
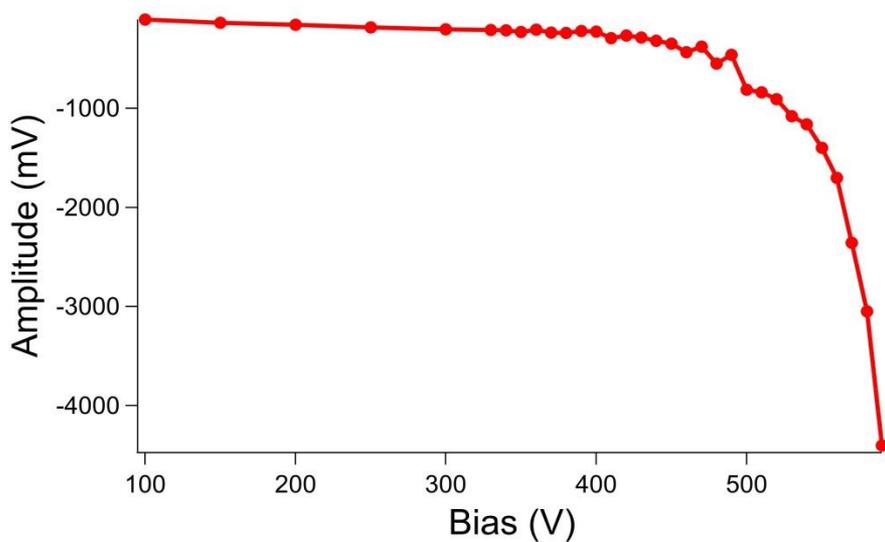
W1 LGAD (1.5e15 50 um) LGB, 3.5x3.5 mm²

Signal of the sensor vs bias is relatively linear for lower values (up to 400 V). For higher values we observe **rapid highly nonlinear increase of the signal amplitude and significant broadening of the waveforms.**

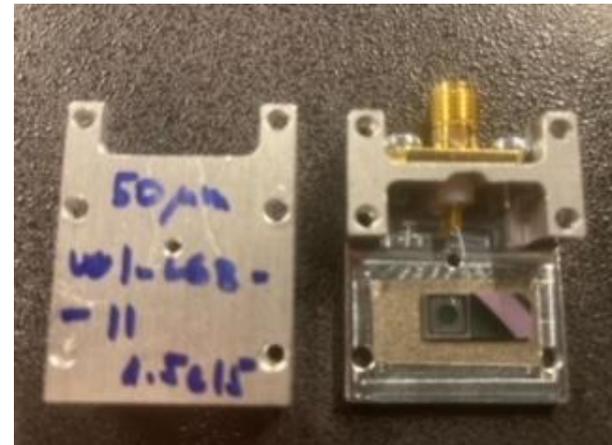
W1 LGAD (1.5e15 50 um):continuation

- Signal is stable up to 600 V
- Above 600 V signal becomes unstable (amplitude vary , the waveform is deformed and extended to microsecond scale)
- **At 615 V the sensor breaks down irreversibly**
- Probably some damage spots appear in the illuminated area after breakdown but further visual inspection with electron microscope is needed (we plan to do it in 1-2 weeks)

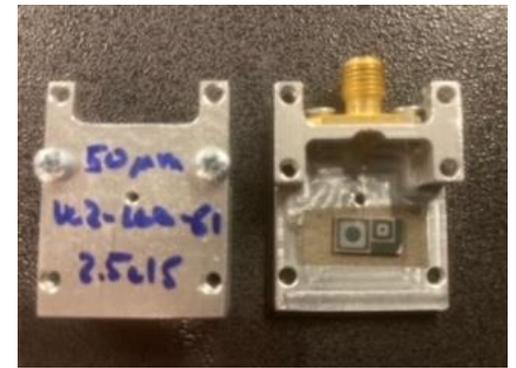
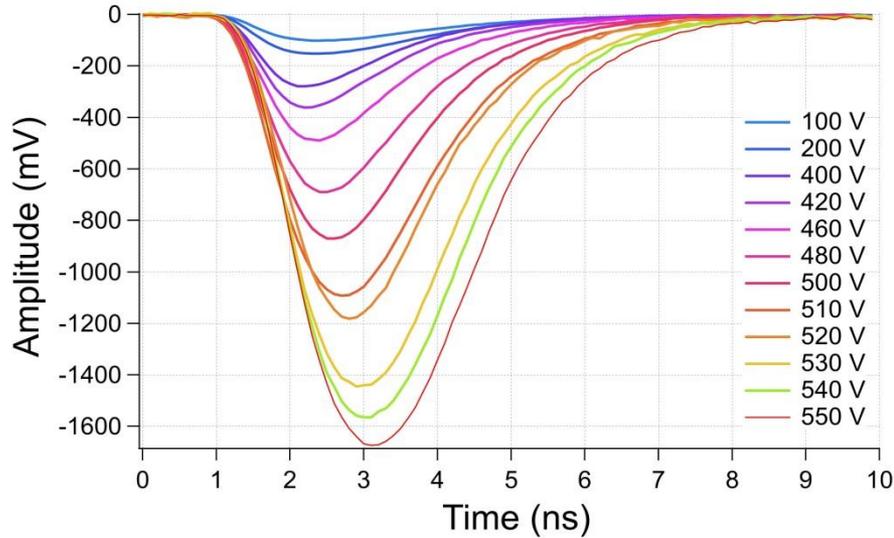
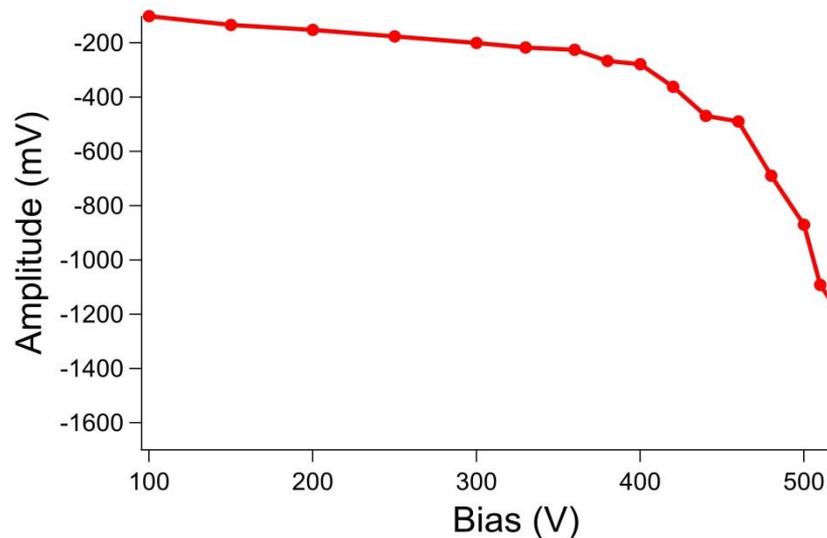
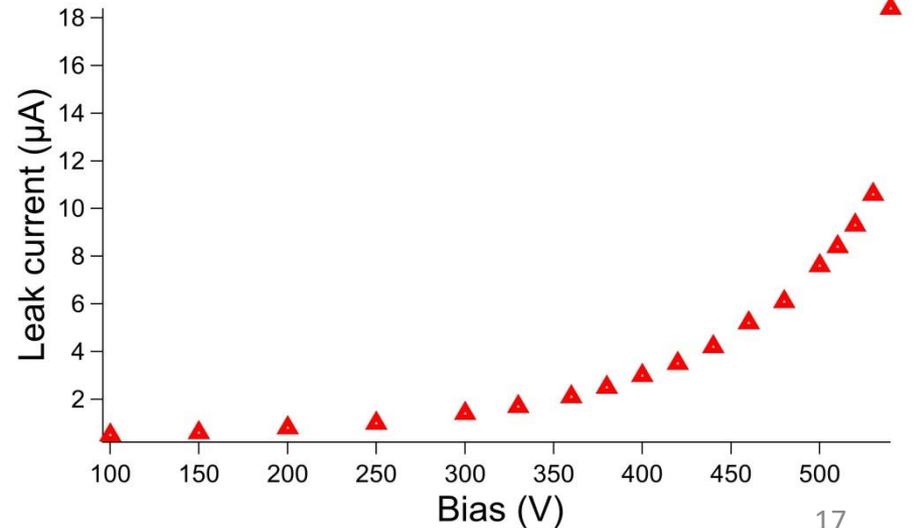
W2 LGAD (2.5e15 50 um) LGB, 3.5x3.5 mm²

- Signal is stable up to 540 V
- **Above 540 V signal becomes slightly unstable** (amplitude varies) and the leak current start jumping.
- At 545 V the leak current rapidly jumps above 0.5 mA what is a safety limit of our HV power supply. In such case further increase of bias is not possible in our setup.
- **No damage at 545 V** (after decreasing the bias the sensor works normally)

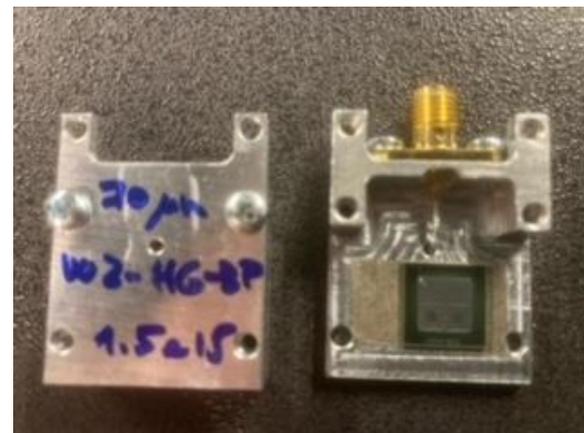
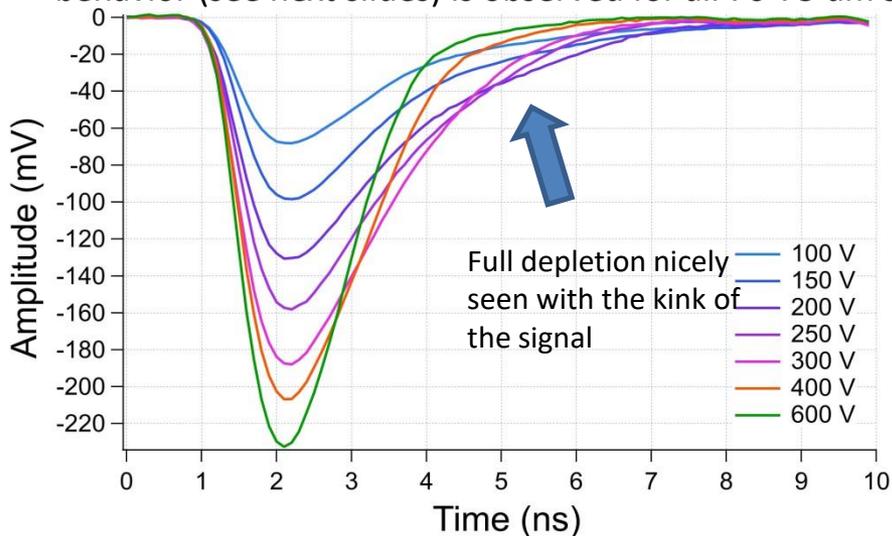
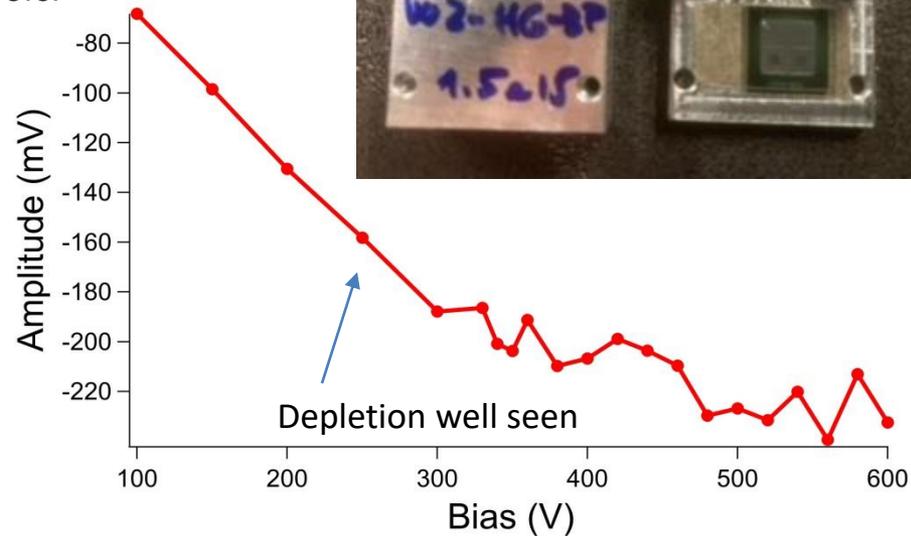
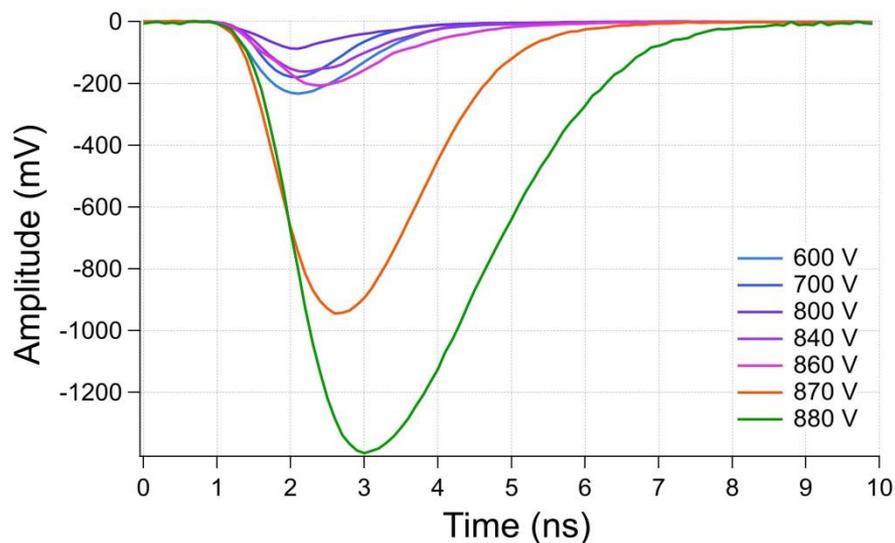
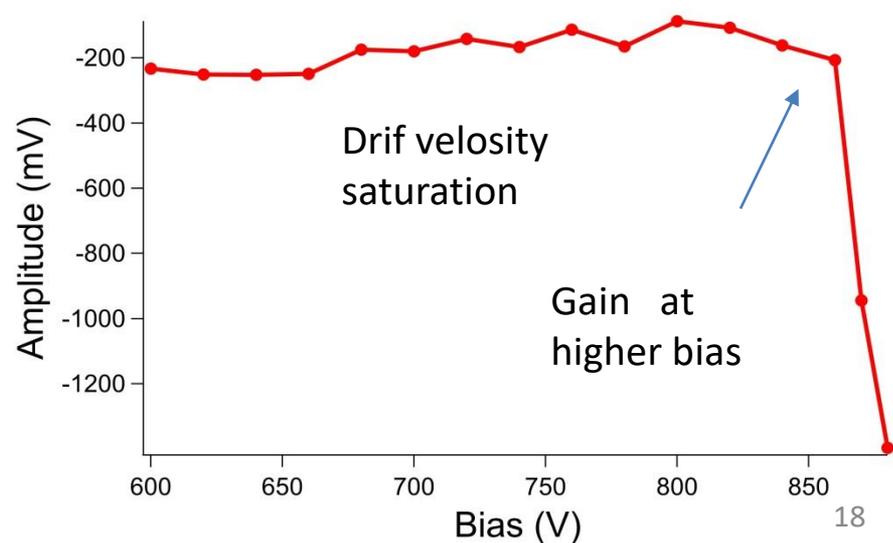
PIN - W2 LGAD (1.5e15 70 um)

Signal of this sensor shows 3-step behavior. First signal grows relatively homogenously with bias. (< 600 V) then is relatively independent on bias (600-850 V) and finally increase drastically when bias is close to the breakdown level (> 850 V). Similar behavior (see next slides) is observed for all 70-75 um sensors.

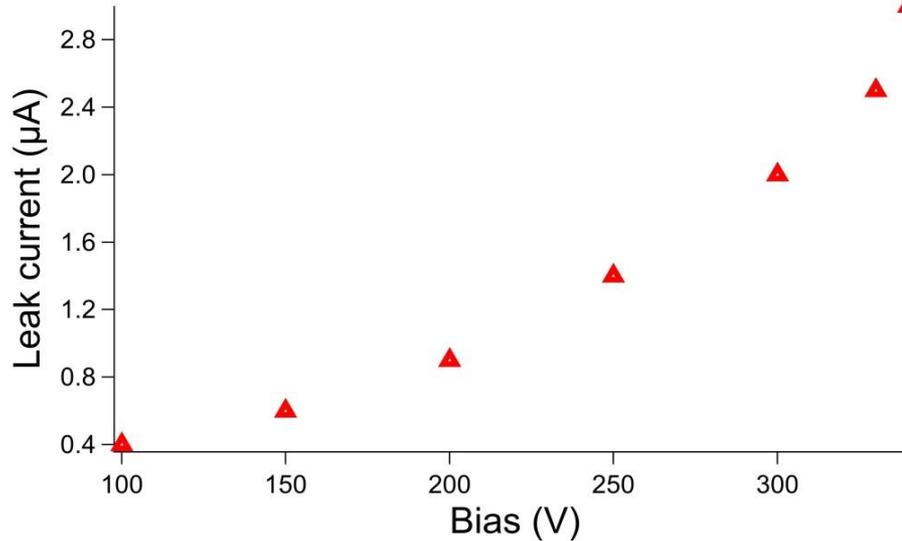
W2 LGAD (1.5e15 70 um) LGM, 3.3x3.3 mm²

- In this particular sensor **the leak current becomes very unstable at relatively low bias 340 V**. We observe rapid amplitude jumping between 3 and 90 µA.
- However the current instability is not reflected in the signal and it looks quite stable up to 800 V
- Signal becomes unstable above 800 V (amplitude and broadening vary)
- **Irreversible break down occurred at 885 V**
- No visible damage in illuminated area

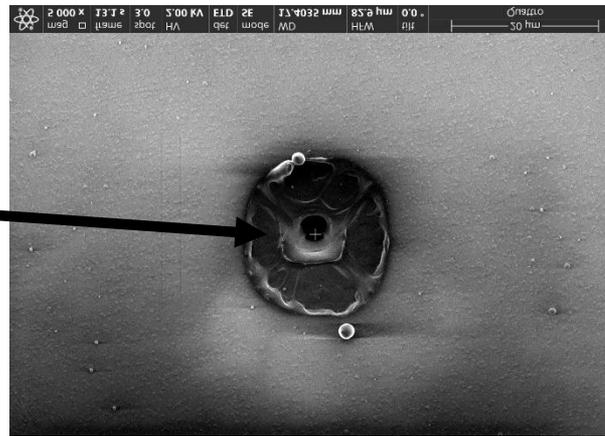
Fatality signature at the same place where illumination was performed (seen in our study as **characteristic feature for CNM sensor; not HPK**)

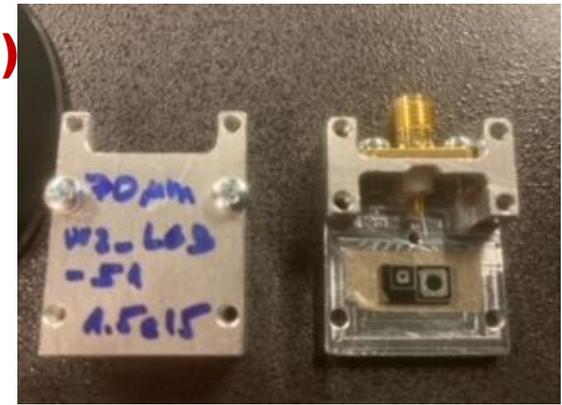
W3 LGAD (1.5e15 70 um)

Similarly to other 70/75 um sensors we observe 3-steps in the signal vs bias

- Signal is stable up to 720 V
- Between 720 and 840 V signal is slightly unstable (small jumping of amplitude)
- Signal is unstable above 840 V (amplitude and broadening vary)
- **Irreversible break down occurred at 910 V**
- Clear damage spot in the place of illumination

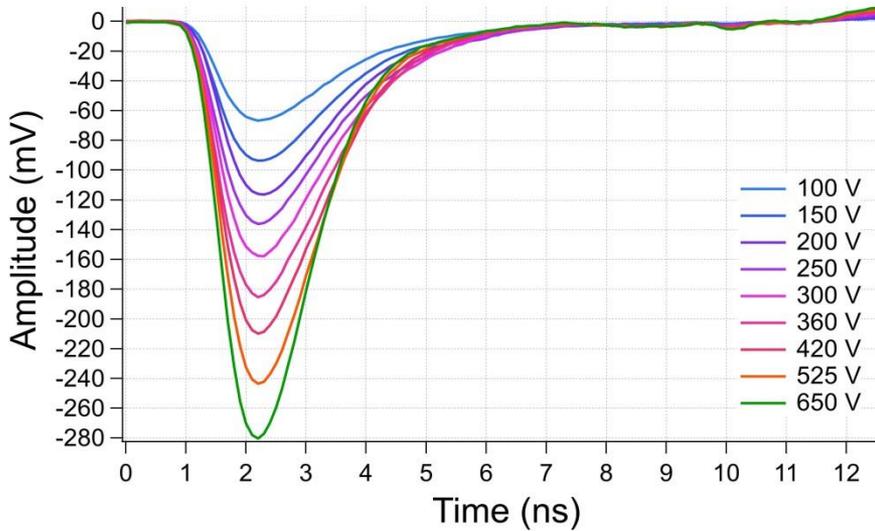
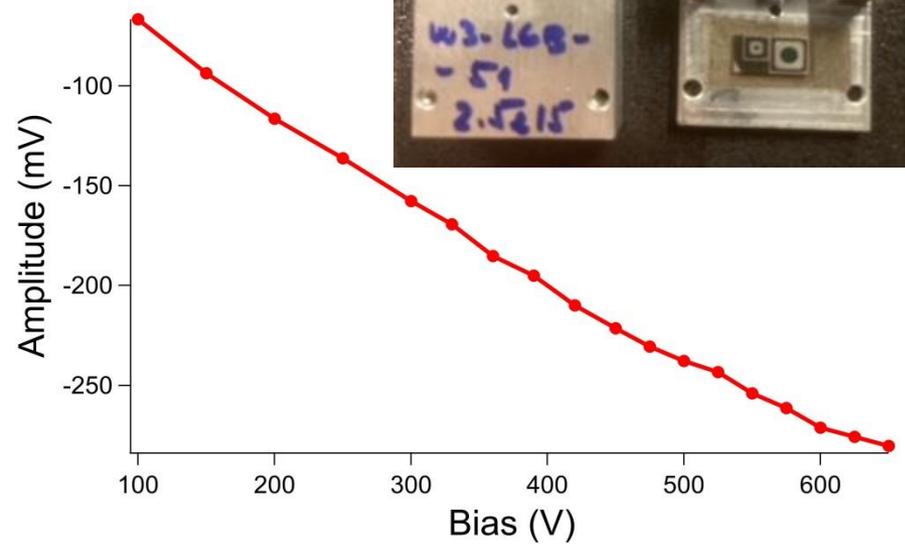
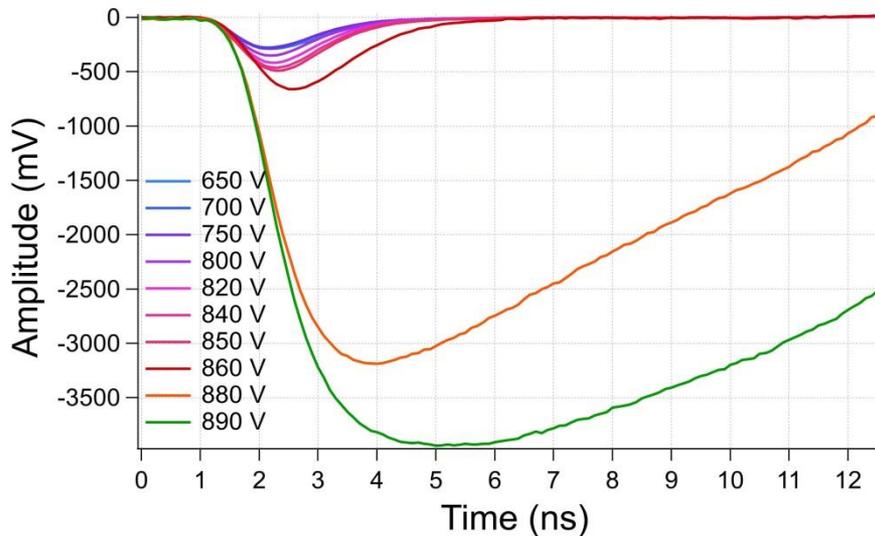
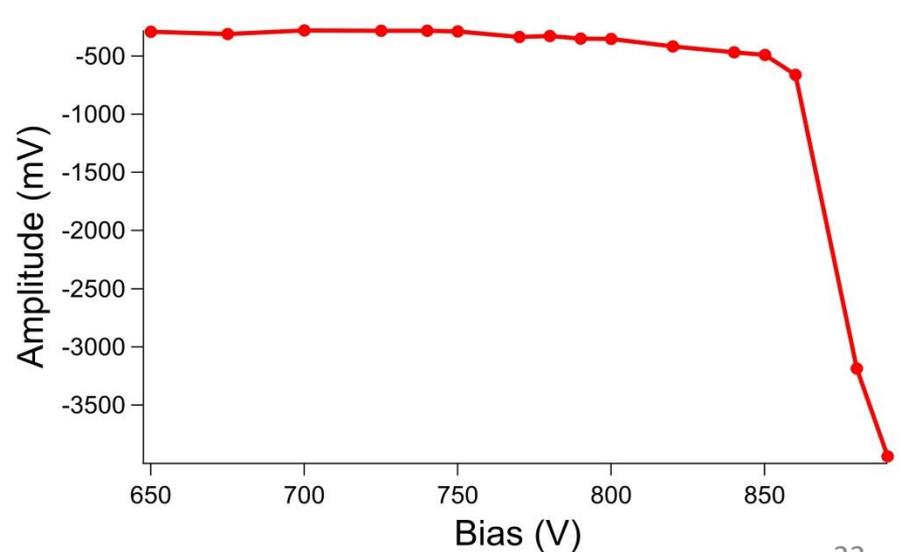
LGB, W3 LGAD (2.5e15 75 um)

Similarly to other 70/75 um sensors we observe 3-steps in the signal vs bias

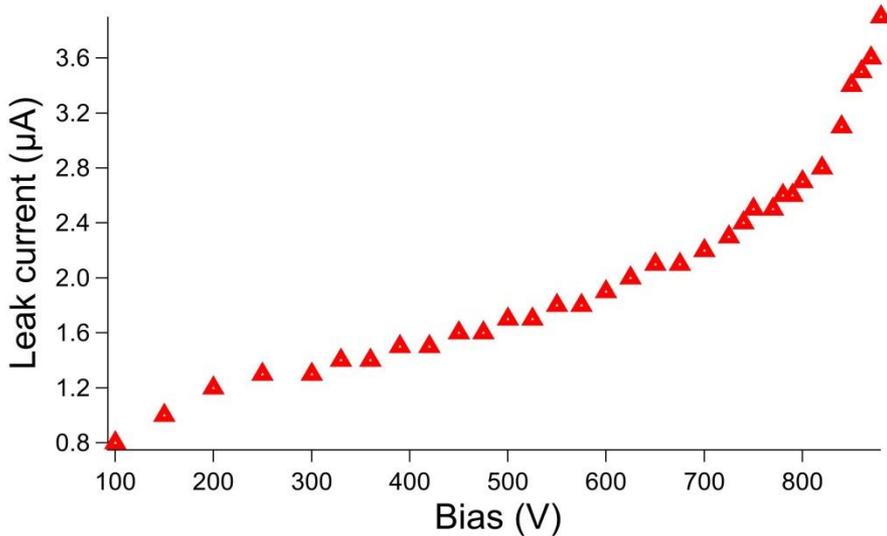
W3 LGAD (2.5e15 75 um)

- Signal is stable up to 820 V
- Between 820 and 860 V signal is slightly unstable (small jumping of amplitude)
- Signal is unstable above 860 V (amplitude and broadening vary)
- Leak current becomes unstable at 890 V
- At 915 V signal is too high to be measured
- I could apply higher bias to reach the breakdown and know exact damage threshold but I decided to save this sensor for other studies. However the waveforms recorded **at 915 V shows that this value is very close to the breakdown limit.**

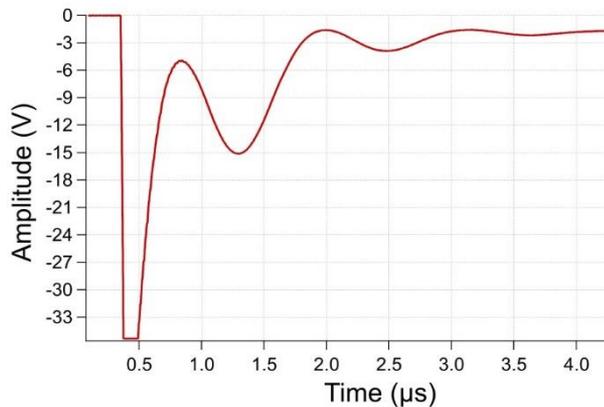
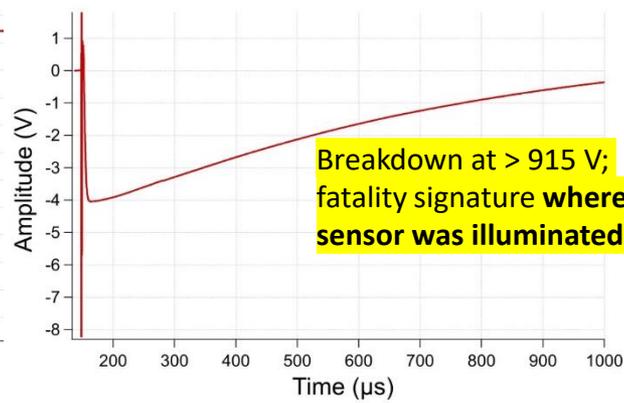
Example waveforms in unstable region (at 915 V)

Breakdown at > 915 V;
fatality signature where
sensor was illuminated

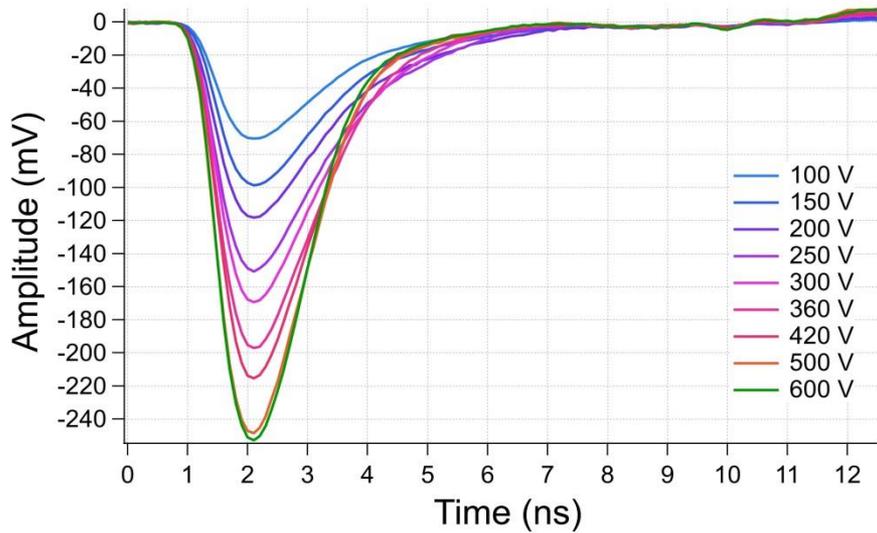
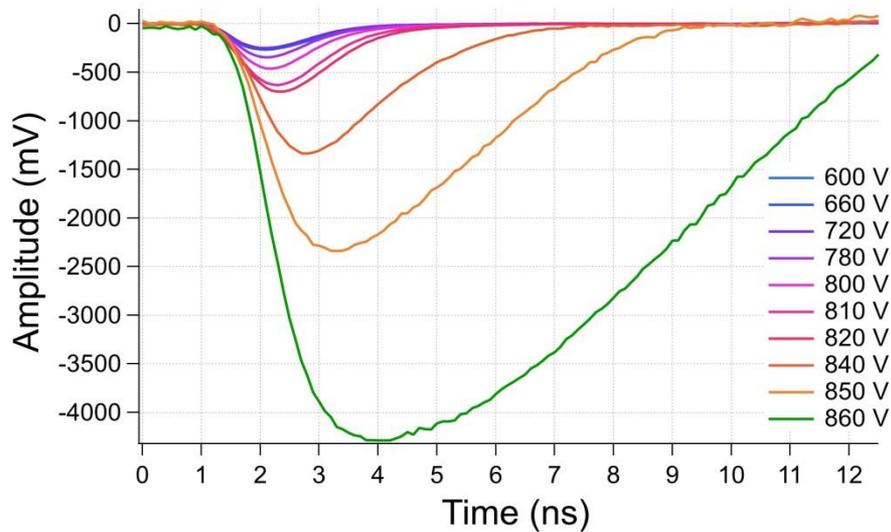
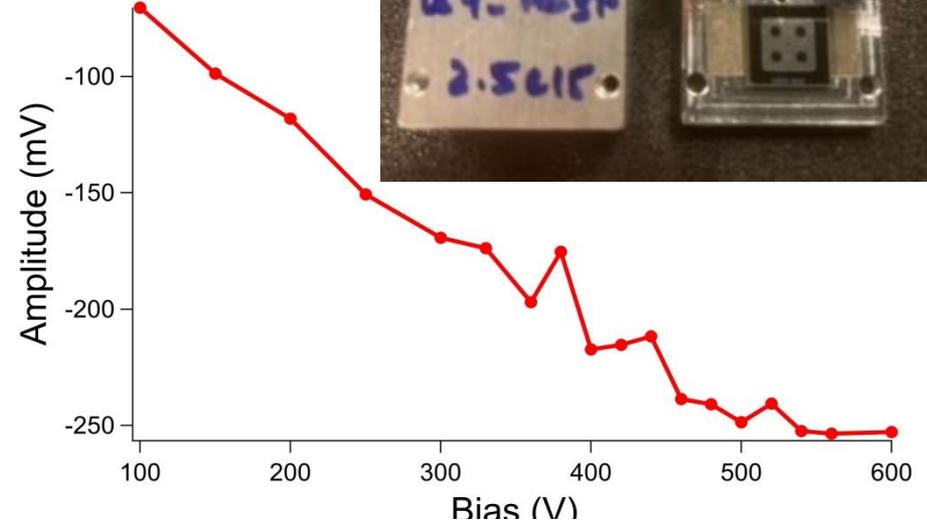
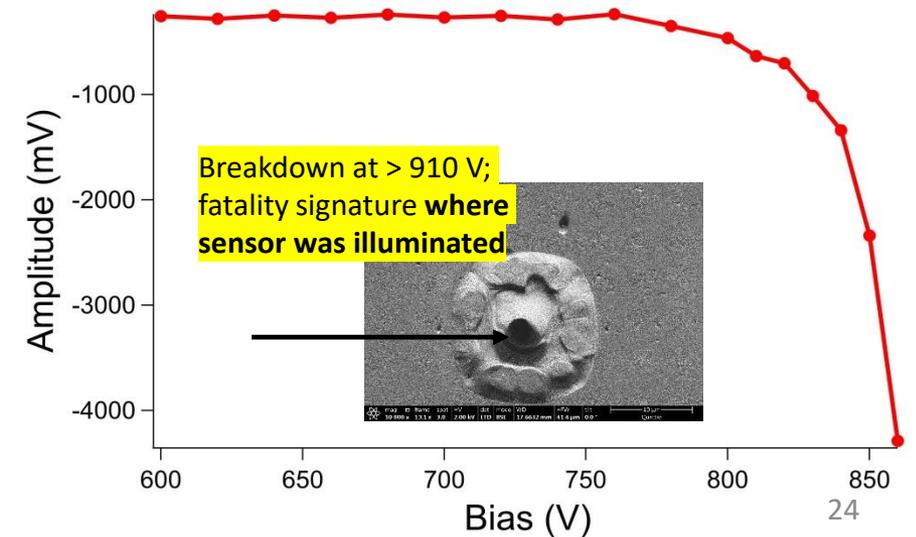
PIN (2.5e15 75 um)

Similarly, to other 70/75 um sensors we observe 3-steps in the signal vs bias

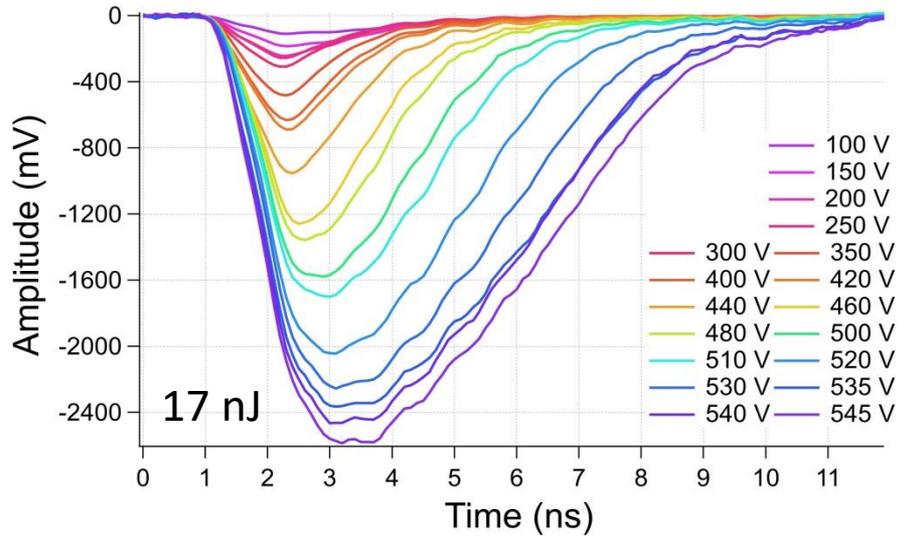
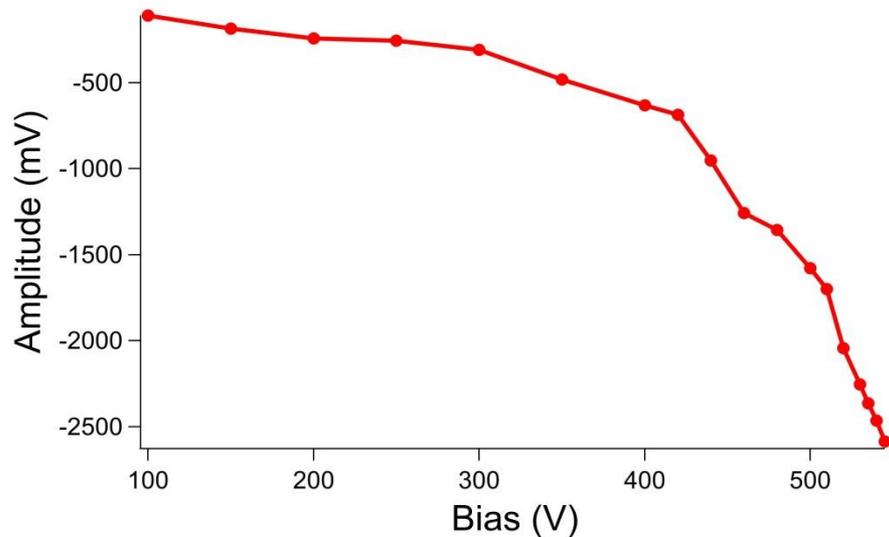
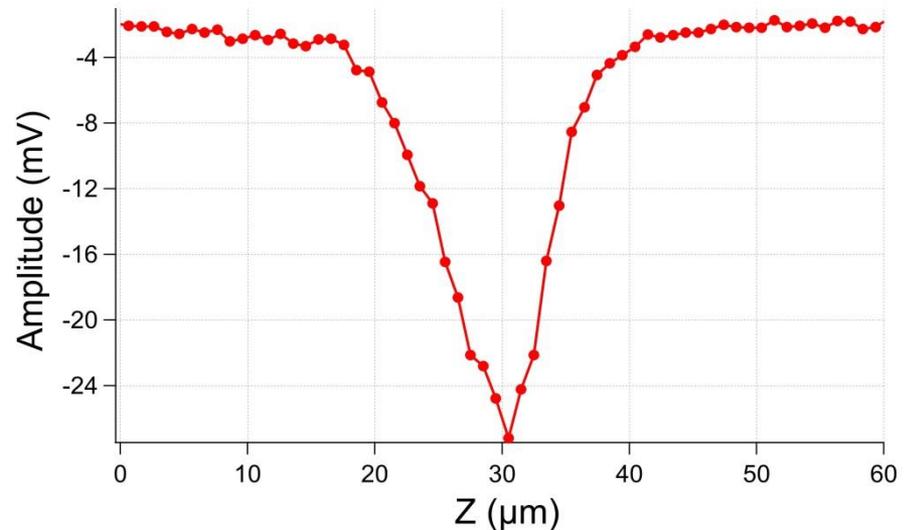
FBK UFSD3.2 W18 LGAD (1.5e15 45 um 2x2 array) (Frontside TPA)

- To generate the signal comparable to **50 pJ SPA** the pulse energy **17 nJ** was used for TPA
- The signal and its evolution vs HV are very similar to SPA results.
- Similarly, to SPA the leak current jumps rapidly above 0.5 mA at 550V but not irreversible damage happens
- sensor works normally after decreasing bias below 550 V
- We didn't succeed to get any reasonable signal by backside illumination (**metal mesh has to be removed**)

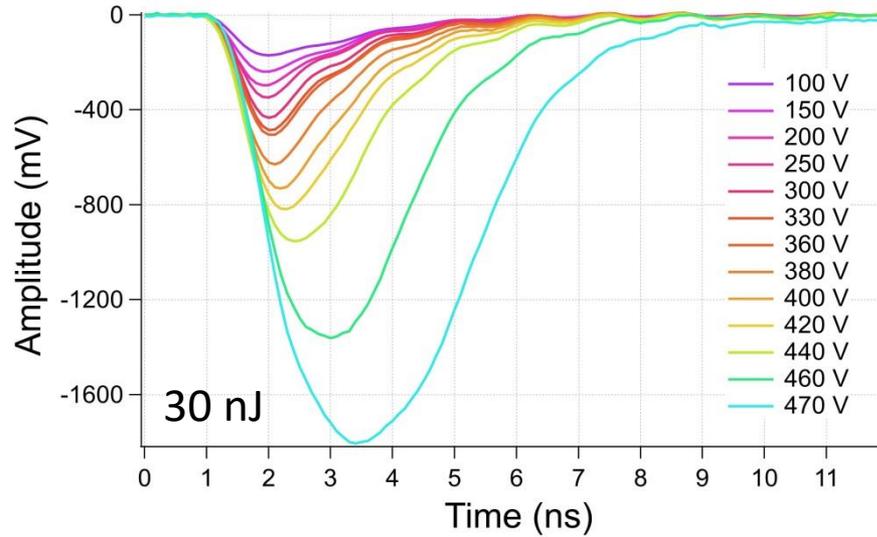
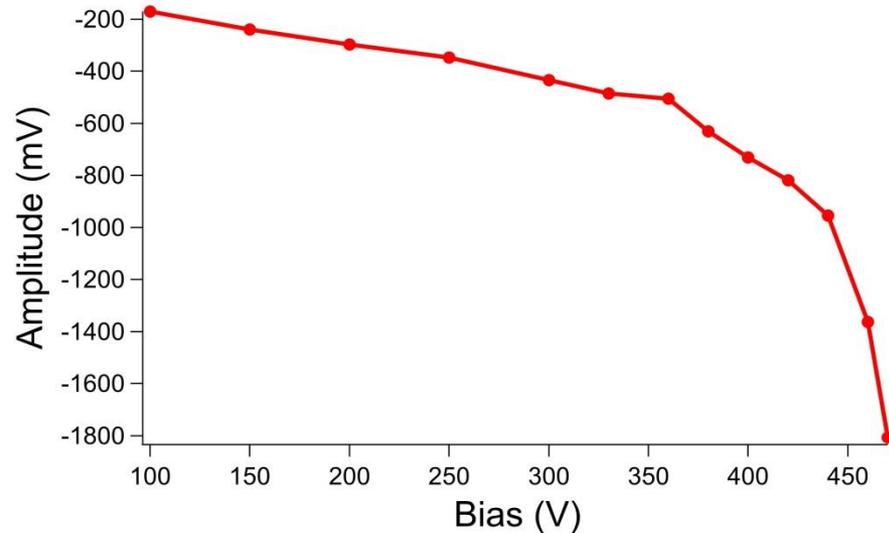
HPK-P1 W4 LGAD (1.5e15 35 um 2x2 array) (backside TPA illumination)

- To generate the signal comparable to front-TPA the pulse energy **30 nJ** was used for backside illumination
- **The signal and its evolution vs HV are very similar to front-TPA**
- Signal is stable up to 470 V
- Above 470V signal starts jumping and extends to microsecond region
- **above 480 V is too high to be measured**

- in SPA a difference between laser power needed to generate the comparable signal by backside illumination was huge (3 orders of magnitude)
- here only slightly higher power (30 nJ vs 12 nJ) is needed to get comparable signal
- Z-scan for back-TPA gives clearly broader profile in comparison to front-TPA
- In spite of these differences, both cases (front and back-TPA gives very similar results in terms of the stability)
