39th CERN RD50 Workshop, 17-19 November 2021, Valencia

THICKNESS DEPENDENCE OF THE SEB BIAS THRESHOLD IN FS-LASER BASED MORTALITY STUDY ON LGAD FROM DIFFERENT PRODUCERS

Study on irradiated LGADs - Fall 2021 campaign at ELI

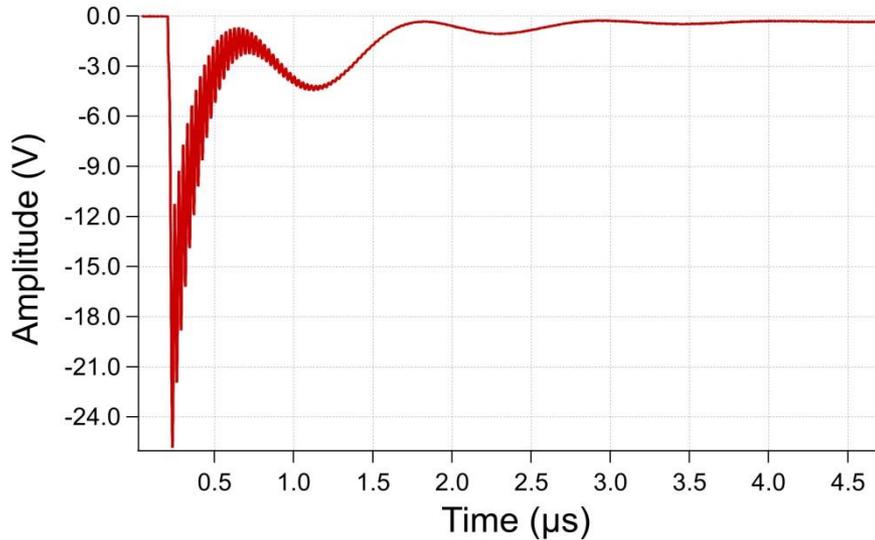
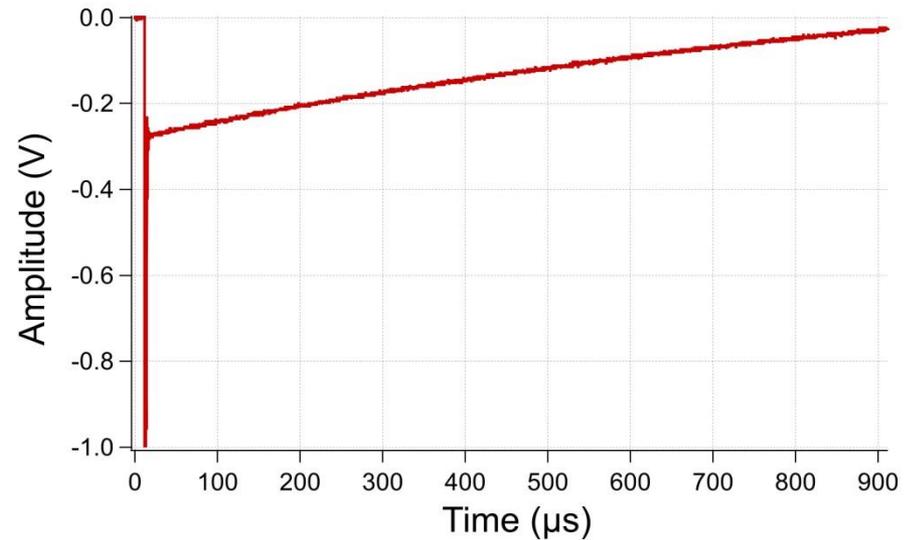
Example waveforms in unstable region (at 480 V)

This sensor is only one where we succeeded to get backside illumination TPA signal.

- in SPA a difference between laser power needed to generate the comparable signal by backside illumination was huge (3 orders of magnitude)
- here only slightly higher power (30 nJ vs 12 nJ) is needed to get comparable signal
- Z-scan for back-TPA gives clearly broader profile in comparison to front-TPA
- In spite of these differences, both cases (front and back-TPA gives very similar results in terms of the stability)

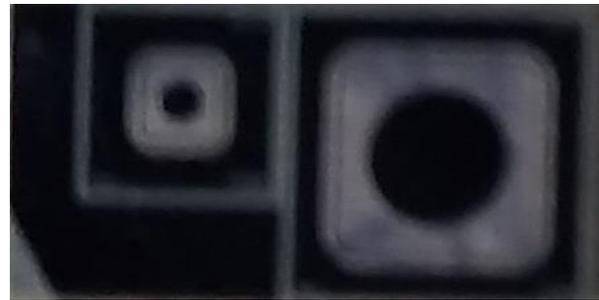
Some of the LGA and LGB samples are not diced (they are stick together as the photo below shows). However they are short-circuited with regard to each other. One can be wirebond and measured while the other don't. The priority set by CNM was to test the mortality of the LGA samples (1.3x1.3mm, the small ones)

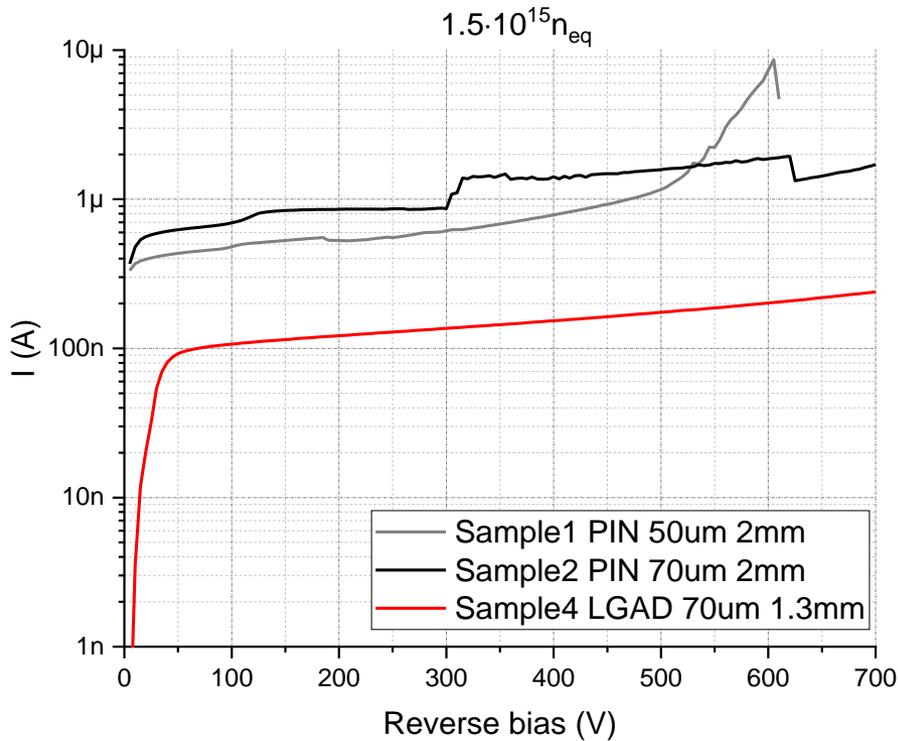
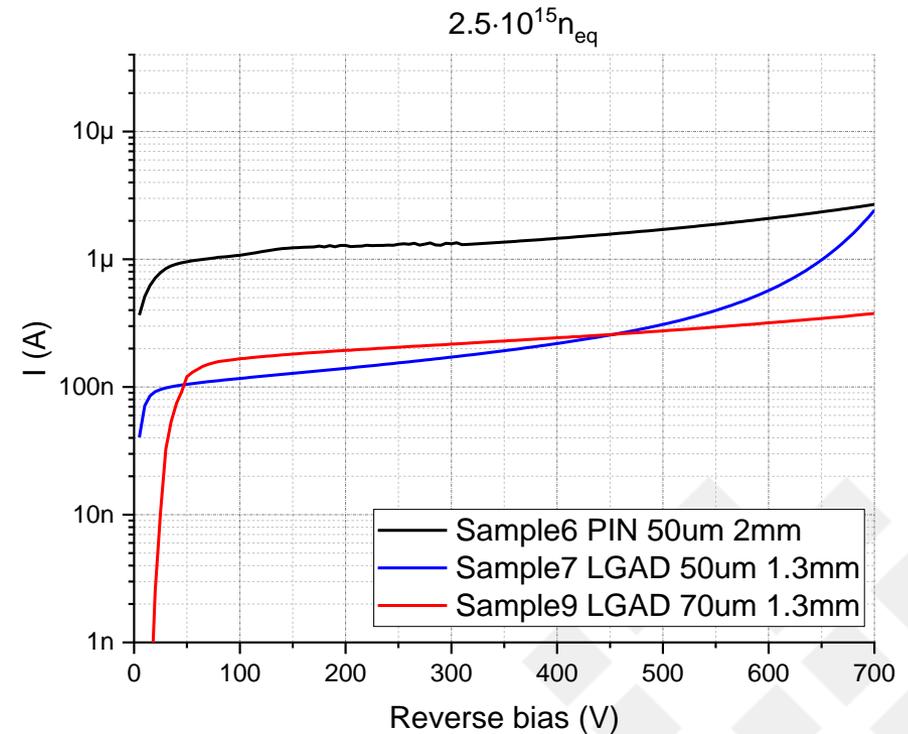
There are 6 housings and 10 devices. The priority is to test first the mortality of the 6 devices enlisted in the following slide (samples 1, 2, 4, 6, 7 and 9)

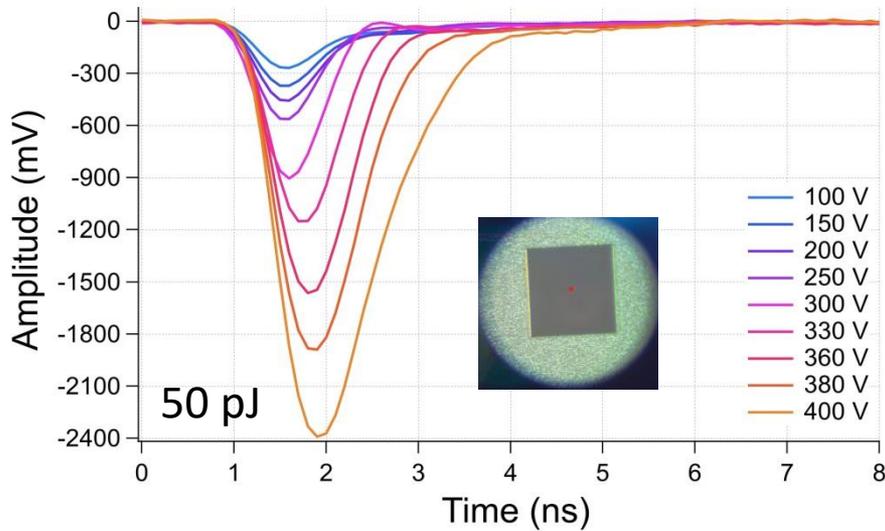
Opening window

- this sensor has nominal max. bias ~ 400 V
- the measurements in this range were performed for opening window and for the guard ring
- the results are nearly identical

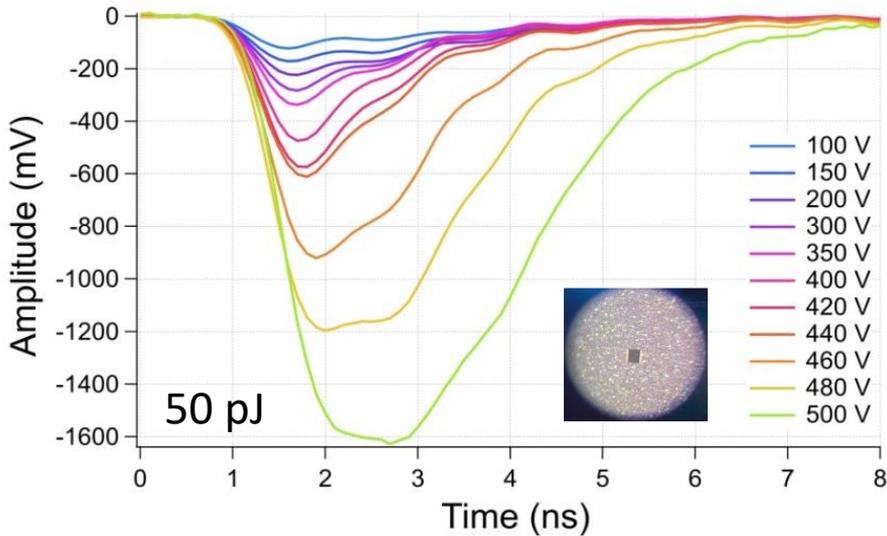
Opening window

The opening window in FBK sensors are much smaller than in others but still big enough ($\sim 10 \times 10 \text{ um}$) to safely focus the beam inside.

The response of the sensor was checked when illuminated in the guard ring region. At exactly the same conditions the signal looks almost identical for window and ring. Leak current was also identical in both cases.

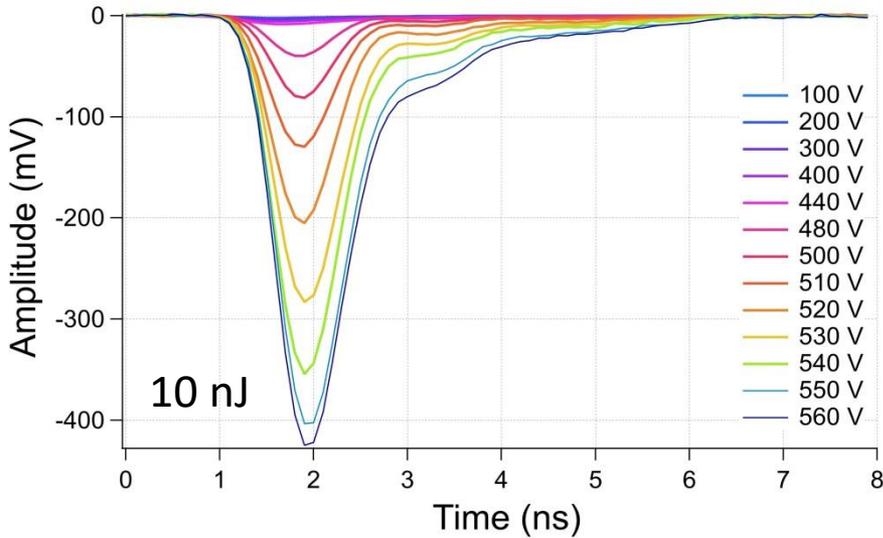
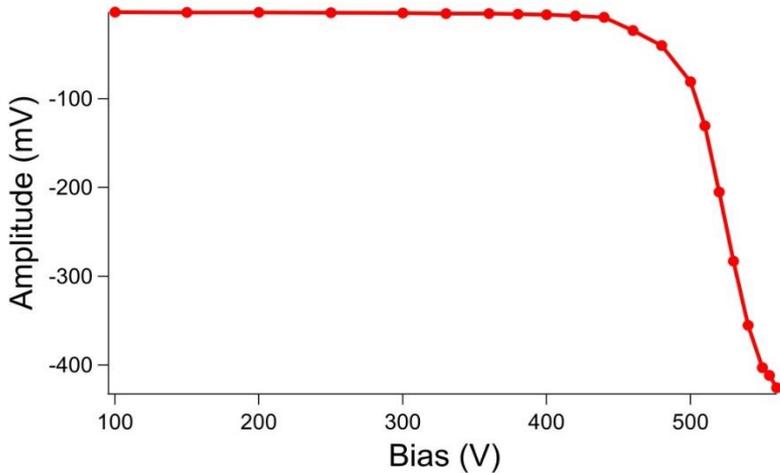
HPK-P1 W4 LGAD (2.5e15 35 um single pad) (backside illumination)

- to get a reasonable signal by illumination from the backside much higher pulse energy is necessary (10s of nJ regime)
- **although nominal max. bias for this sensor is ~400 V it turned out that it can survive significantly higher voltage (at least 560 V)**
- leak current jumps rapidly above 0.5 mA at 560V but not irreversible damage happens *not enough deposited charge
