Updates on LHC external dump (TDE) Evian 2021 workshop

M. Calviani on behalf of SY-STI

23rd November 2021

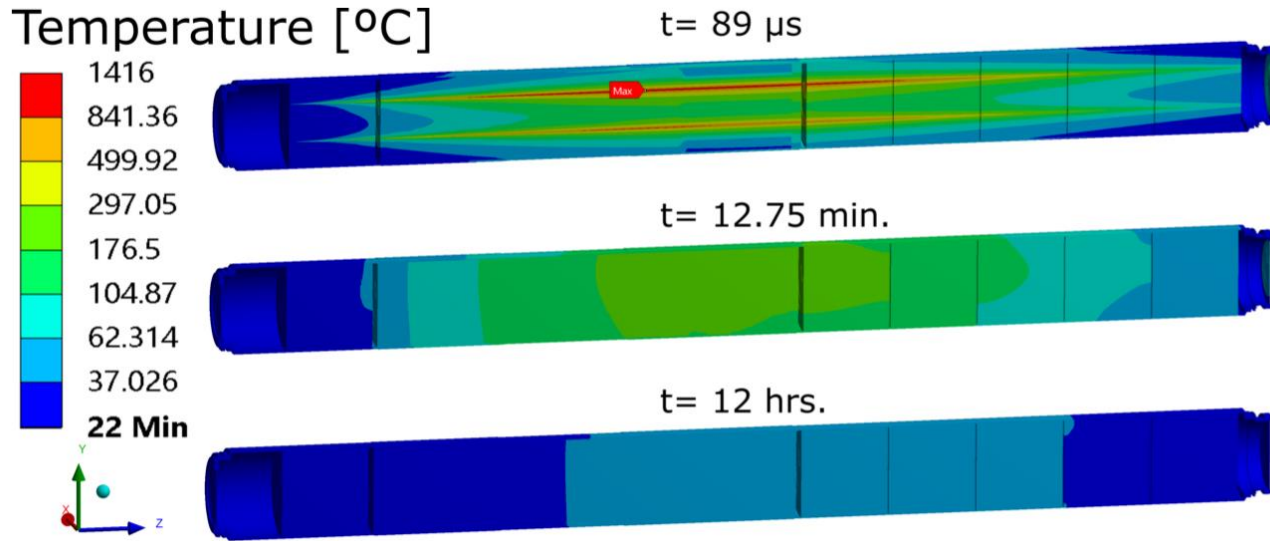
Dump slow response

Simulation package appears to be in good agreement with data

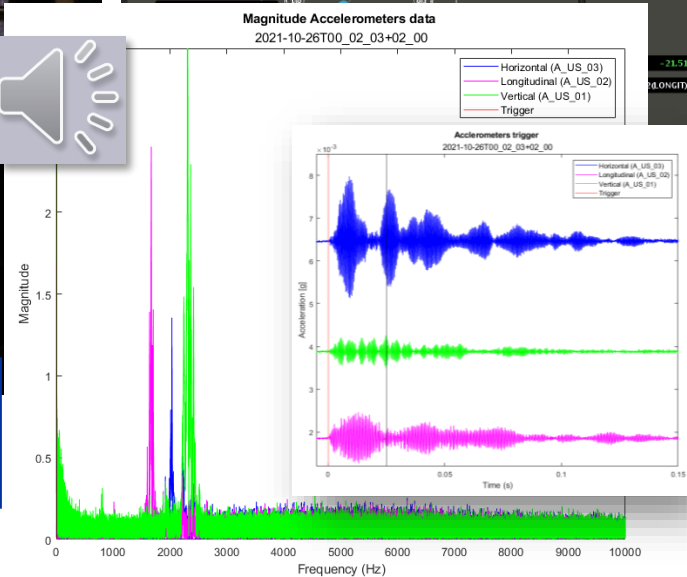
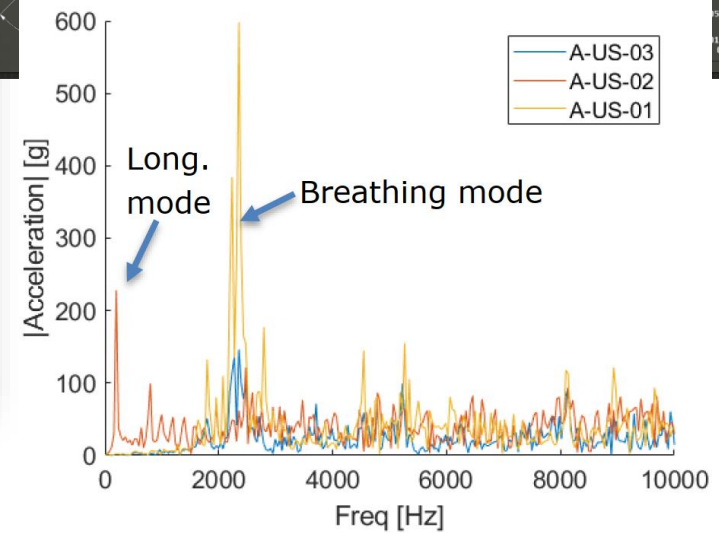
UD62 Dump on 26/10/2021 at 00:02:03, $3.4 \cdot 10^{11}$ dumped intensity (few bunches)

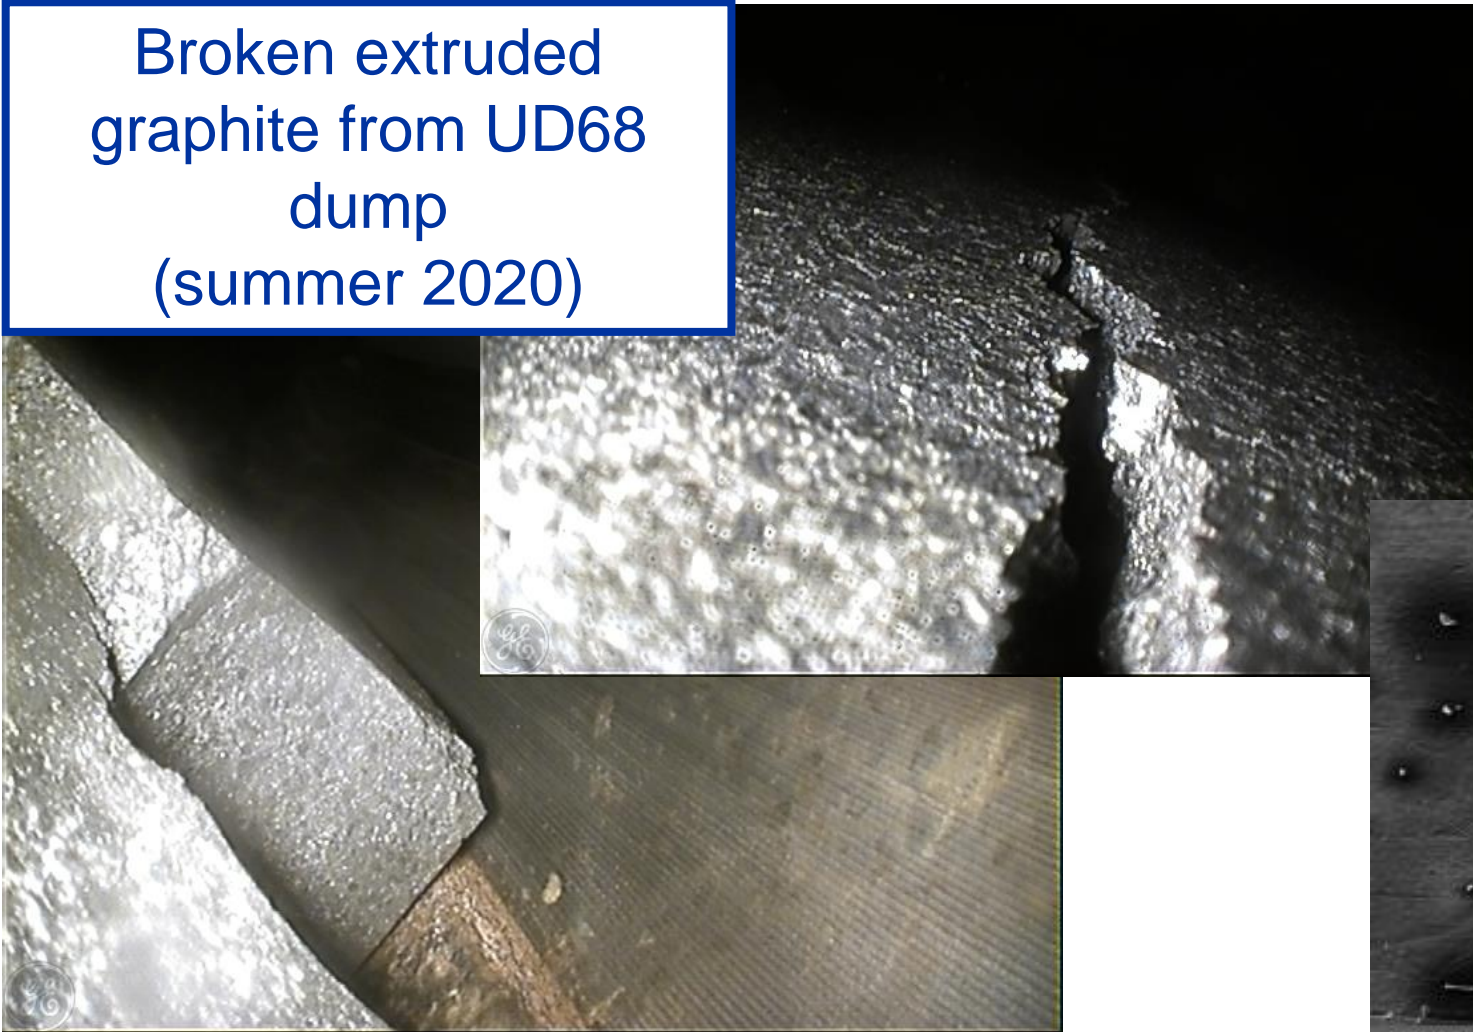
Broken extruded graphite from UD68 dump (summer 2020)

- Autopsy of the highly radioactive UD68 dump to assess core status (Run 2 parameters)
 - Technical Review November 2021 <https://indico.cern.ch/event/1072664/>
 - Execution in Jan/Feb 2022, results to follow in the weeks/months
- Execution of HRMT56 and subsequent PIE
 - Experiment completed and results to be available starting from January 2022
- Ongoing CERN-NTNU collaboration (Sigraflex[®])
