# Electro-polishing experience at KEK

Yoshiyuki Morita

KEK

# EP of LHC crab cavities

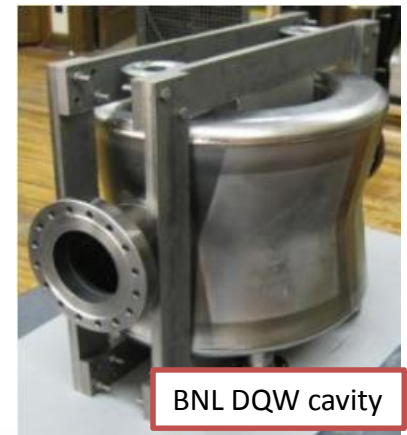
BNL DQW cavity

- Compact and complicated cavity structure to meet space requirements
- High fields are required for sufficient bunch rotation
  - 3.4 MV per cavity at 400 MHz
  - $Q \sim 10^{10}, T=2K$
  - (KEKB crab: 1.4 MV at 509MHz with  $Q=10^9, T=4.4K$ )
- Surface treatment is one of important issues
  - CP (Chemical polishing) is used

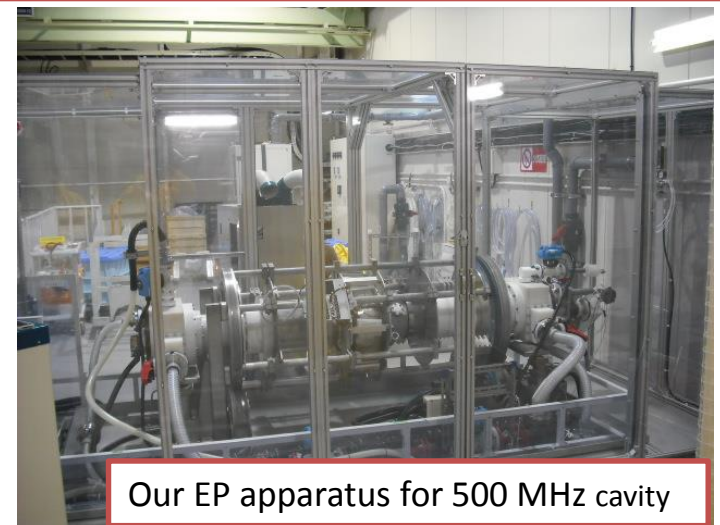
Our EP apparatus for 500 MHz cavity

- We proposed an R&D on application of EP to LHC crab cavities
- Horizontally rotating technique is difficult to apply
- Develop vertical EP at our EP station
- Applied VEP to BNL PoP DQW crab cavity

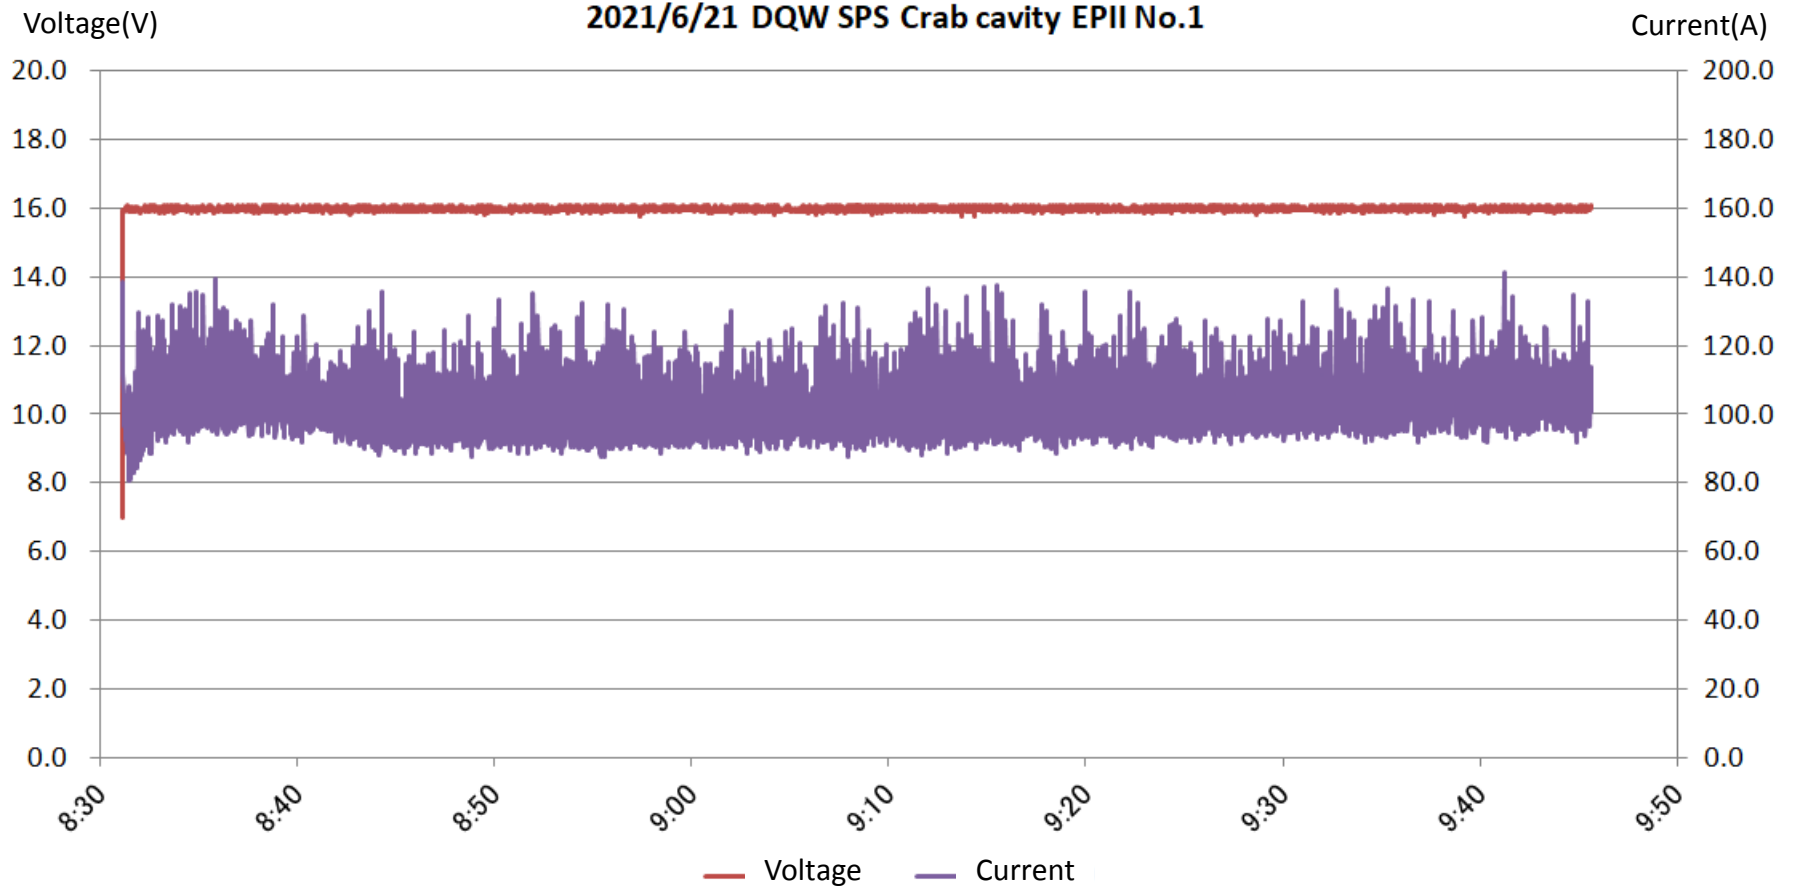
# Current and voltage during 1<sup>st</sup> VEP

Voltage : 16V  
Average current: 108 A  
Current density: 16 mA/cm<sup>2</sup>  
Average polishing: 15  $\mu$ m

2021/6/21 DQW SPS Crab cavity EPII No.1

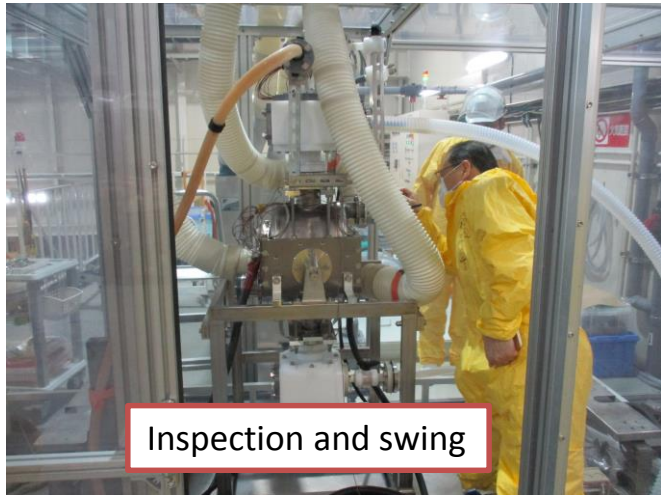
Inspection and swing

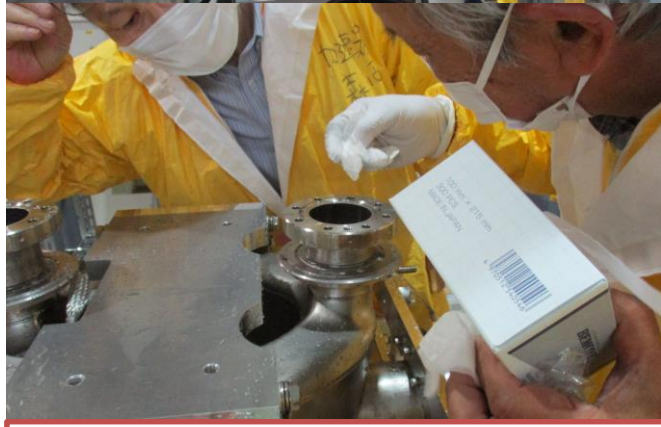
Sampling for X-ray fluorescence analysis  
=> Niobium Oxide

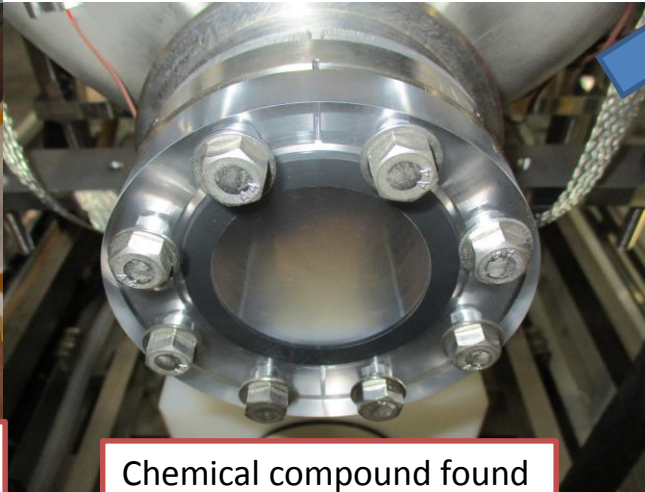
Chemical compound found  
in the lowest HOM port

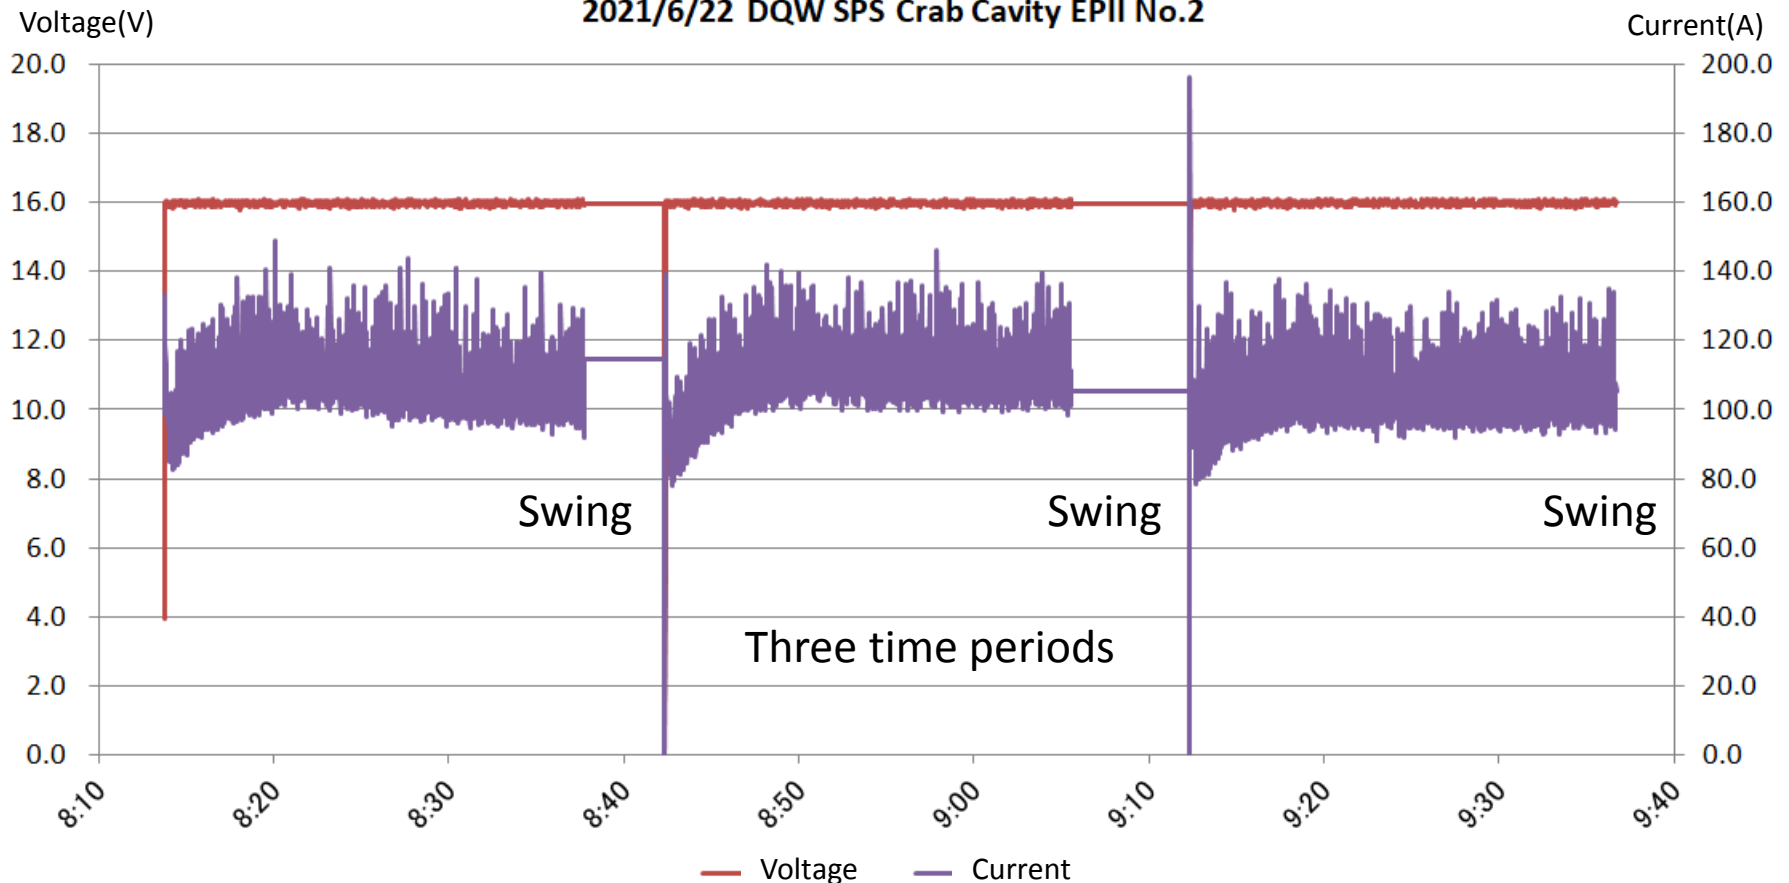
# Current and voltage during 2<sup>nd</sup> VEP

Voltage : 16V  
Average current: 108 A  
Current density: 16 mA/cm<sup>2</sup>  
Average polishing: 15  $\mu$ m

2021/6/22 DQW SPS Crab Cavity EPII No.2

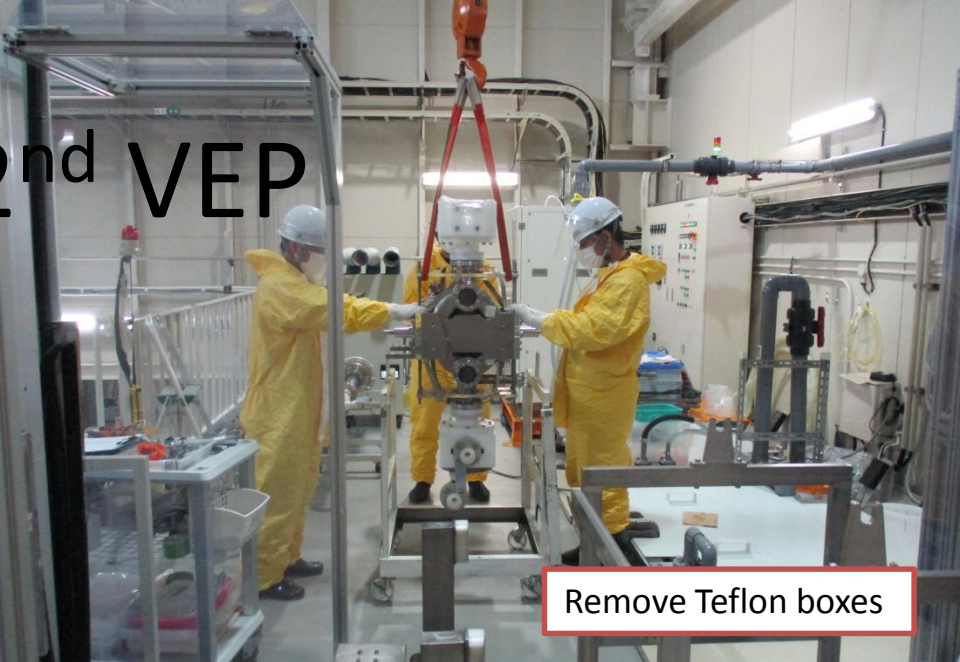
Chemical compound in HOM port  
A large part of compound dissolved

After 2<sup>nd</sup> VEP

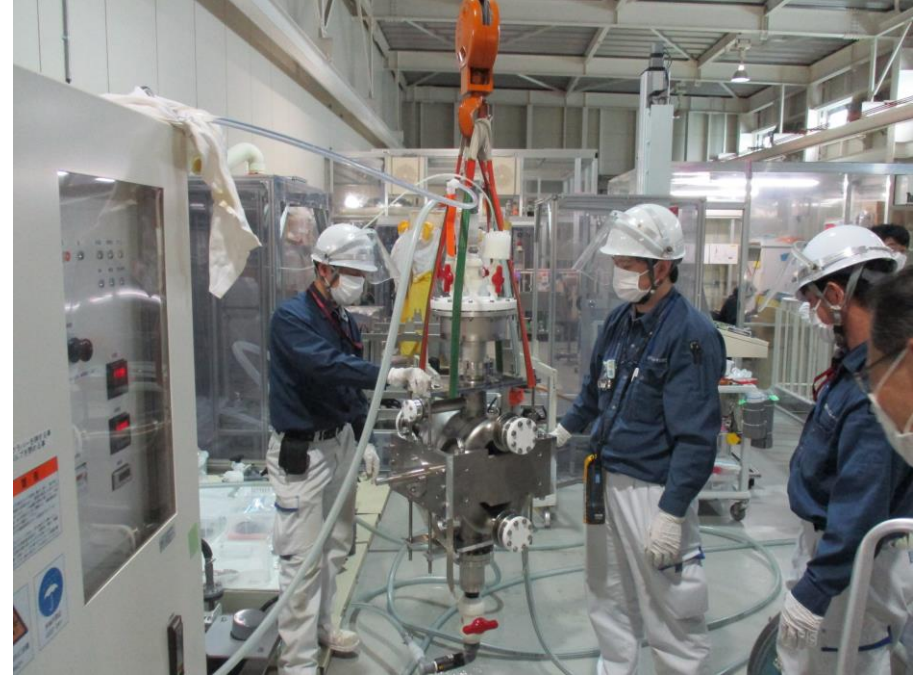
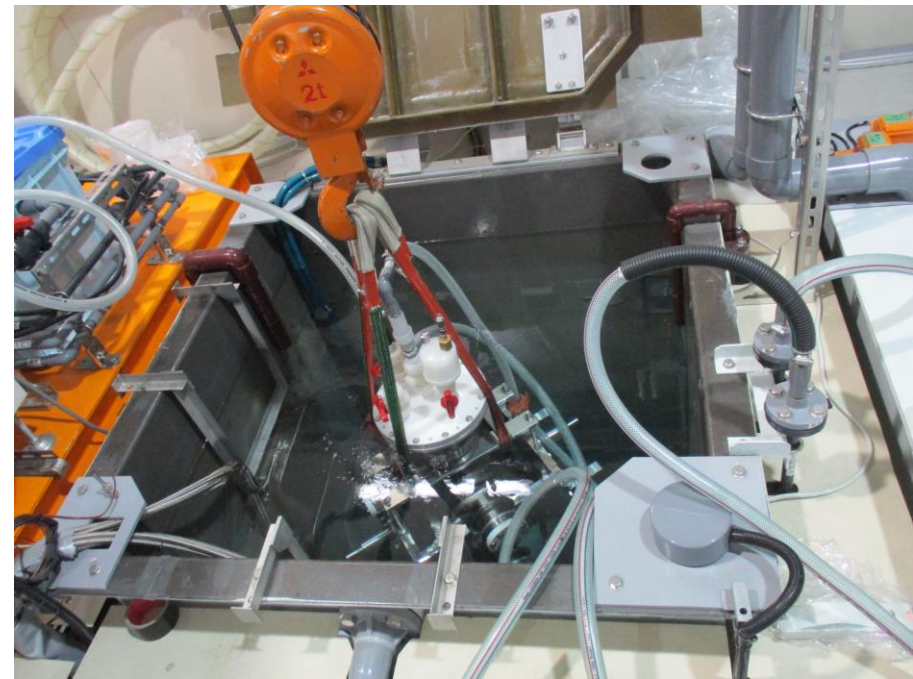
Rinsing after VEP  
O3 water rinsing  
Ultrasonic rinsing

Ozonized water rinsing  
Ozonized water: 3.3 ppm  
Overflowing for 10 min.

Ultrasonic rinsing  
Ultrapure water  
Overflowing for 1 hour  
Ultrasonic: 40 kHz  
Hot bath temperature: 50 °C

Purging with nitrogen gas

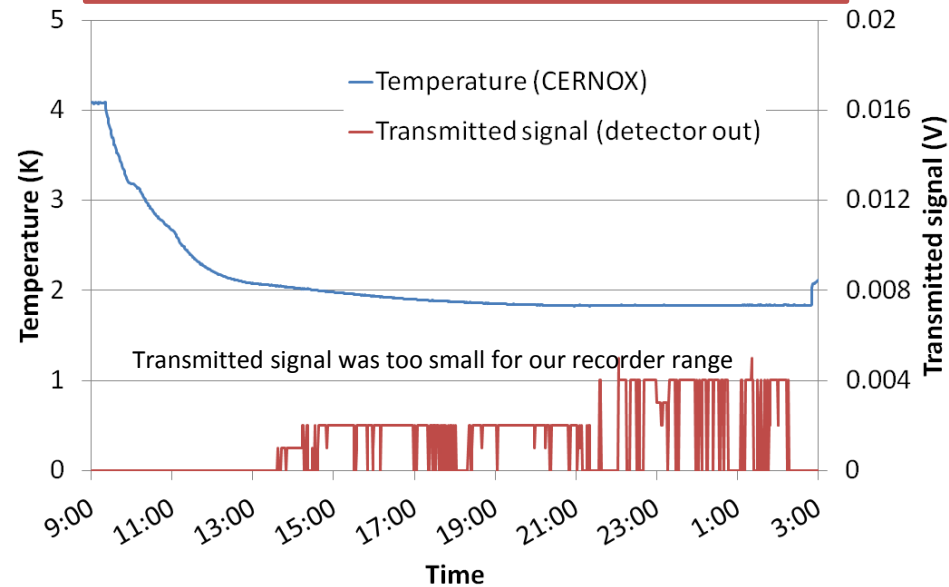
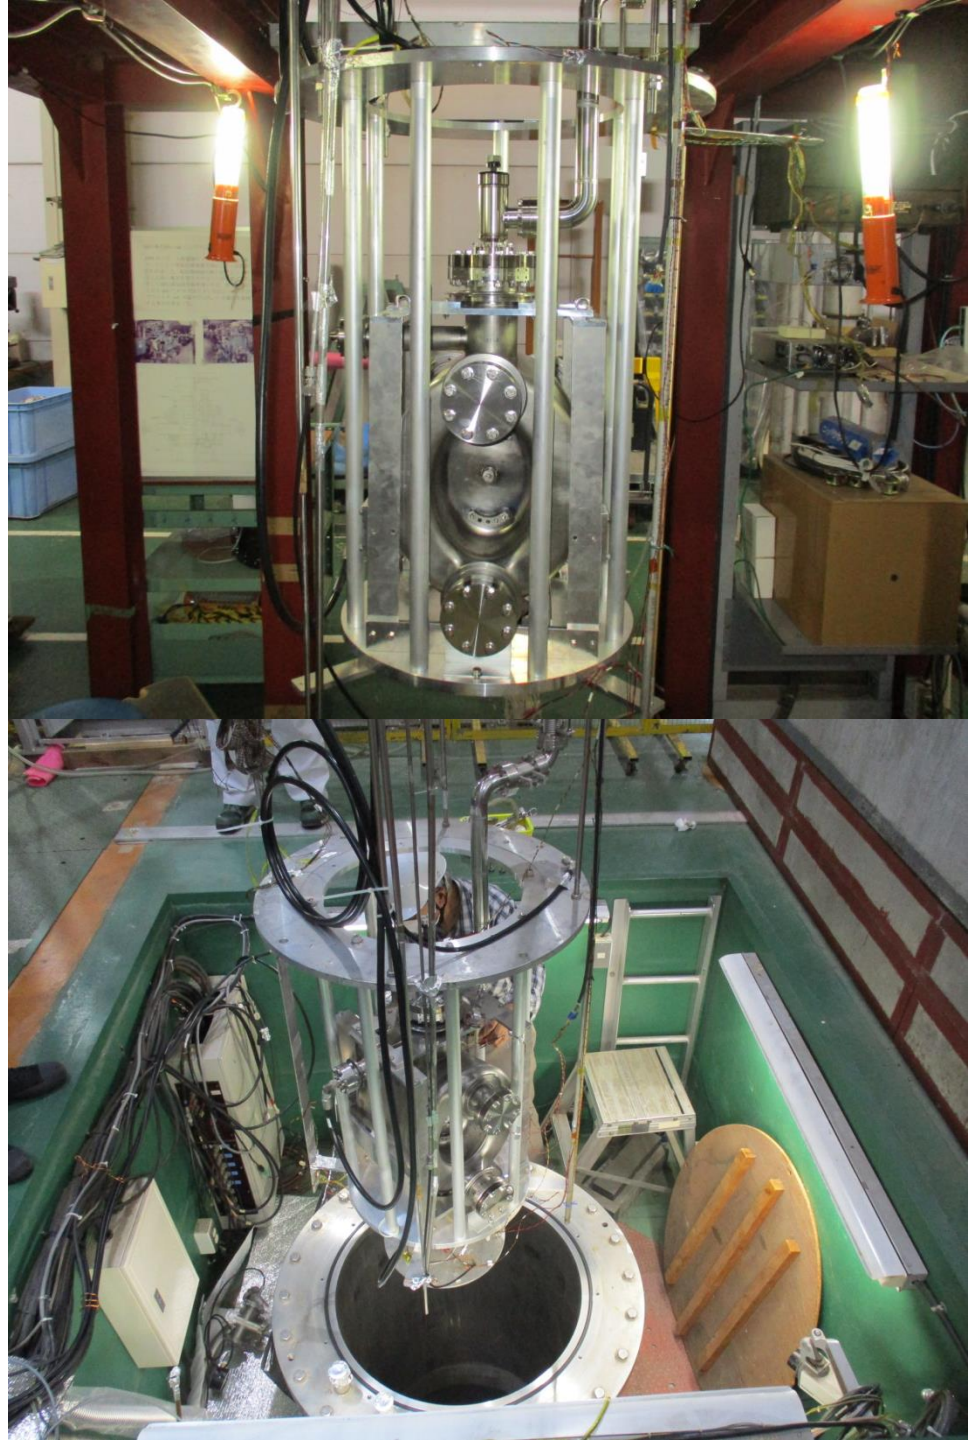
# Cold test

Set up and baking (120 oC x 48 Hours)

Cool-down to 4K with Liq.He of 1700L  
Cool-down to 2K by pumping

Frequency search and phase lock  
Frequency shift after VEP: 2.3MHz  
(Too large, shape deformation?)  
Multipacting processing at around 0.1MV  
Could not process MP within 12 hours

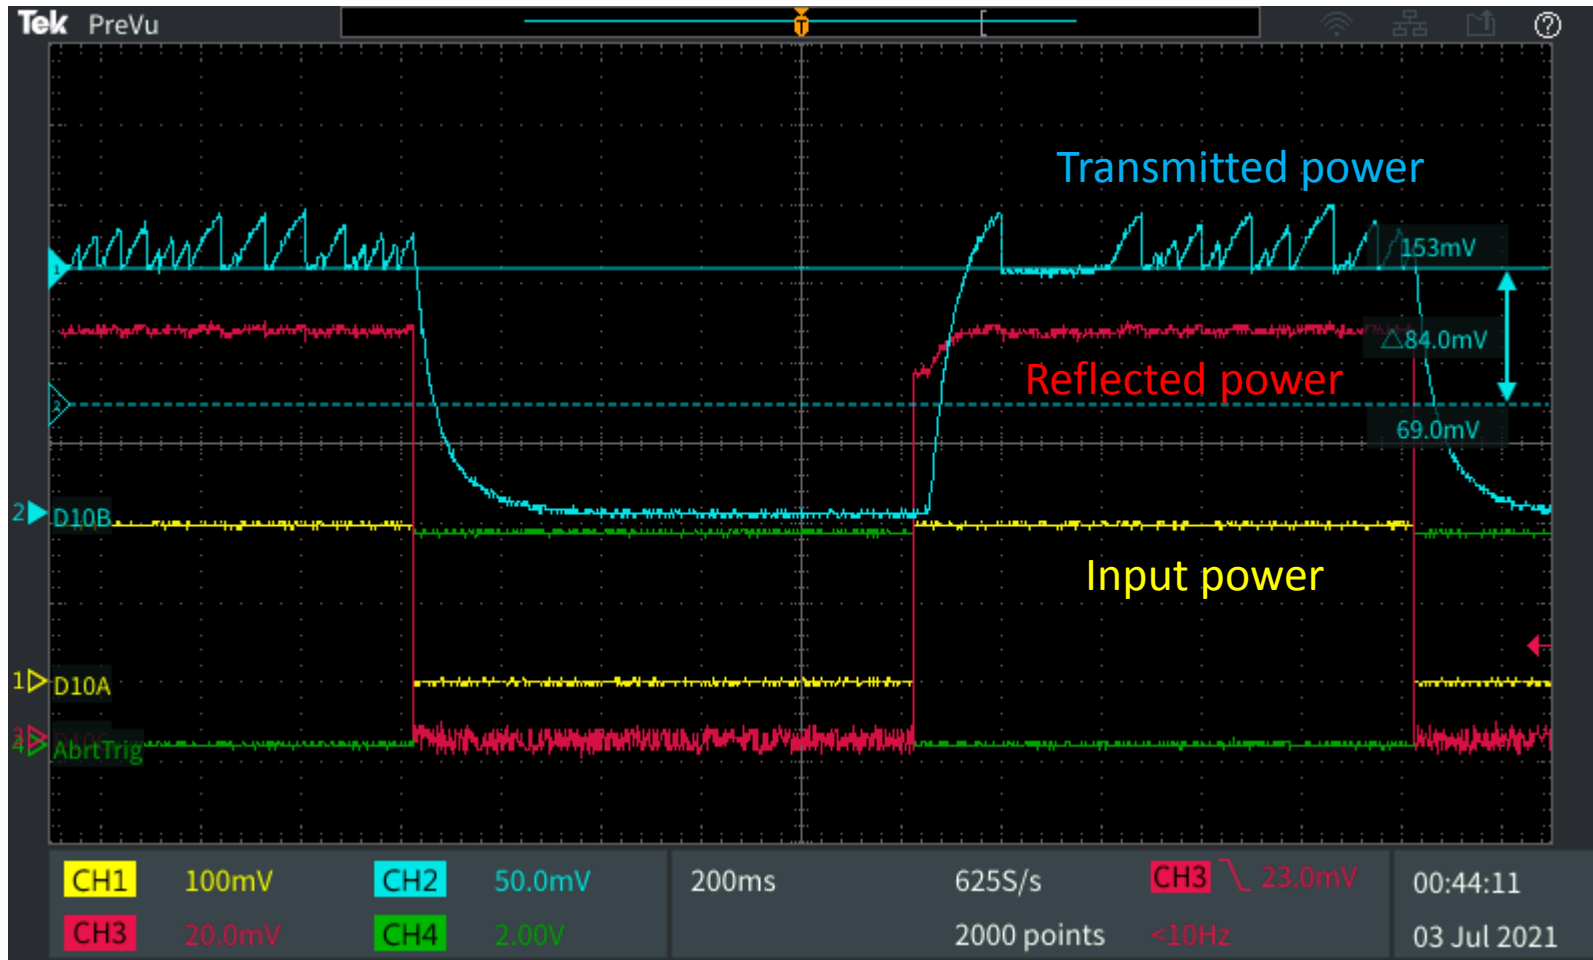
# Multipacting at low fields

Used pulsing to process multipacting.  
Input RF power: 5~8W  
Transmitted power: ~2.5 microW  
Corresponding  $V_c$ : ~0.1MV  
This multipacting level was quite hard.  
Could not process this barrier.

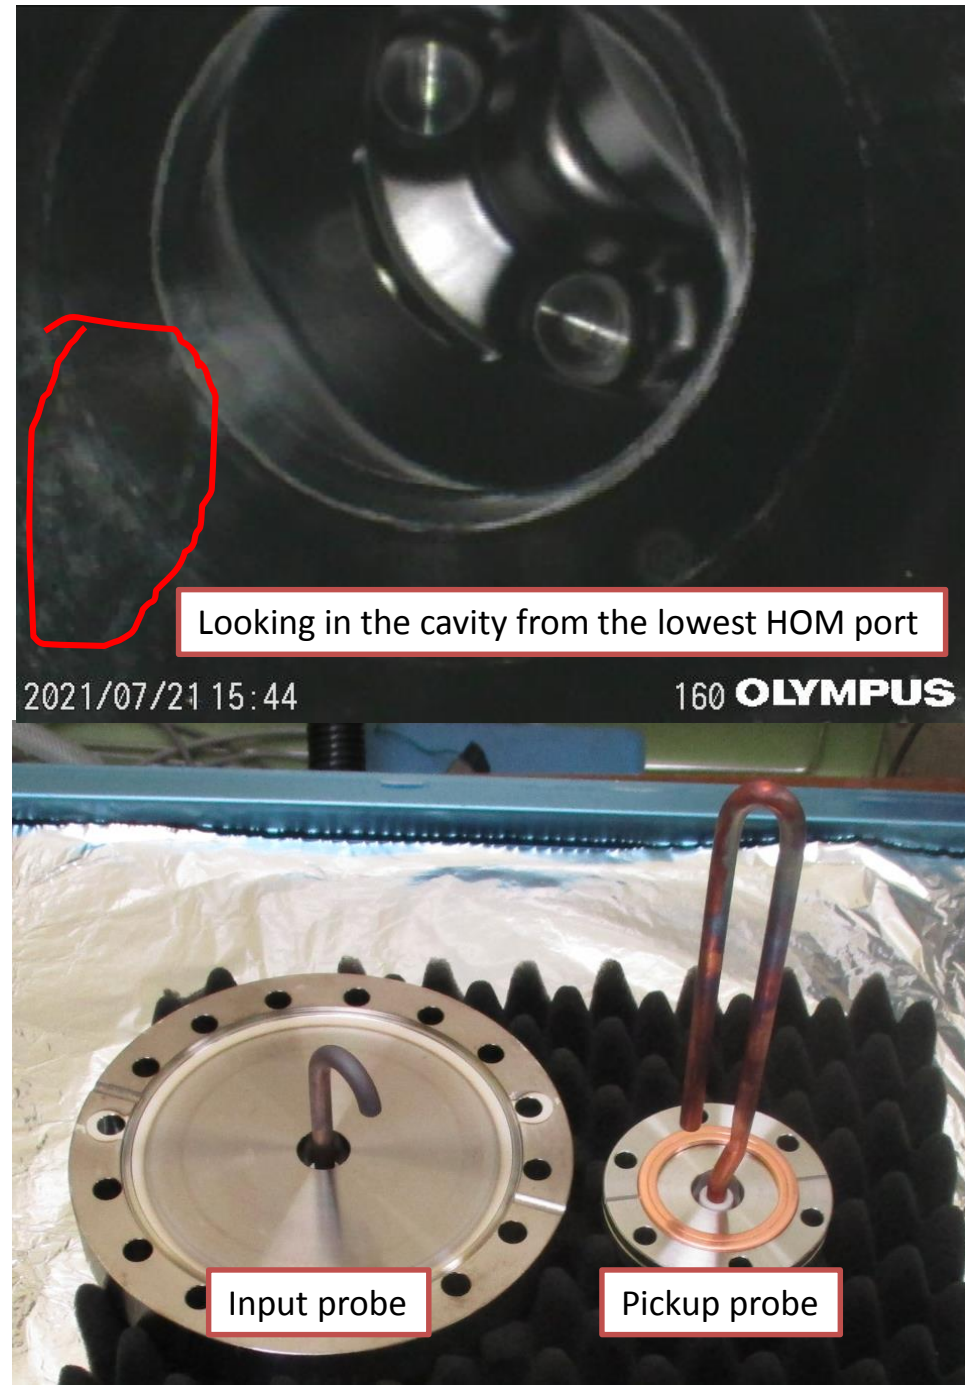
Cavity frequency before and after VEP

- Frequency at room temperature
  - 404.385 MHz
  - +2.3MHz after VEP
  - Shape deformation?
- Inspection of inner area
  - White Niobium oxide layer found
  - Niobium oxide not well dissolved
- Input and pickup probes
  - Change of color found
  - Multipacting occurred on the probes

Room temp.	4K	2K
Before EP (MHz)	402.087		402.777
After EP (MHz)	404.385	403.906	405.083
