QPR sample polishing update

Nb QPR sample

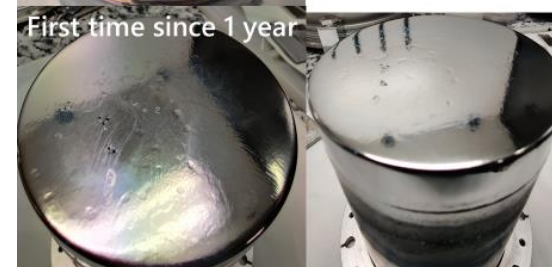
Longer treatments results

- After a long treatment:
1. Well polished the disk, almost disappeared lines.
 2. Disk defects are smoothed, not removed.
 3. Some signs of oxides (can be improved...)
 4. Some crater-like defects.

Unknown reasons
Possibly due to the oversaturation of the solution, non-uniform treatment in a close environment, cathode effect...

1. 60 min, removed ~100 μm
2. RR = 1,66 μm/min

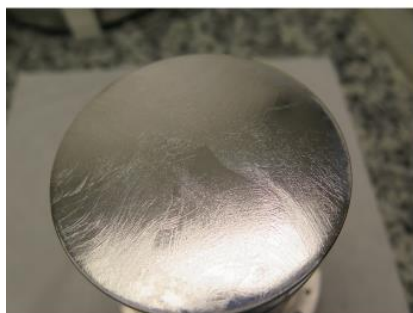
Preliminary results

After a short treatment:

1. Well polished external circle.
2. Disk defects are smoothed, not removed.
3. Some signs of oxides.
4. 10 min, removed 17,2 μm
5. RR = 1,7 μm/min

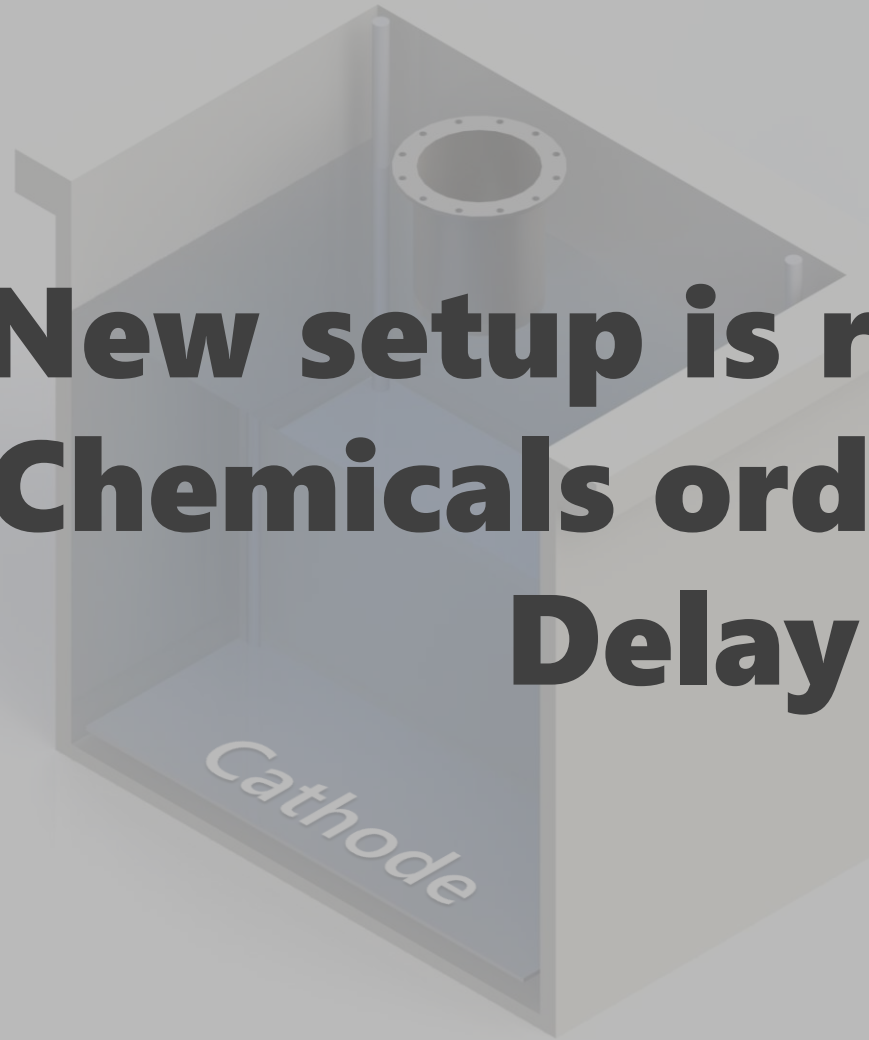
PEP setup for QPR sample polishing to be tested soon

- Bath of 40 L (full size)
- Developed water purification system
- Cathode: Aluminium or stainless steel
- Heating by heated resistance
- Temperature 80-90 C.
- More uniform treatment, temperature, concentration etc.
- Avoid undesired oxides.
- Local polishing

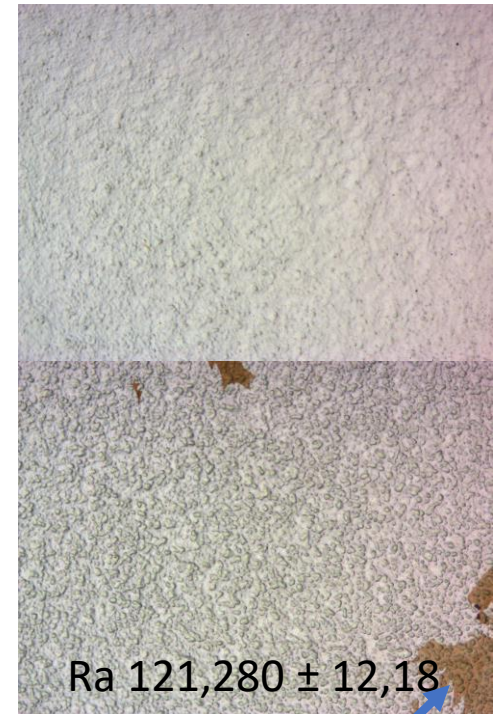
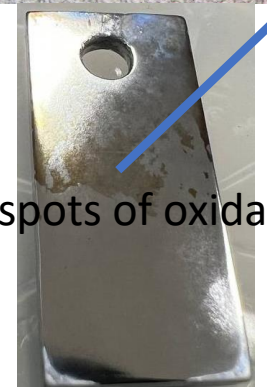
1,5 min, 3,5 um

Local spots of oxidation
