Cleanroom refurbishment in SM18

Upgrade for the SPL high gradient
resonators

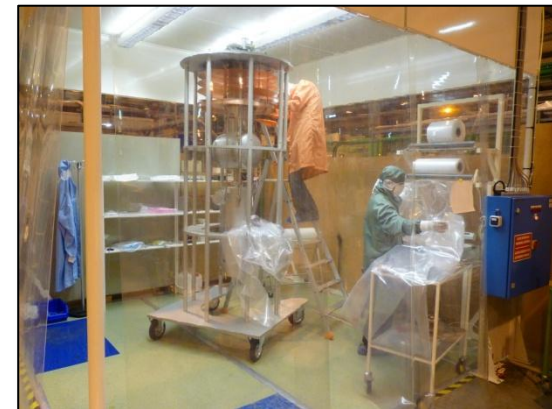
- High Pressure Rinsing (HPR)
- Ultra Pure Water (UPW)
- Clean space dedicated to the cleaning operations
- Better cleanliness
- More space

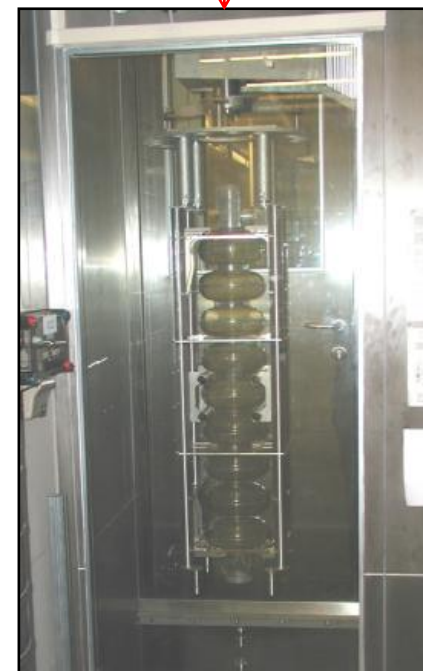
DESY's HP rinsing system

- HPR: nozzle moving through a rotating cavity
 - Collaboration with DESY ⁽⁴⁾ is welcome (but XFEL remains priority)
 - New HPR in Brookhaven and Saclay
 - Expensive equipment
- Control done at outlet used as cleanliness indicator:
 - Water resistivity
 - TOC measurement
 - Particle counting (limited by bubbles in water)
 - Analysis of a filter at water outlet under microscope (2h long by analysis, up to 6 analysis per cavity)

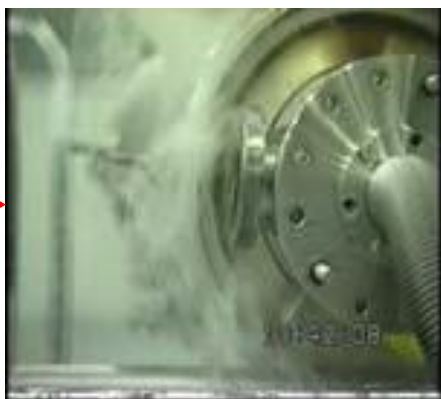
Flow pattern at power coupler port at DESY (argon overlay flow from cavity switched on)
