# *Construction and Installation of a 300kW Solid State Power Amplifier for Taiwan Photo Source*

*Fu-Tsai Chung*  
*2022/09/12*

*RF Group*  
*NSRRC, Taiwan*

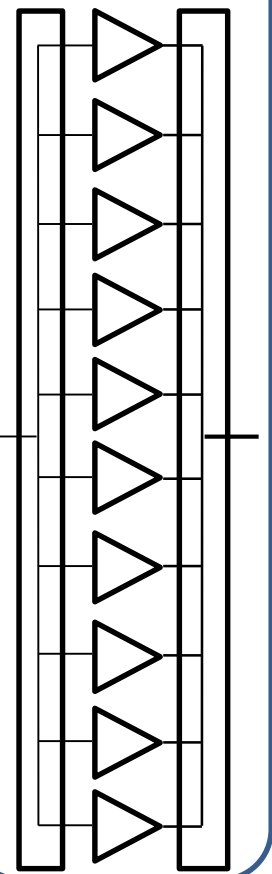
8.5kW

0.9kW x 10

For better redundancy in pre-amplifier

100W x 2

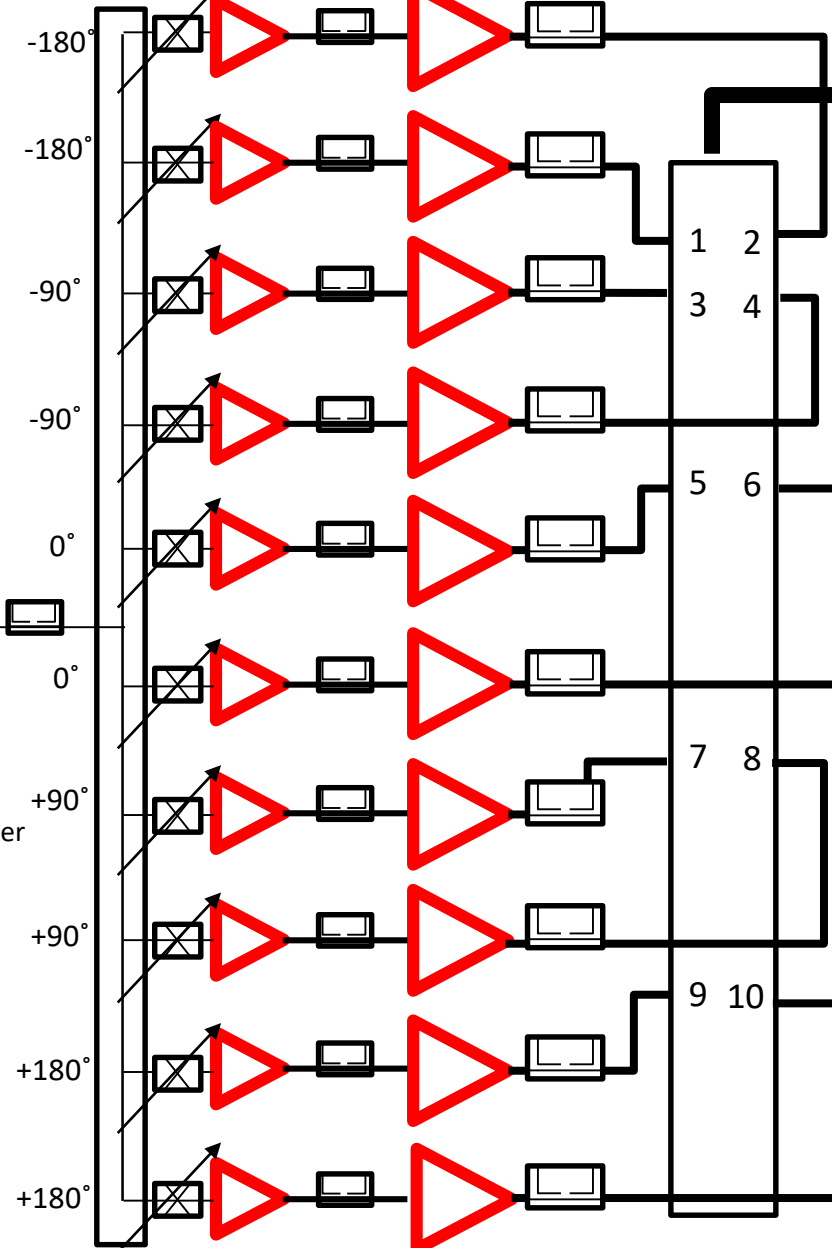
2-way N to N divider      2-way N to N combiner

10-way N to N coaxial divider      600W      8.5kW x 10

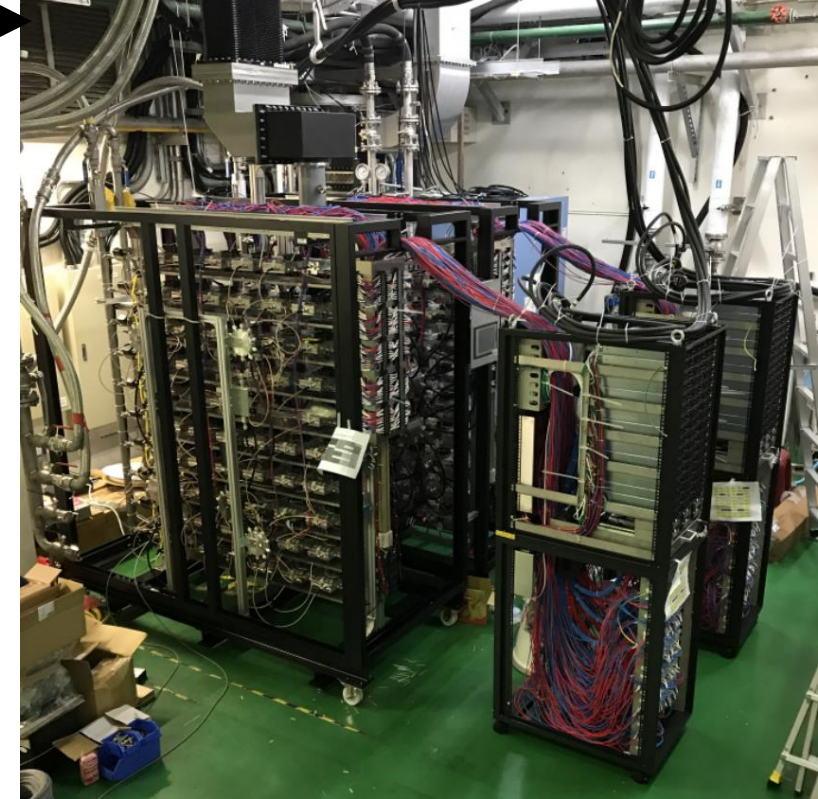
80kW

completed assembly before high power test.

**Total modules: 100+10+2  
20 modules with analog module included.**

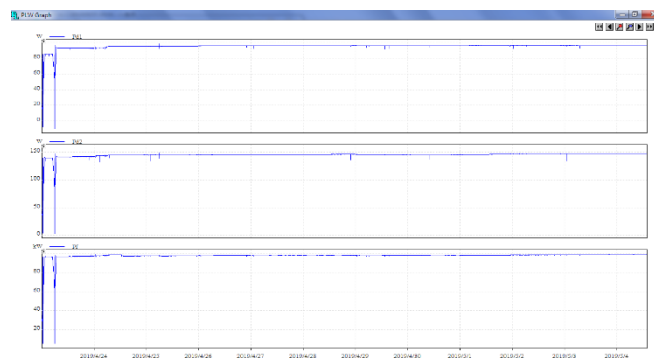
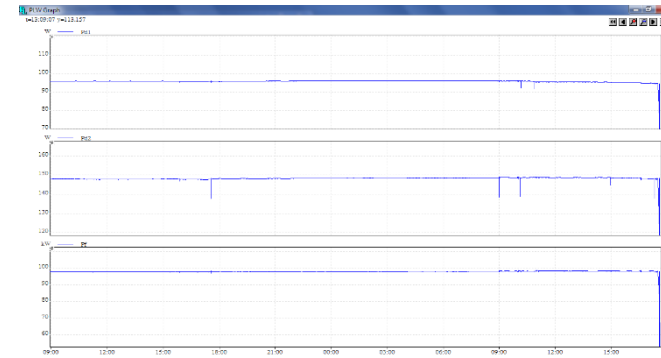
2019.4.23 17:15

15 days continuous run without trip

2019.5.8 17:30

- Target: continuous operation at full power for weeks with no trip event.
- Full RF Power test ( 3 times )
  - 1<sup>st</sup> test 2019.04.23-05.08: 15 days (1 module fault)
  - 2<sup>nd</sup> test 2019.05.29-06.12: 15 days(2 module faults)
  - 3<sup>rd</sup> test 2019.06.13-06.17: 5 days (no module fault)
- There was no trip event due to any module abnormality, as the expected advantage of SSPA.

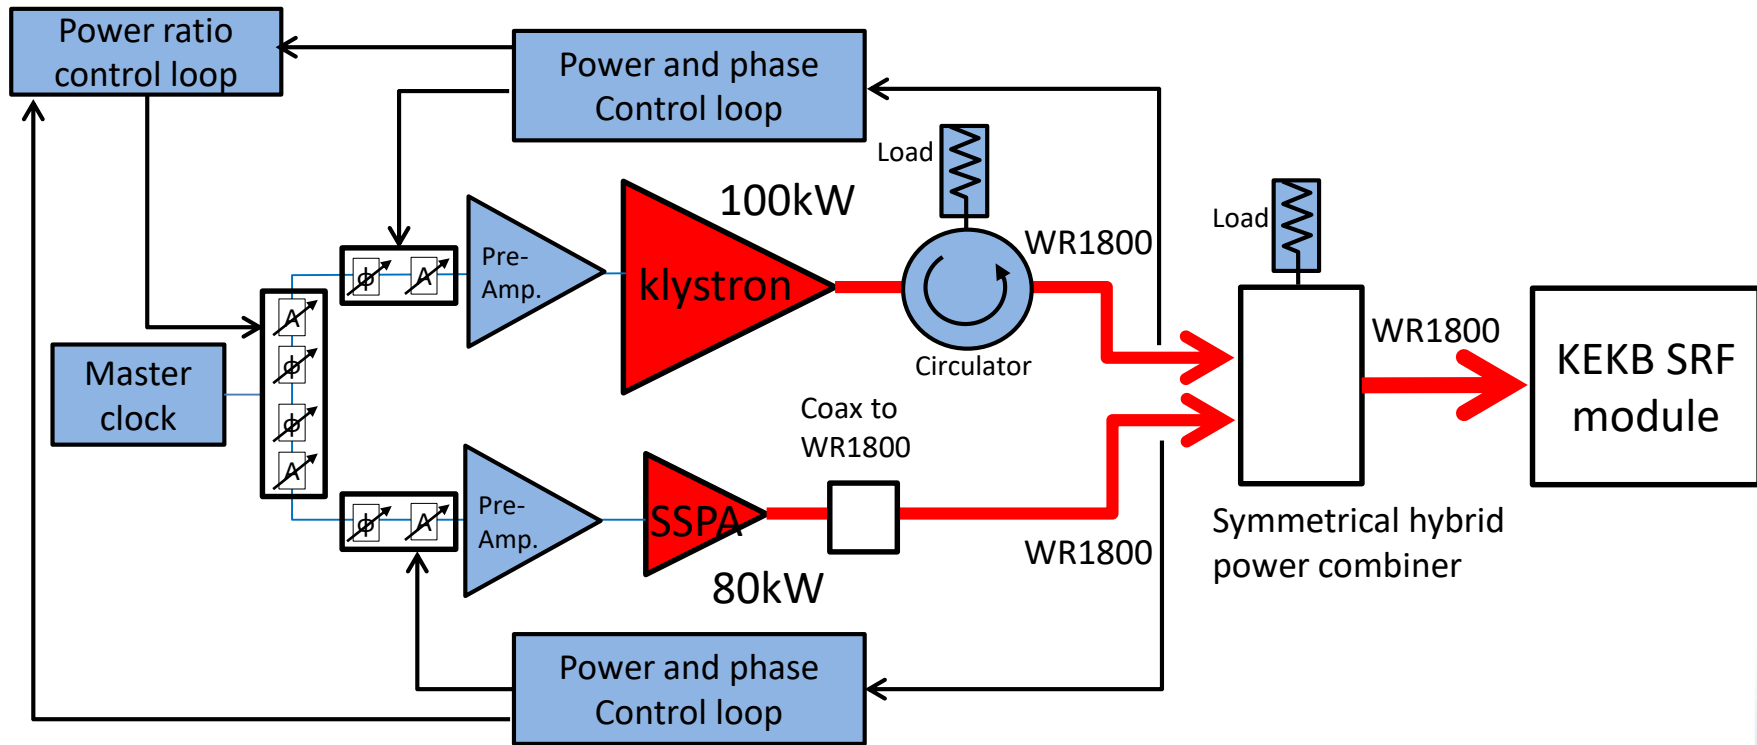
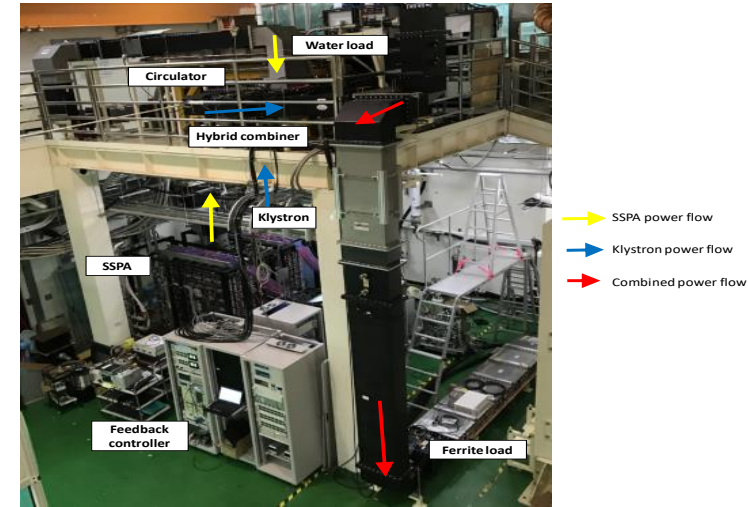
- The 80kW SSPA was combined to a 100-kW klystron
- High-power test on the SRF module of the 3<sup>rd</sup> RF plant.

- Observe Pr of each power source & Pf<sub>total</sub> to see if the power is balance

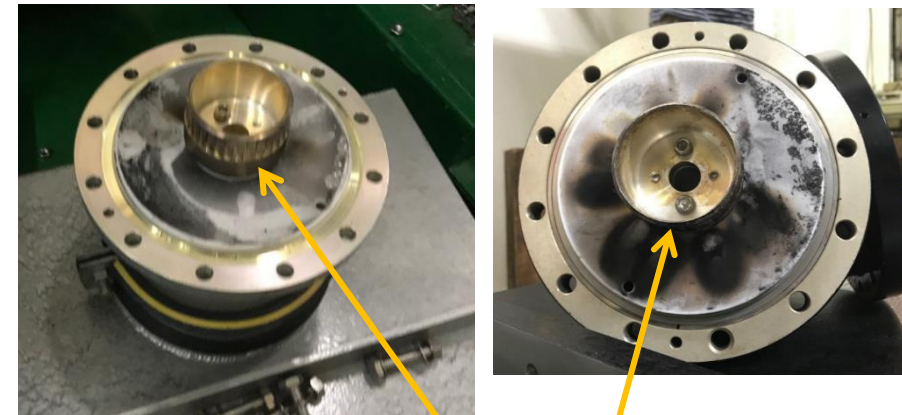
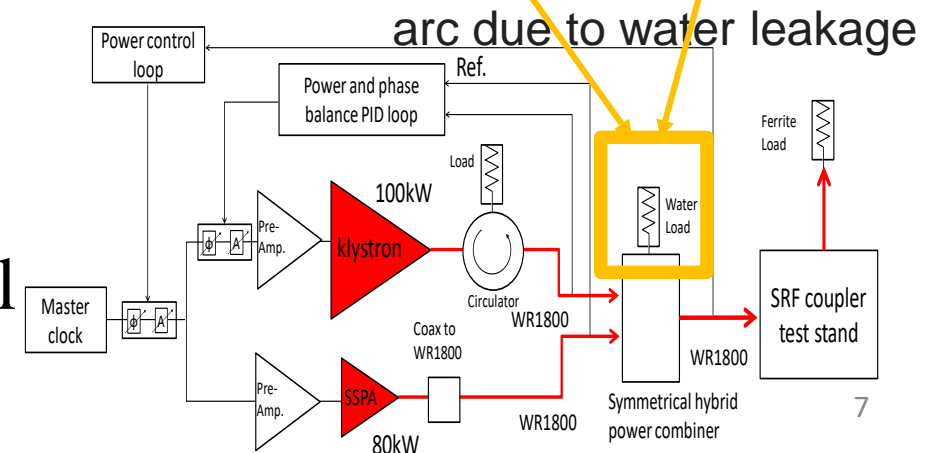
- (1) RF power up to 120kW → no trouble
- (2) RF power up to 140kW → water load crash

- After water load crash event: (water leakage)
  - 13 modules were repaired
- After CPL aging:
  - 22(No DC current)+2(current low)=24 modules.

✓ Most arc happen due to non-proper IC model  
(BLF578XR(low efficiency) → BLF578)

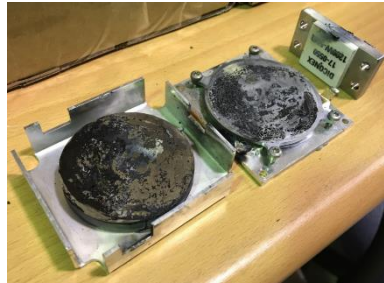
circulator

Reason	SSPA module				
	IC-BLF578	1000W-Circulator	1200W-RF Load	RF Circuit Board	analog Circuit
ARC (Reflection Power)	★	★		★	★
CPL aging	★	★	★		
Operation RF Power	★	★		★	★

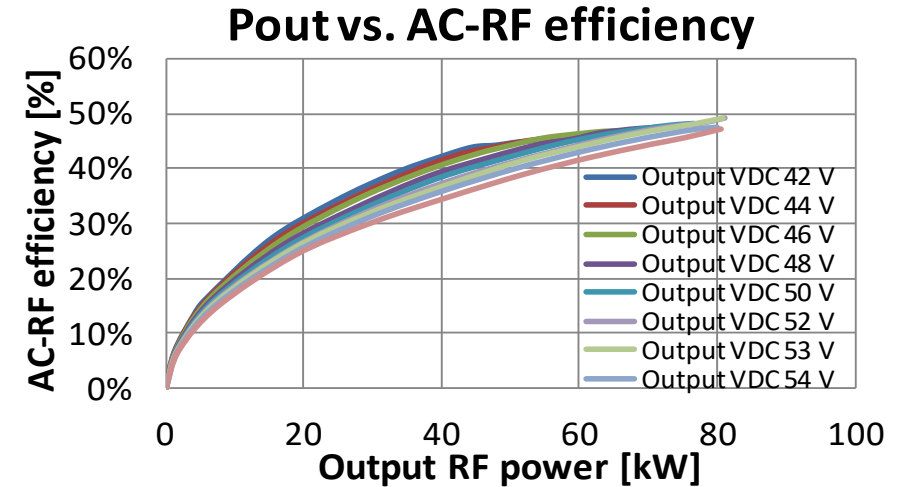
- The possible loss in SSPA system
  - AC-DC efficiency: 90%
  - DC power loss at wires: 3.5%
  - DC-RF efficiency: 55-60% (BLF578XR has lower efficiency)
  - RF cable efficiency: 98.2% (-0.05dB/m)
  - RF combiner efficiency: 98.7%
  - Theoretical efficiency: 45.7%-50%
  - The best AC-RF efficiency to obtain: **49.5%**

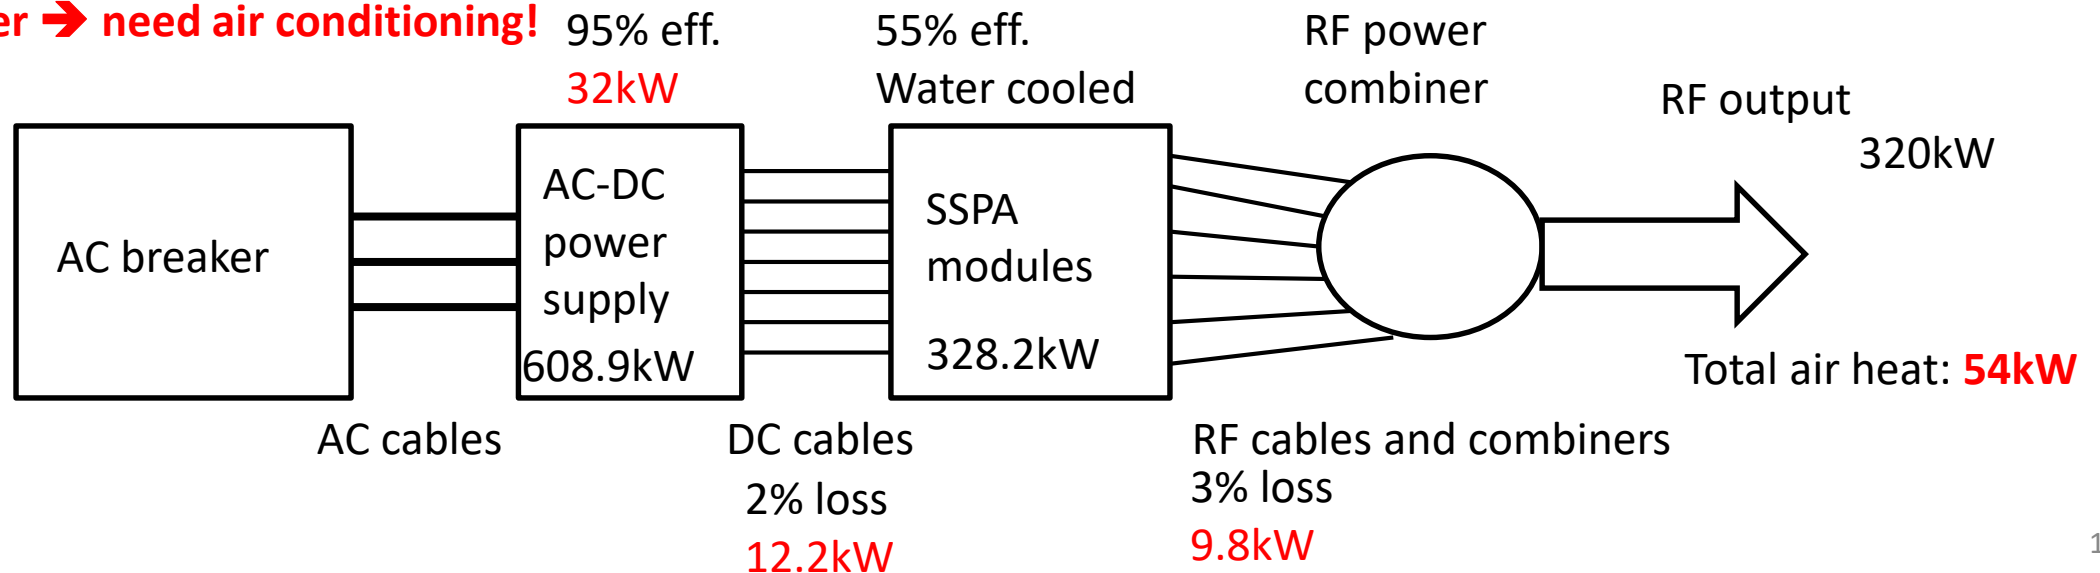
Estimation of the heat of 320kW SSPA to air:

**A Big warmer → need air conditioning!**

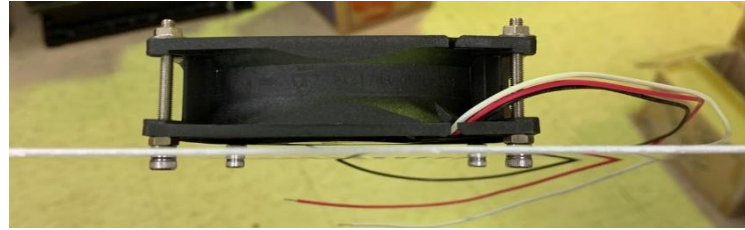
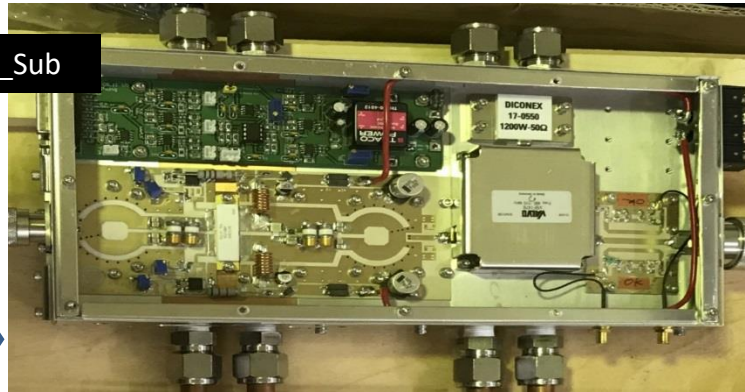
- (1).Vdc current/voltage
- (2).Temp(balun-IC-Load)
- (3).Fan frequency

Need Shielding (EMI)

15pin-D\_Sub

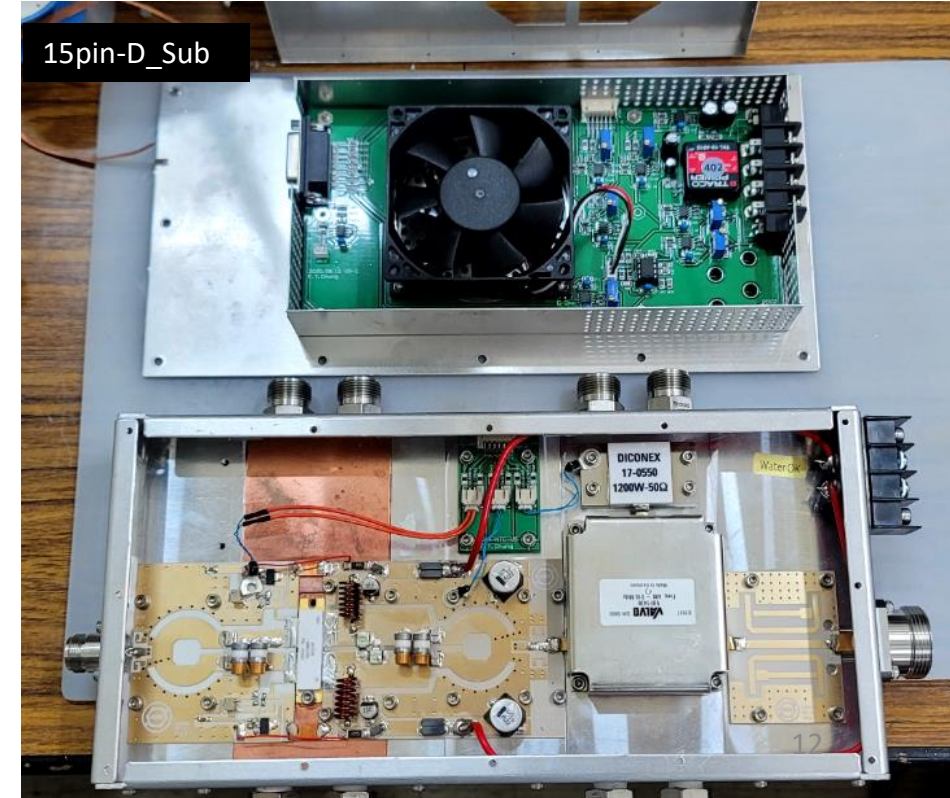
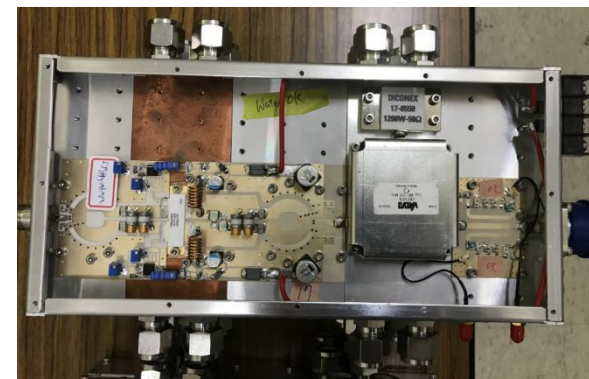
# Simplify the assembly of analog modules into SSPA

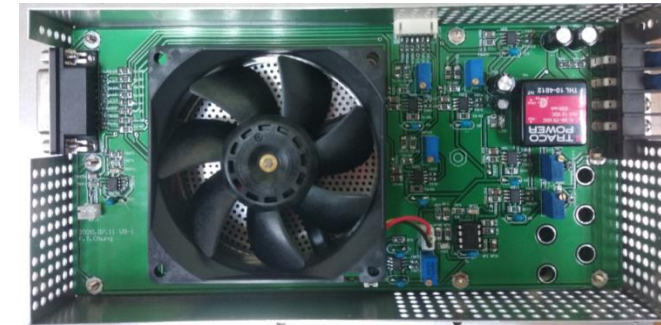
Analog module

- (1).DC current/voltage
- (2).Temp(balun-IC-Load)
- (3).Fan frequency

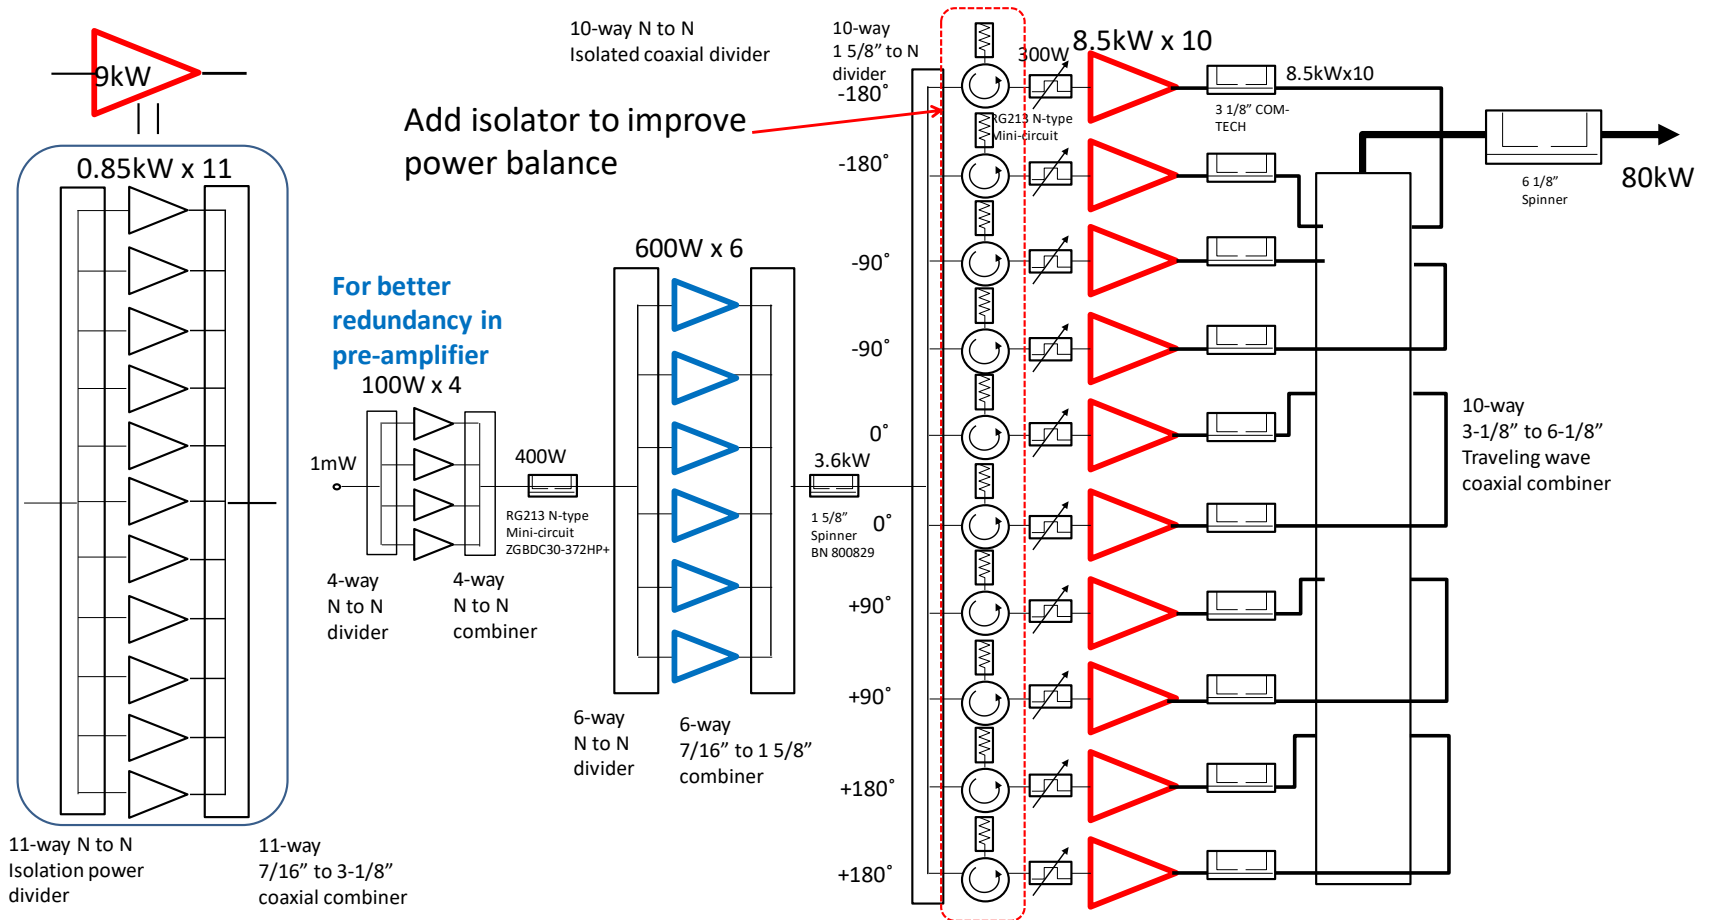
# Single 80kW SSPA Tower design

- Frequency: 499.65 MHz
- Power rating:  $\geq 80$  kW
- Bandwidth:  $\geq \pm 1$  MHz
- Power gain:  $\geq 80$  dB
- Side band noise:  $\leq 65$  dBc
- Harmonic:  $\leq 40$  dBc
- Elements:

- 100 W pre-amplifier x4
- 600 W drive amplifiers x6
- 880 W amplifiers x110
- 4-way divider/combiner (400 W) x2
- 6-way combiner (3.6 kW) x1
- 10-way divider (3.6 kW) x1
- 11-way divider (300 W) x10
- 11-way combiner (8.5 kW) x10
- 10-way combiner (80 kW) x1

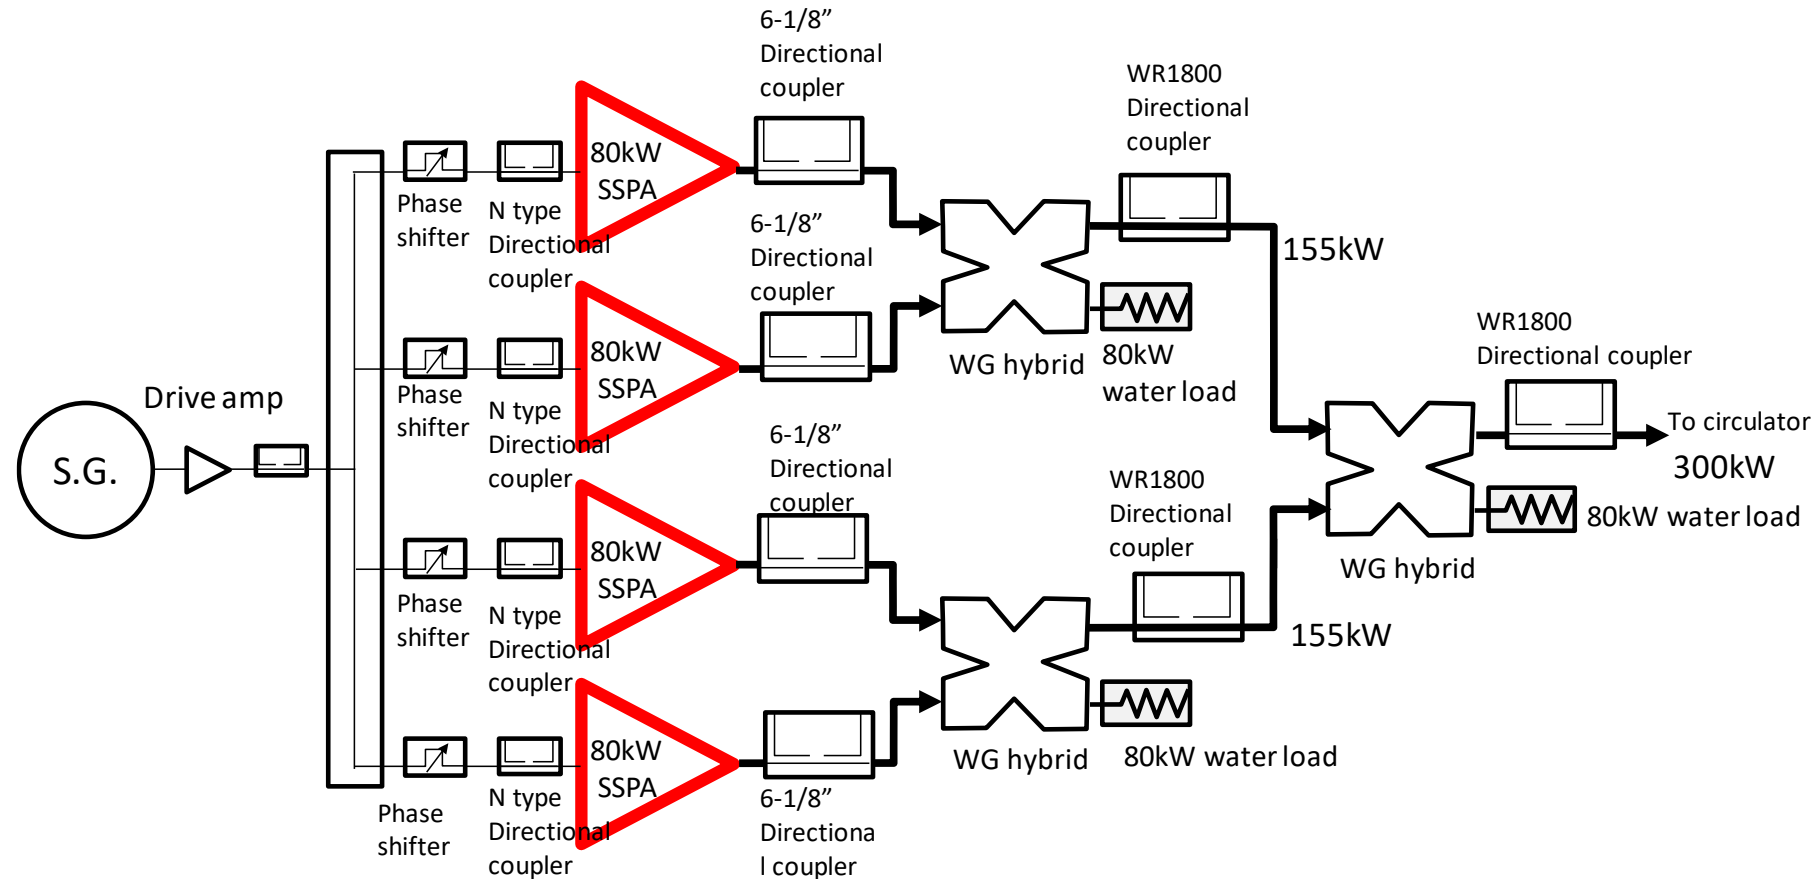
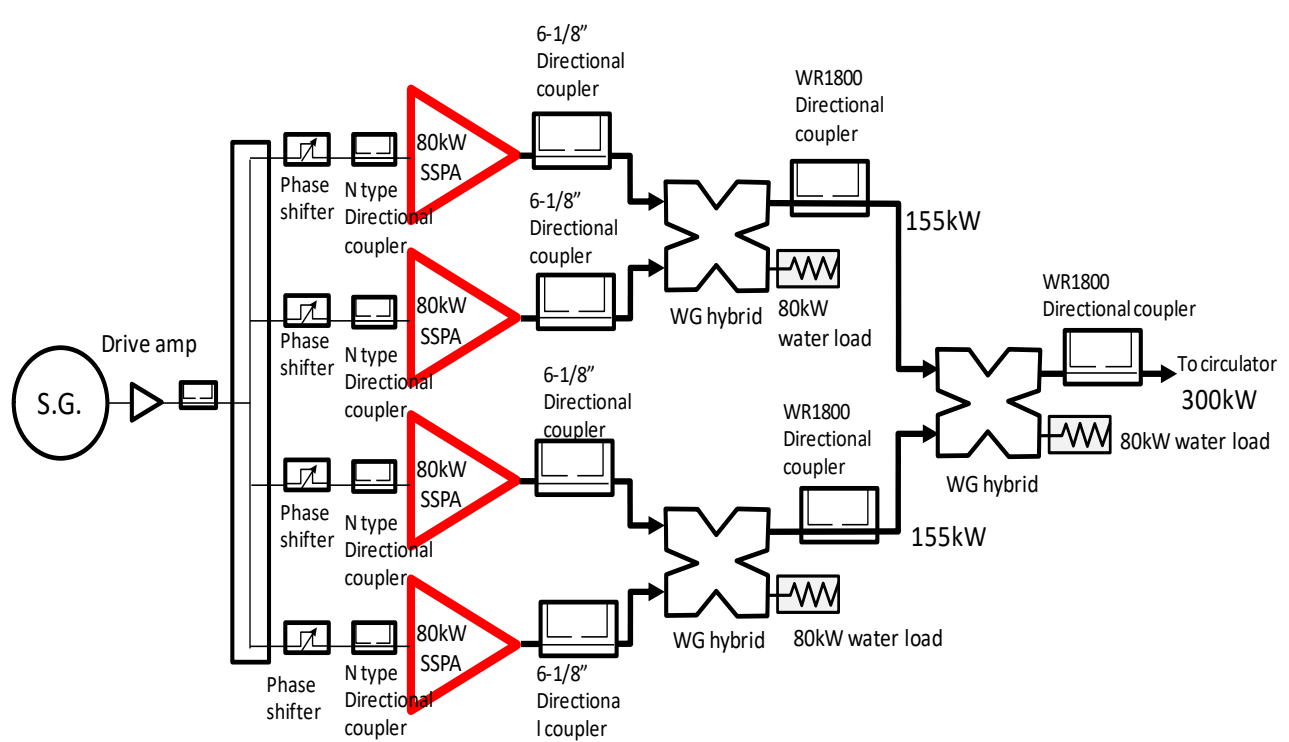
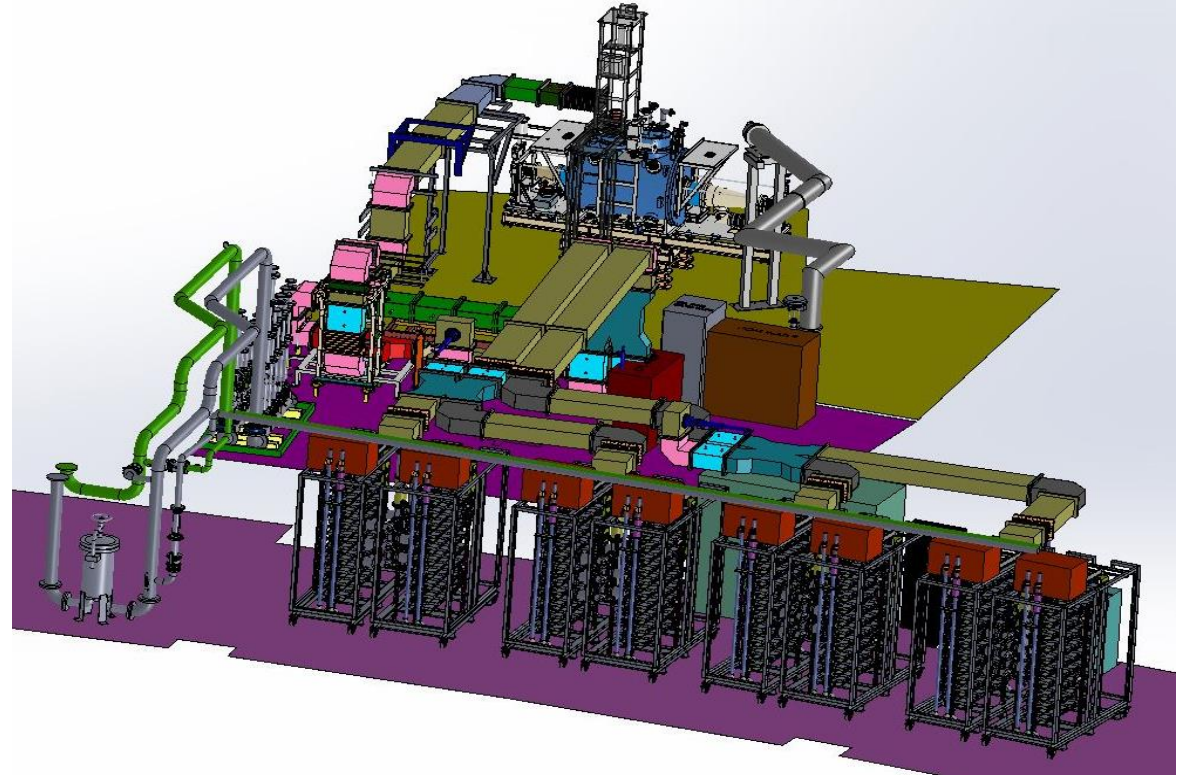
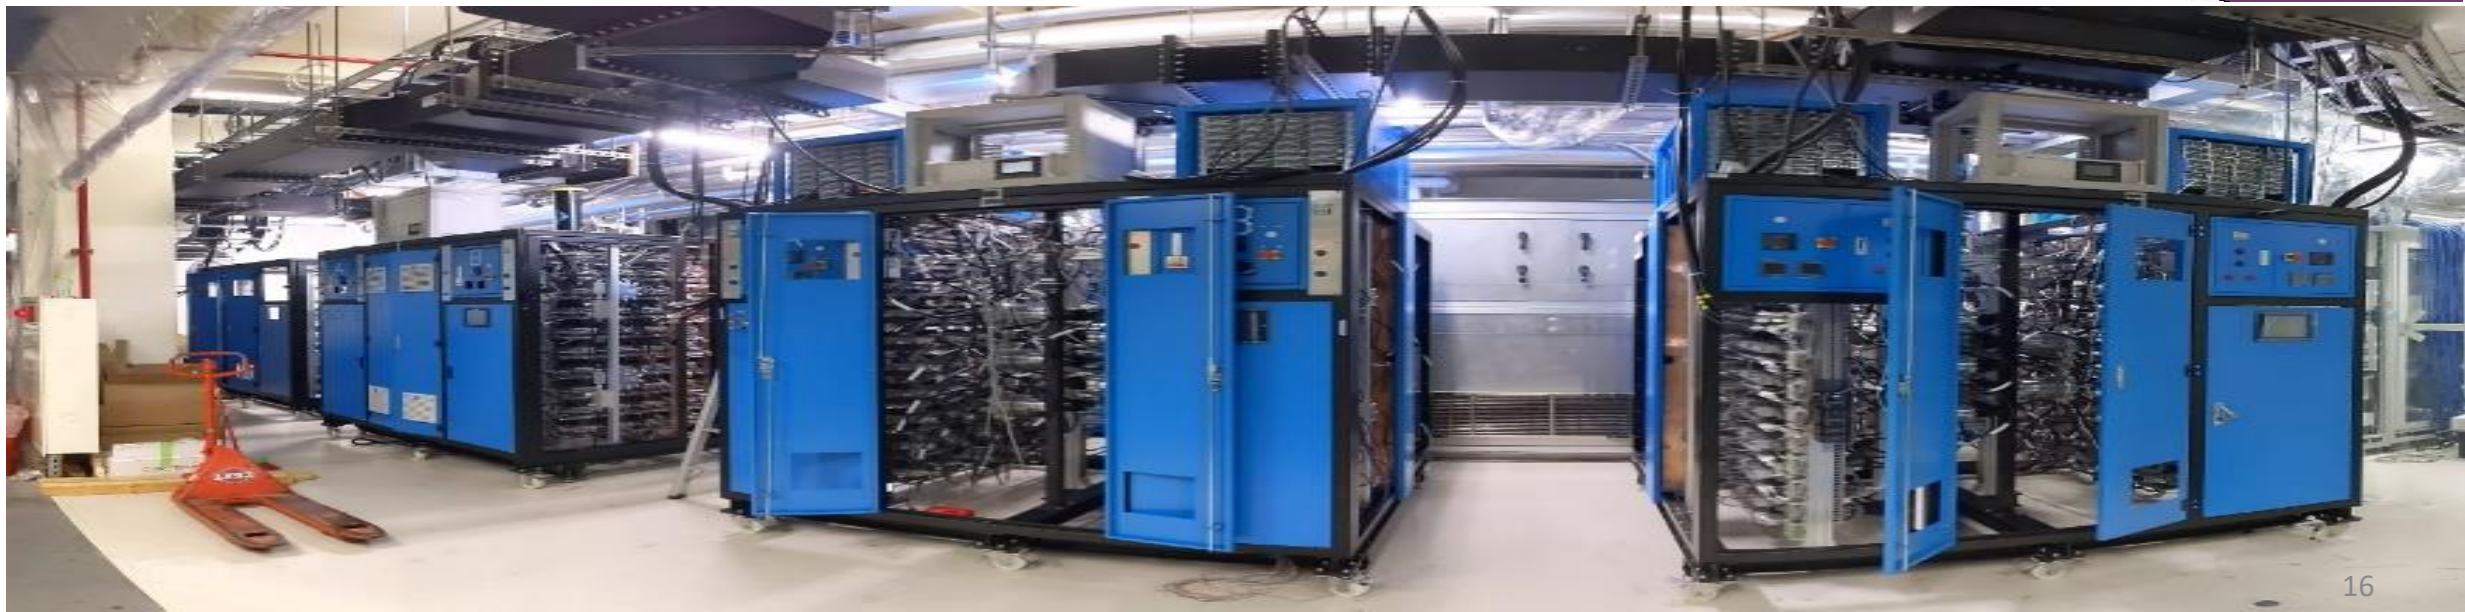
# 500MHz RF power 300 kW SSPA System Design

- Frequency: 499.65 MHz
- Power rating:  $\geq 300$  kW
- Bandwidth:  $\geq \pm 1$  MHz
- Power gain:  $\geq 75$  dB
- Side band noise:  $\leq 65$  dBc
- Harmonic:  $\leq 40$  dBc
