R2E assessment and mitigation of failures in the SPS access system

Matteo Cecchetto, Ygor Aguiar
G. Lerner, R. García Alía
on behalf of the R2E project

R2E Annual Meeting 1-2 March 2022
<https://indico.cern.ch/event/1116677/>

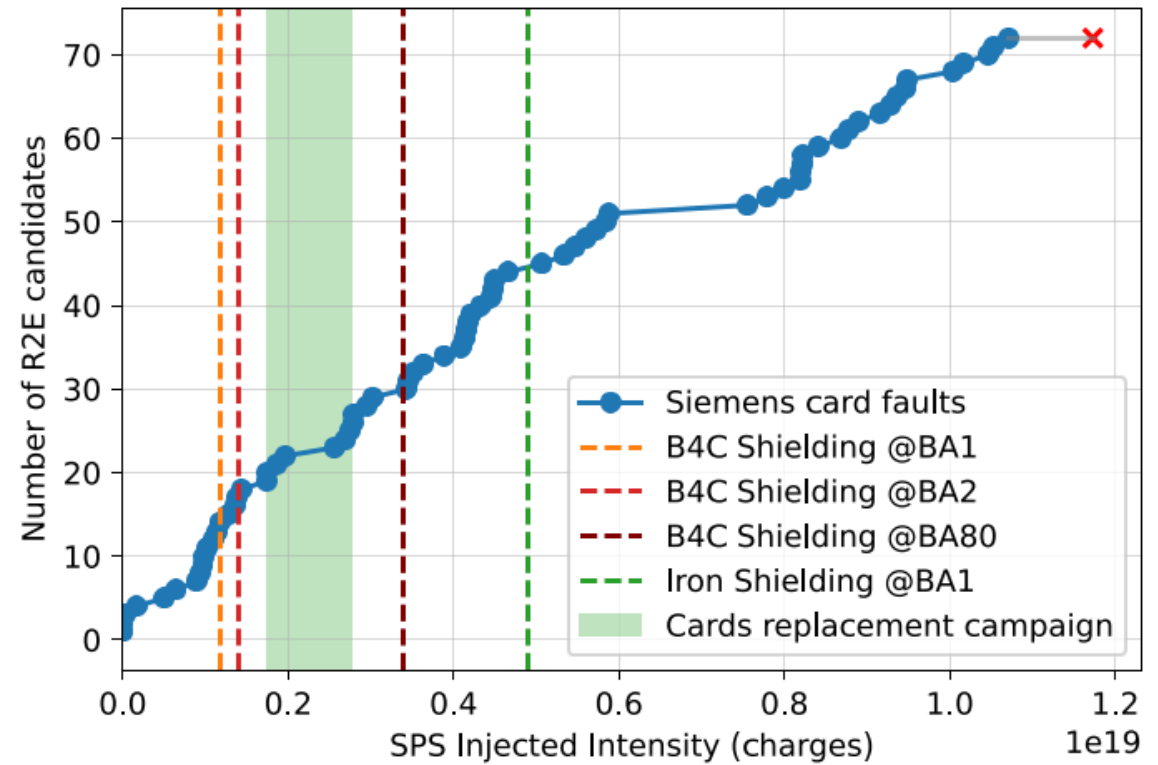
Overview: failure rate and SPS injected Intensity

- **Total of 75 R2E events** have been recorded in the input cards.
 - Not all of them lead to beam dump, but can possibly increase the downtime of the machine as the modules need to be manually reset during a beam stop.

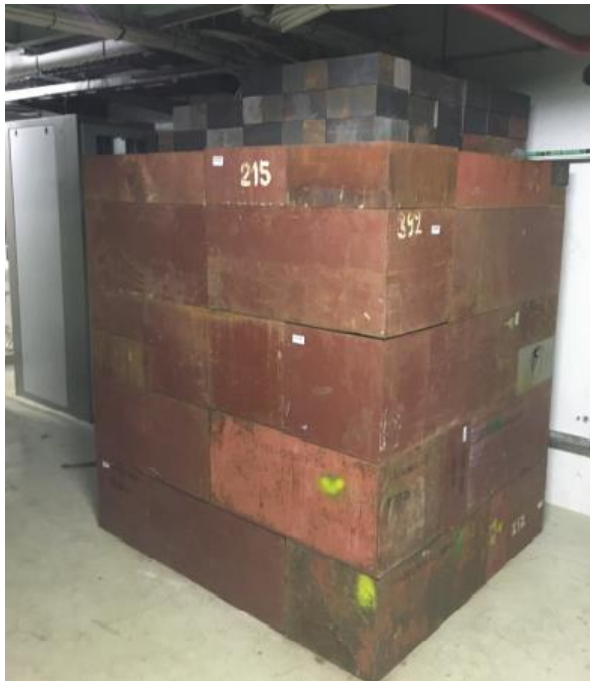
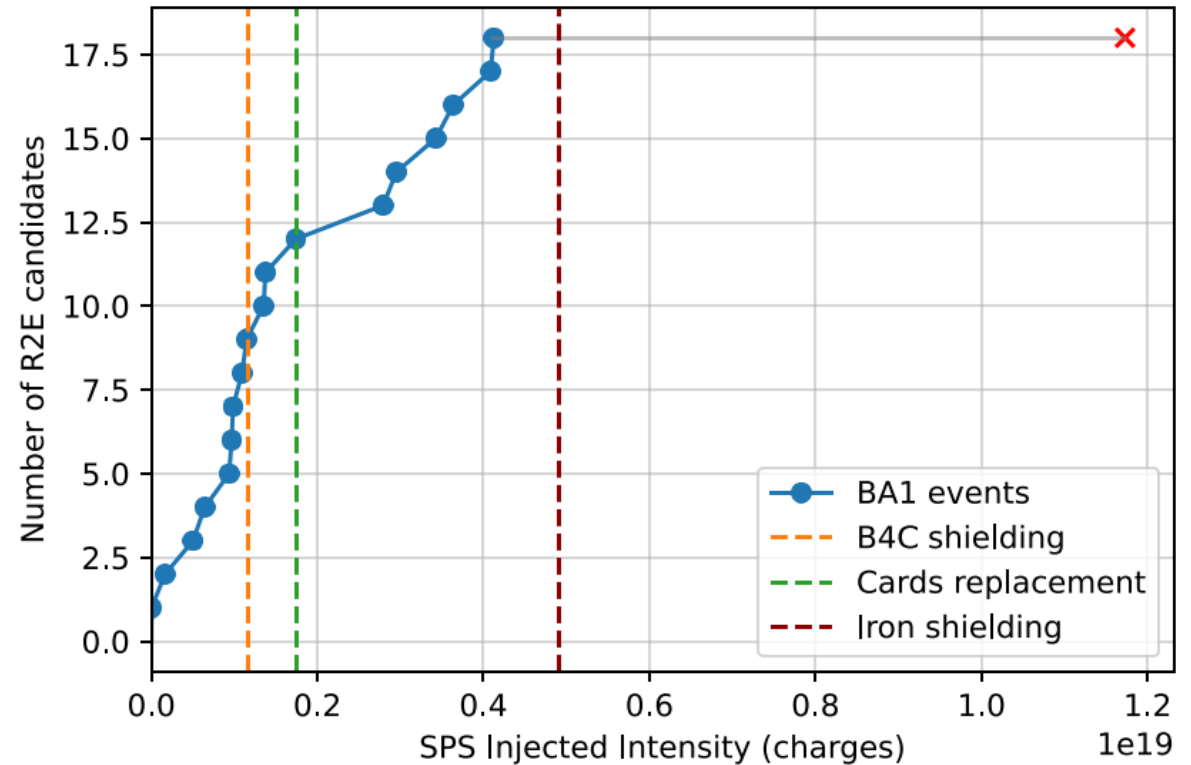
Heavy Shielding in BA1

- **40 cm Iron shielding installation (~ 17 T) on the 15th of September 2021.**
 - More info on the installation can be found in [T. Ladzinski's presentation](#) at 292nd IEFC meeting.

Shielding wall

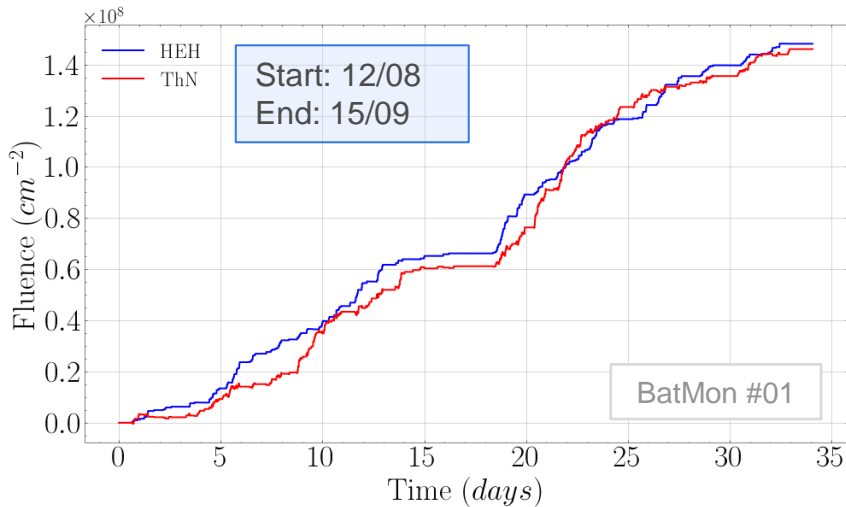
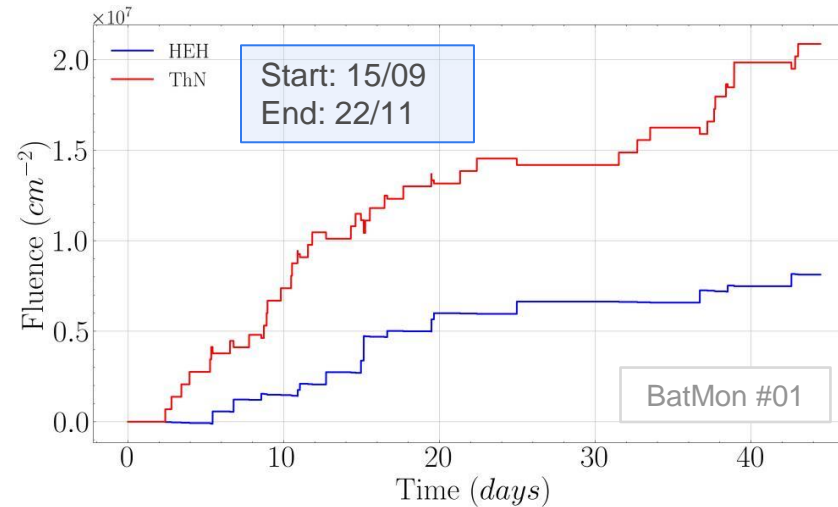
BA1 - Fluence measurements: BatMon*

- 2x BatMon installations: on the side of the rack facing the SPS tunnel and inside a boron carbide (B4C) layer facing the front of the rack

Before Iron shielding installation

Norm. HEH fluence = $5.6e-11 \text{ cm}^{-2}/\text{charge}$

Norm. ThN fluence = $5.5e-11 \text{ cm}^{-2}/\text{charge}$

47x
reduction

After Iron shielding installation

Norm. HEH fluence = $1.2e-12 \text{ cm}^{-2}/\text{charge}$

Norm. ThN fluence = $3.1e-12 \text{ cm}^{-2}/\text{charge}$

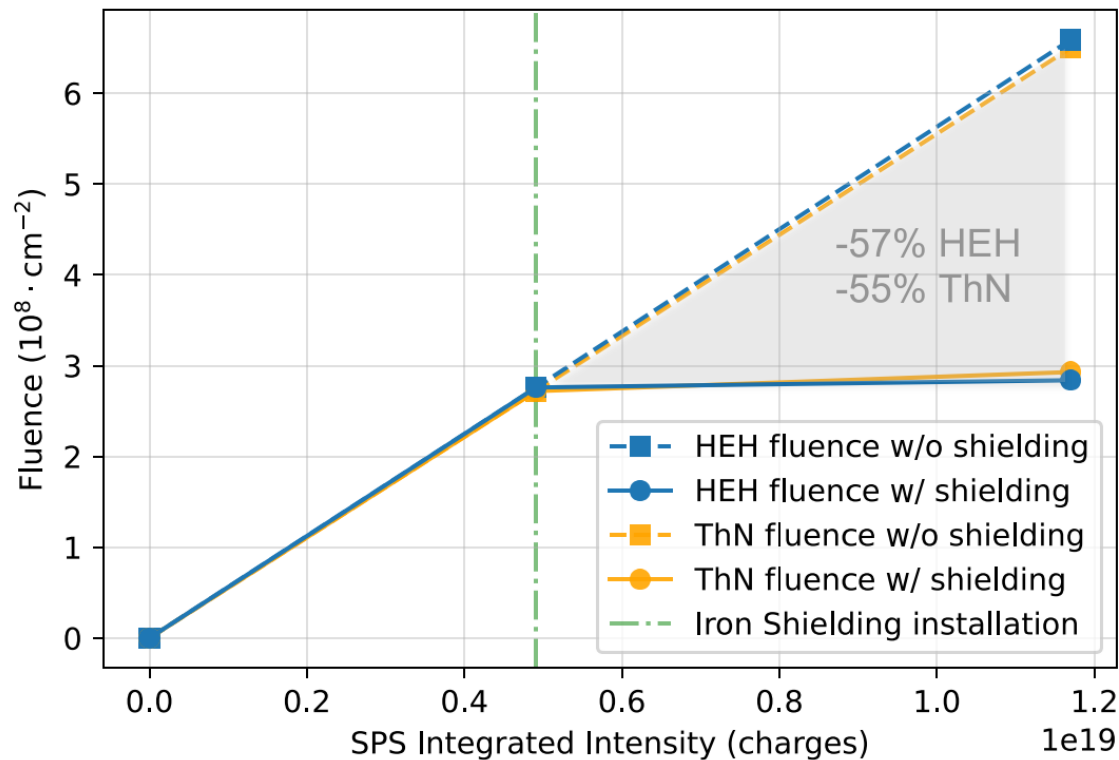
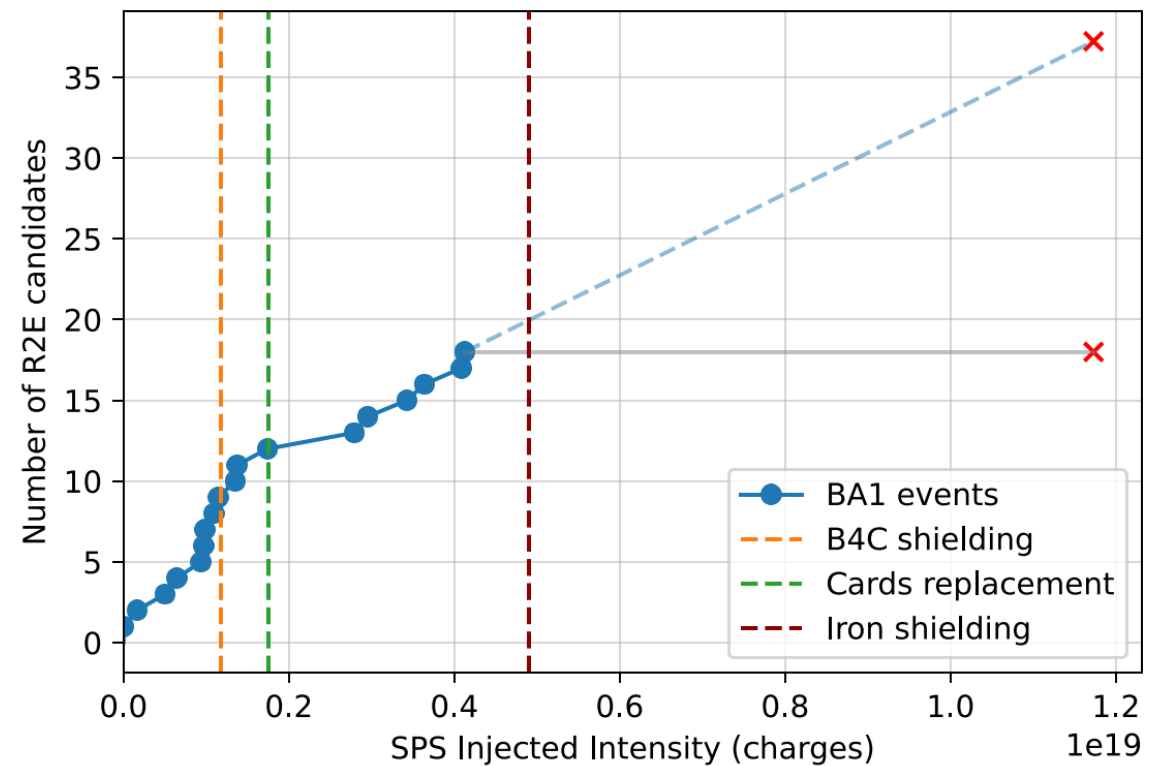
Impact of the Iron Shielding

- Assuming the radiation levels scale proportionally with the SPS intensity

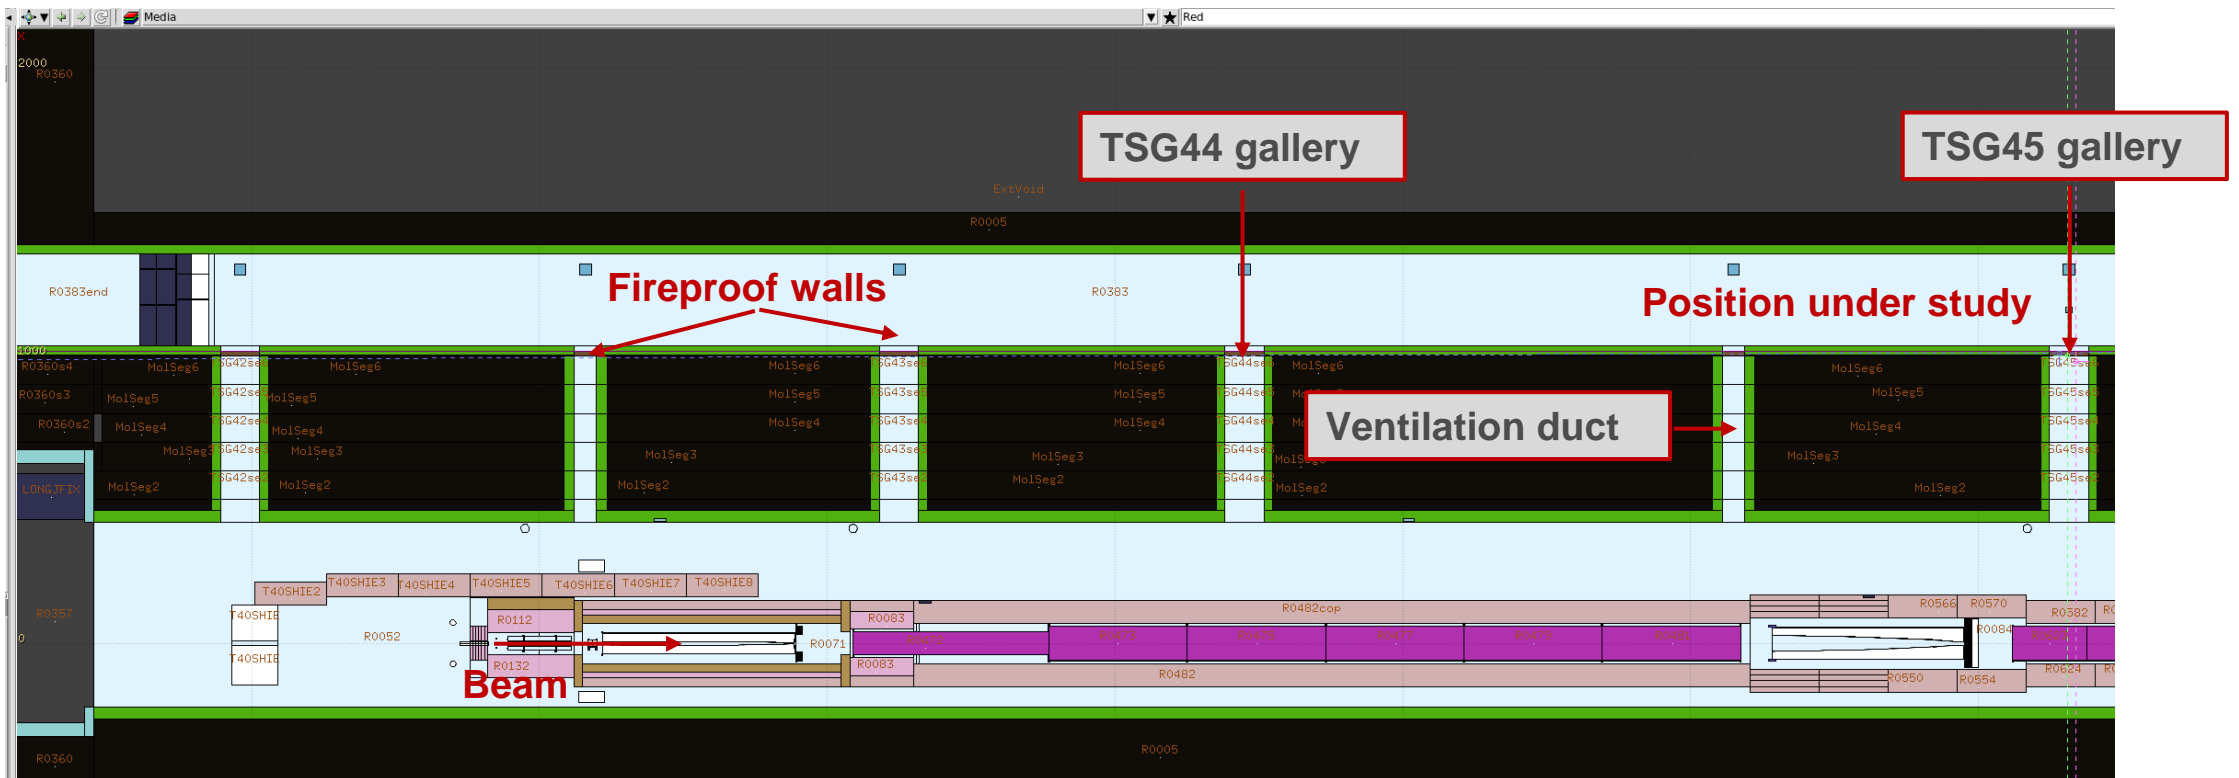
- FLUKA geometry (input from E. Nowak, C.Ahdida, HSE/RP).

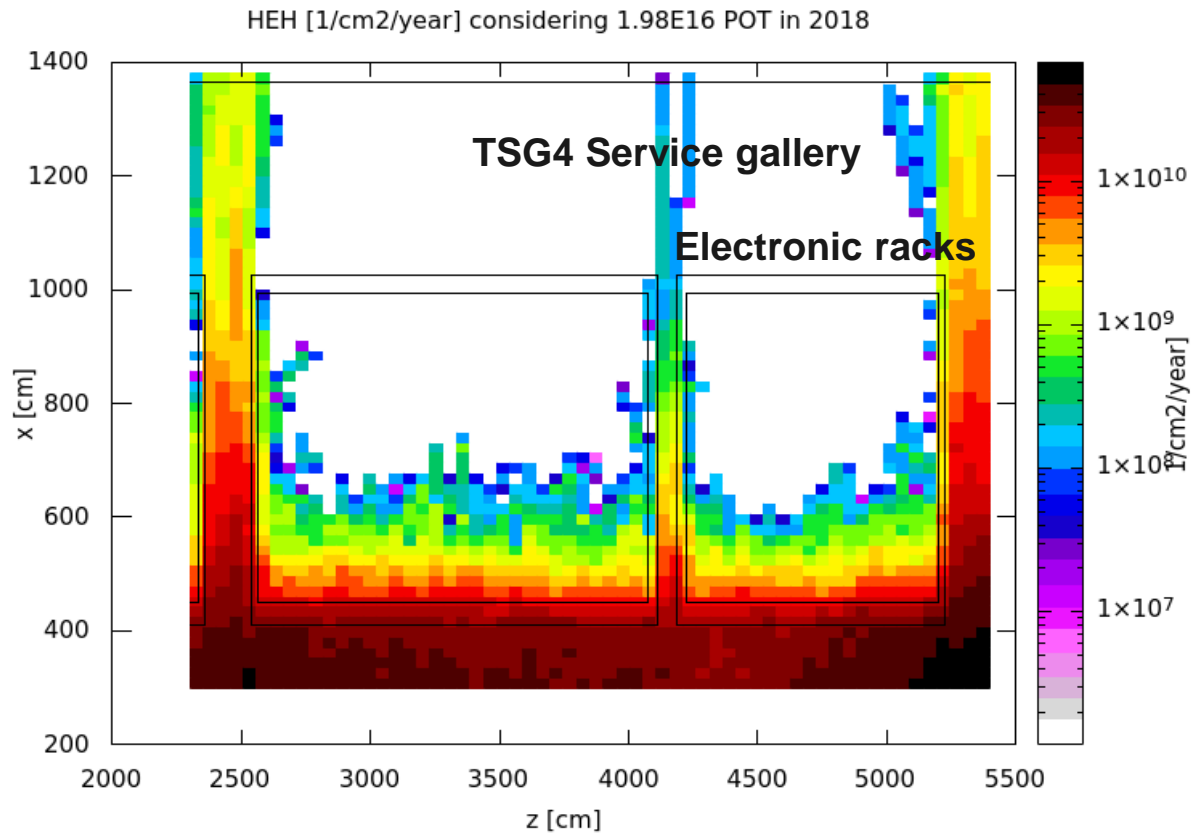
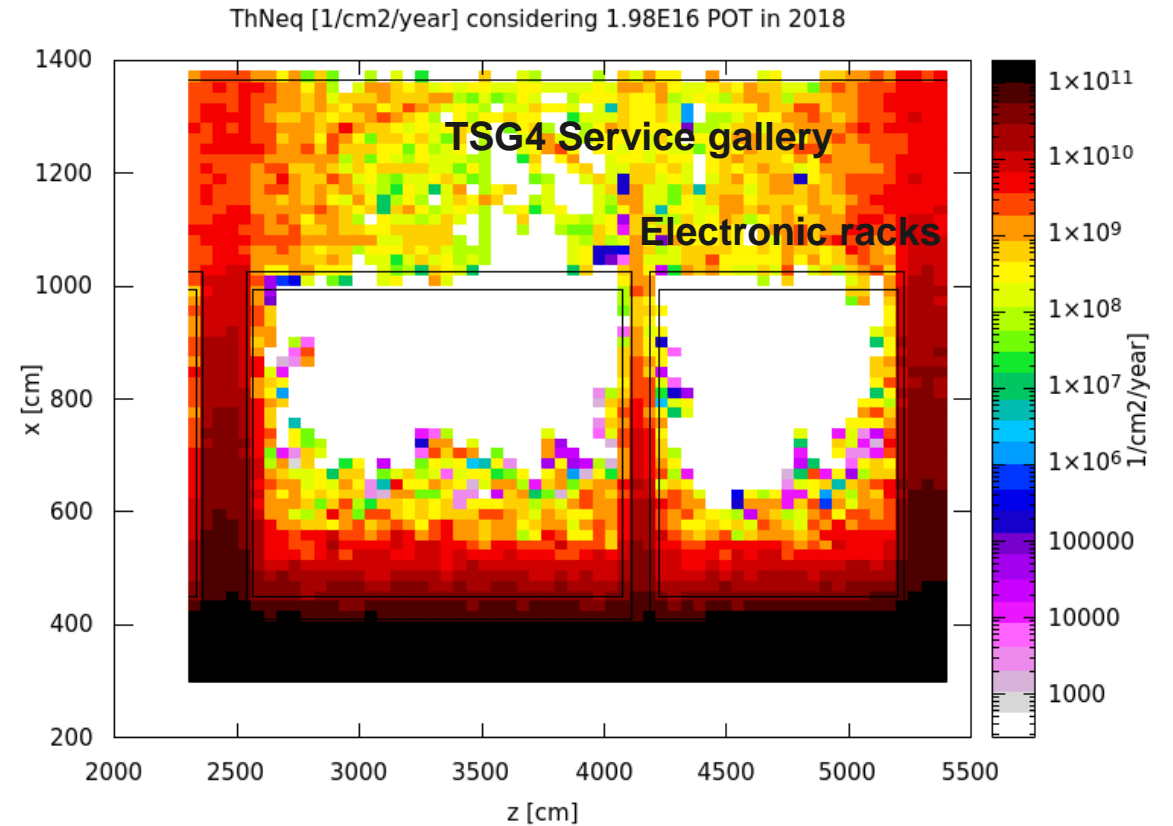
HEHeq and ThNeq overview (protons delivered in 2018)

- The beamline is on the bottom of the picture (top view), while the service gallery on the top part.

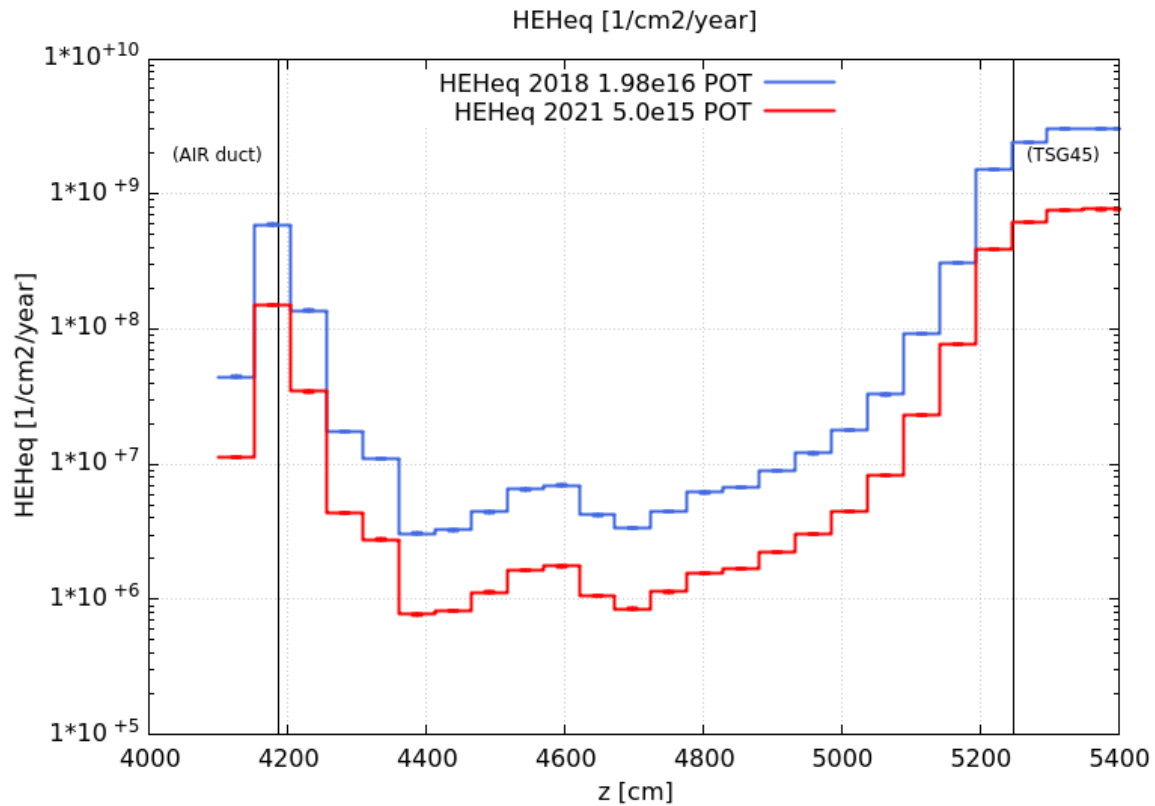
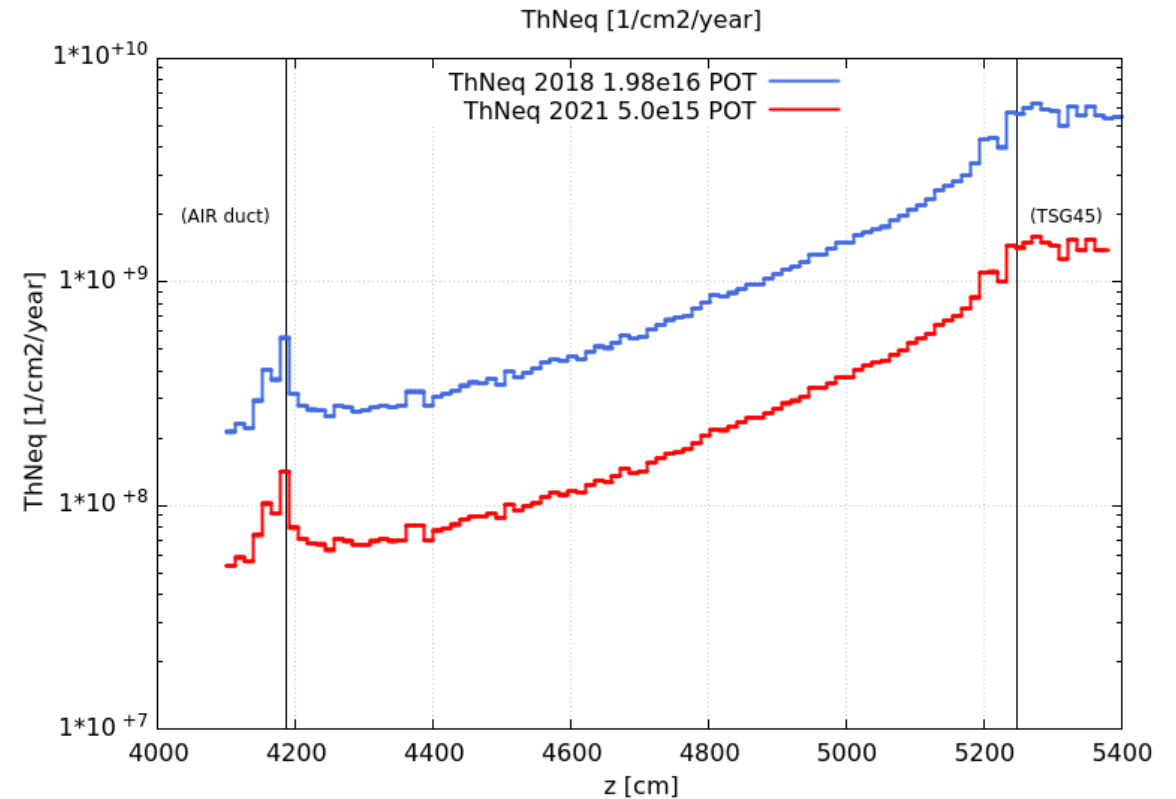
HEHeq and ThNeq fluence in 2018 and 2021

Radiation levels [$\text{cm}^{-2}/\text{year}$] between ventilation duct (to the left) and TSG45 gallery (to the right) for the full 2018 and 2021 operation.

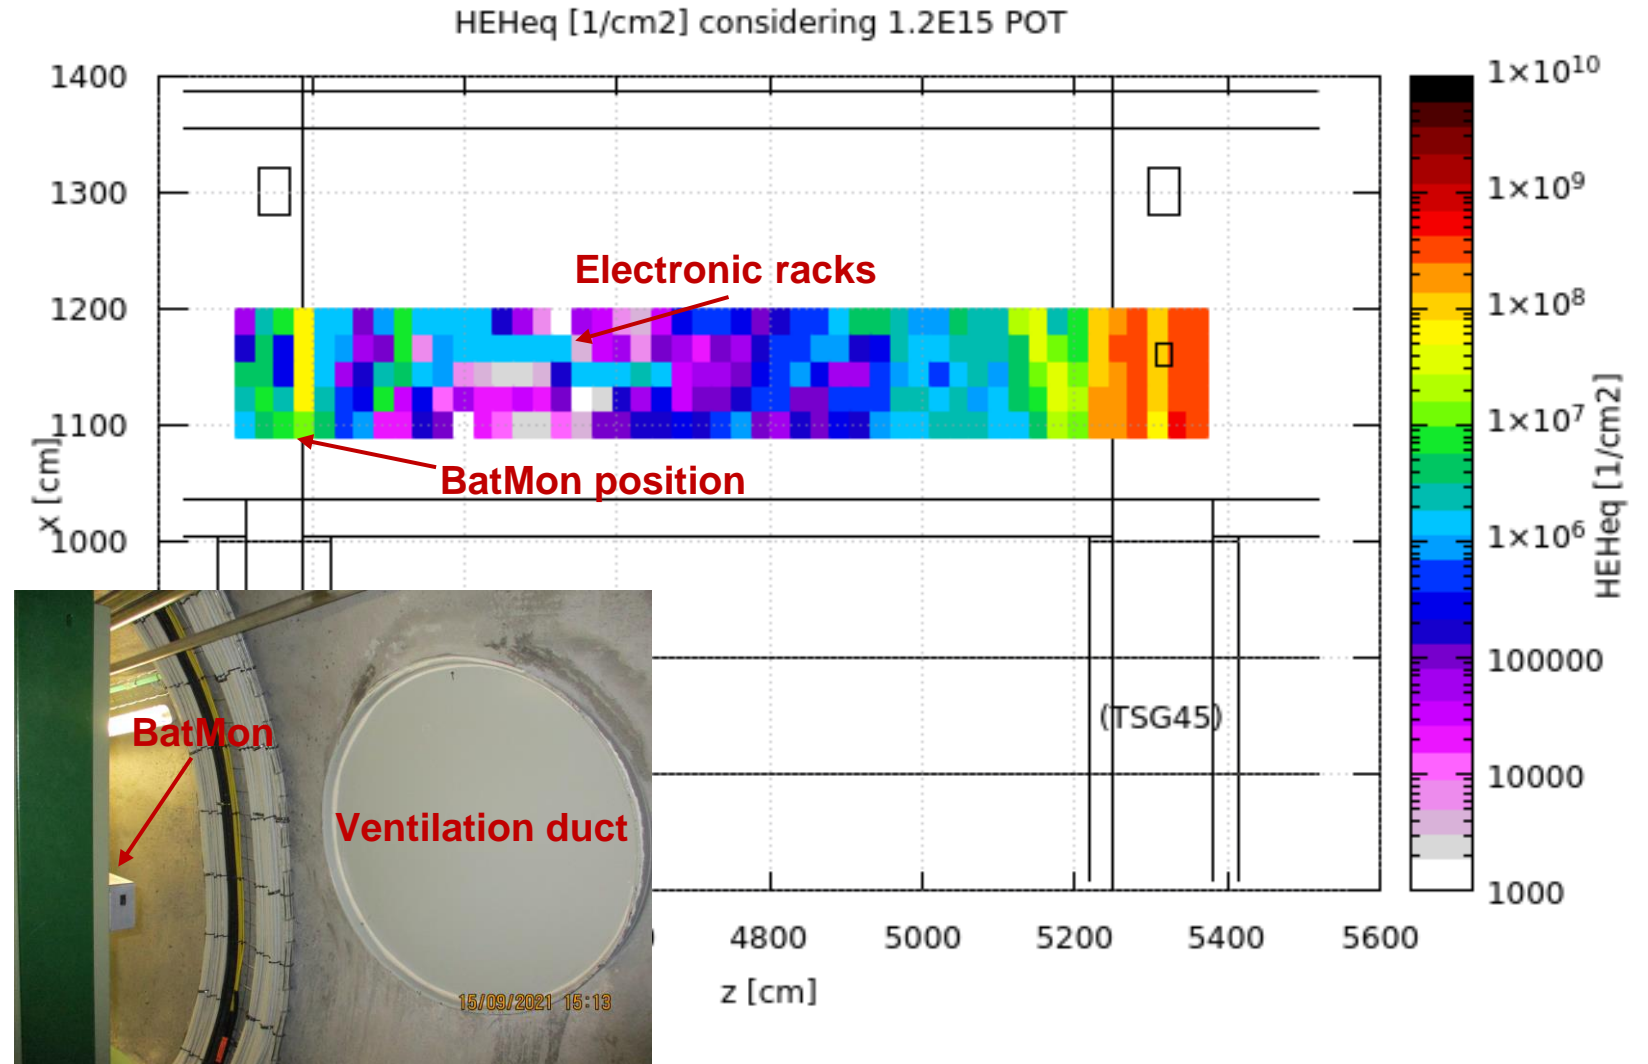
HEHeq - FLUKA simulations – BatMon position

- HEHeq top view scoring at the height of the BatMon (~1m above the floor).
- Very strong HEHeq and ThNeq fluence gradient at BatMon location.
- Hence, the agreement with measurements can be considered within “order of magnitude”.

- Good HEHeq agreement between FLUKA and BatMon (~20%).
- ThNeq fluence present a factor of ~10 difference between FLUKA and BatMon.
- We should take into account that the BatMon SEU statistics was quite low (~50 events) corresponding to about **10 days of acquisition** (**1.2e15 POT** delivered in AWAKE).
