Changes to BLM system on 28. April 2010

Eva Barbara Holzer
for the BLM team

LHC MPP
CERN, April 30, 2010

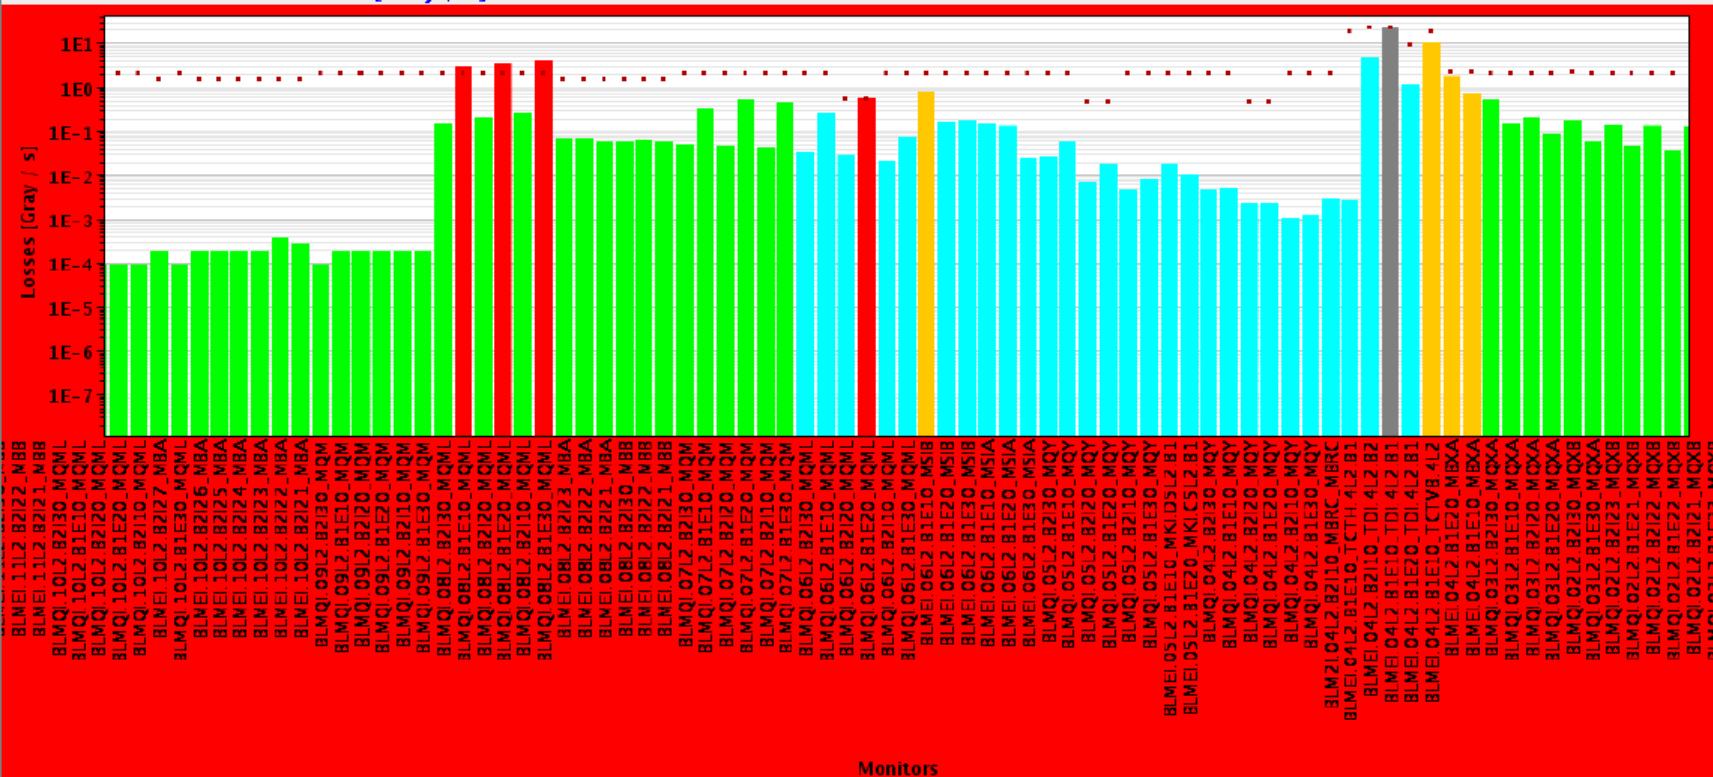
Over-injection

- Thresholds 4 MBX monitors now allow for over-injection onto a 'fat' pilot. Requested: Brennan
 - 40us to 10ms (RS1 to RS6) changed for injection energy
 - BLMEI.04R8.B2E10_MBXB and BLMEI.04L2.B1E10_MBXA
 - Up to 'pilot' of $\sim 8e9$
 - At the next possibility: increase margin to $1.2e10$ (same as MQXA)
 - Thresholds to be recalculated (unnecessarily low for higher energies)
 - BLMEI.04R8.B2E20_MBXB and BLMEI.04L2.B1E20_MBXA
 - To be verified and possibly changed
- Threshold on TCT not increased (requested: Ralph) → next in the line to trigger
- Two additional corrections:
 - Swap names: BLMEI.04L2.B1E10_MBXA and BLMEI.04L2.B1E20_MBXA
 - Past logging data reassigned accordingly – should be transparent
 - Corrected threshold settings (3 MBX monitors were in wrong family)
- ECR to be done once all changes finalized

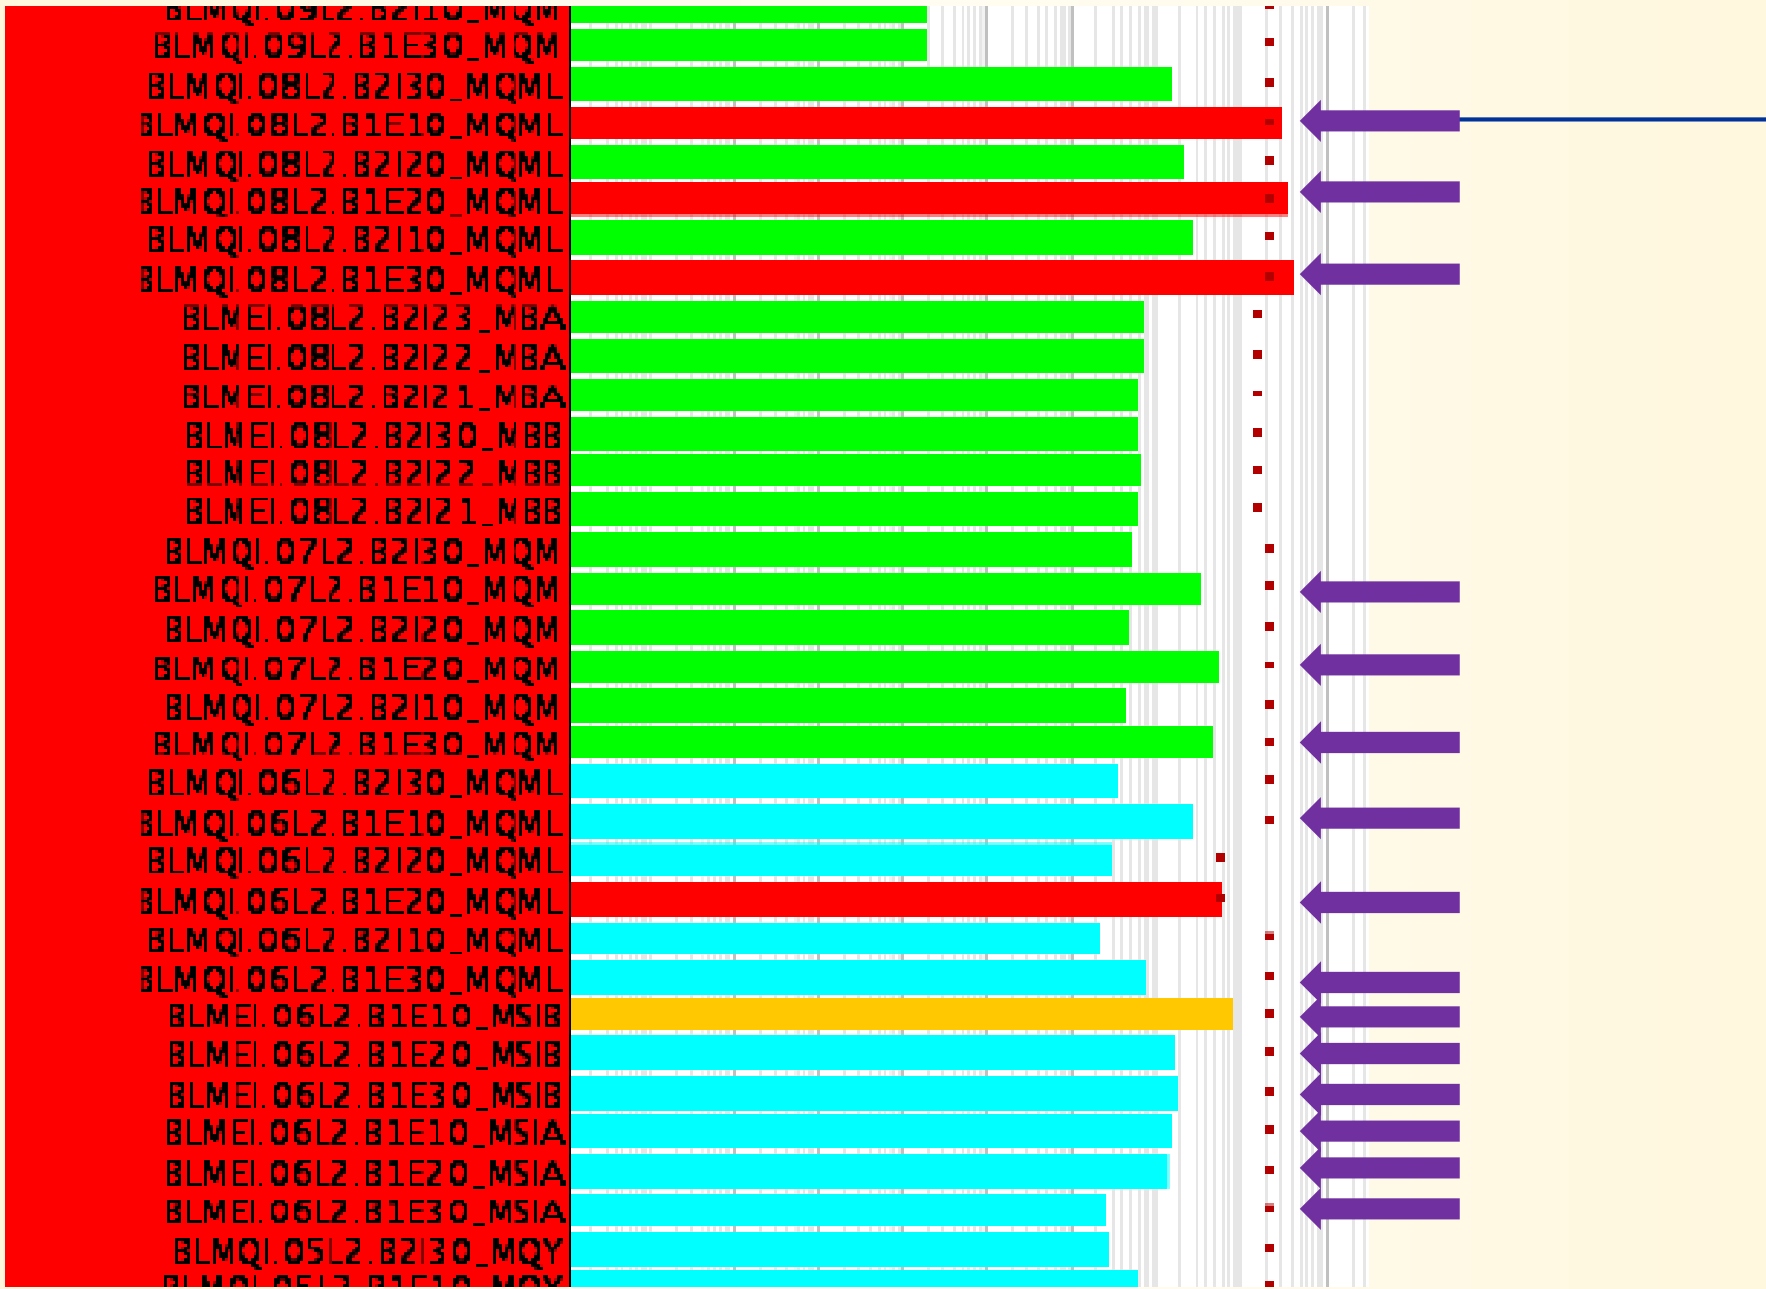
Injection of higher intensity

- RC filter for the monitors requested by the injection team factor 25 (all are external monitors;)
- Maximum current will be reduced by a factor of 8.3 by RC filter and additional factor of 3 with (future) thresholds
- Factor of ~10 between signal on external and internal monitors
- For moment the threshold values not changed!
- → For all other energies the thresholds are now too high
 - A quench could occur
 - New thresholds to be calculated asap
- All these monitors set to maskable
- Estimate: Quench of magnet by outside shower if injection intensity $2e13$

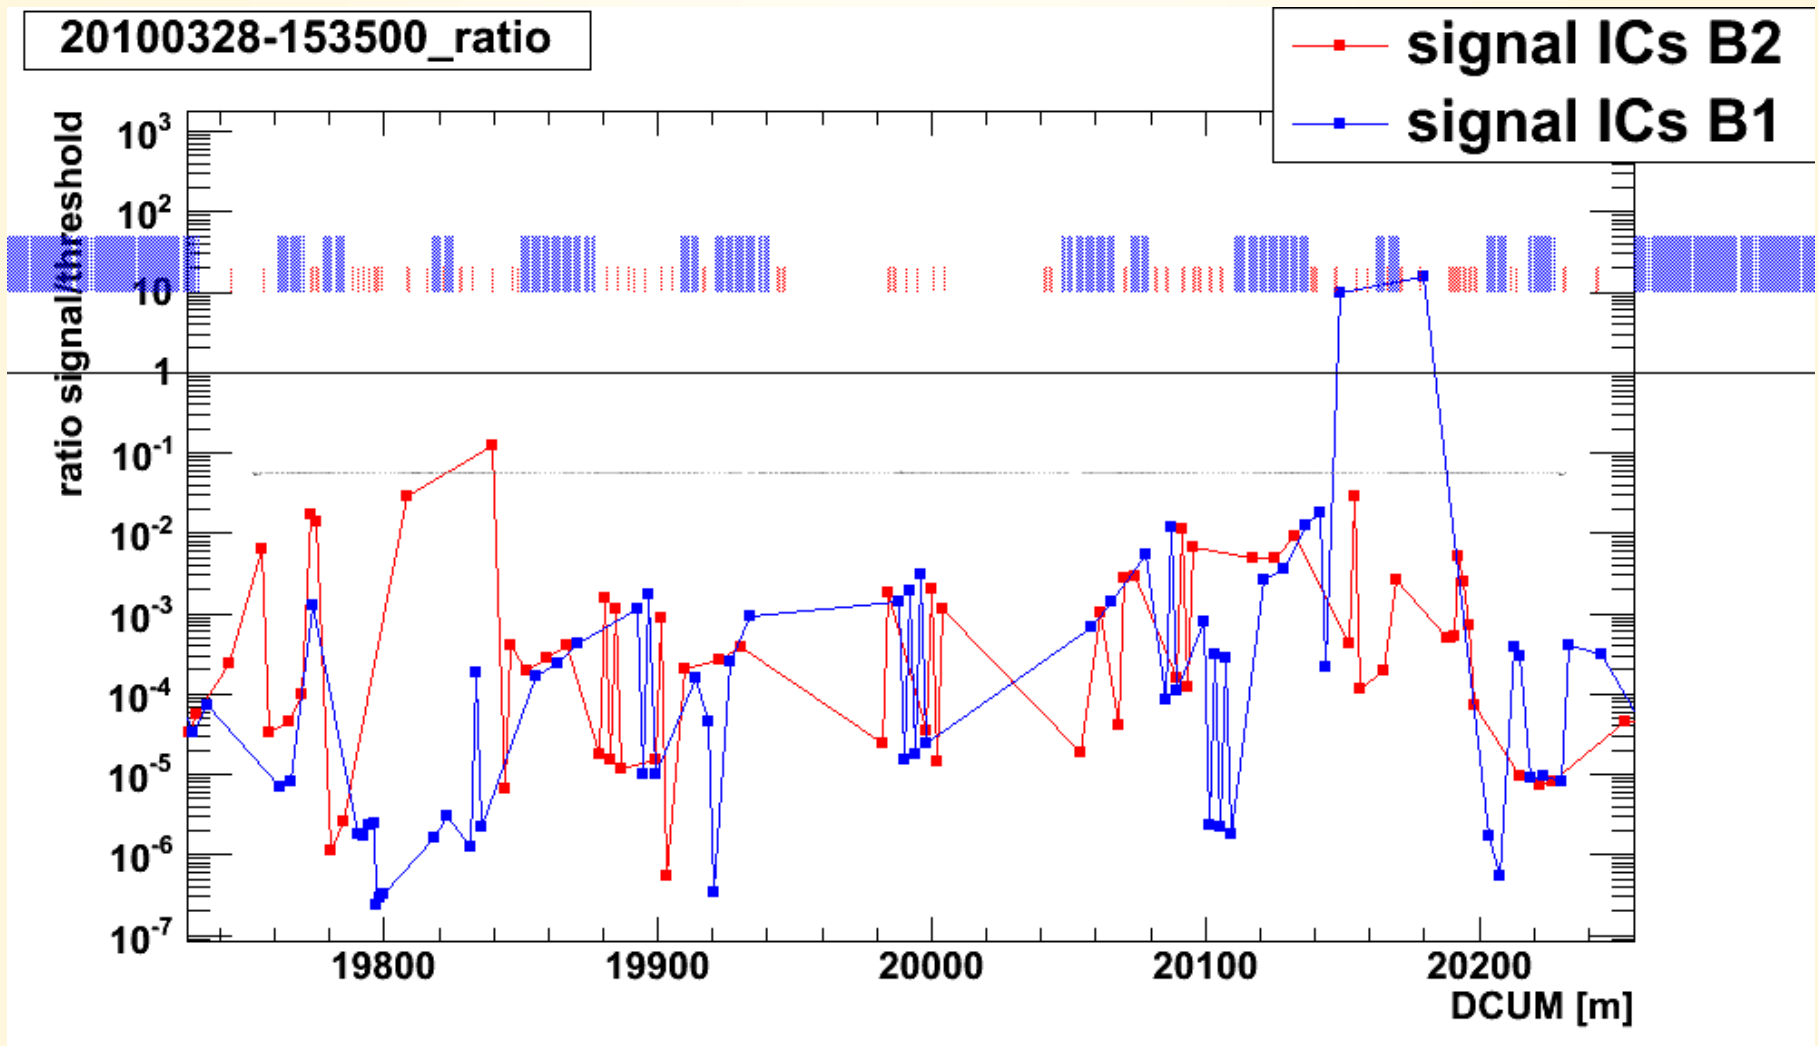
Constraint (a)

Resonance Crossing Beam 2 Horizontal

RATIO B2H

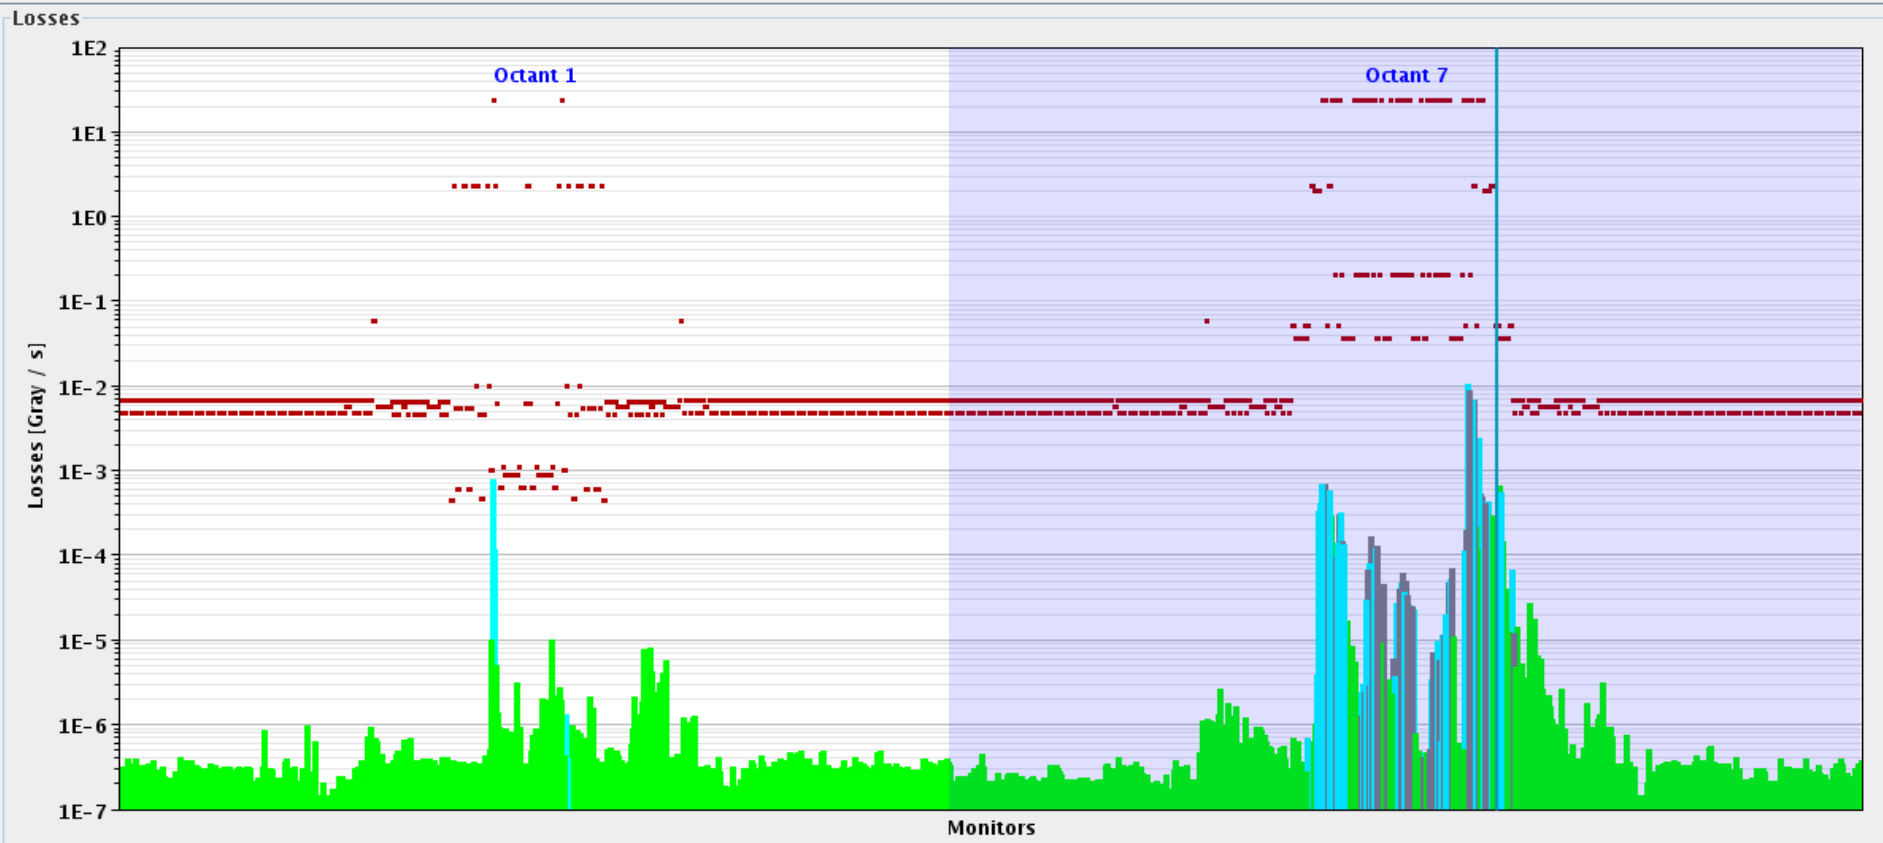
Scraping with TCLA

(First TCLA collimator TCLA.A6R7.B1 for beam1 moved into the beam. Recorded loss maps will allow to adjust TCLA thresholds more accurately. Beam dump triggered by BLM RS 655ms TCT collimator (TCTH.4L1) in IR1.

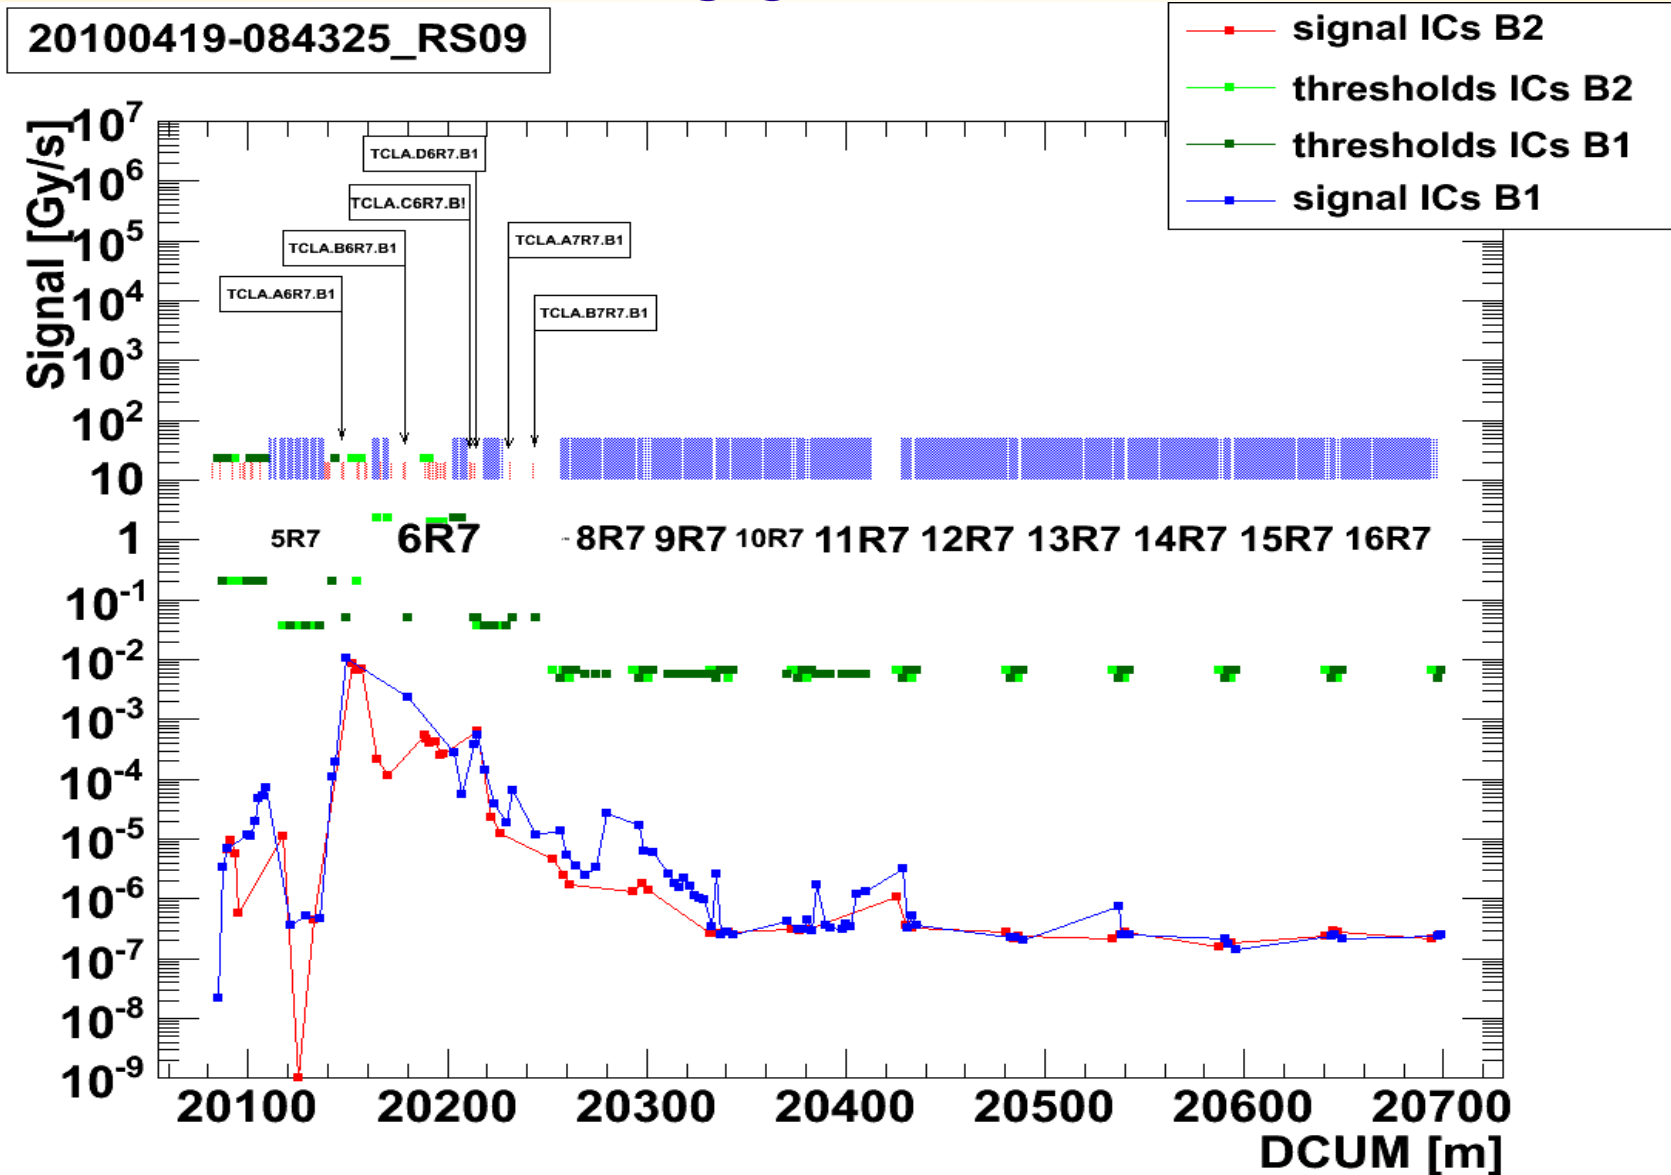
Moving TCLA.A6 into circulating beam 1

SIGNAL

- The TCLA A & B in cell 6 (which sit in the shower of the TCP of the opposite beam) thresholds increased by **2500** with respect to the original values, to satisfy condition (a). (1600 would be enough)
- The TCLA C & D in cell 6 and TCLA A & B in cell 7 (which do not sit in the shower of the TCP) thresholds increased by a factor of 2 with respect to the original values, in order to satisfy condition (a). Condition (b) is satisfied as well.
- **Protection** of TCLA A & B in cell 6 against potentially dangerous **direct proton impact**:
 - Only the thresholds of TCLA C and D in cell 6 can protect. But a factor of **40** (20×2) more protons can directly hit TCLA A & B, than originally specified.
 - **Constraint (b) not satisfied**

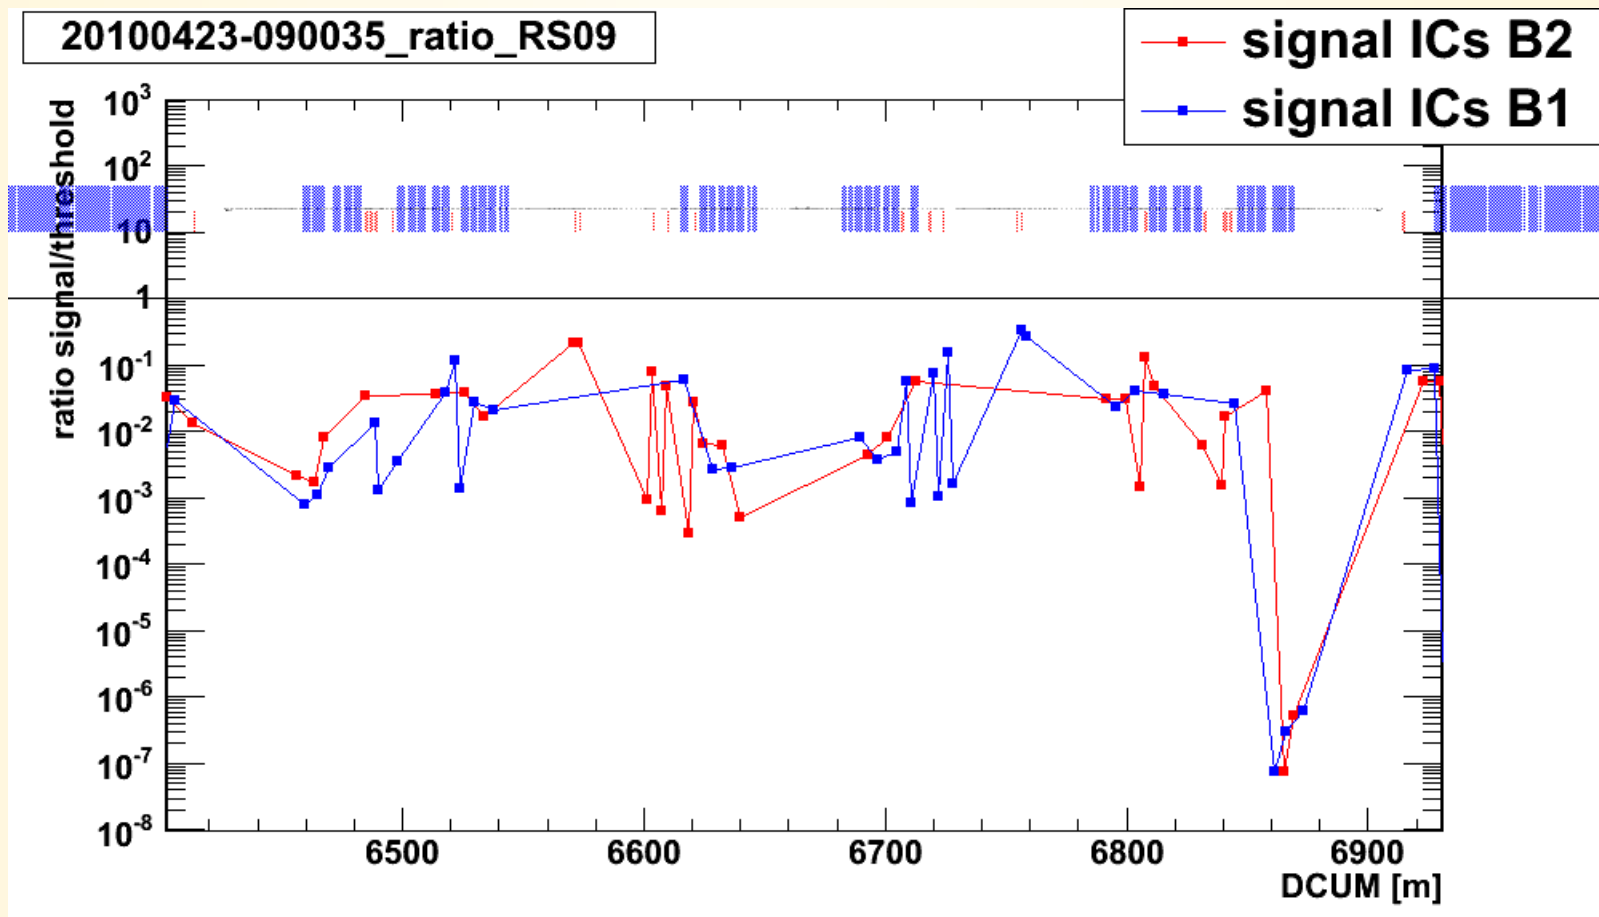
Momentum cleaning IP3 Ratio

- 50 times higher than the original values from Ralph
- Constraint (b) not necessarily satisfied for all TCLAs (not proven to be satisfied)
- Not changed this week:
 - For momentum cleaning on 23.4.2010, the signal to threshold values for the TCLA are not significantly higher than for other elements.
 - In fact the TCLAs do not seem to sit in the shower of the TCPs.
 - The TCTs in IP2 had the highest signal to threshold ratio. They went over threshold while the TCLAs did not.
 - We don't have data of direct proton losses on the TCLAs yet. So we cannot determine the protection level be distant monitors.

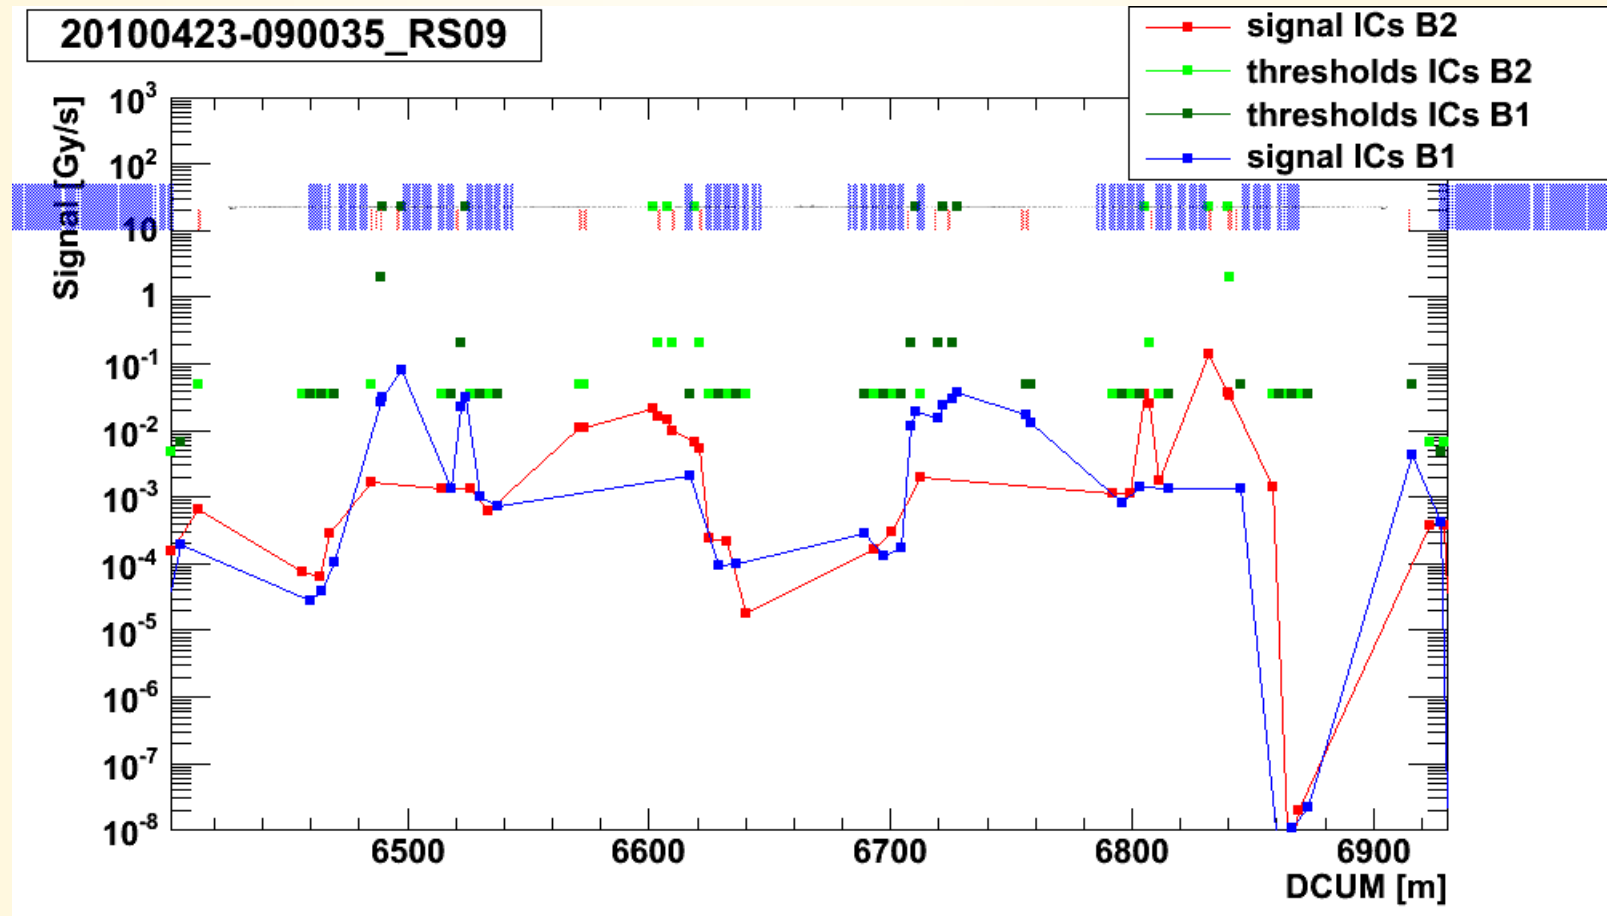
Momentum cleaning IP3

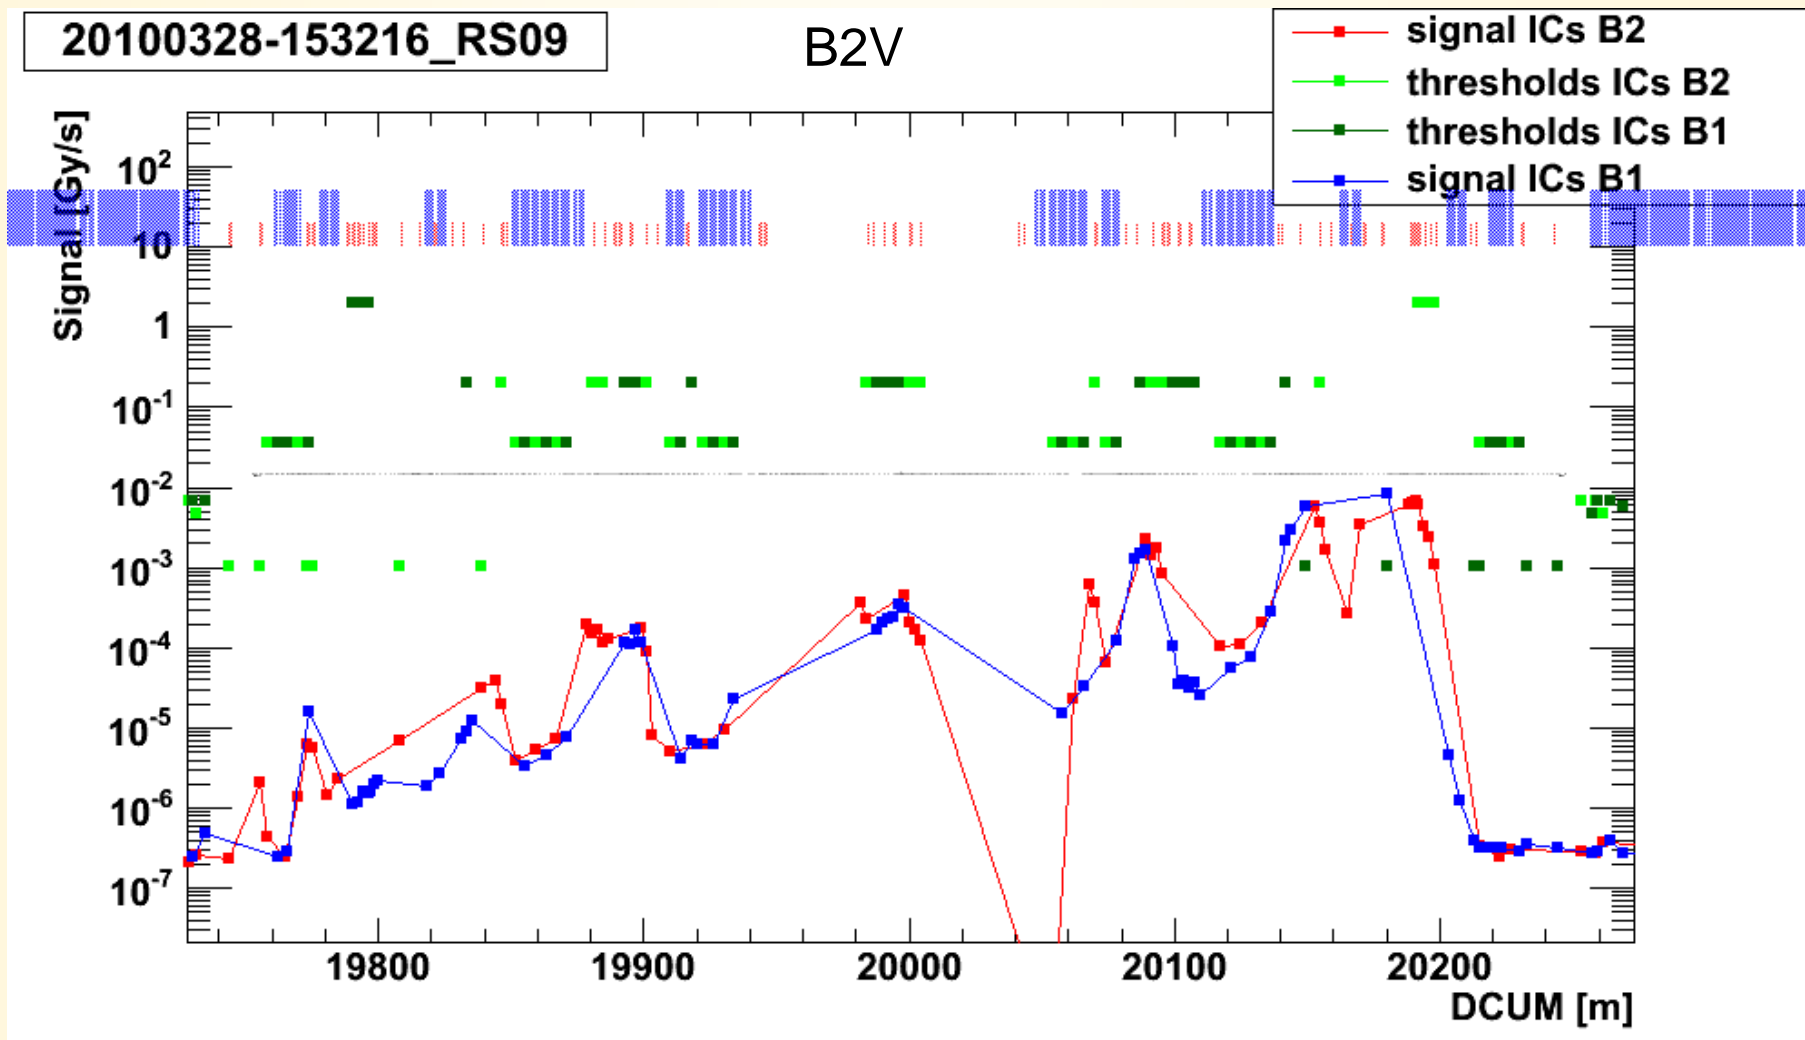
Compare to 'shower' case in IP7

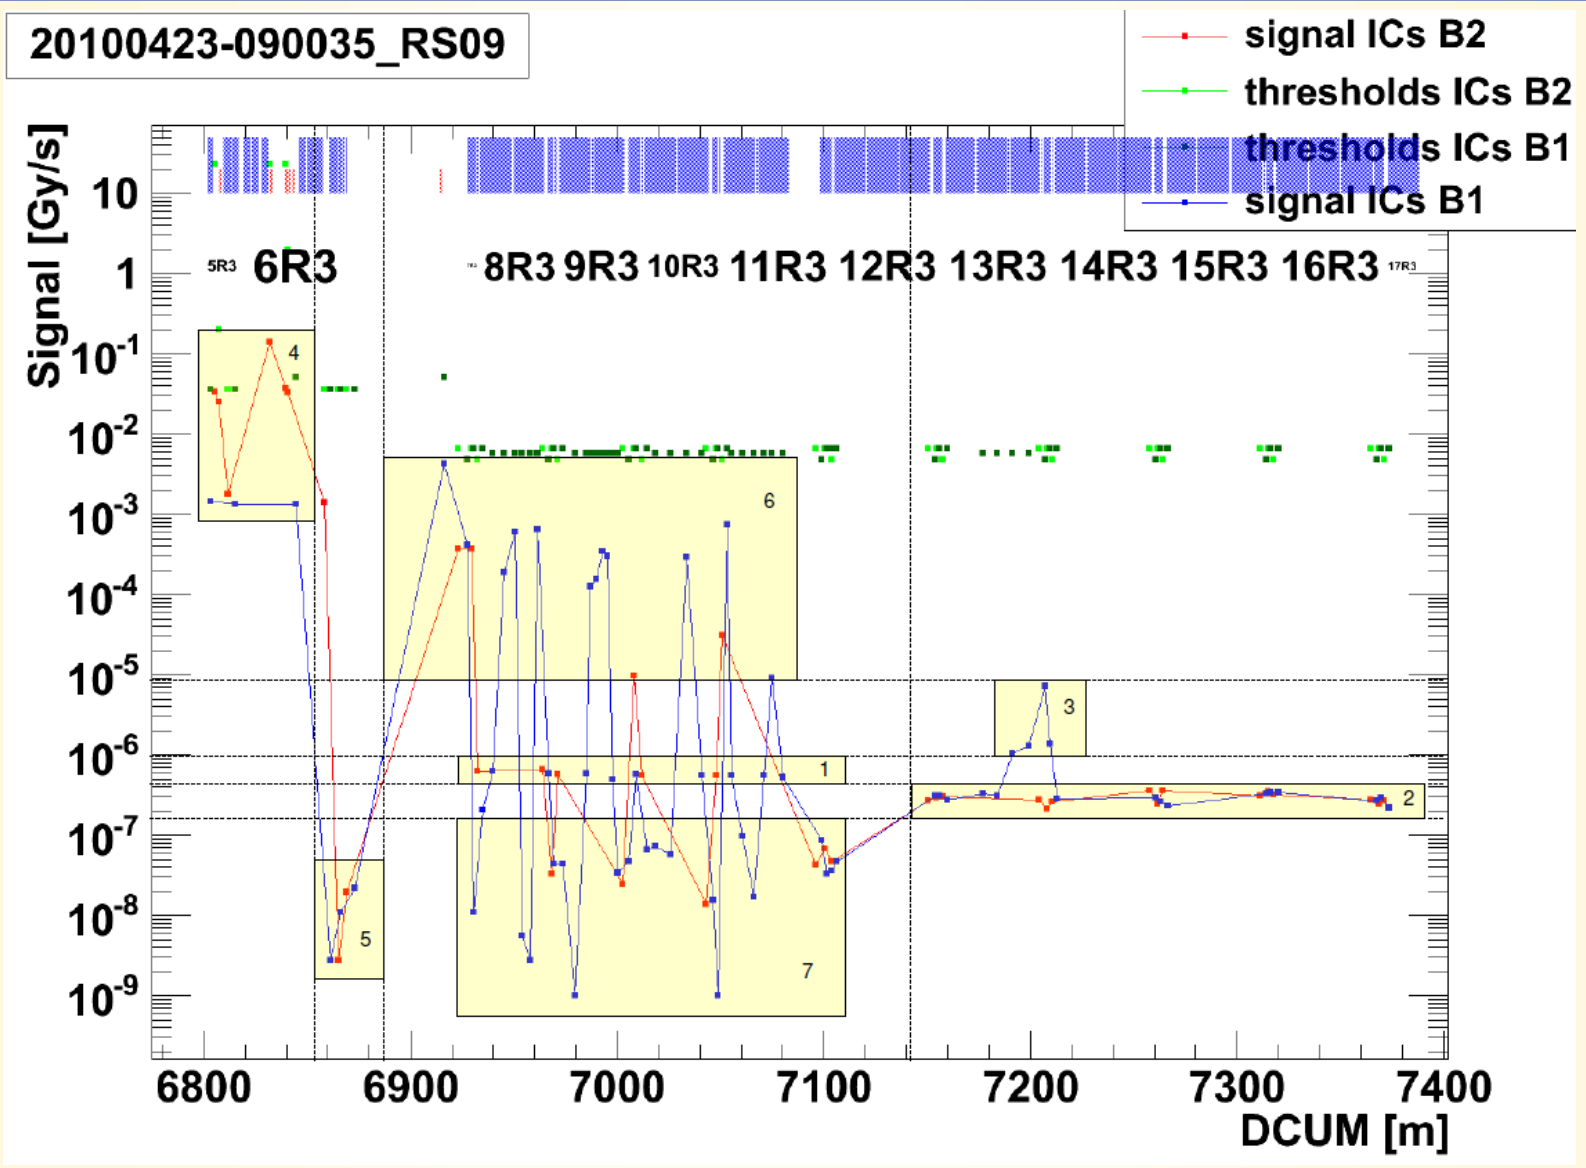
Start to study noise right of IP3

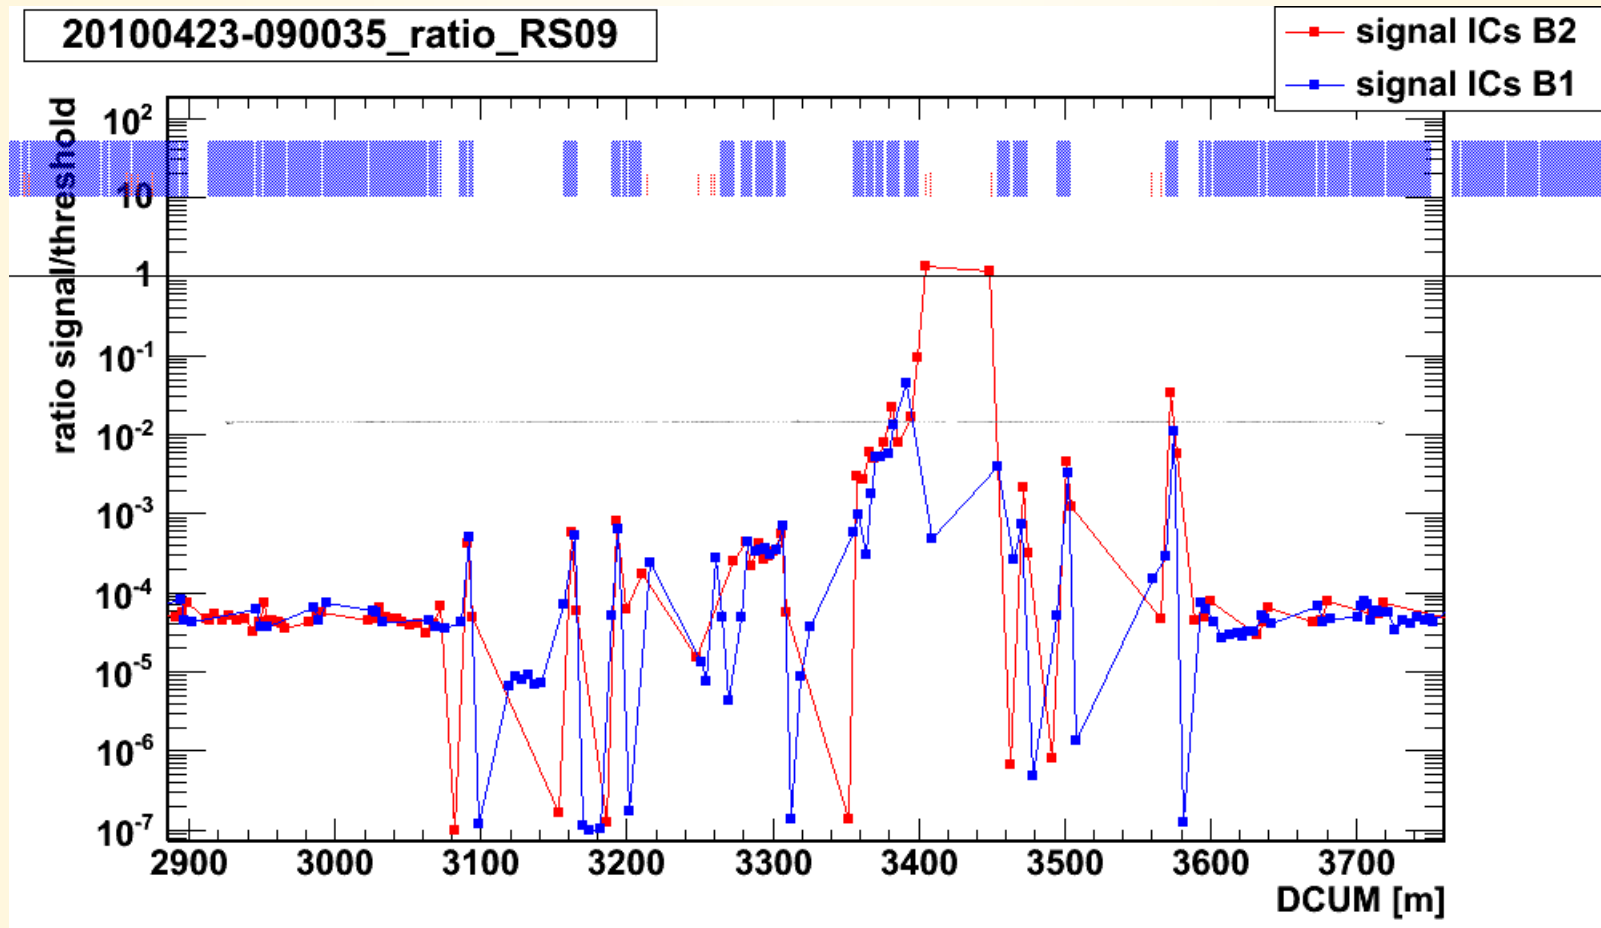
Momentum cleaning IP2 TCT over threshold

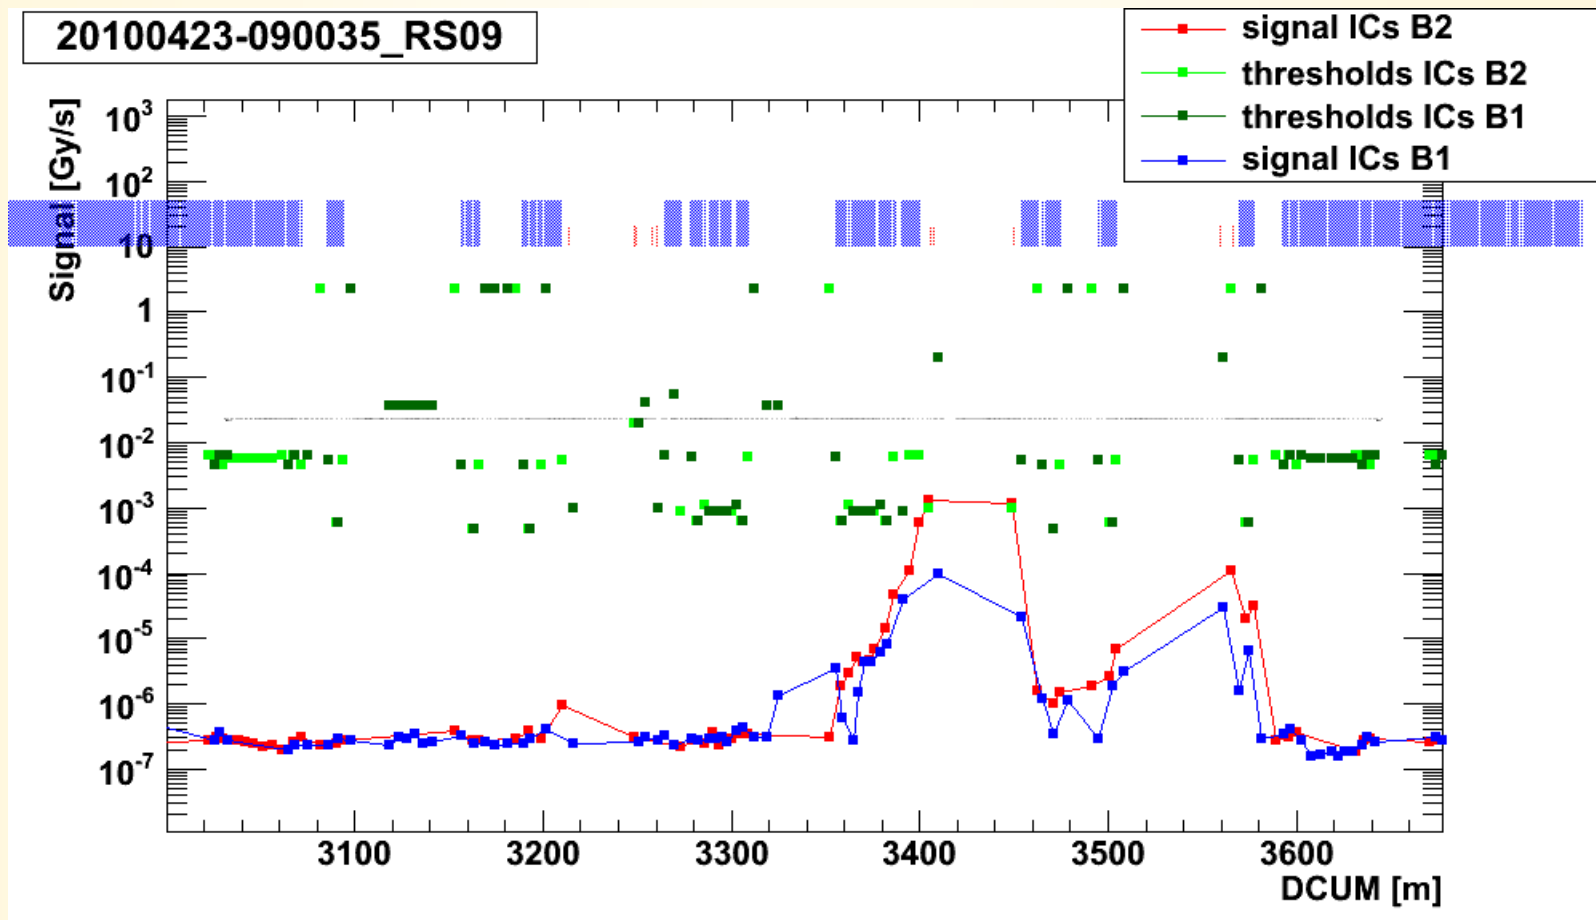
Momentum cleaning IP2 TCT over threshold

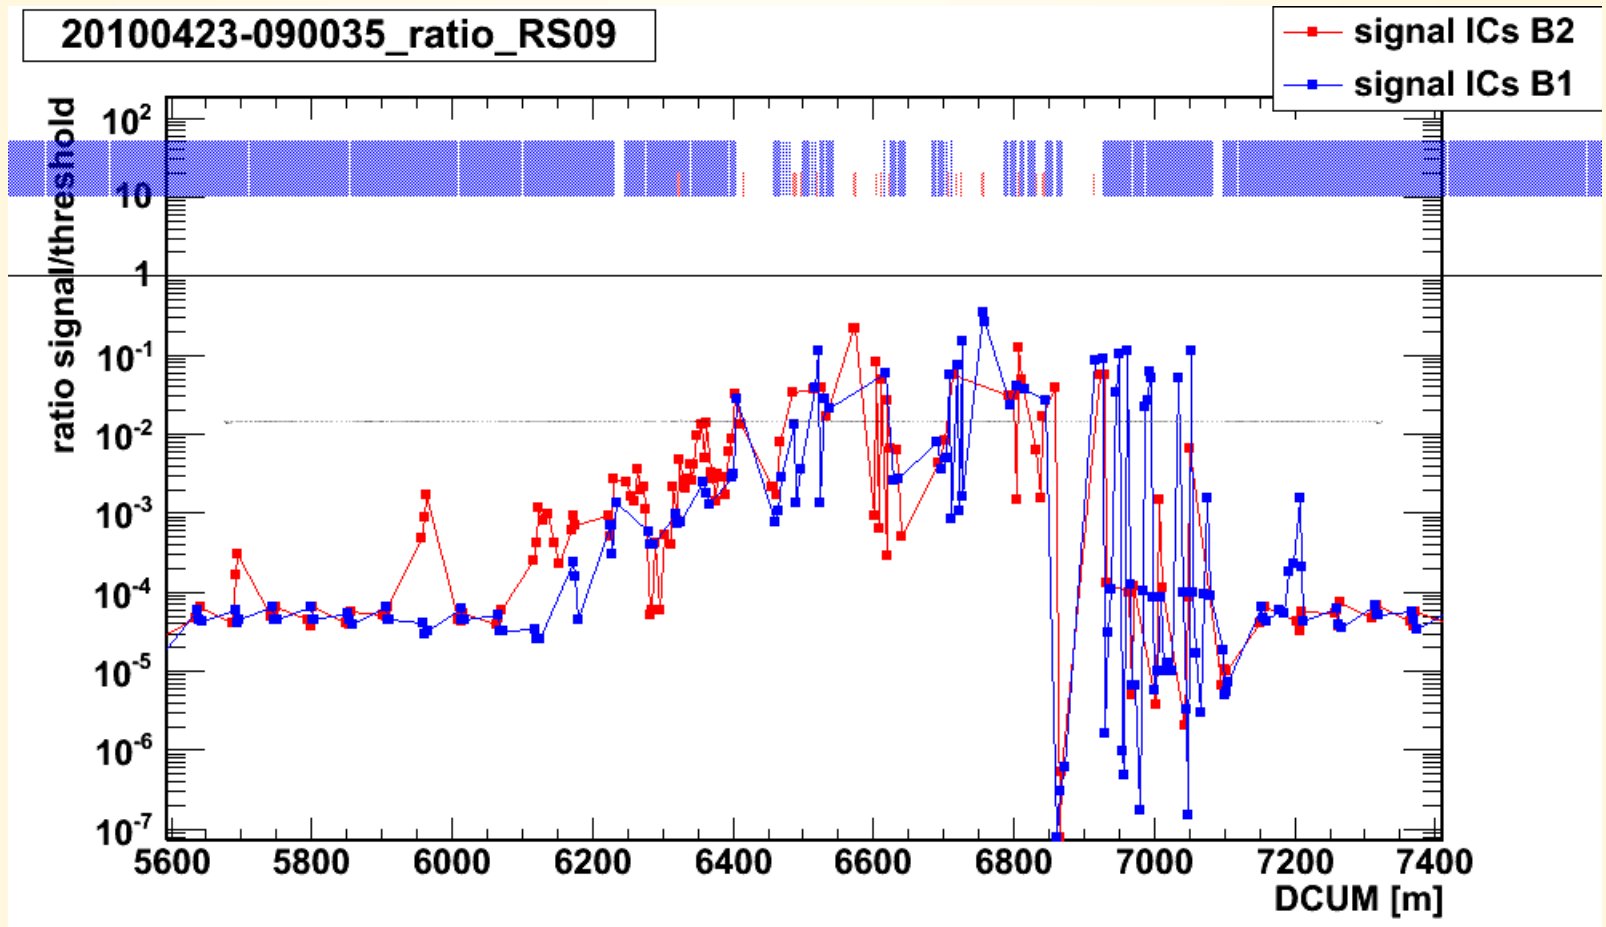
Momentum cleaning IP3 Ratio

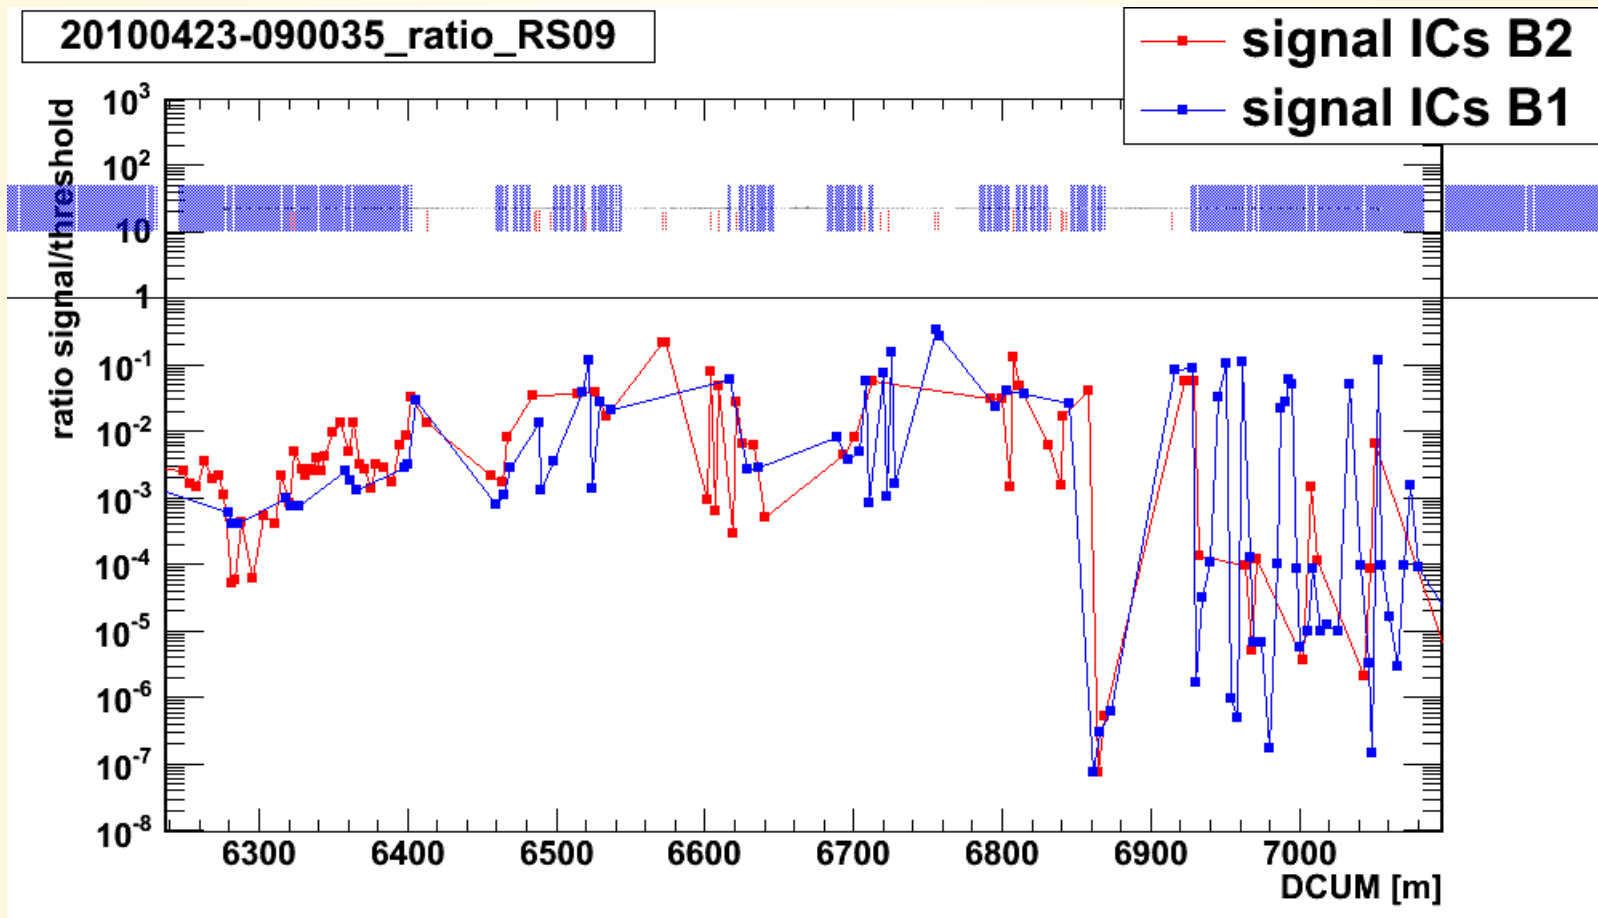
Momentum cleaning IP3 Ratio
