Changes to BLM system on 28. April 2010

Eva Barbara Holzer
for the BLM team

LHC MPP
CERN, April 30, 2010

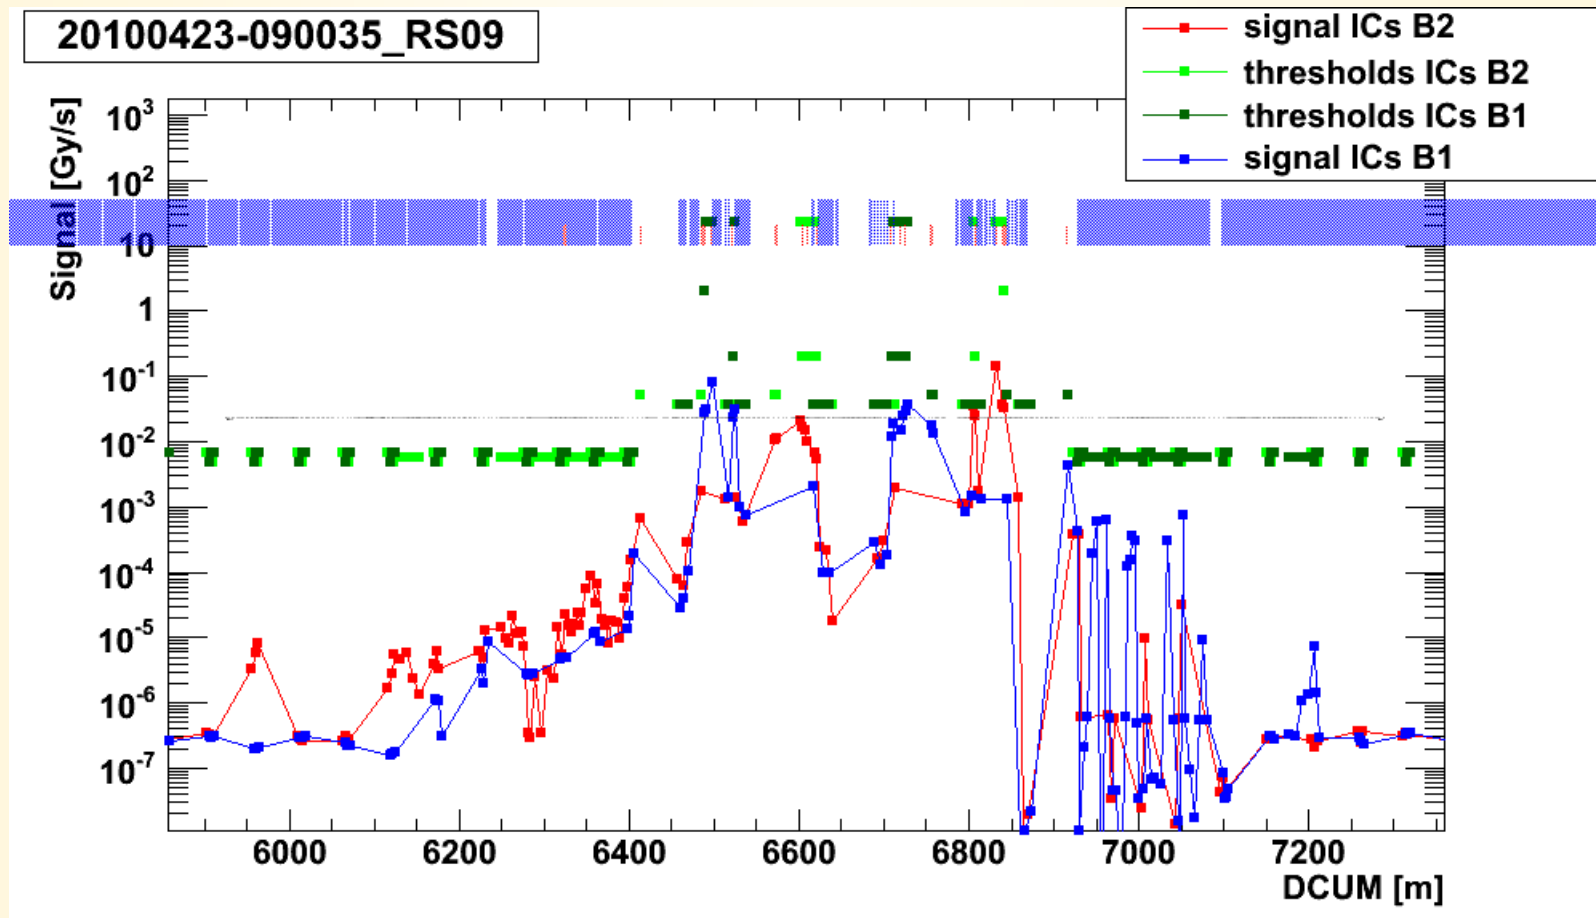
Momentum cleaning IP3

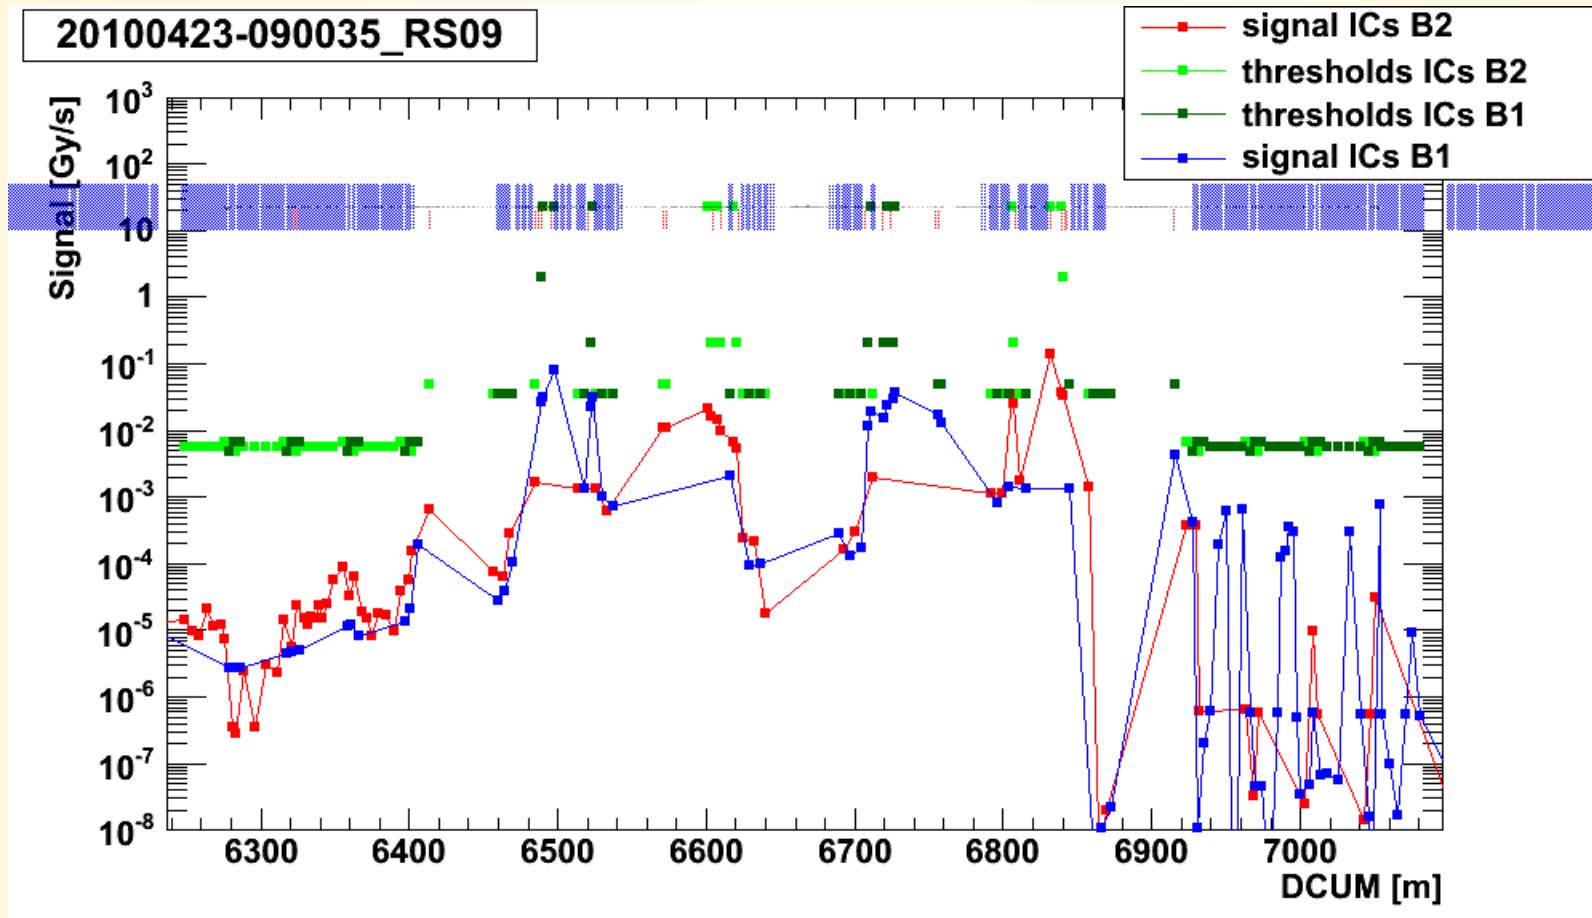
Momentum cleaning IP3
