Overview of single bunch asynchronous dump failures on collimators

BE/ABP
9th March 2012
MPP meeting

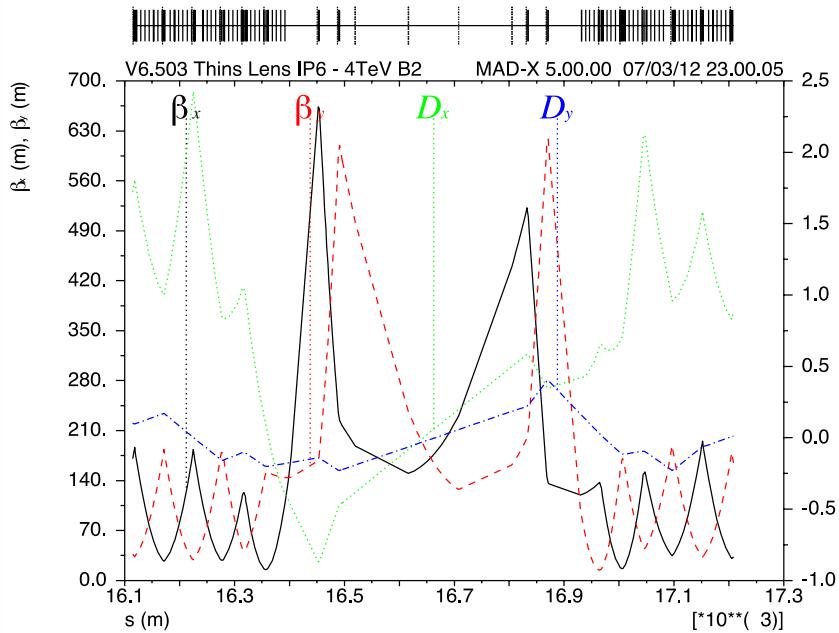
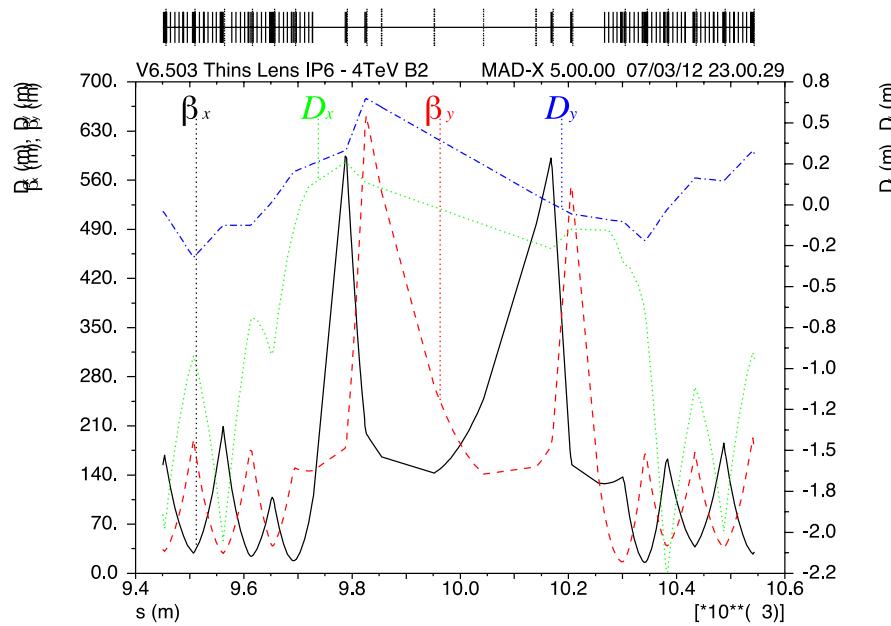
Optics IP6
