LIC performance in the LHC

E. Nebot del Busto for the BLM team

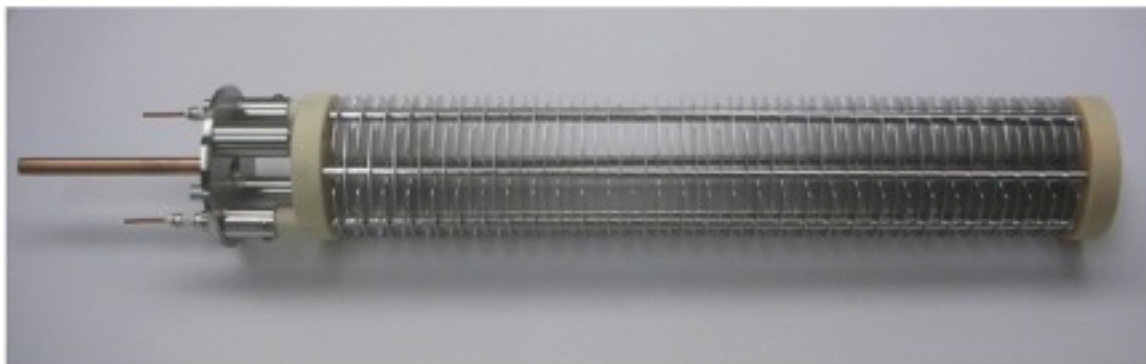
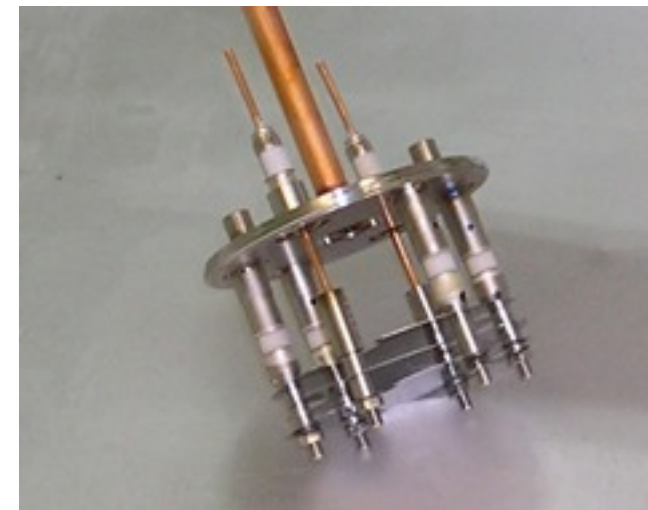
LIC Motivation and description

- Detector with low sensitivity in order to increase the dynamic range of the BLM system (Limited by 23Gy/s in 40 us)
- Possibility of reaching a factor 5 margin between dump threshold and average losses at injection
- Little Ionization Chambers. Reduced Volume (from 60 to 2 active Volumes).
Reduced gas pressure (from 1.1 bar to 0.4 bar)

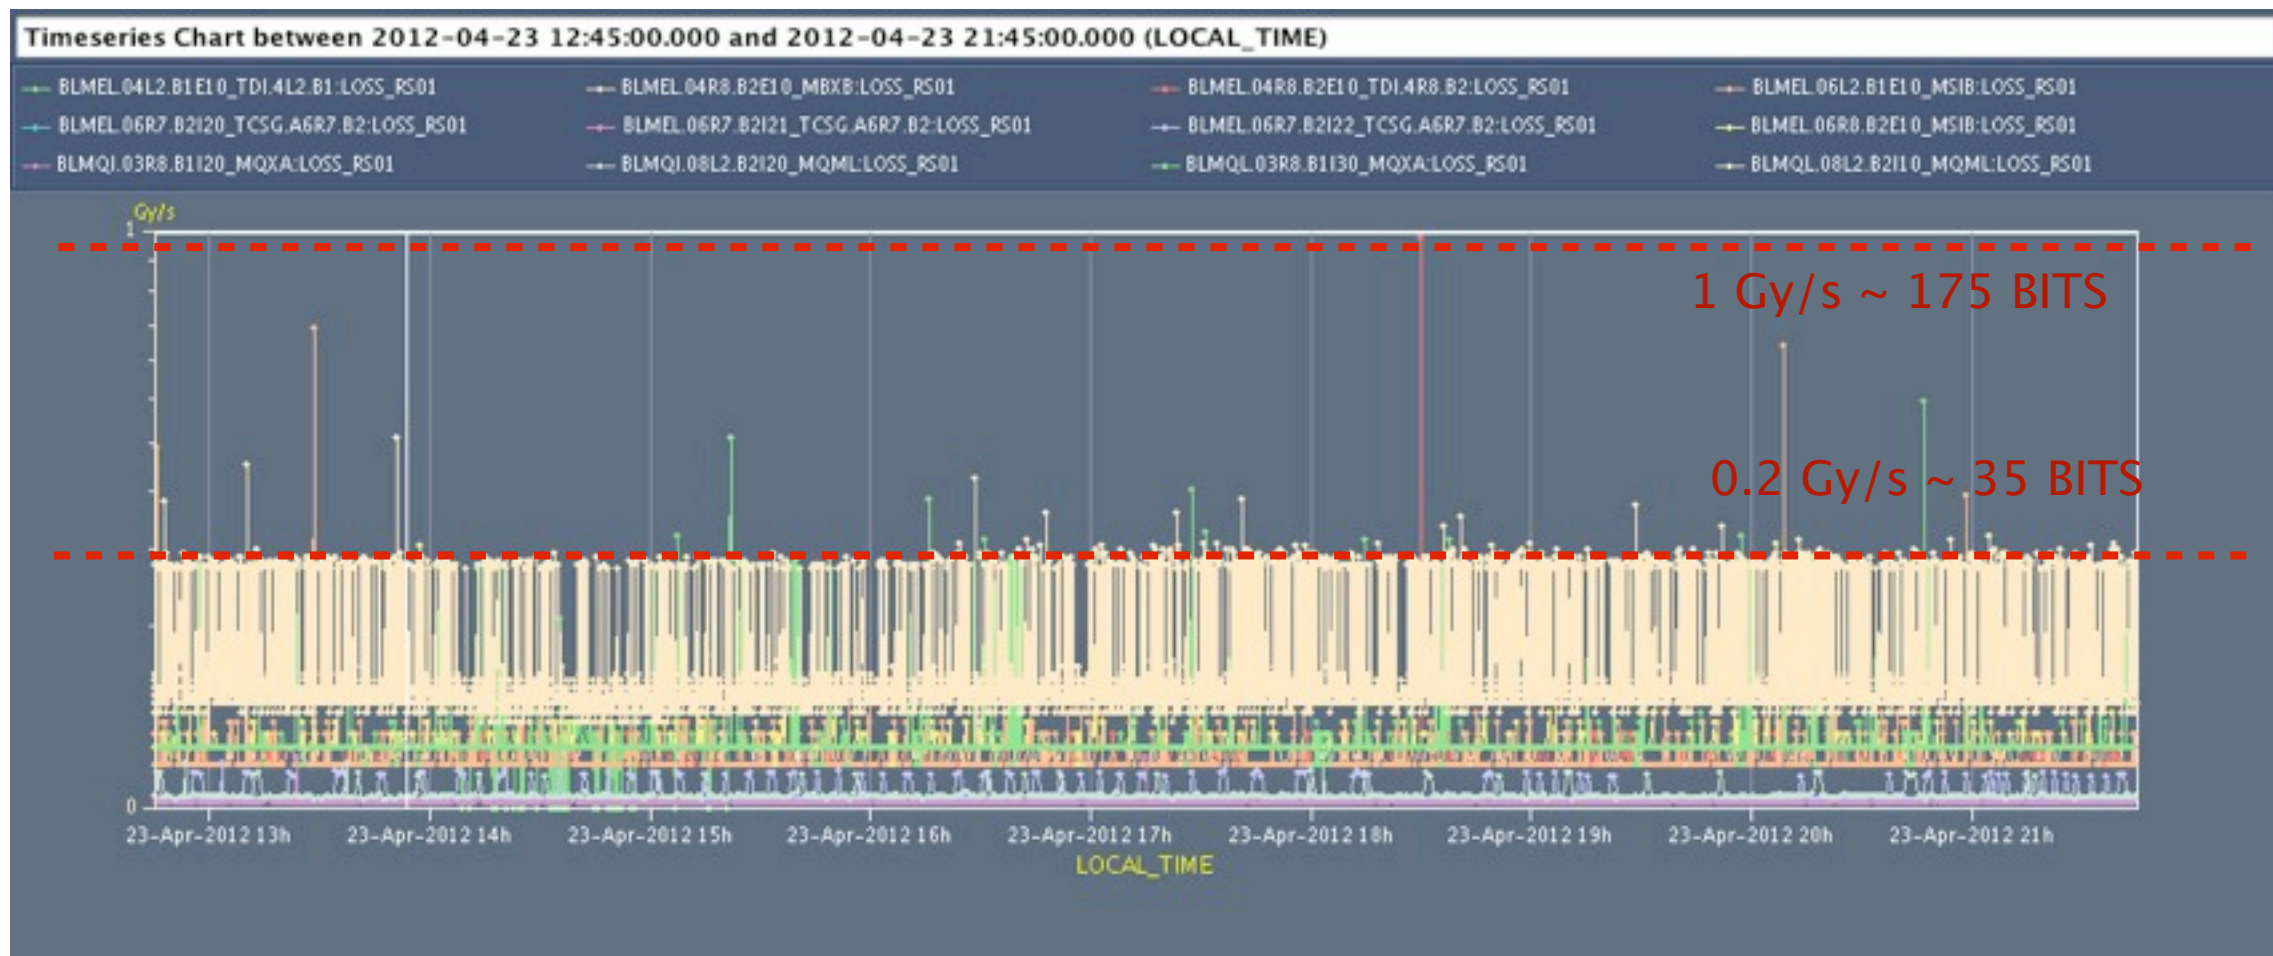
LIC-LHC. Noise

- Several spikes of up to 1Gy/s (~175 BITS)
- BLML at MQML shows high noise.

- Several Noise spikes observed within 9 hours.
- LICs have performed well under slow loss conditions collecting significantly less charge (up to a factor 58)
- Losses observed by LIC during injections of up to 144 bunches (fill 2533) compared with losses observed during injections last year (fill 2221). Agreement within a factor 2 for monitors at TDIs, MSIs and MBXB.
- LIC monitor at MQML systematically records large signals. This monitor was previously exchanged for giving spurious signals. The monitors are under investigation of gas purity and filling pressure.
- Replacement of 6 SEM by LICs to gain experience.

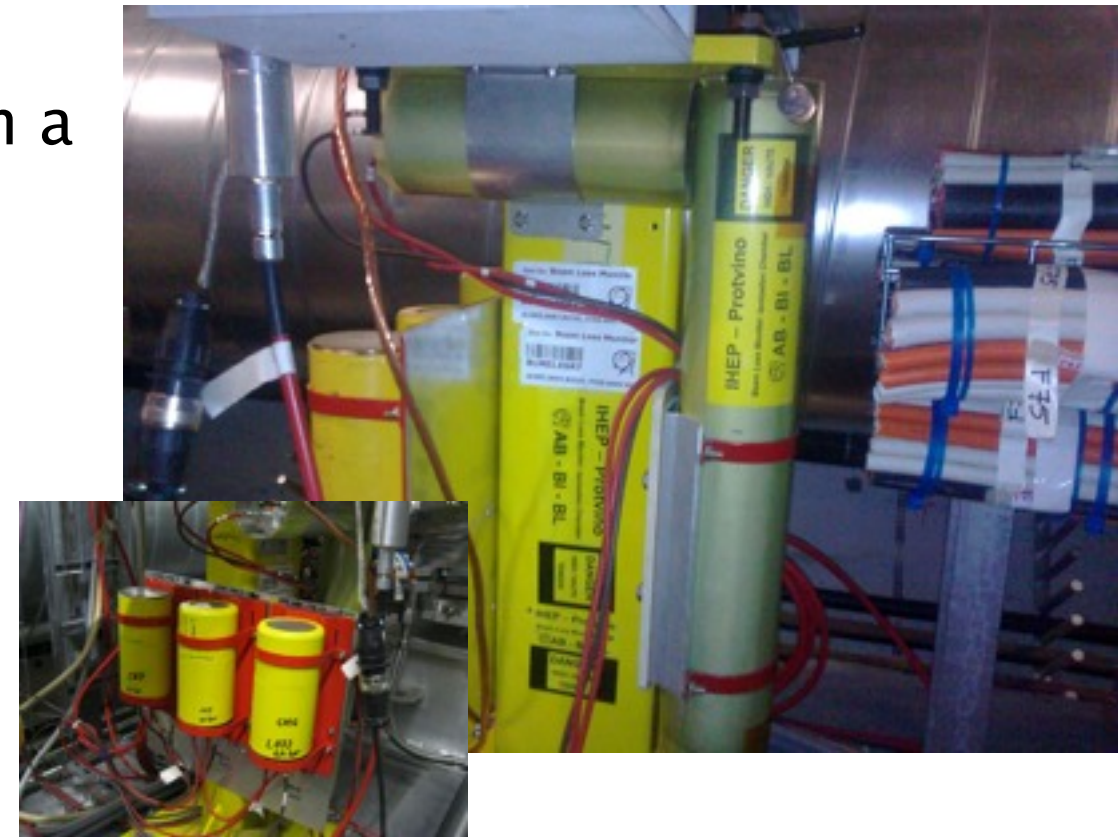
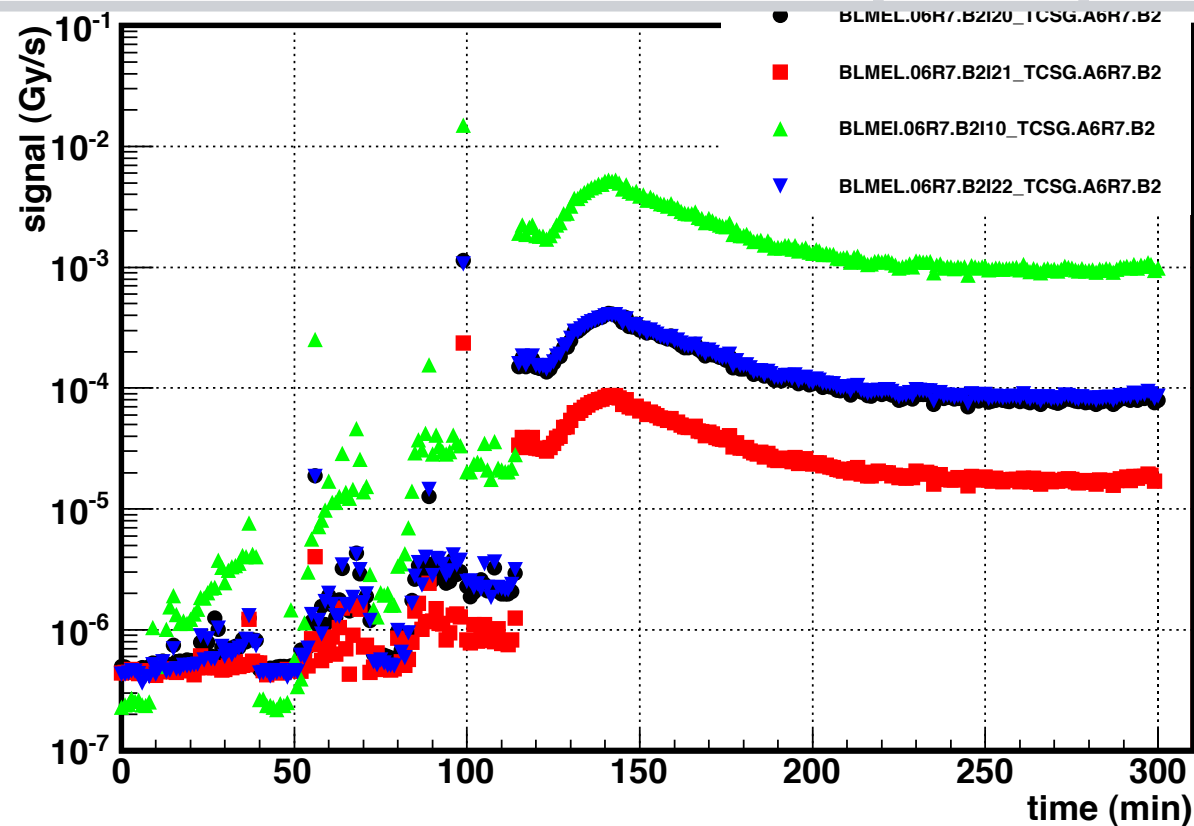
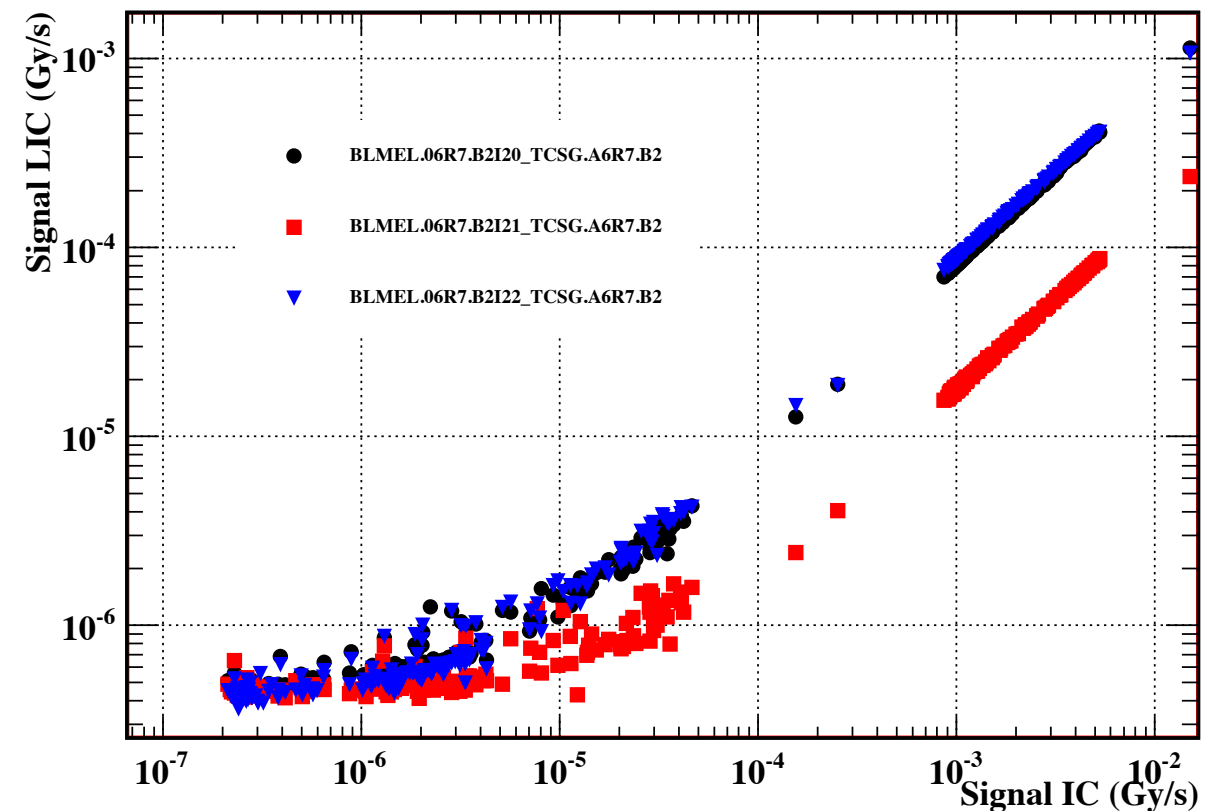
Slow losses. Betatron cleaning.

- Three LIC detectors located in IR7 downstream a secondary collimator.
- 5h in Fill 2208 (2011-10-13 00:54:00)

Monitor Name	Type	P (bar)	ratio
BLMEL.06R7.B2I10_TCSG.A6R7.B2	IC	1.1	---
BLMEL.06R7.B2I20_TCSG.A6R7.B2	pLIC	1.1	12.5
BLMEL.06R7.B2I21_TCSG.A6R7.B2	LIC	0.4	58.8
BLMEL.06R7.B2I22_TCSG.A6R7.B2	pLIC	0.1	12.0

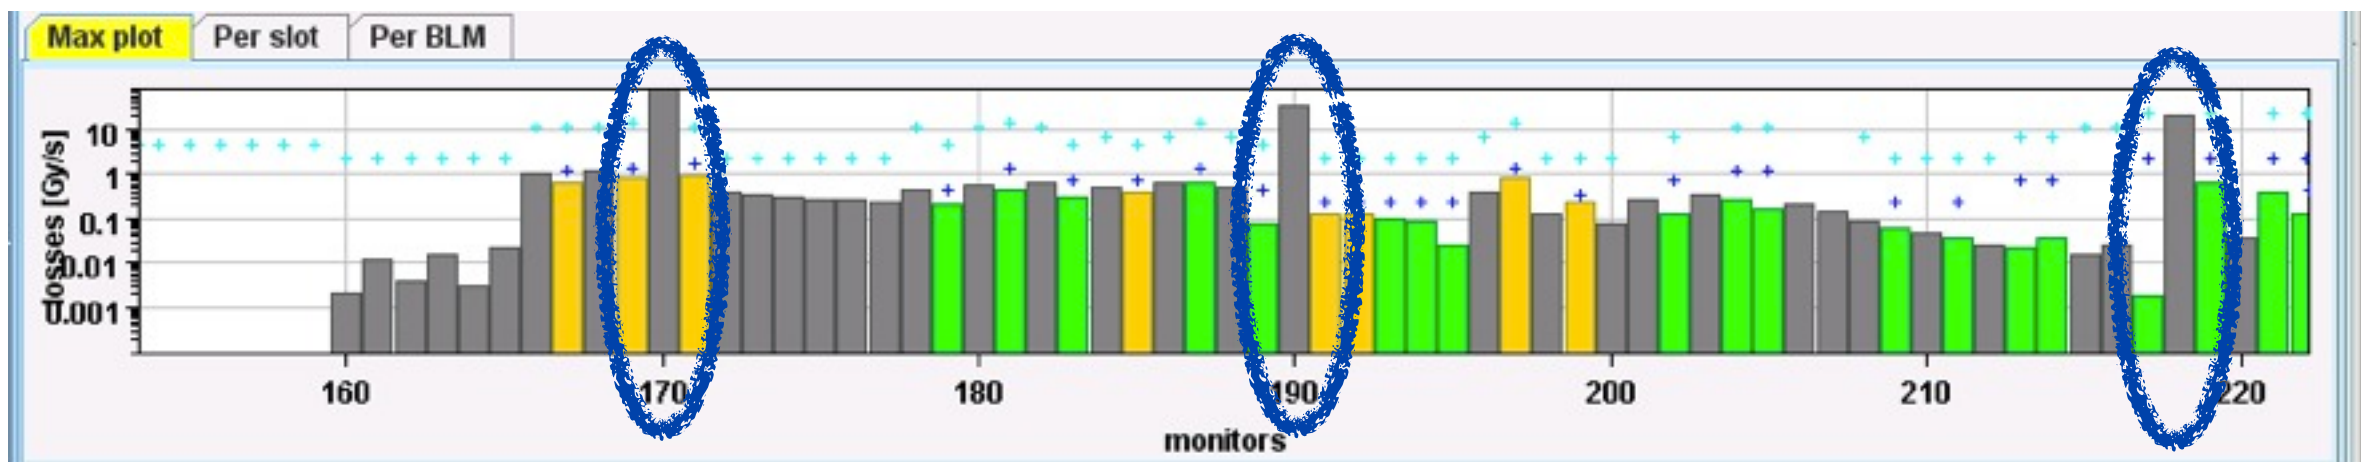
Injection region

- Seven Ionization chambers were replaced by LICs during the shut down.

- Unexpectedly large signals observed during injections.

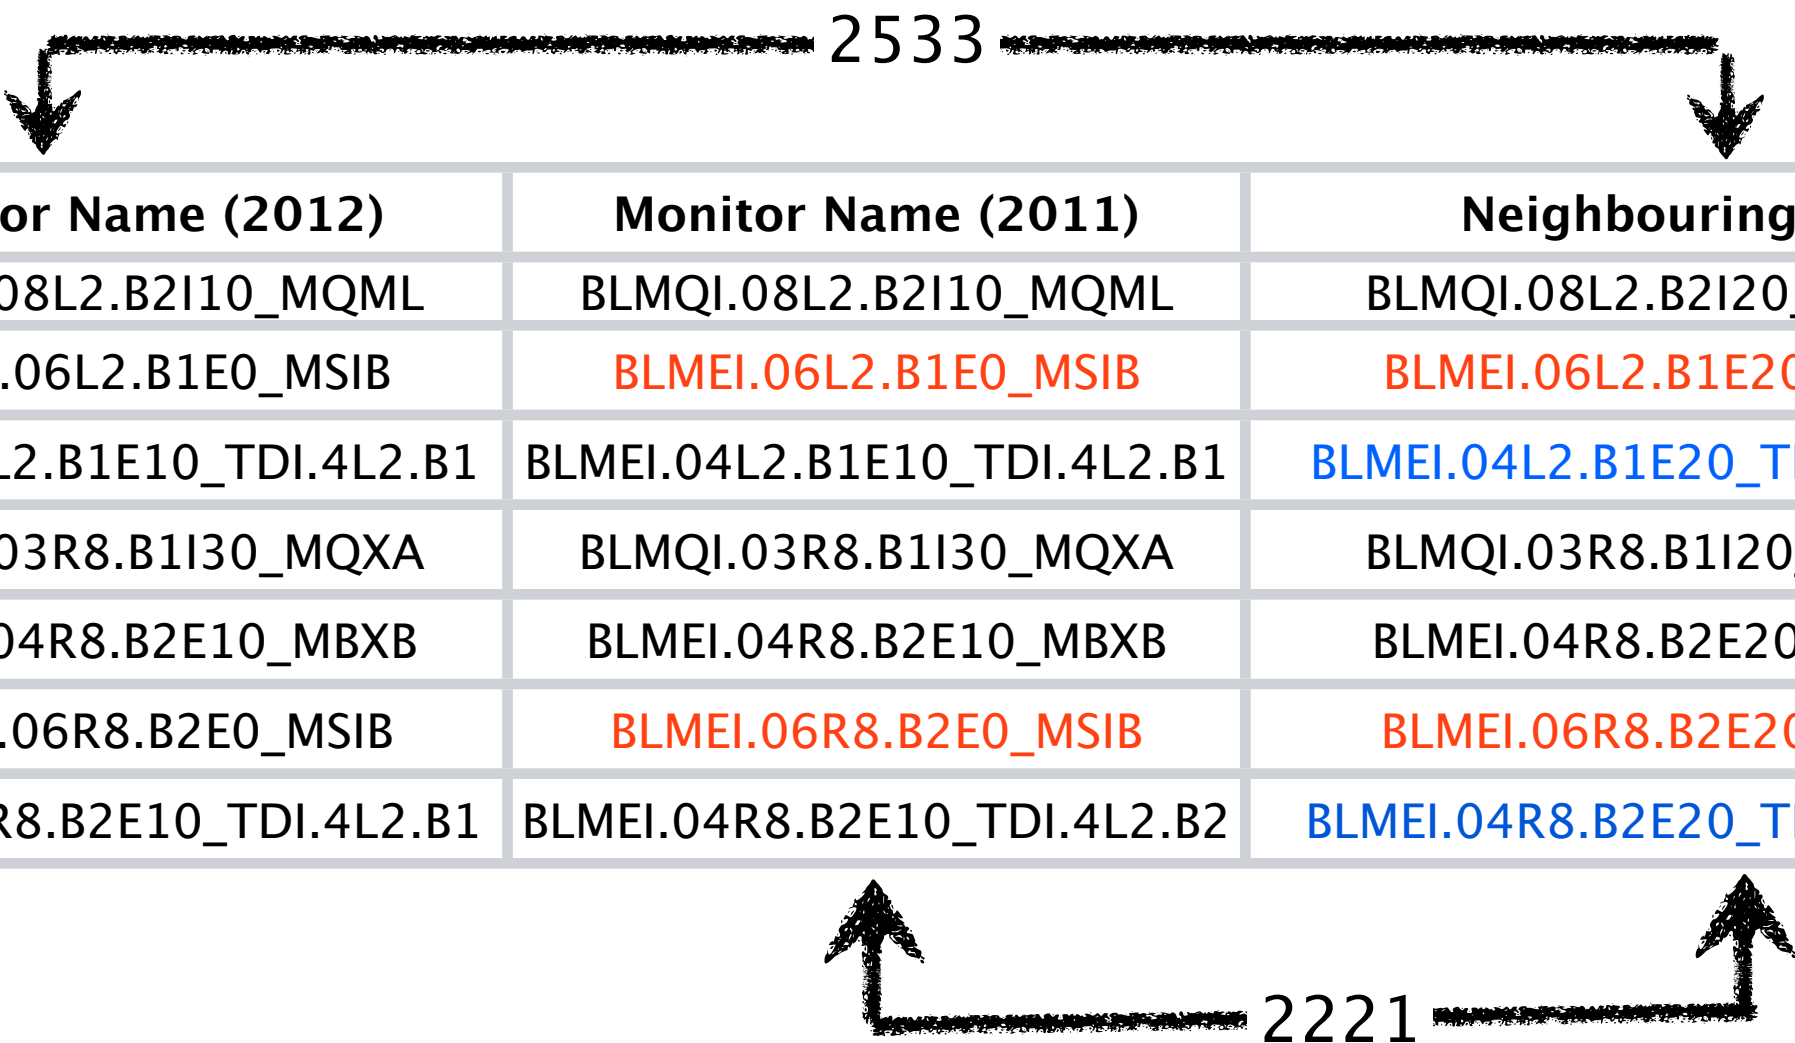
LHC. Injection region

- Comparison of losses at injection for fills 2533 (18/04/2012) and 2221 (17/10/2011).

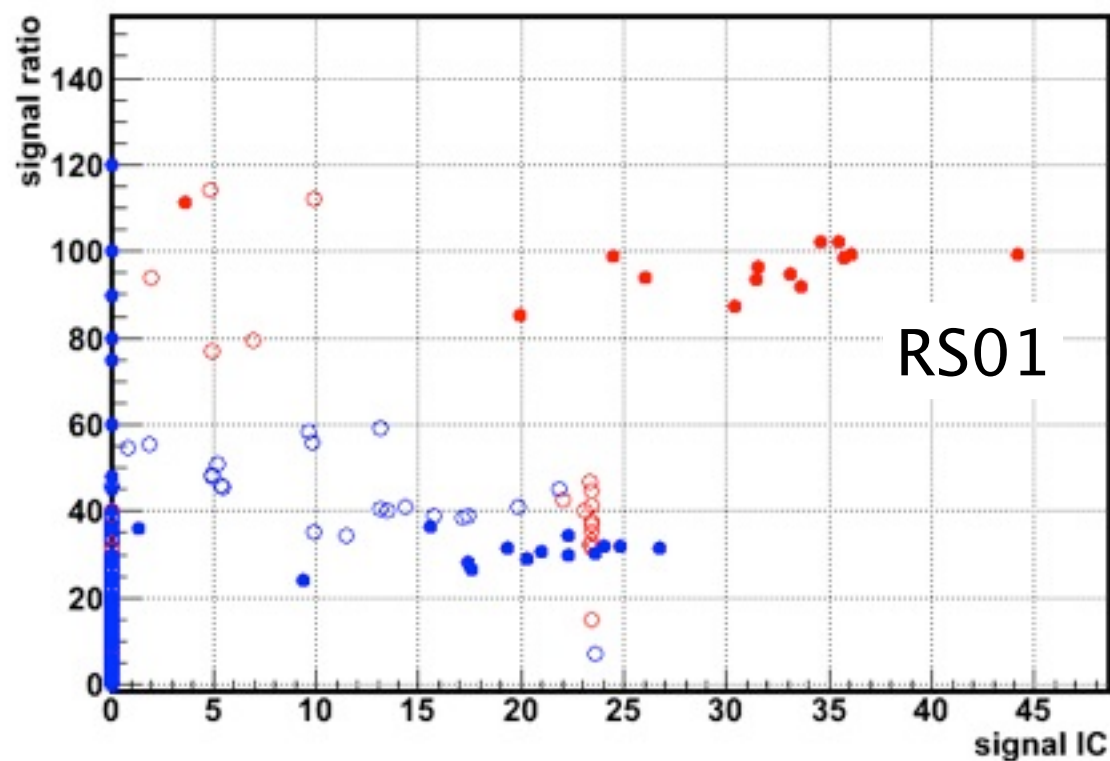
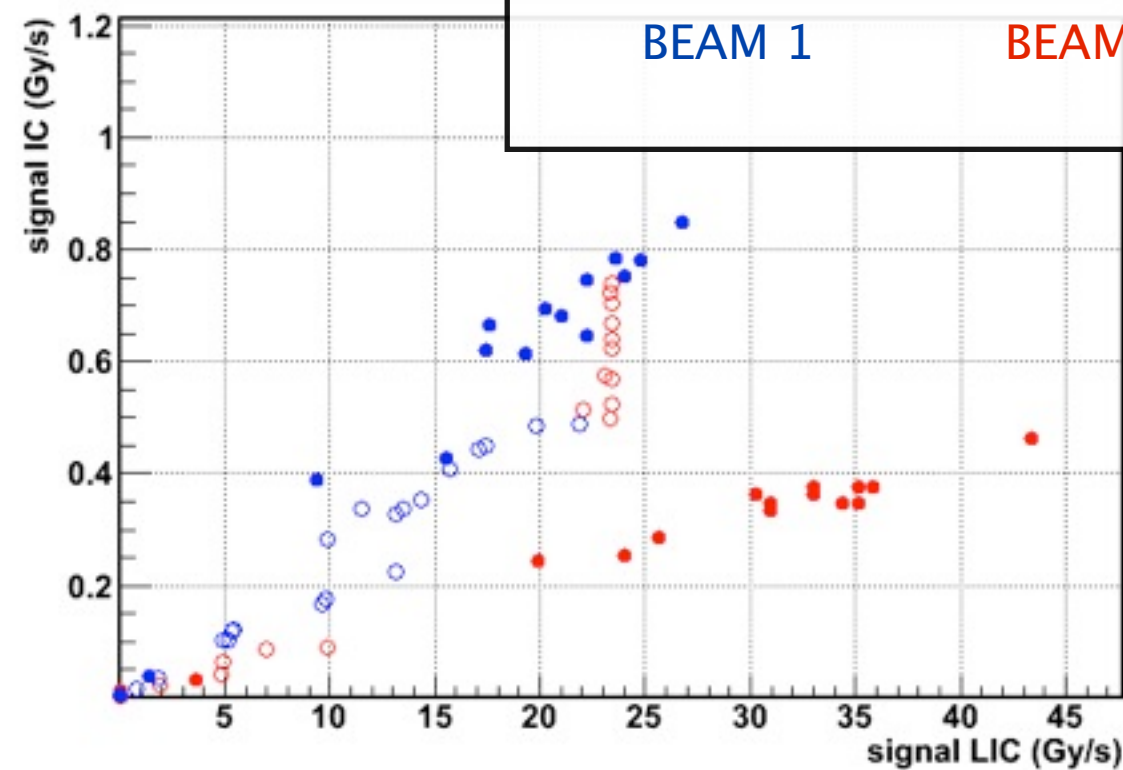
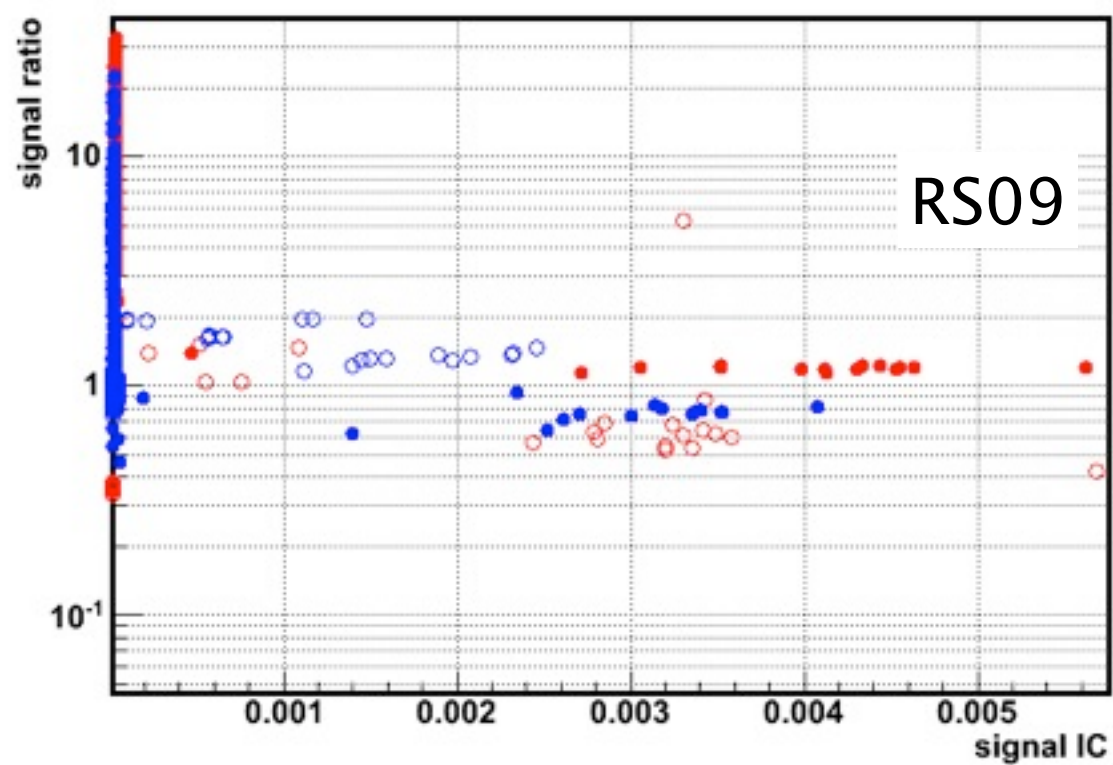
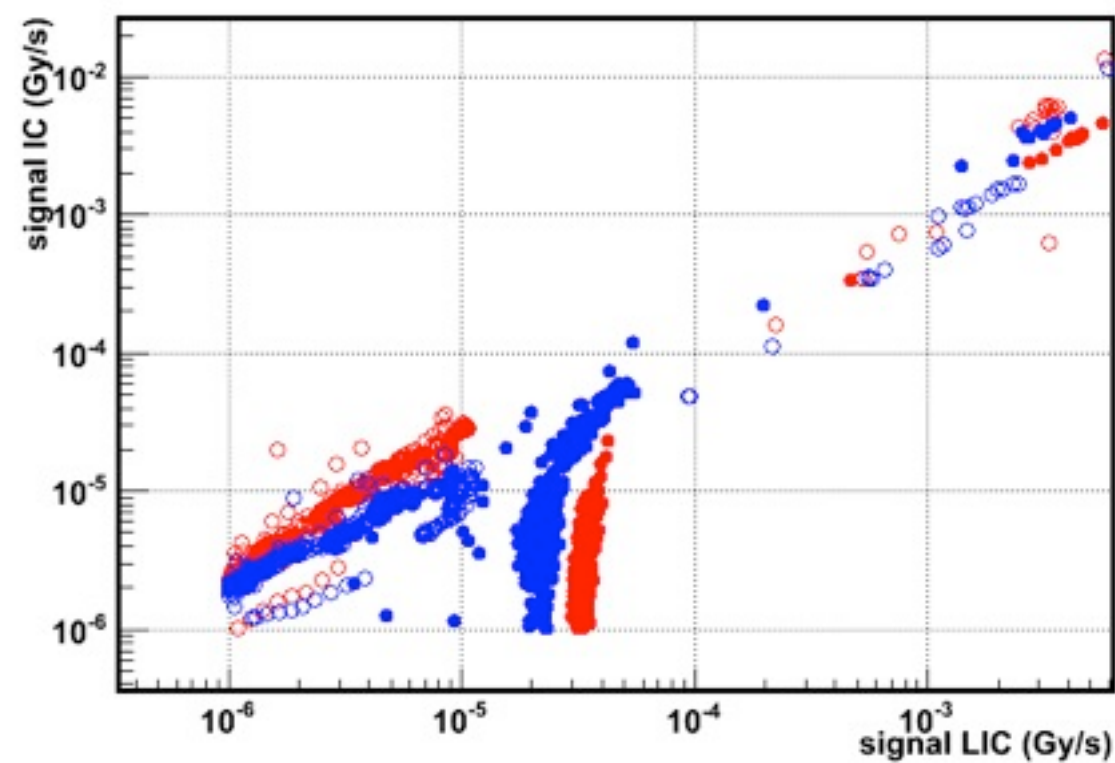
Monitors at TDI

○ Fill 2221 ● Fill 2533

BEAM 1

BEAM 2

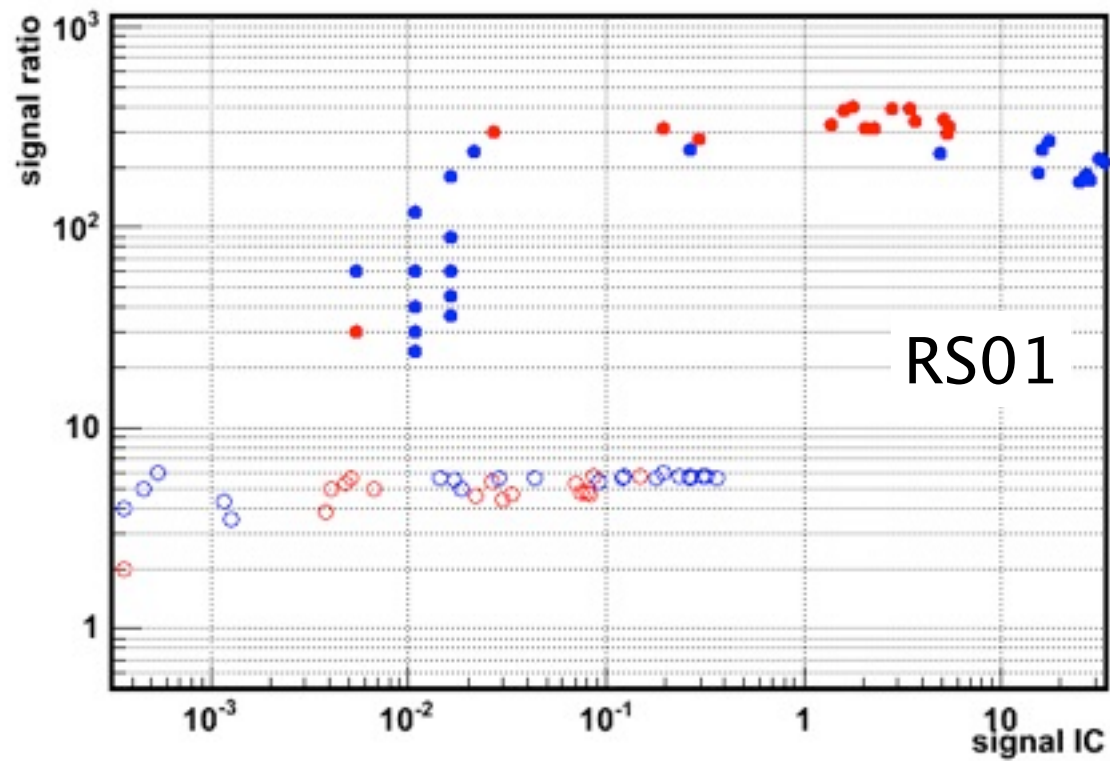
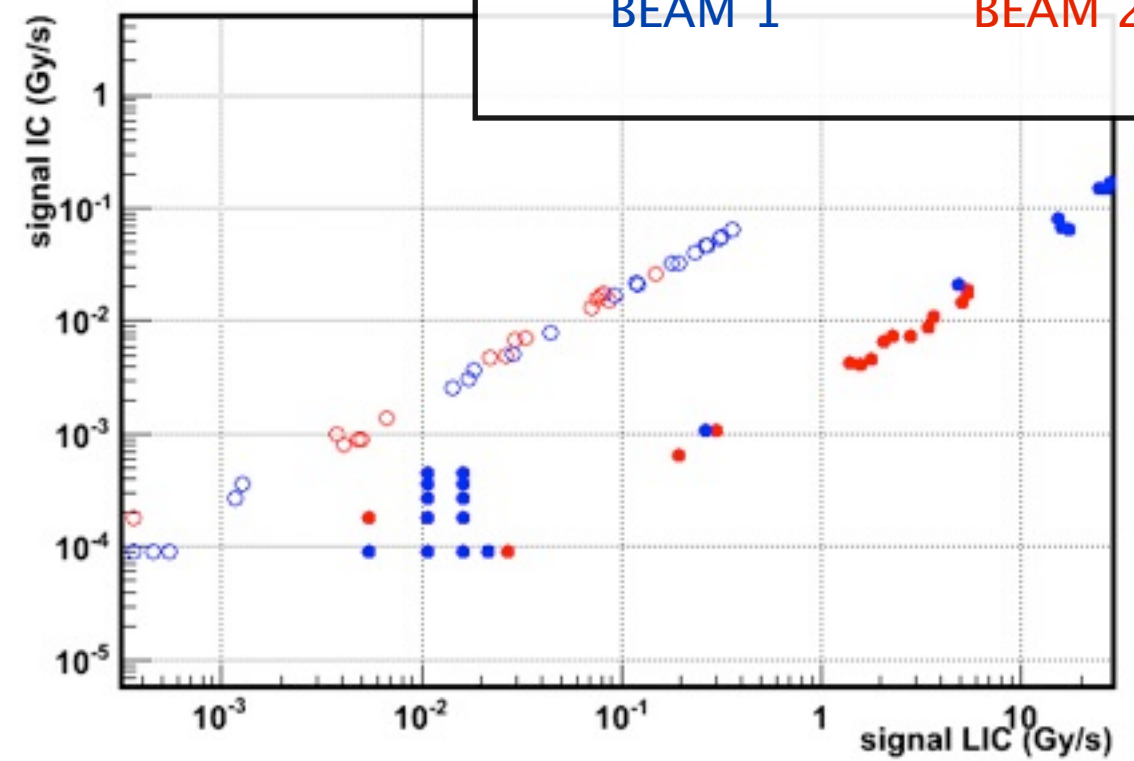
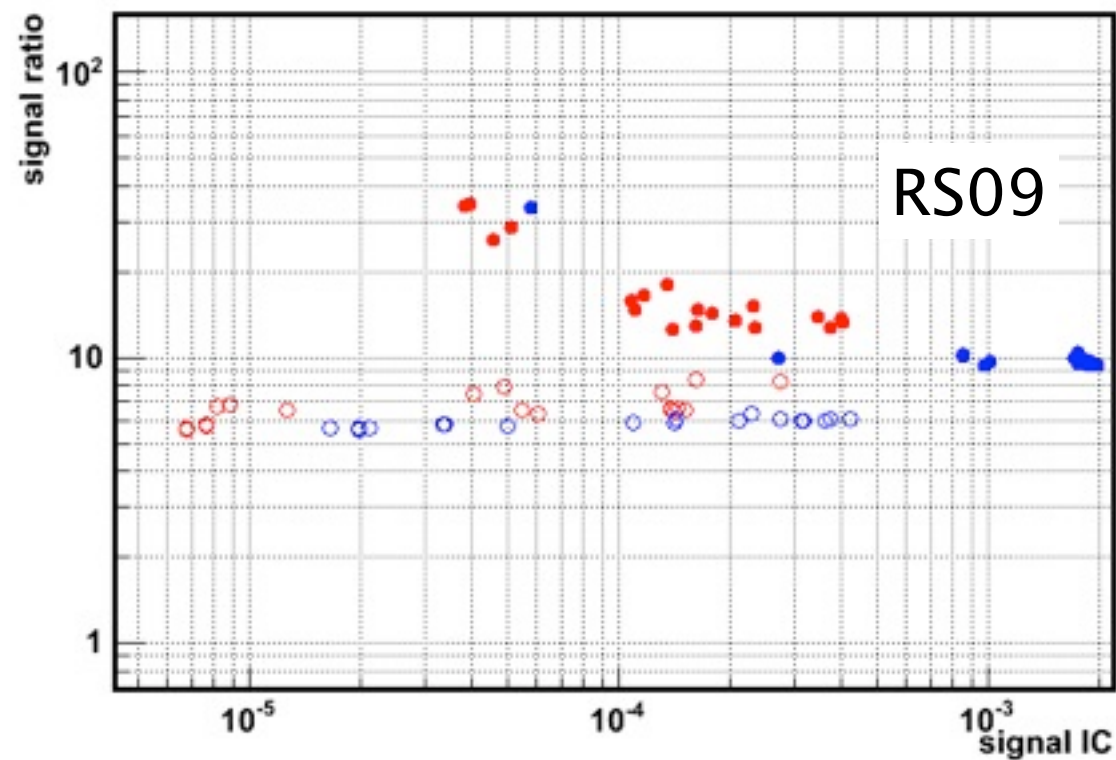
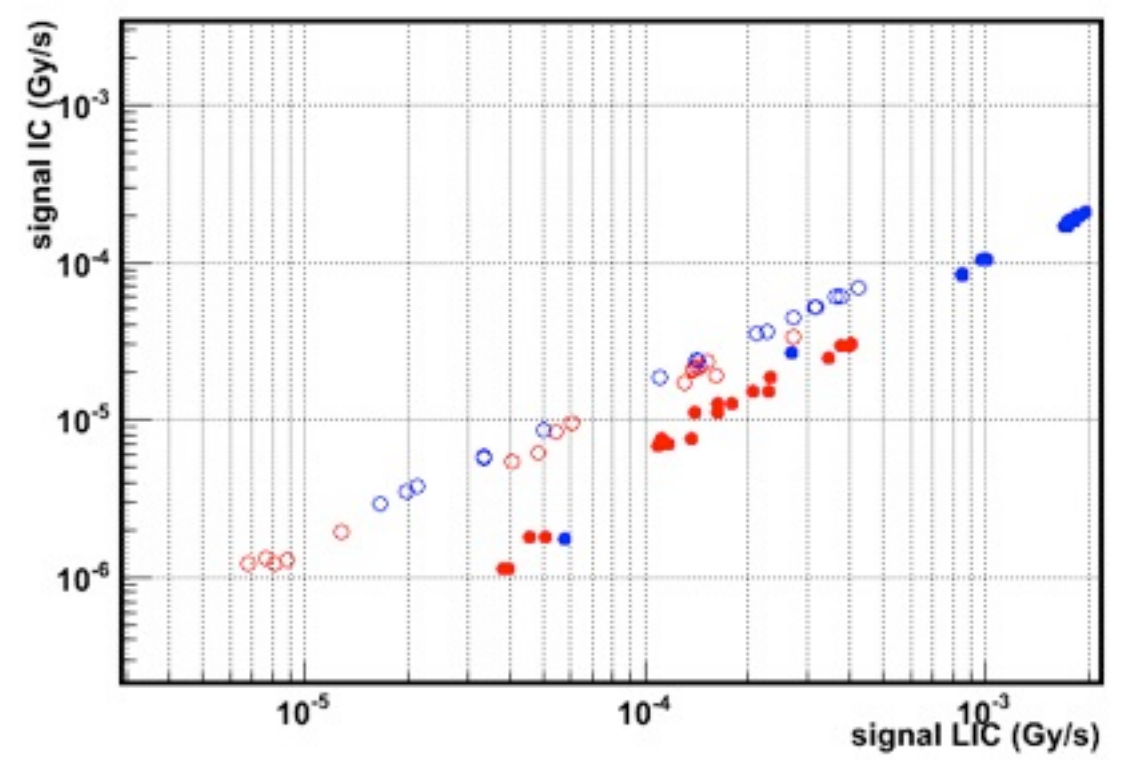
LHC. Monitors at MSI

○ Fill 2221 ● Fill 2533

BEAM 1

BEAM 2

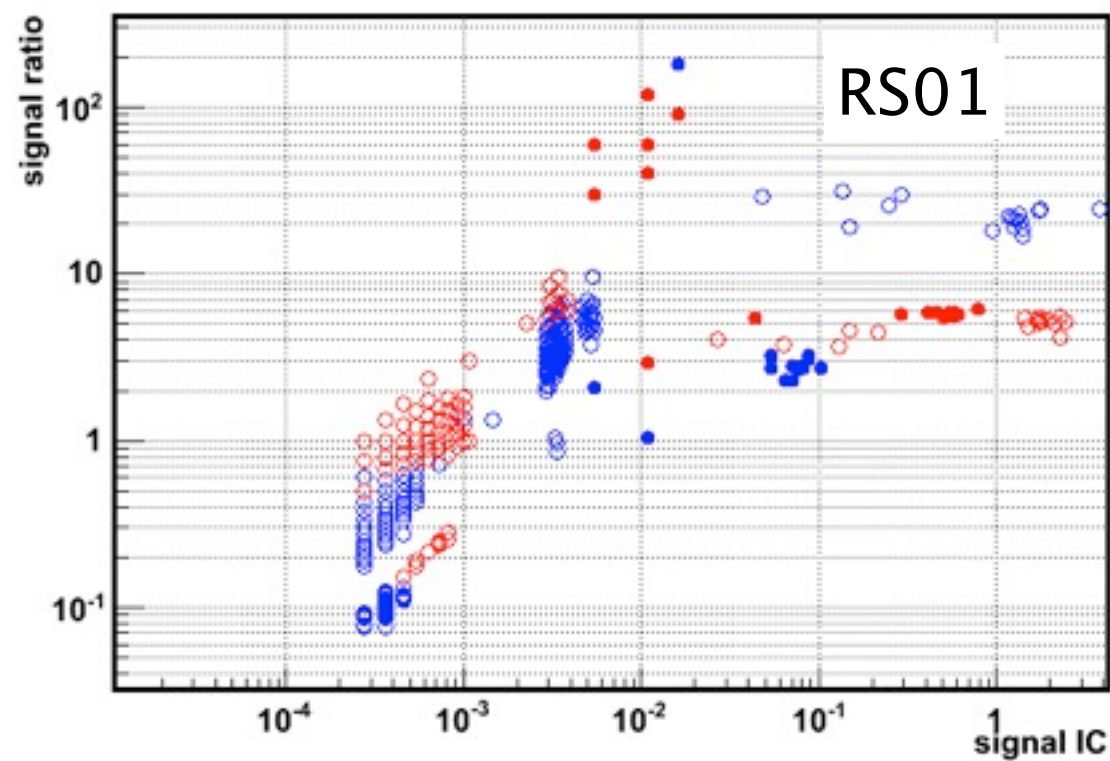
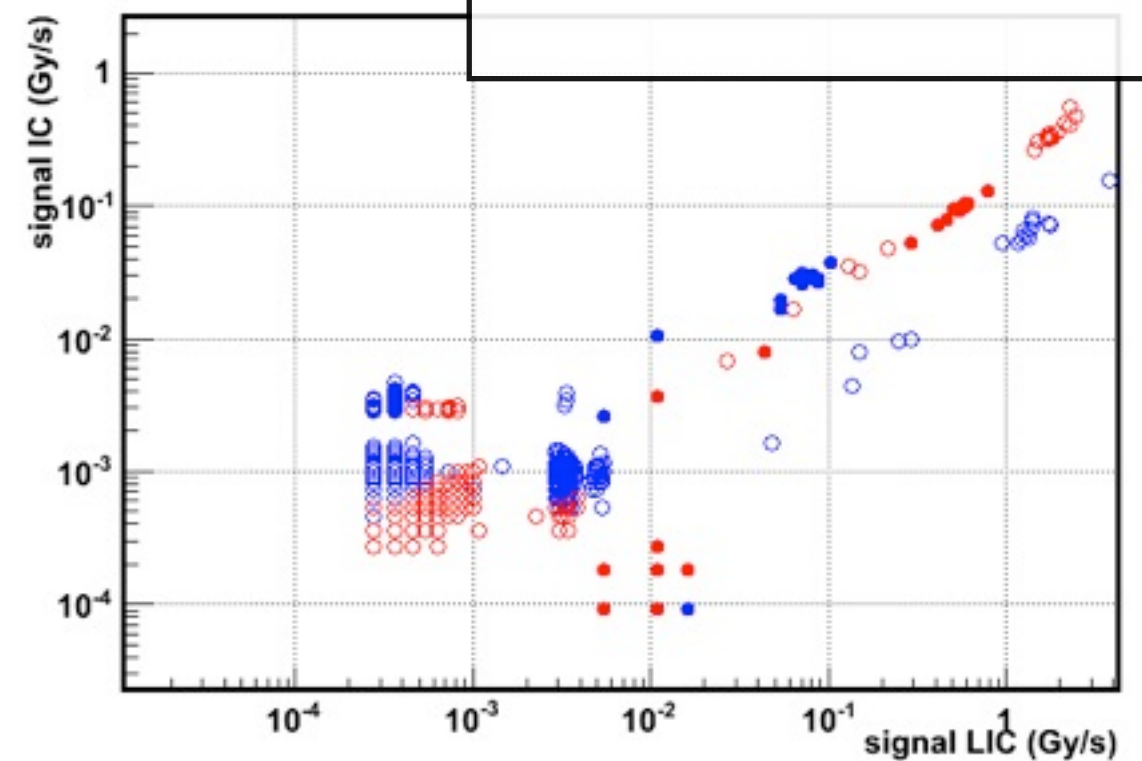
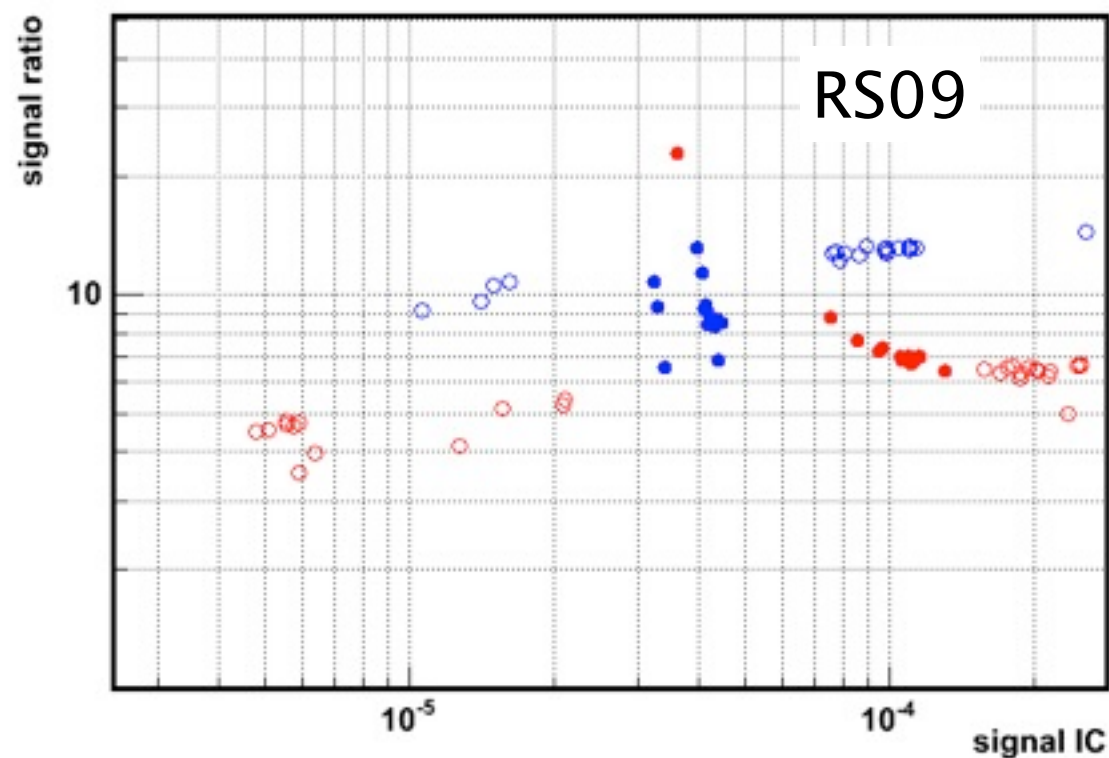
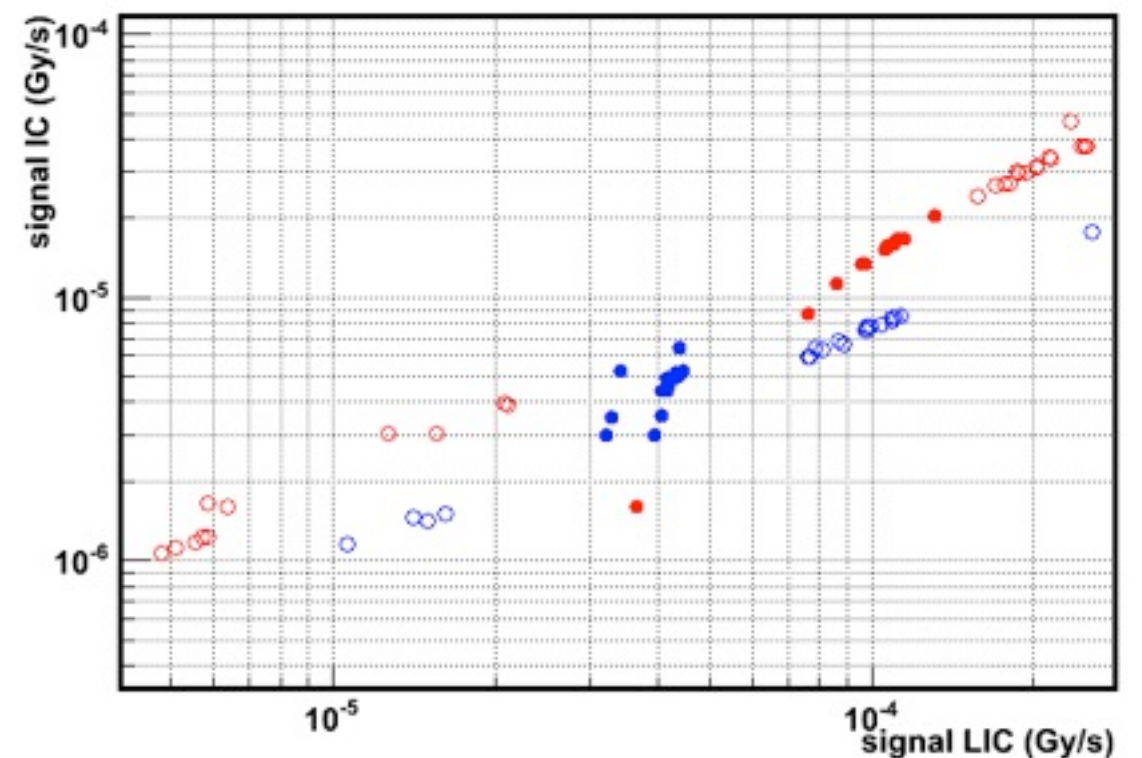
Monitors at MBXB – MQXA

○ Fill 2221

● Fill 2533

BEAM 1

BEAM 2

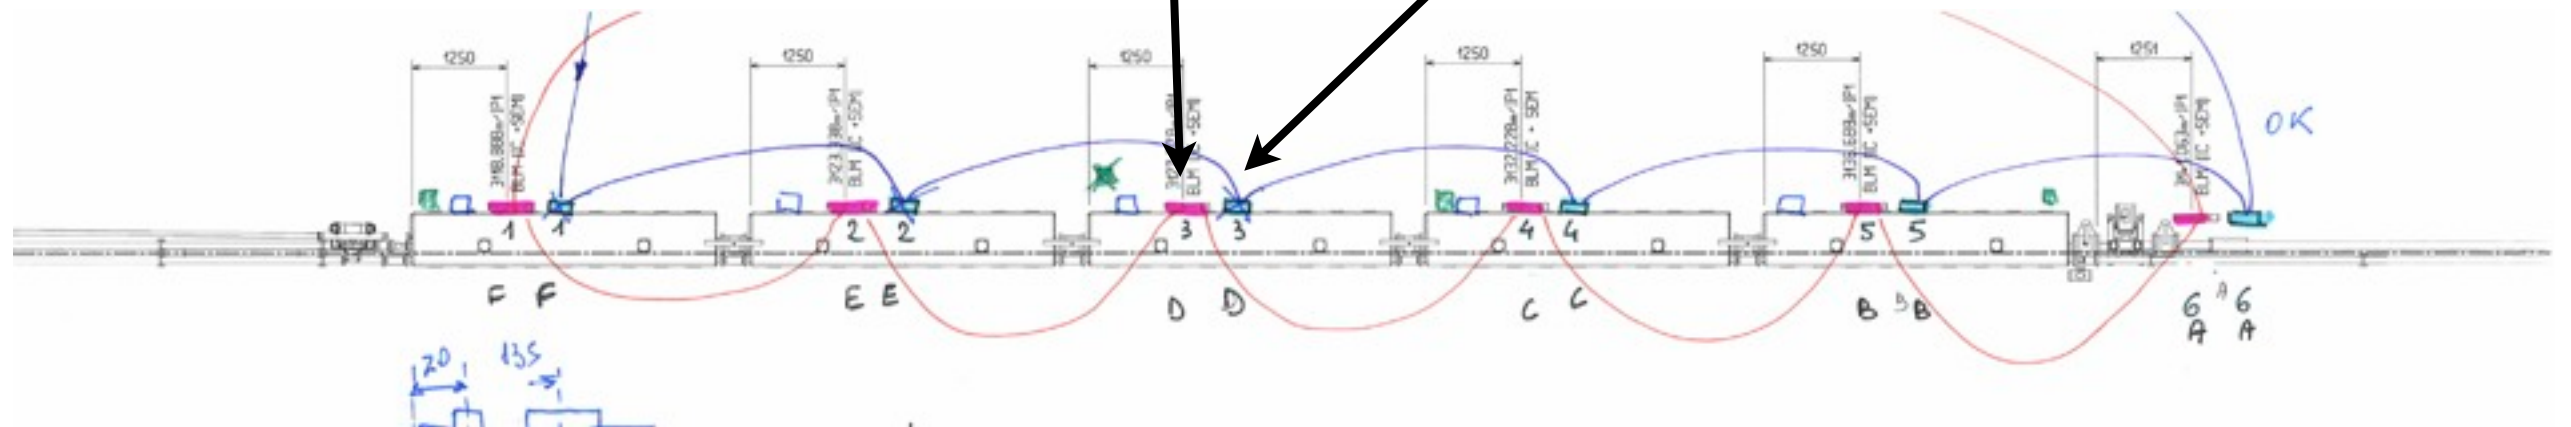
LHC. Installation MSI 06L2

- Original situation: 6 IC + 6 SEM separated by ~60cm (on top of MSI magnets)
- SEM detectors are not connected to BIS
- Replace SEM by LICs to gain more experience with these detectors. LICs not connected to BIS

IC SEM -> LIC
