LIC performance in the LHC

E. Nebot del Busto for the BLM team

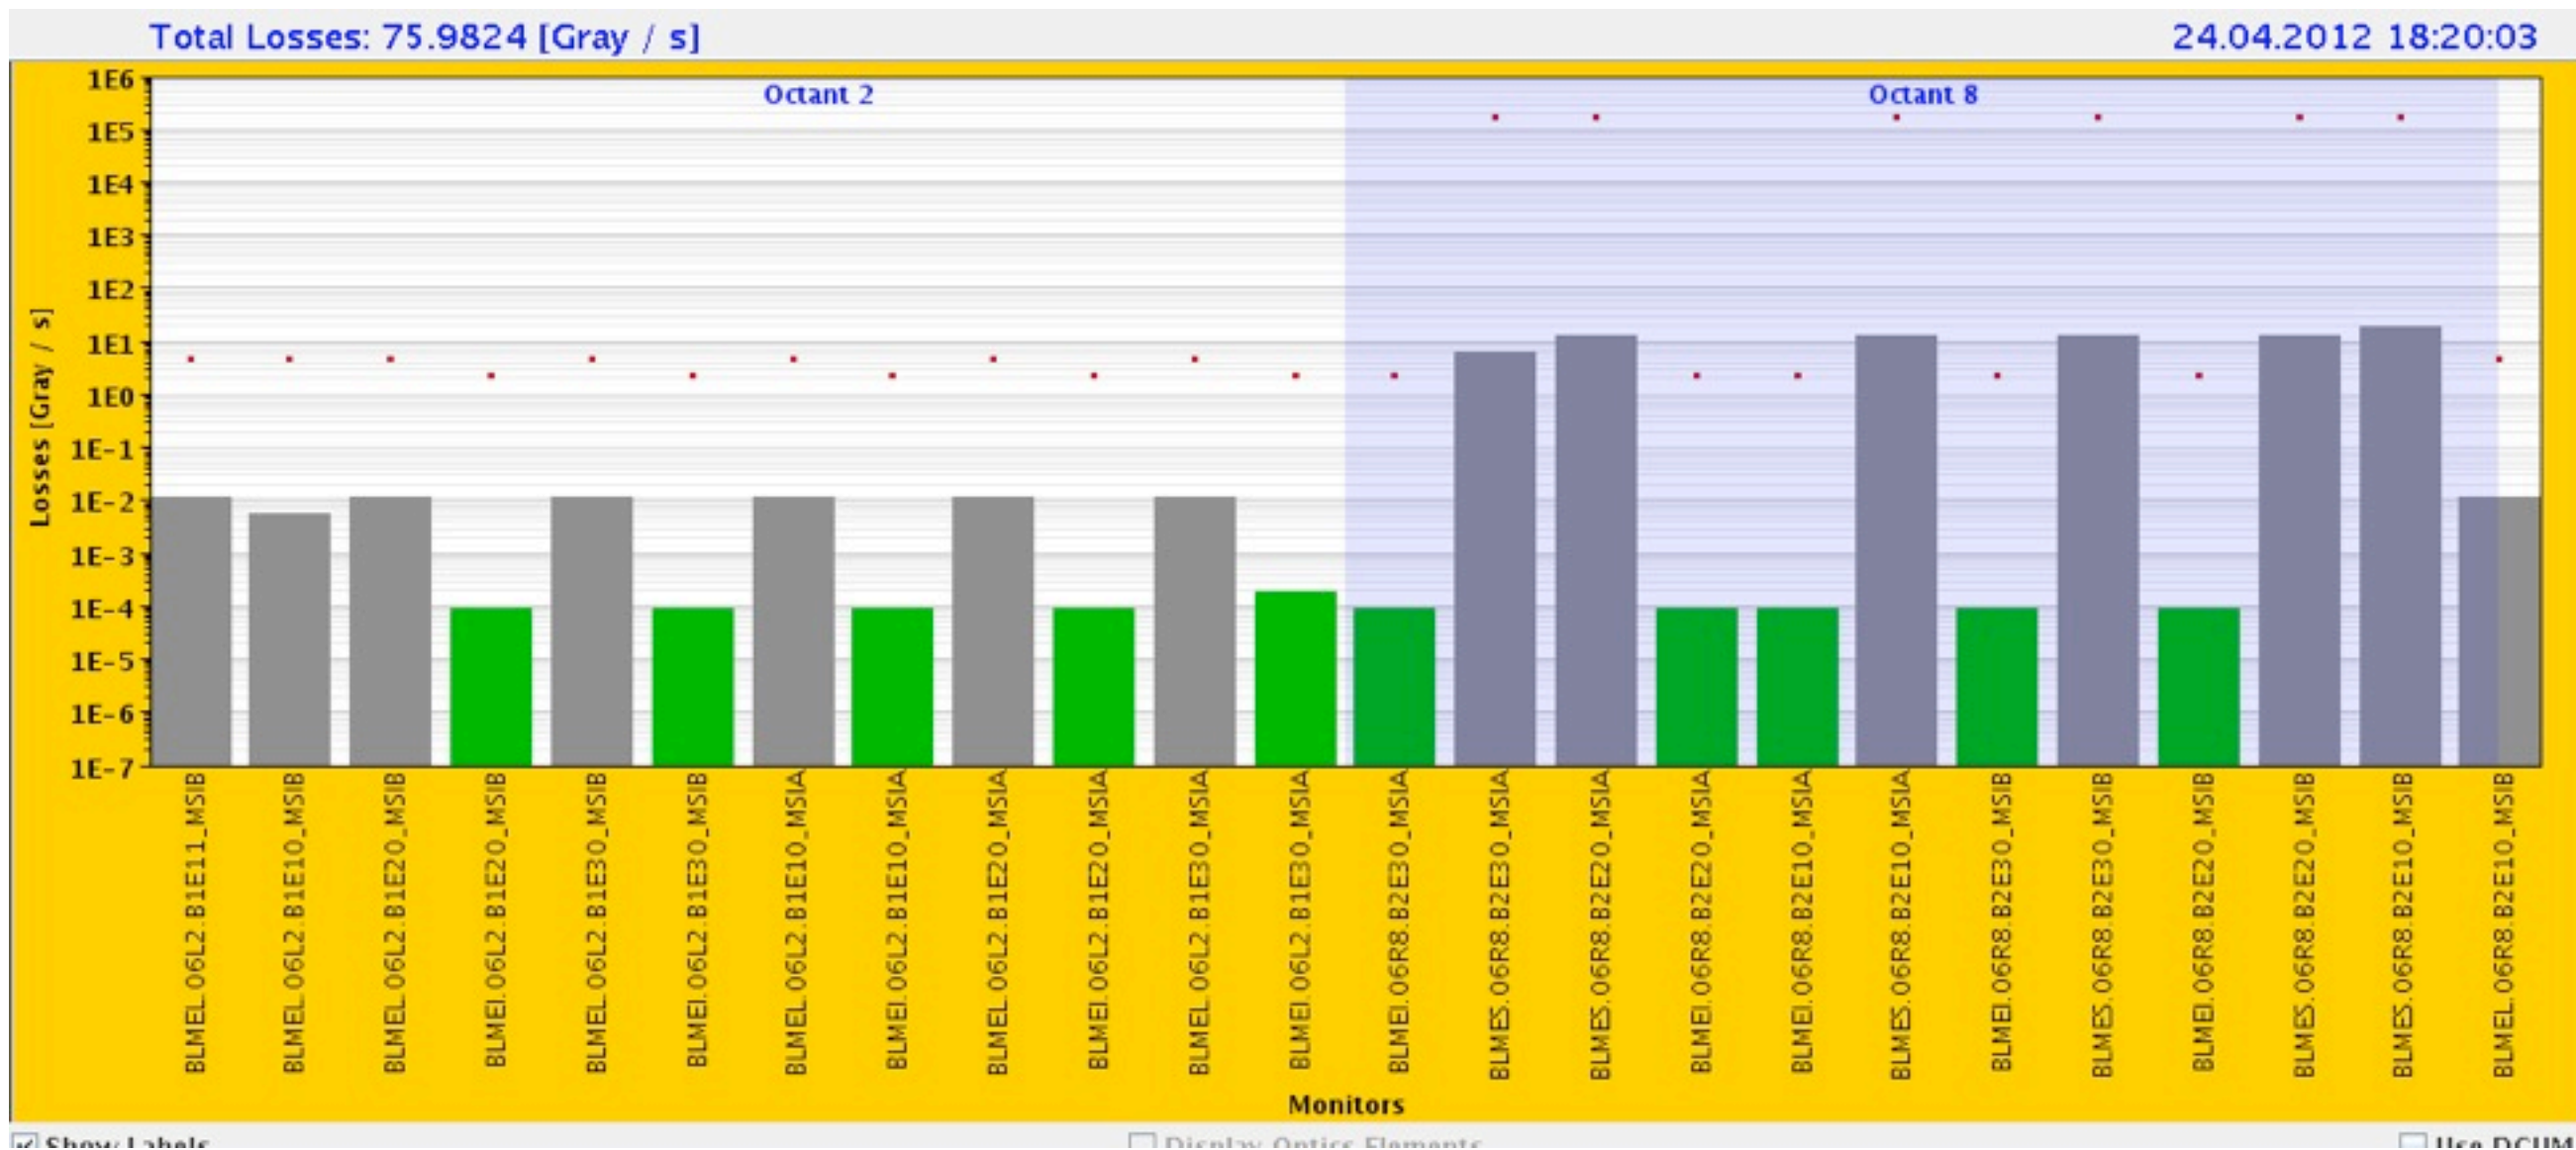
LHC. Installation MSI 06L2

- SITUATION after installation. IP2 vs IP8

The two attached plots show the situation in cells 06R8 and 06L2 before (note that when this plot was produced the SEM monitors in 06L2 were already removed from LSA. therefore they do not show up in the graphic) and after the modification. In the after plot, there are 7 LIC monitors in 06L2 whereas in 06R8 1 LIC and 5SEM detectors are observed.

Six SEM monitor located in the septa magnets in 06L2 were replaced by LIC to gain experience on the performance of these detectors with LHC losses. The old (SEM) and new (LIC) monitor expert names are listed below.
