# Muon Production Target at J-PARC

Shiro Matoba  
KEK J-PARC

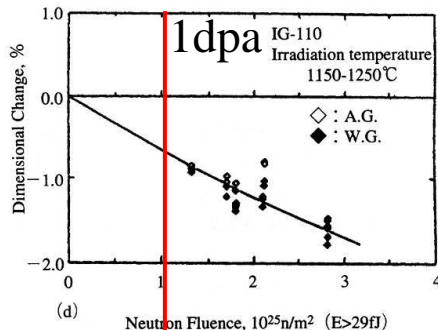
1 %/year shrinkage of graphite  
on the beam spot

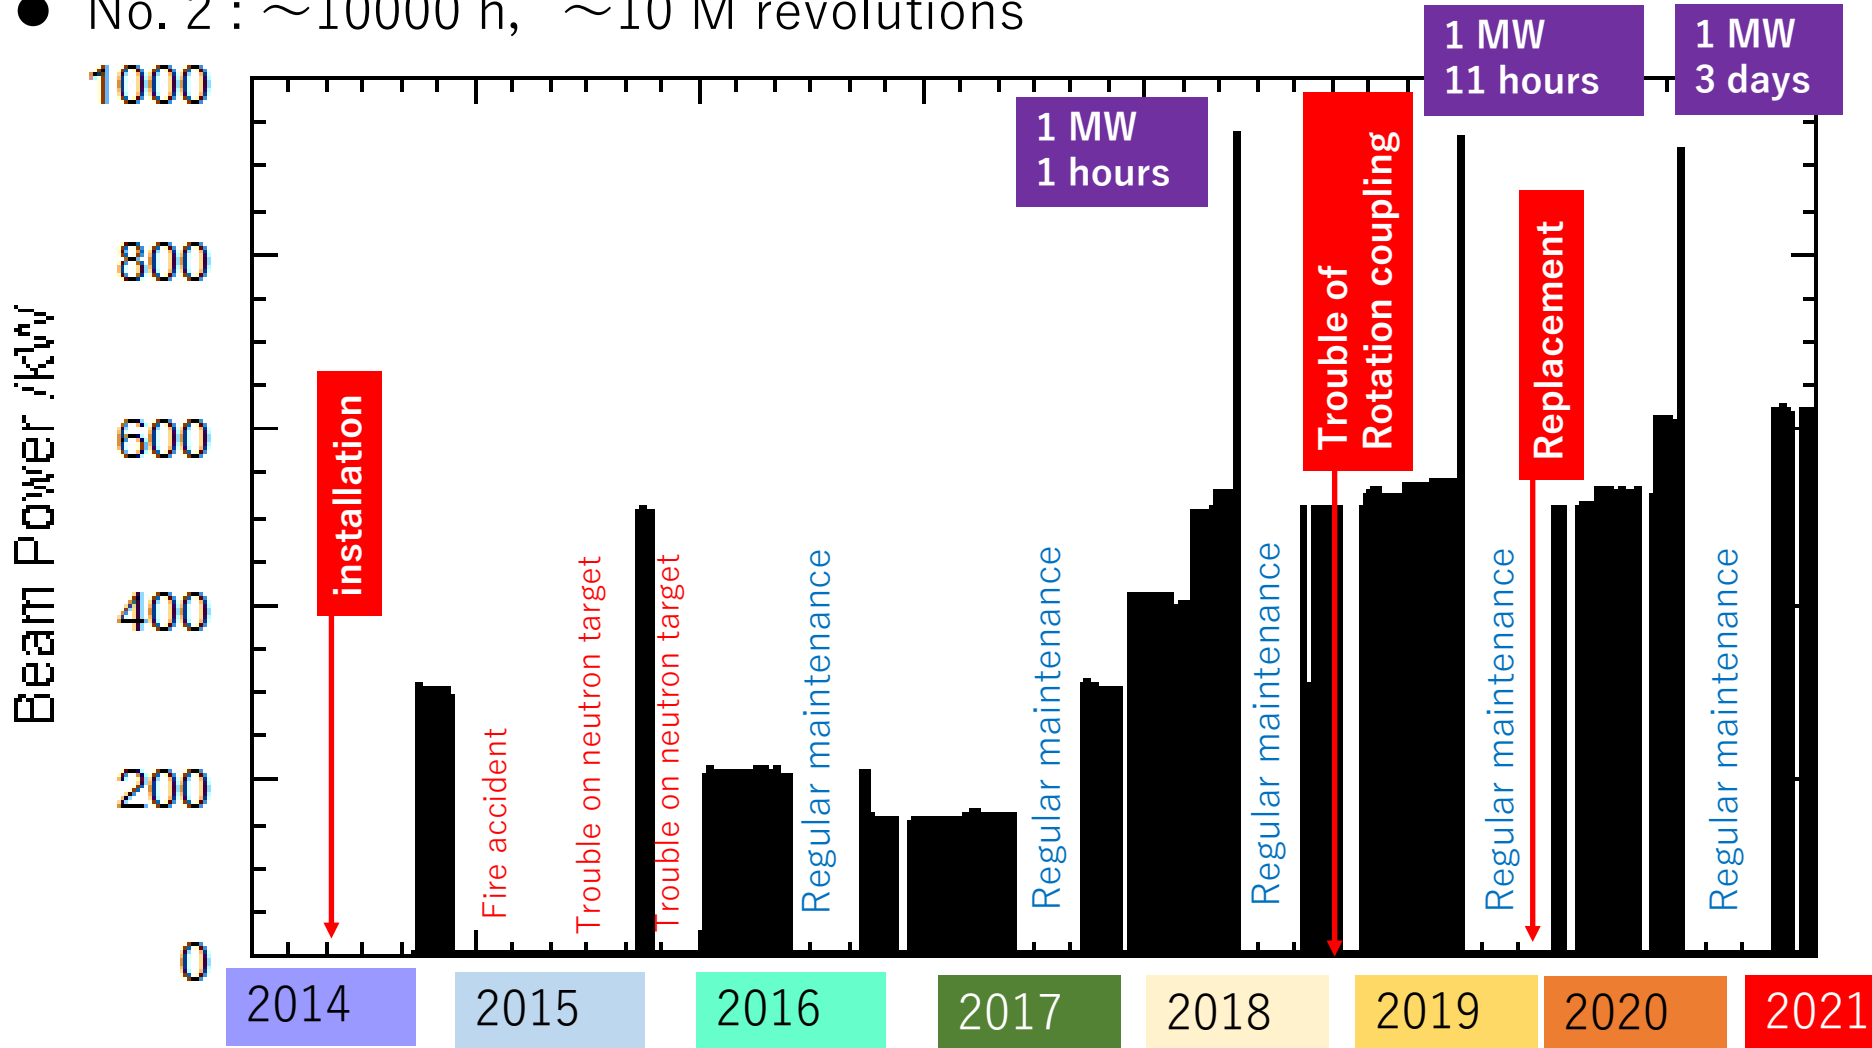
- No.1: Operation for the 5 years.
- History of beam operation ( ~June 2019) : ~15000 h  
Rotation : ~15 M revolutions (Service life of WS<sub>2</sub> bearings ~50 M)
- No. 2 : ~10000 h, ~10 M revolutions

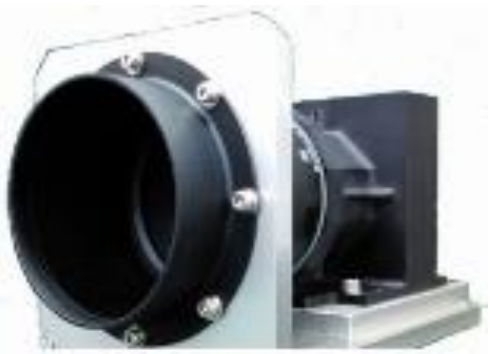
(C)Vision sensing

★ULVIPS-04171SL

Pixels : 648 × 480  
accuracy : ± 2 K or ± 2%  
focal distance : 150 mm

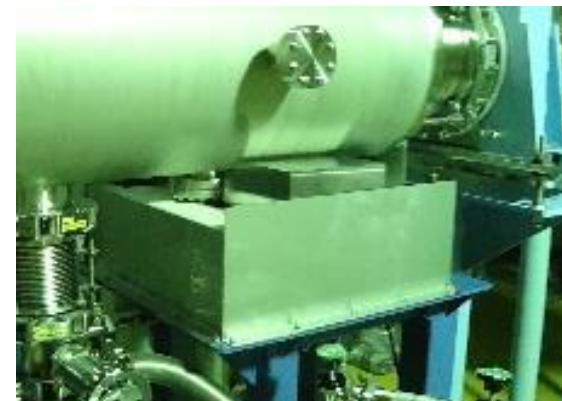
Shielding for the camera

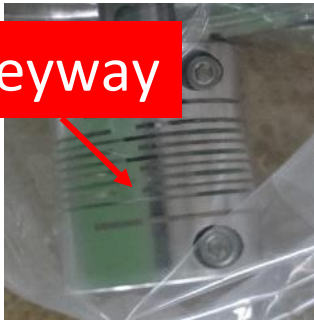
Rotating coupling

- The rotating coupling to transmit rotational motion was broken (found in Sept. 2018 during maintenance work).
- The rotating coupling has a keyway process to prevent slippage at the joint with the rotating shaft. There was a mistake in the processing of the keyway, and the strength of the coupling was reduced.

The damaged coupling was replaced with a stronger one in the summer of 2018.  
Another weak coupling is used in vacuum.  
Beam operation was continued until 2019 under strict monitoring.

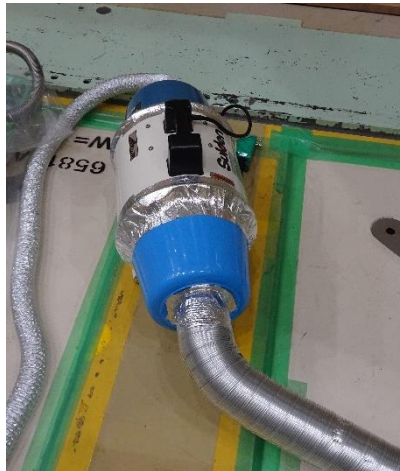
Blower for negative pressure control  
Exhaust to stack piping after contamination measurement

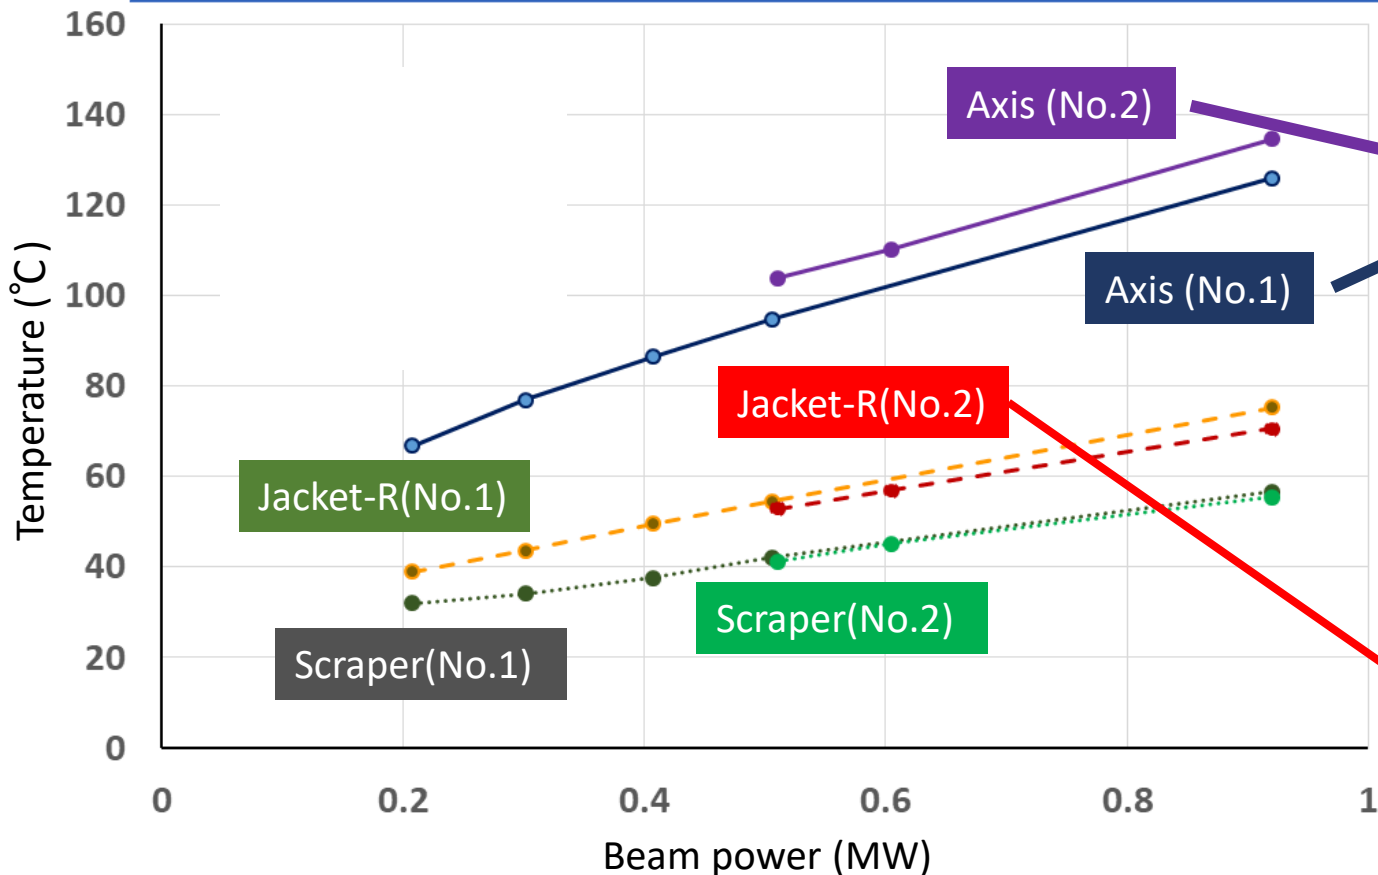
- Thermal response of targets and scrapers was found to be consistent with the prediction.  
No difference was observed between the previous (No.1) and current (No.2) target systems.
- Motor torque showed no anomaly during 1 MW operation.

Beam-power dependence of target system temperature
