ATLAS ITk Strip Sensor quality control and review of ATLAS18 pre-production sensor results

CHRISTOPH KLEIN (ON BEHALF OF THE ITK STRIP SENSOR COLLABORATION)

VERTEX 2022 WORKSHOP

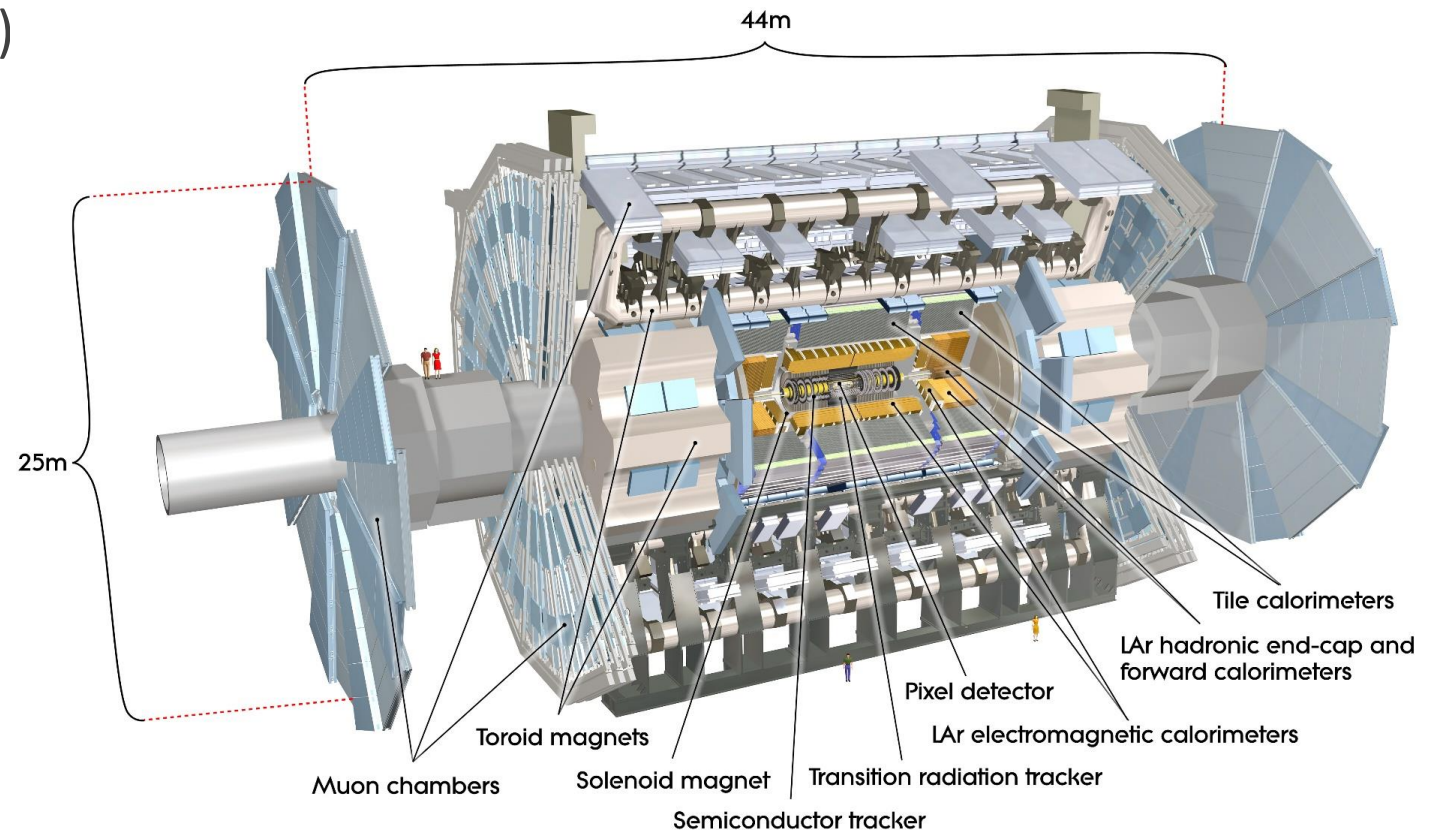
- ITk replaces current Inner Detector from Run 4 (2029) onwards (HL-LHC)
- all silicon pixel + strip detector
- large area sensor surface

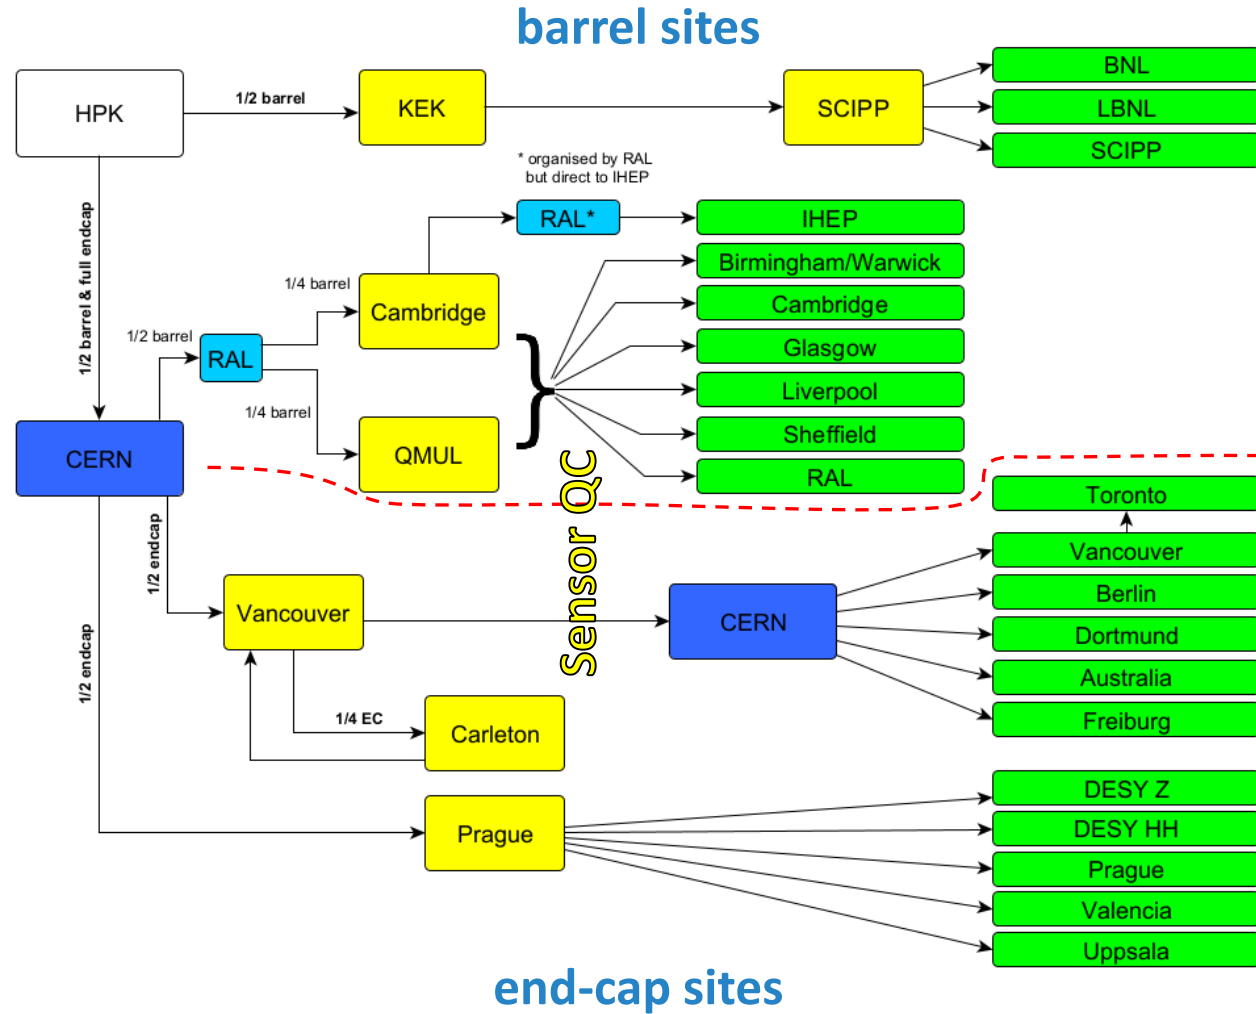
Strip Sensor Part Flow

- all sensors undergo QC
- all end-cap sensors distributed through CERN
 - $\frac{1}{2}$ EC sensors to Prague
 - $\frac{1}{4}$ each to Vancouver and Carleton
- barrel sensors divided between KEK and CERN
 - QC test subset for $\frac{1}{2}$ barrel by KEK (HPK) and SCIPP
 - $\frac{1}{4}$ each to Cambridge and QMUL
- subsequent distribution to module assembly sites

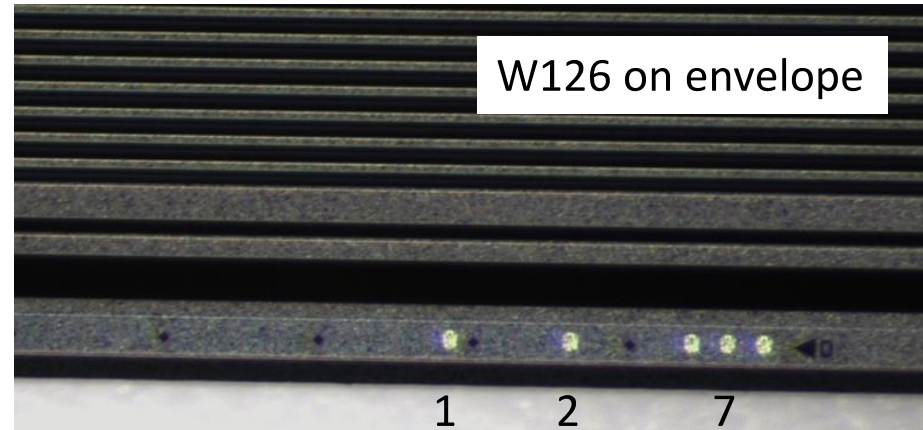
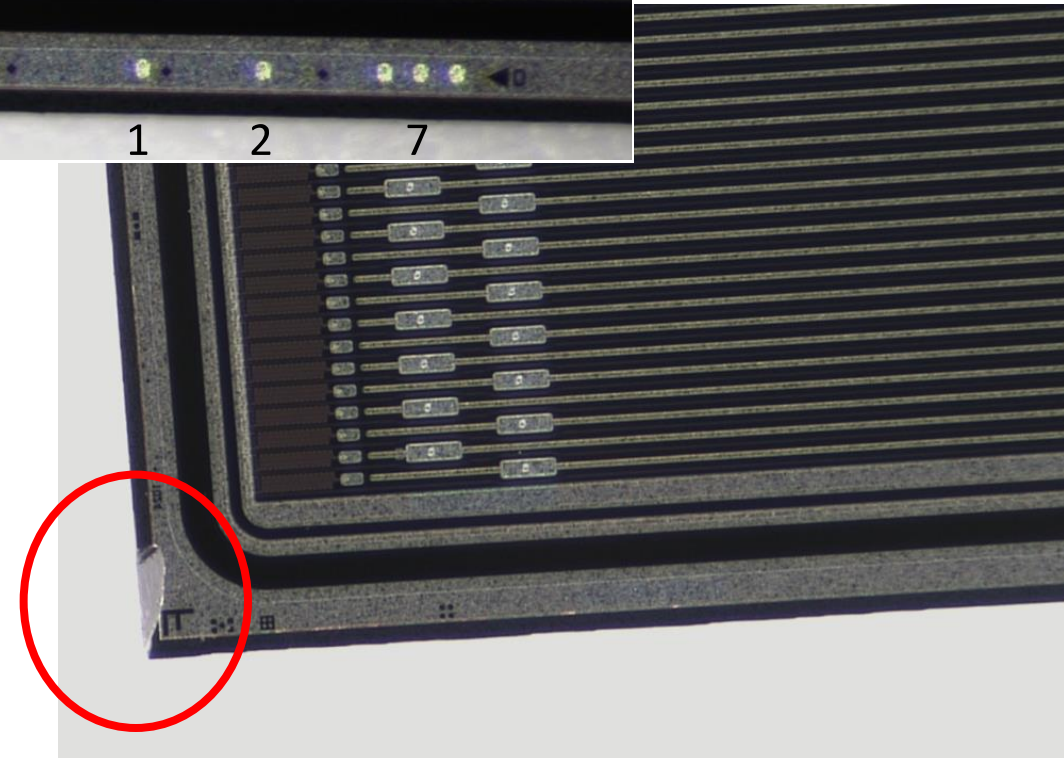
Visual inspection findings

- scratch marks (serial number) on 4 sensors did not match serial number on HPK envelope
- one sensor had chipped corner
- no other major issues observed
- typical minor issues:
 - (light) scratches
 - debris on surface

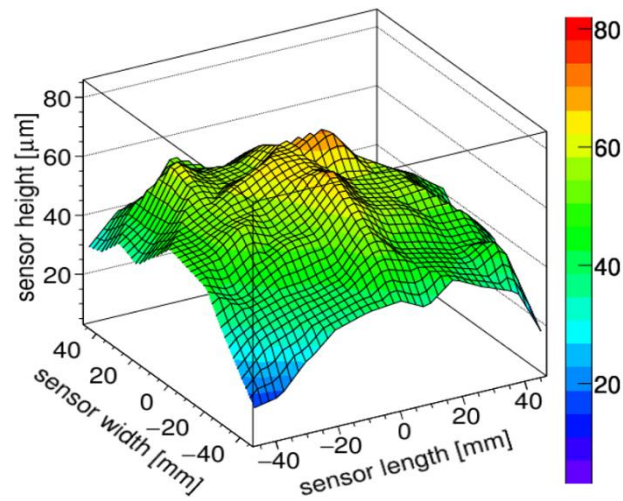
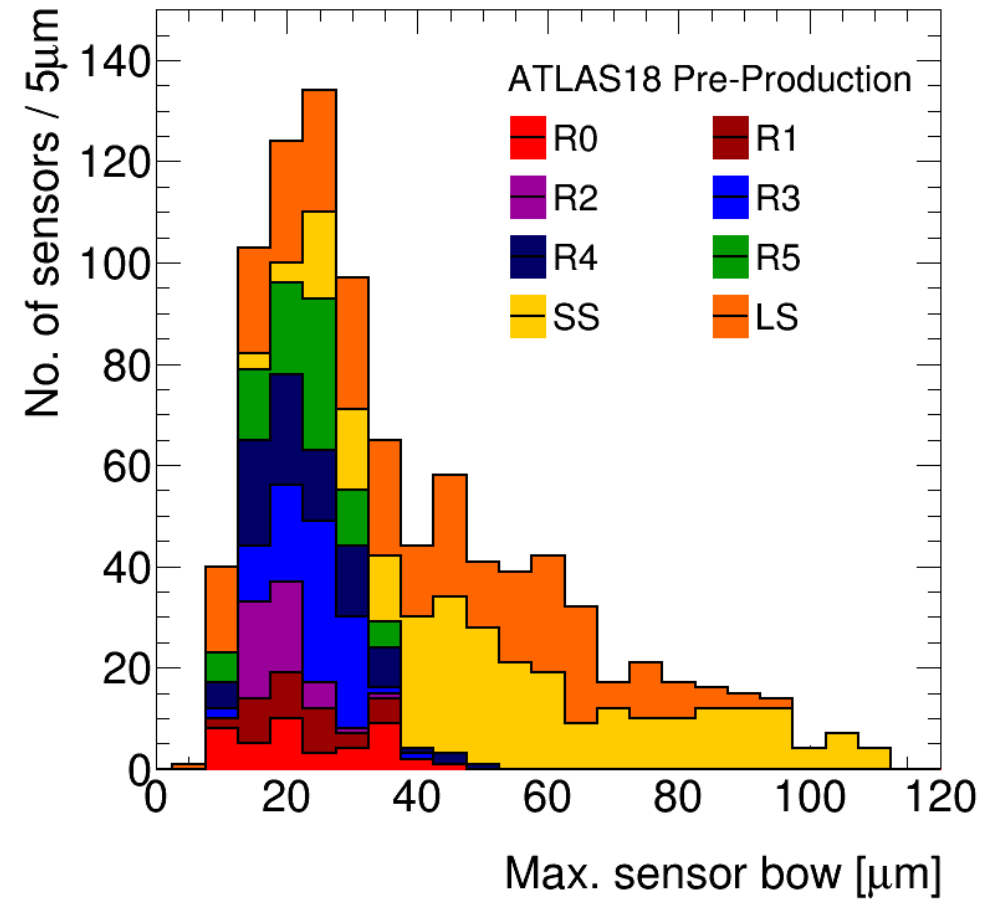
Metrology results

- ‘bow’ is defined as maximum height difference from a reference plane (to correct sensor tilt)
- majority of sensors even have bow below $50\mu\text{m}$
- no failures

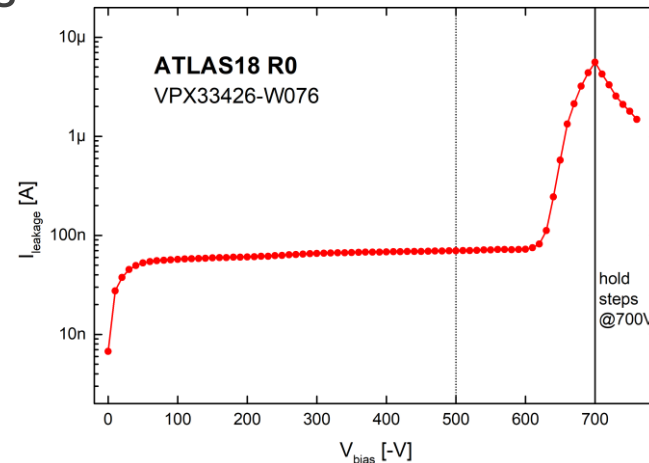
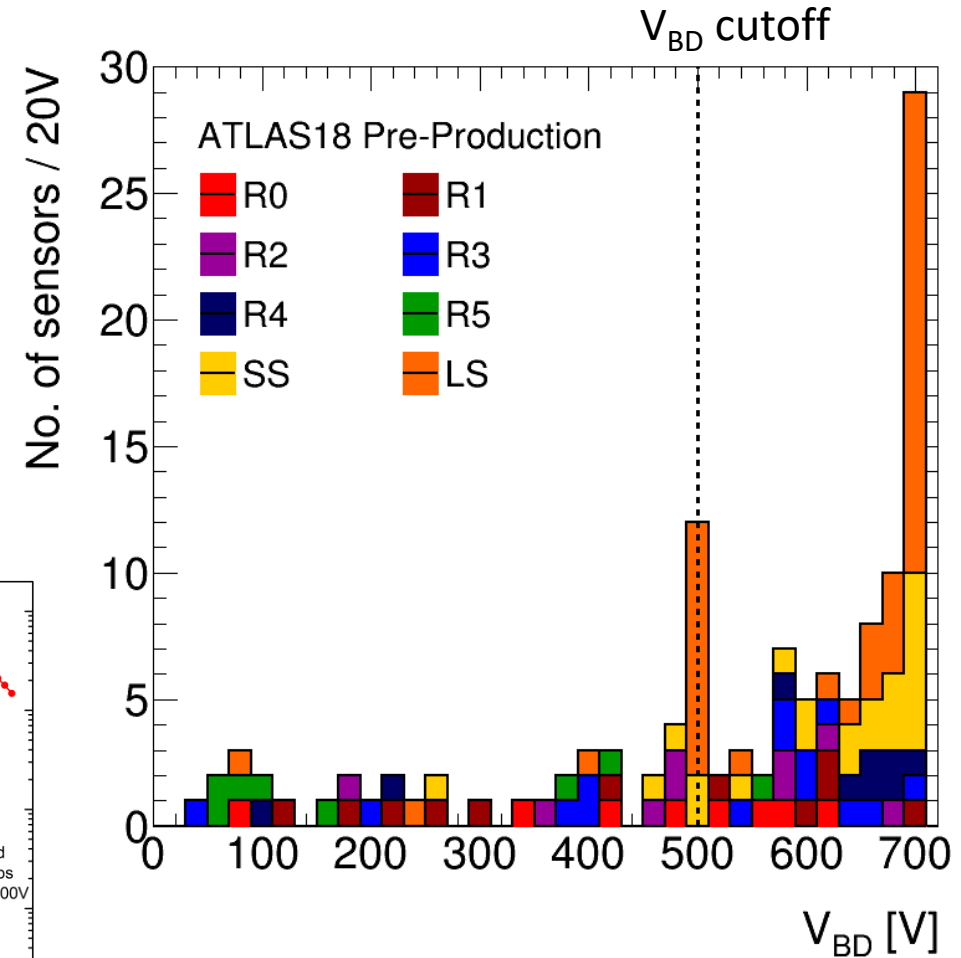
IV results

- IV is the most-failed QC test
- sensors fail to meet breakdown criteria $V_{BD} > 500V$
 - rather than current limit spec
- some sensors with $500V < V_{BD} < 700V$ show recovery during hold steps
 - candidates for stability test

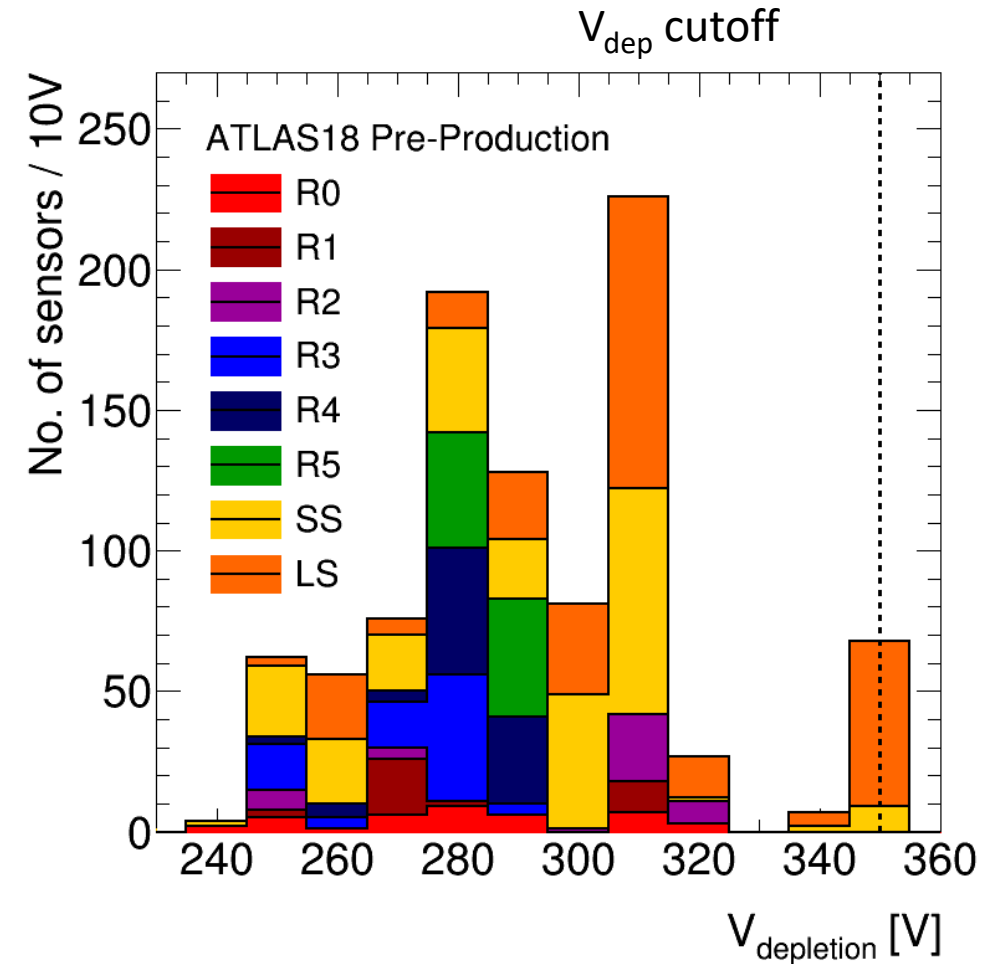
CV results

- one barrel shipment with larger number of 'marginal' sensor
 - V_{dep} less than 5V above specification for ~20 sensors
 - ⇒ partially related to measurement steps
 - sensors otherwise good
 - discussion with HPK, stricter internal process, acceptance criteria loosened slightly (<360V)
- vast majority of sensors fully deplete well below 350V

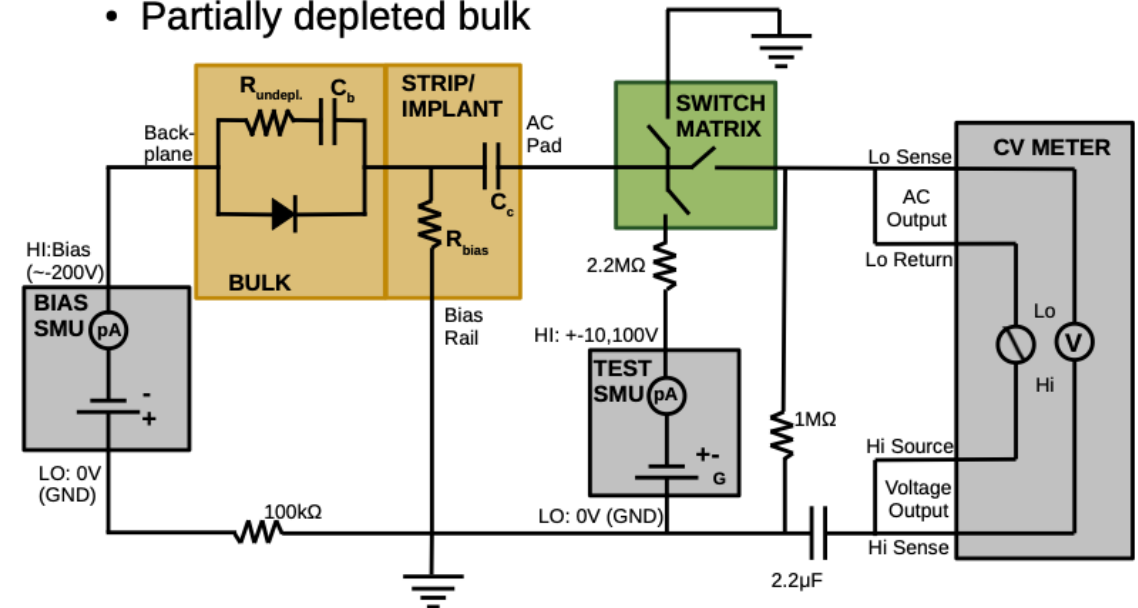
Strip test results

measurement procedure:

- sensor partially depleted (-150V), strips isolated, contact each strip
- readout strip isolation, current through dielectric (10V/100V applied to AC pad)
- coupling capacitance to strip implant
- bias resistance to bias rail

⇒ measured values determine failure mode

- 1 out-of-spec sensor identified
- usually <10 failed strips, if any

- Partially depleted bulk
