Operational Experience and Performance with the ATLAS Pixel detector at the Large Hadron Collider at CERN

➤ VERTEX 2022, Tateyama Resort Hotel, 24-10-2022

Kerstin Lantzsch

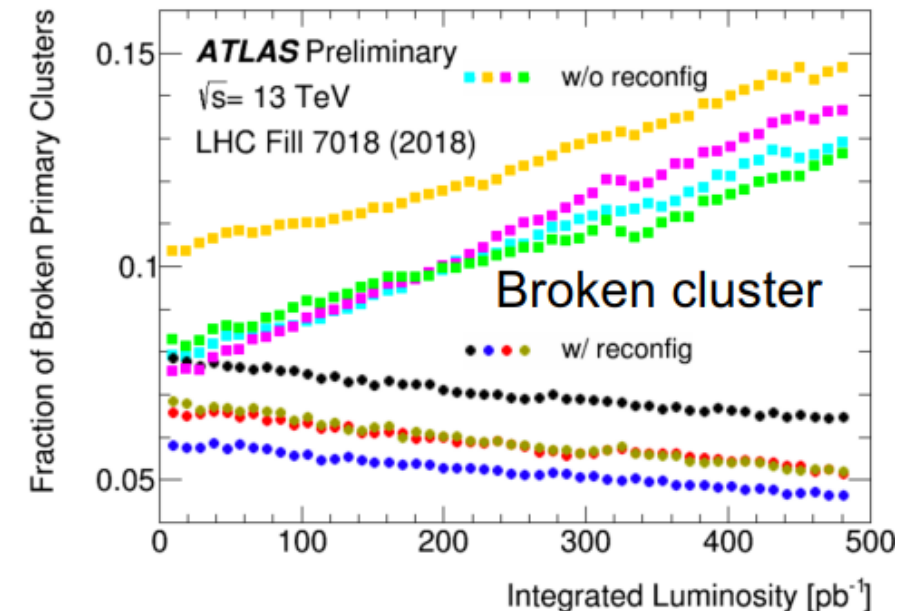
Operation in Run 2: Single Event Upsets

- Particles crossing the frontend chip can cause register settings to be corrupted.
- In IBL, the consequence of a global register upset is often visible as a drop in occupancy together with a change in current consumption. This is recoverable by reconfiguring the global registers.
- The global registers in the FEI4 are implemented as triple DICE latches. The main upset mechanism are glitches on the load line (SET).
- An automatic reconfiguration of the global registers inside a 2 ms gap every 5 seconds was implemented. Since this gap is without triggers, no deadtime is incurred.
- A pixel level reconfiguration will also be deployed.

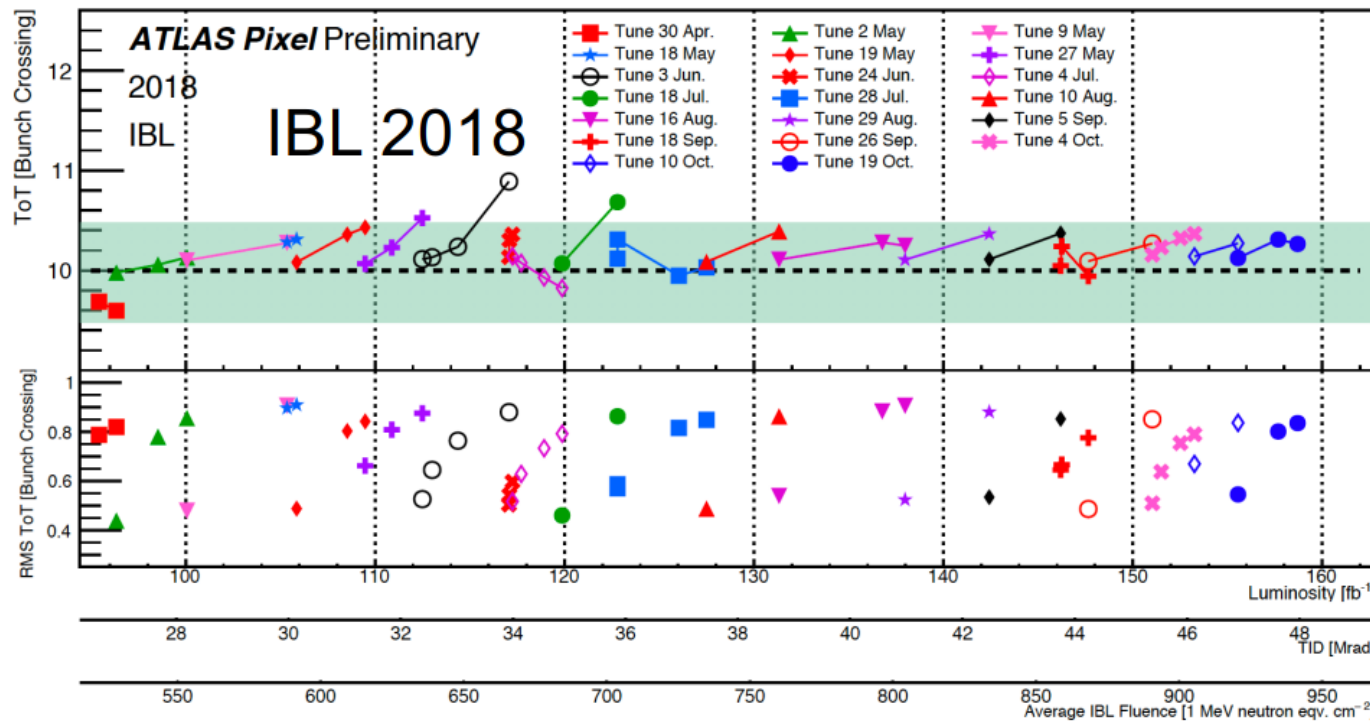
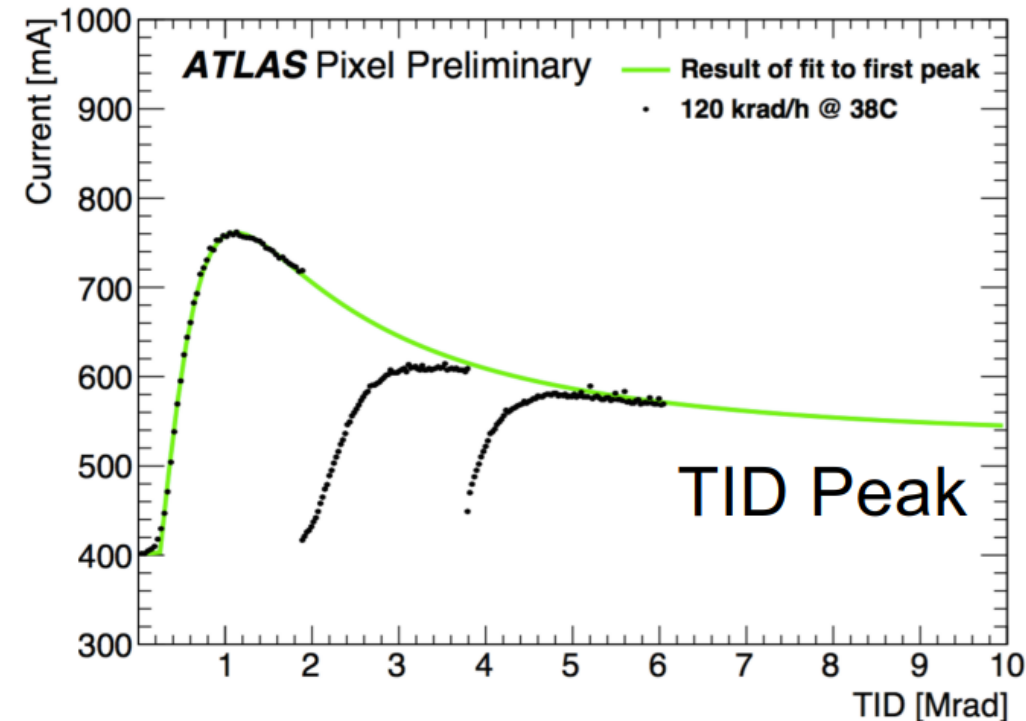
Operation in Run 2: IBL calibration drift

- The leakage currents inside the transistors of the FE-I4 readout chip (130 nm IBM process) show a strong dependence on TID with a peak at 1 Mrad.
- The leakage currents have a direct impact on the tuning of feedback currents and thresholds.
- The peak was overcome in 2016. Now we are on the falling edge.

- The detuning of threshold and TOT is carefully monitored during LHC interfills.
- Depending on an appropriate window without beam for a retuning/recalibration.

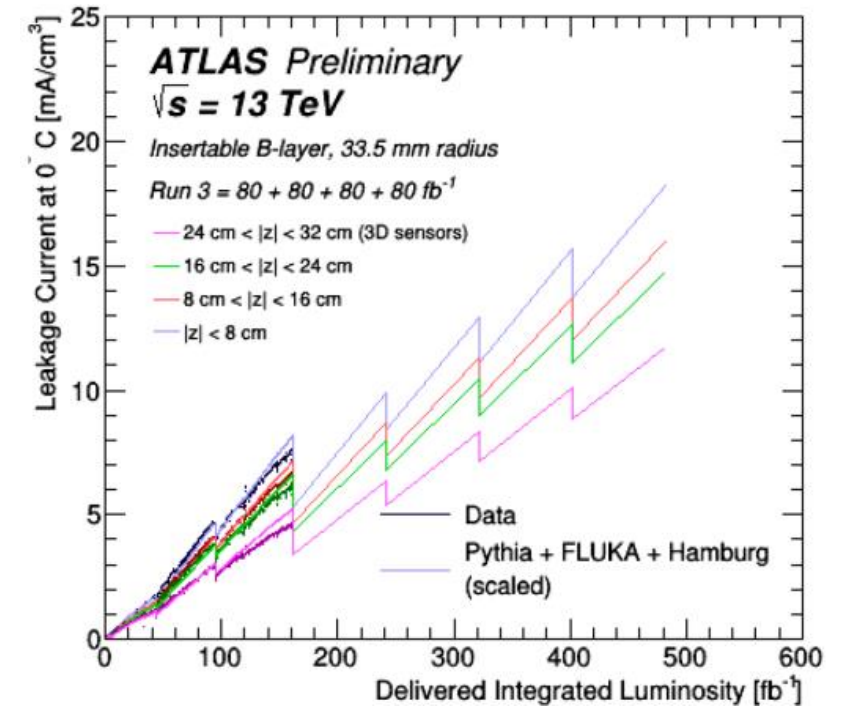
- The evolution of the leakage current can be described with the Hamburg model. Global scaling factors are, however, required.
- Towards the end of run 2 the leakage current is overestimated.

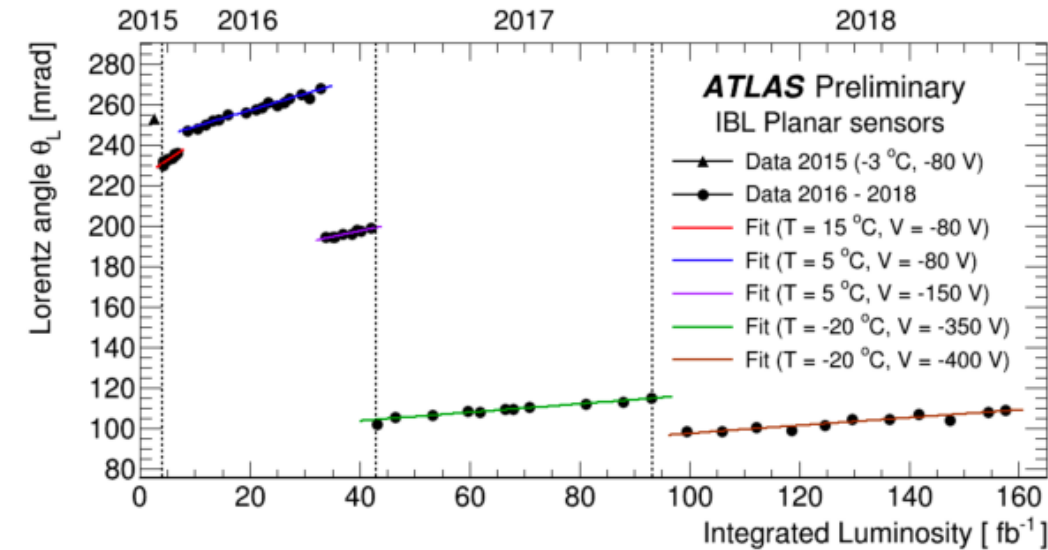
Lorentz Angle

- Charges drift transversally in planar sensors because of the perpendicular magnetic field.
- The angle between electric field and the drift direction is called the Lorentz angle.
 - This effect introduces a bias on the cluster position reconstruction.
- The electric field changes with radiation damage. This results in a drift of the Lorentz angle with integrated luminosity.

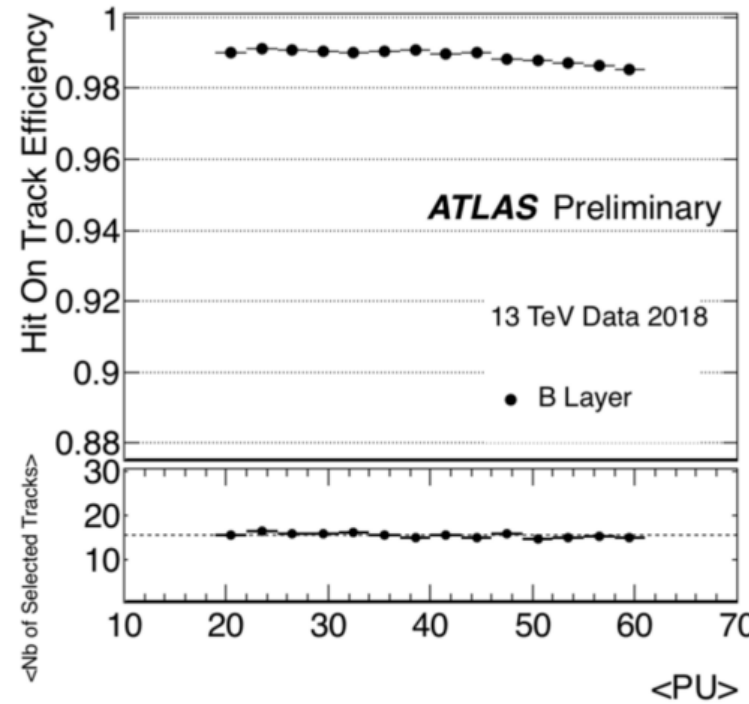
Threshold

- Occupancy decreases over time due to radiation damage causing efficiency losses.
- In 2018, the threshold could be lowered for the first time without hitting the bandwidth limitations, counteracting efficiency losses due to radiation damage.
- Optimization of keeping efficiency high and keeping the bandwidth manageable.

- Almost full efficiency in B-Layer recovered after lowering thresholds in 2018.
- Good stability of efficiency at high pile-up.

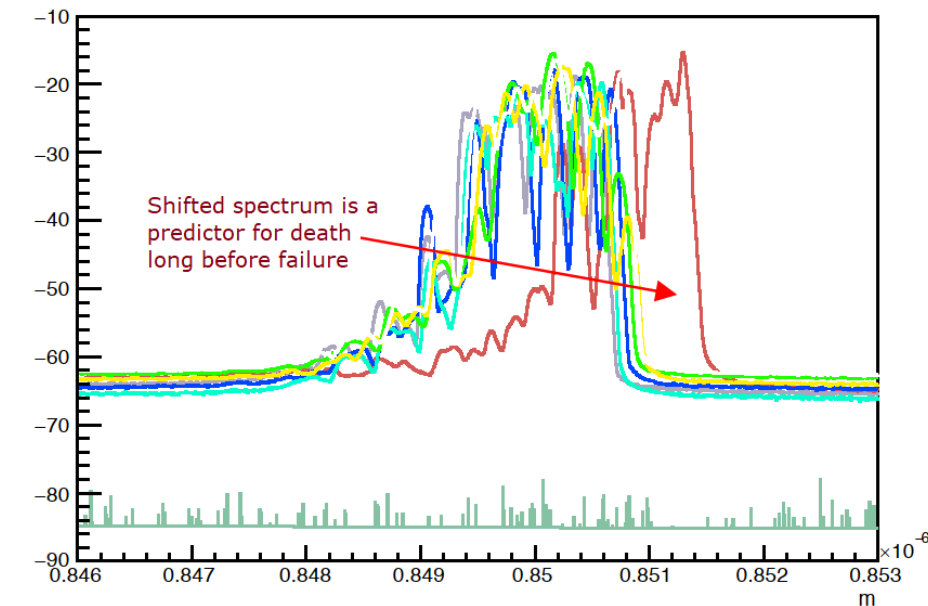
Optoboard replacement

- The major contribution to module failures during Run 2 was due to dark VCSEL channels.
- The failures started about 2 years after installation of the optoboards.
- Humidity is now the main suspect as failure cause.
- About 30 boards were replaced before the run of 2018. 20 additional VCSELs have died since then.
- An additional 400 optoboards were produced, and ca 2/3 of all optoboards were replaced during LS2, among them all failing and suspicious ones. In addition, the crates housing the optoboards were sealed against humidity.
- No new VCSEL channels have failed since then.

- LHC was in shutdown for three years. For Pixel the biggest hardware project was the successful replacement of the optical data transmitters on the detector. After sealing them against humidity, no further failures have been observed.
