# Report on Ongoing Actions for MQXFB

## New test and measurement techniques

S. Russenschuck, F. Mangiarotti, G. Willering  
with the contribution of (at least) 32 staff from TM, MSC, TE

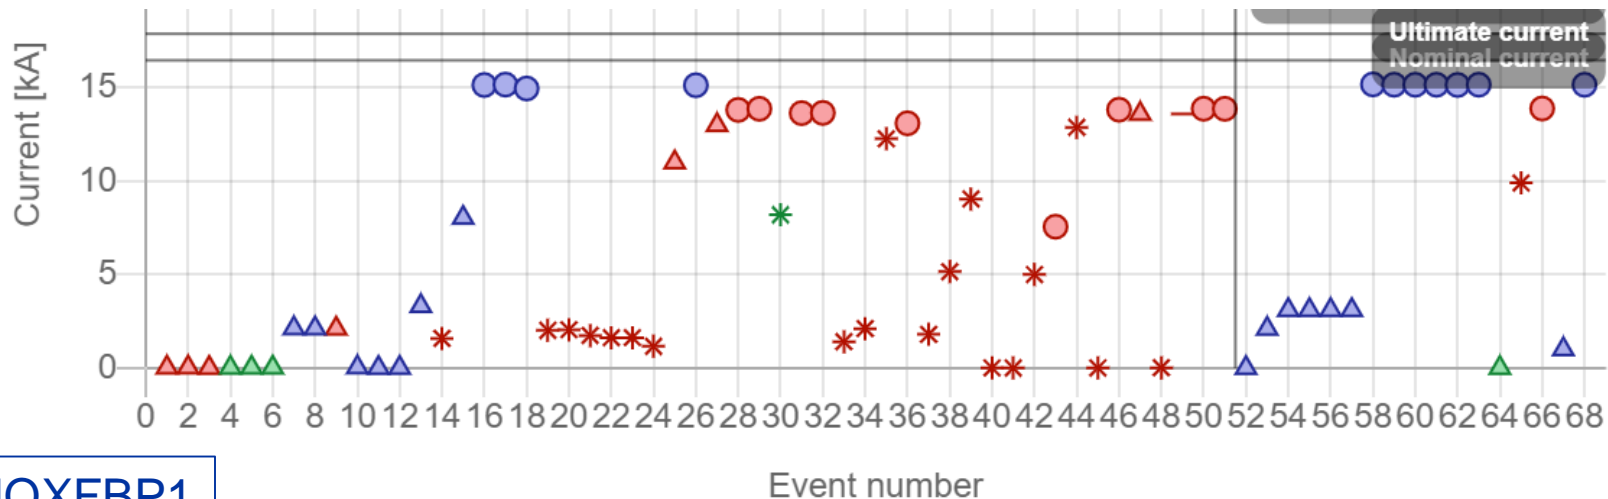
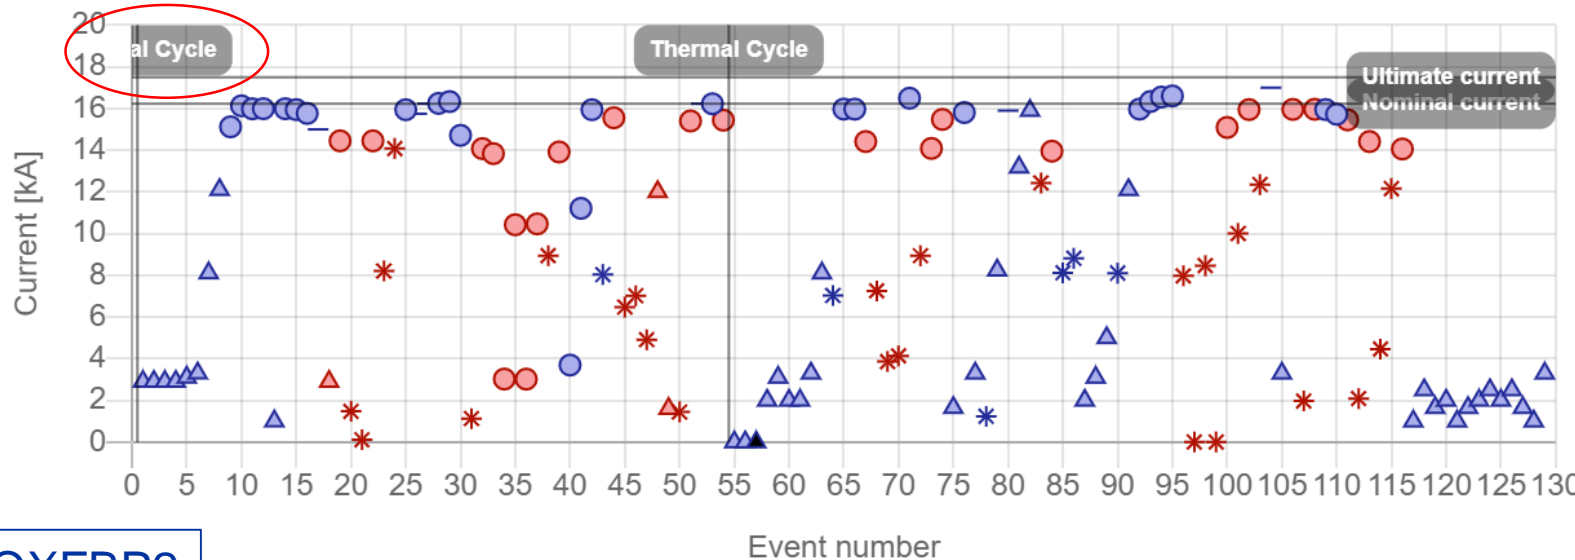
MQXFBP1

MQXFBP2

- No quench
- Natural quench
- ▲ Provoked quench
- ★ Trip

- T = 1.9 K
- 1.9 < T < 4.5 K
- T = 4.5 K

Almost 200 quenches in total

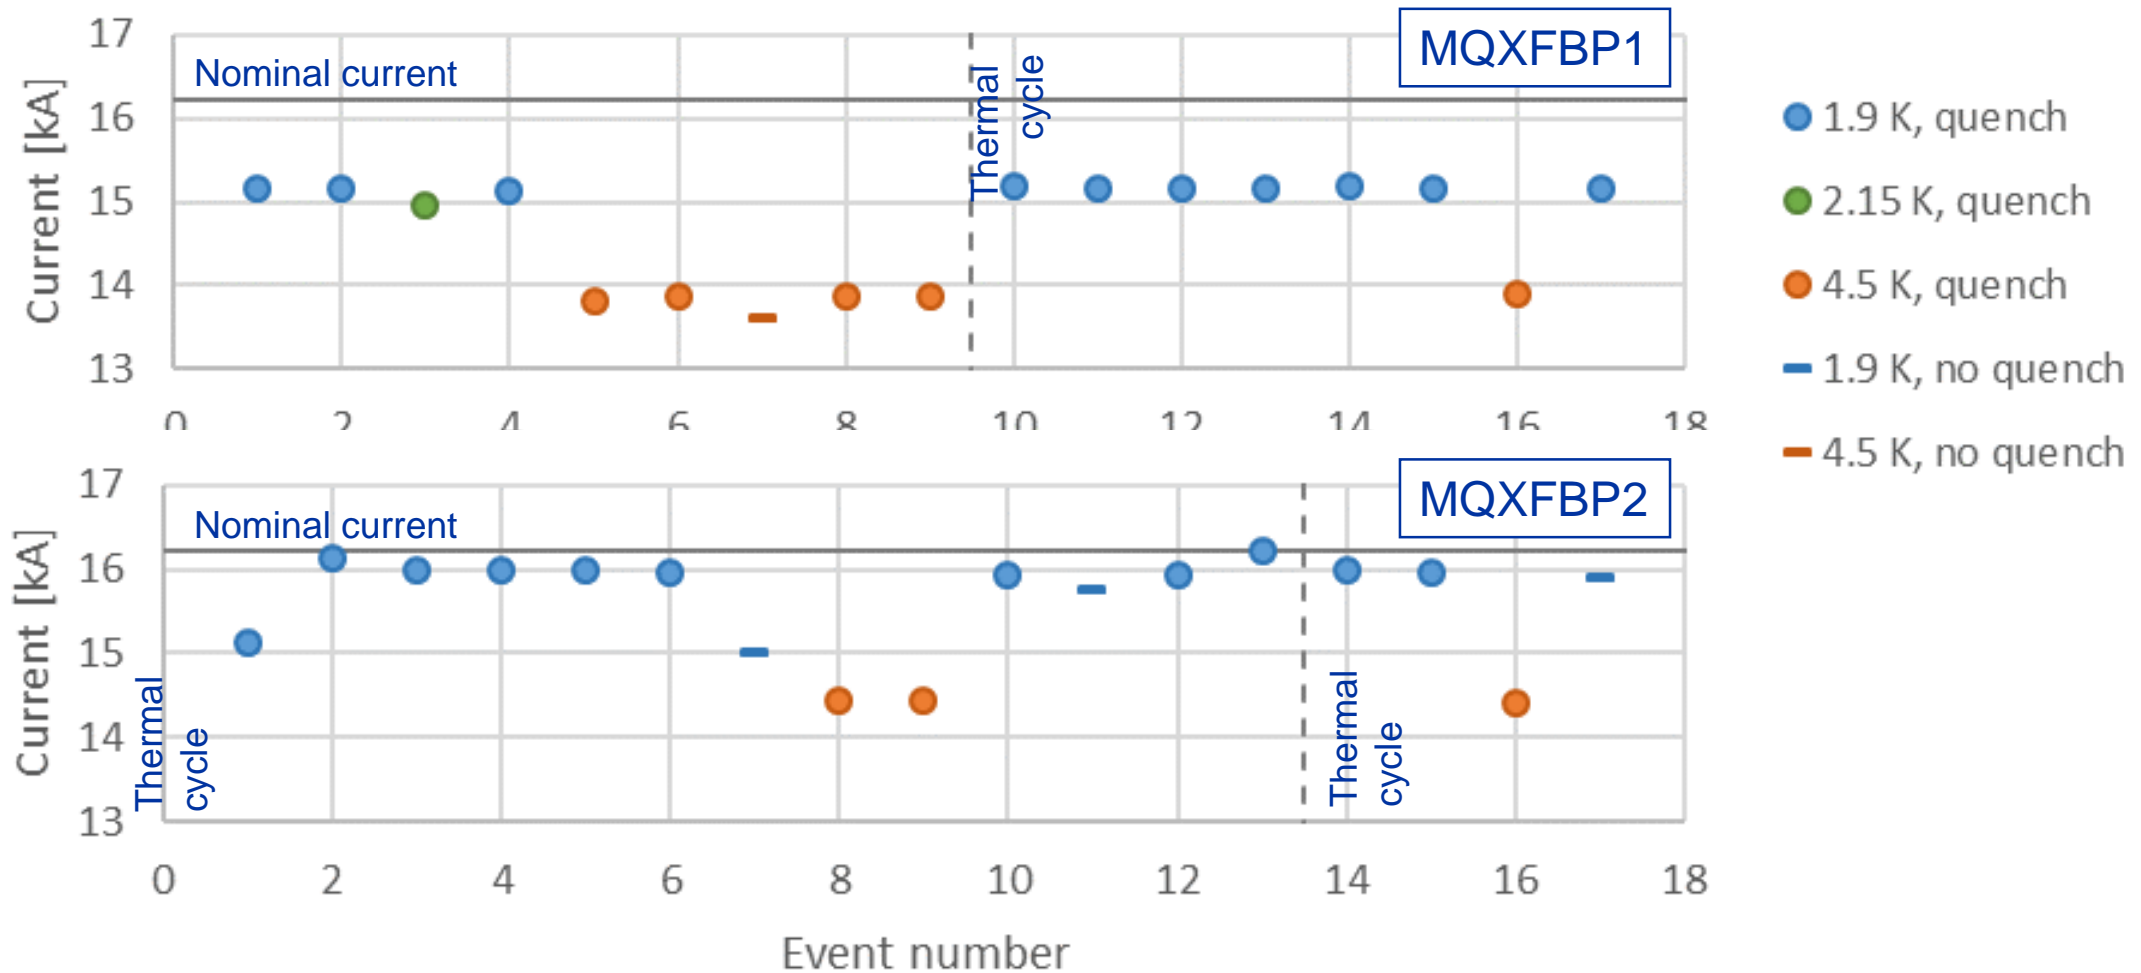
The magnets reach a quench limit in the first or second quench: same current, voltage signature and quench antenna signals.

The magnets show almost no training; they reach a current limit at the first or second quench

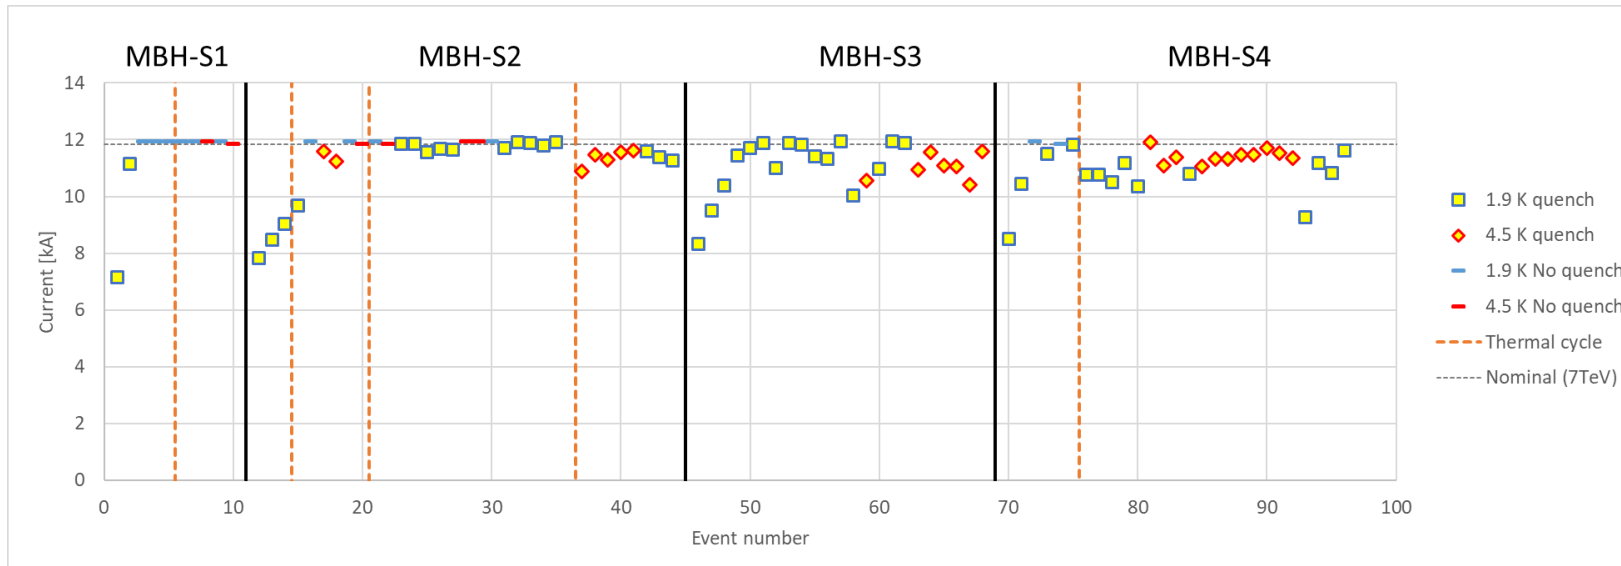
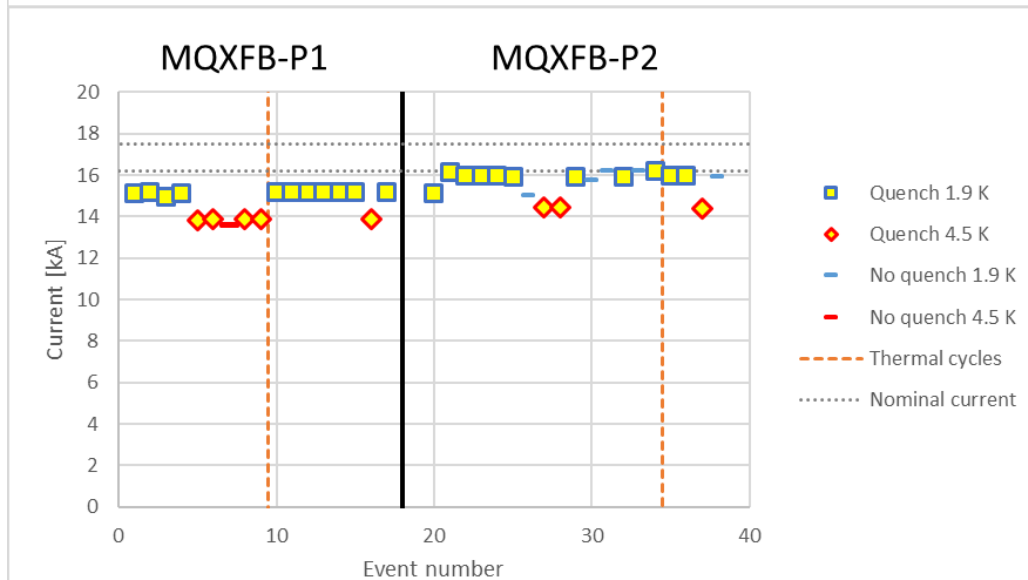
In these plots: tests at nominal ramp rate

The type of degradation in the 11 T (gets worse after each thermal cycle) is different from that of the MQXF (no further degradation so far)

The current limit did not change after one thermal cycle (as opposed to the 11 T where it got worse after successive thermal cycles (degradation versus limitation))

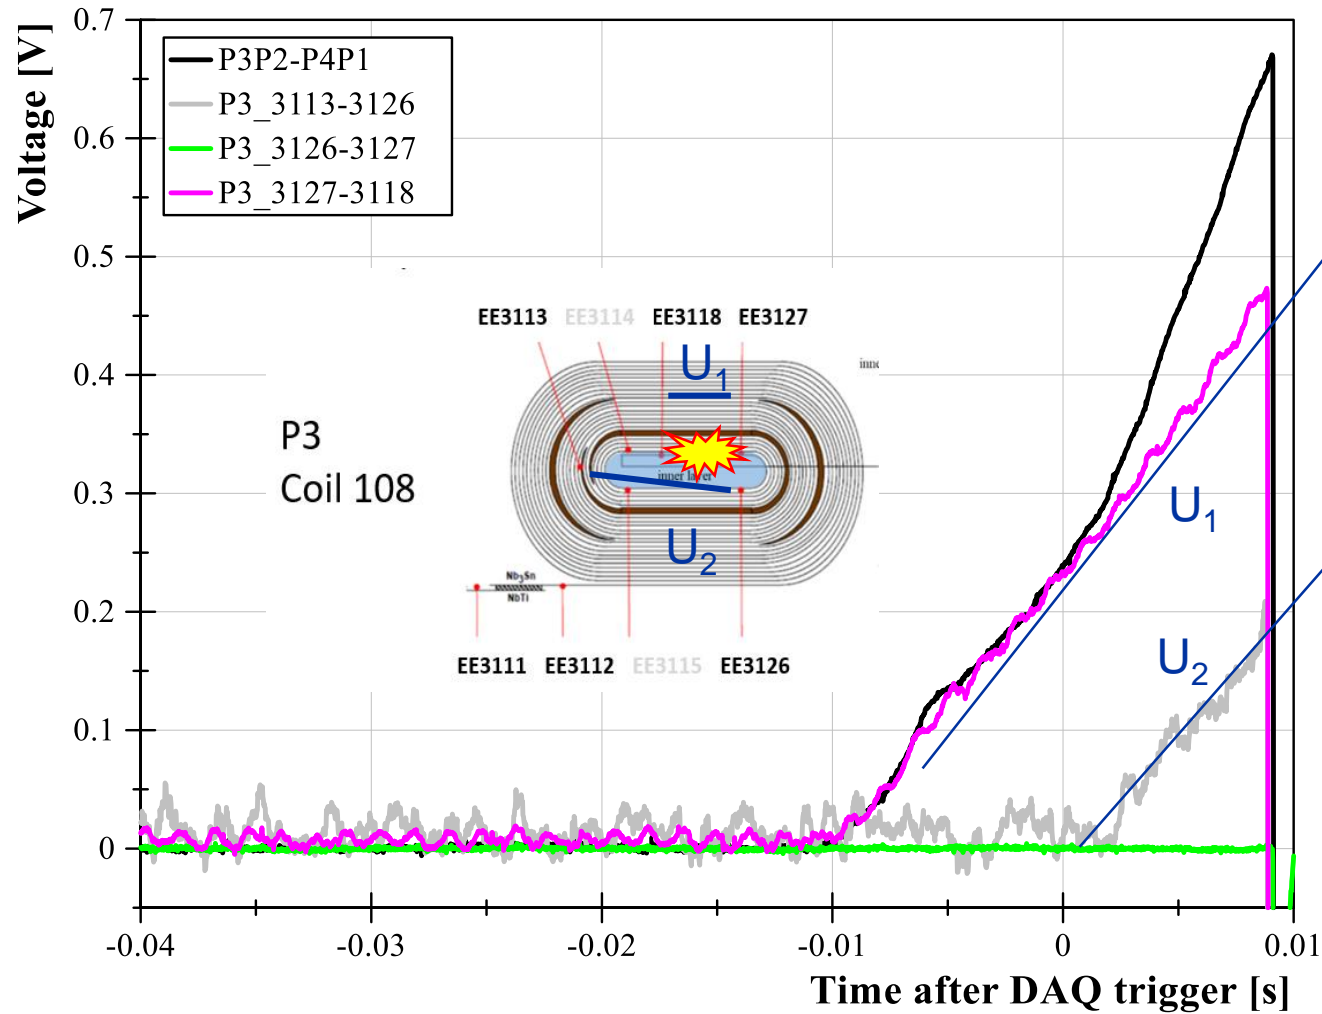
Quench starts between 3127-3118 (pole turn center)

After ~13 ms it propagates transversally to 3113-3126

Quench does not reach longitudinally neighboring segments (3126-3127 and 3118-3212)

QPV: ~15 m/s at 15 kA, 1.9 K

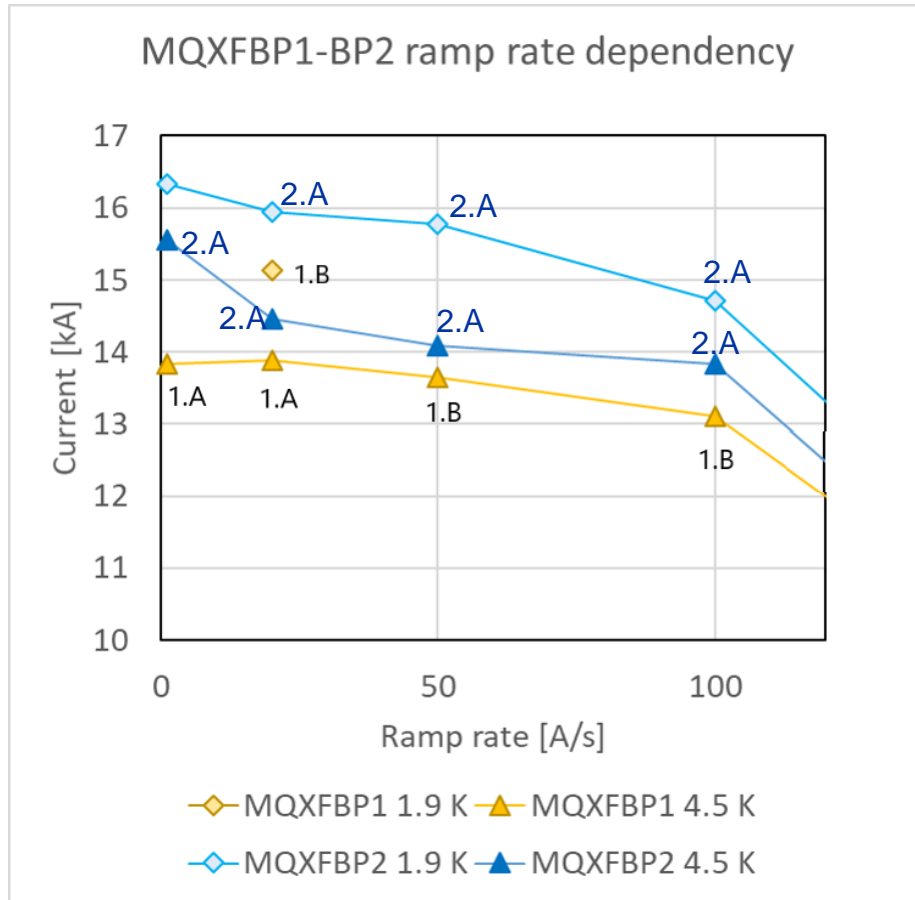
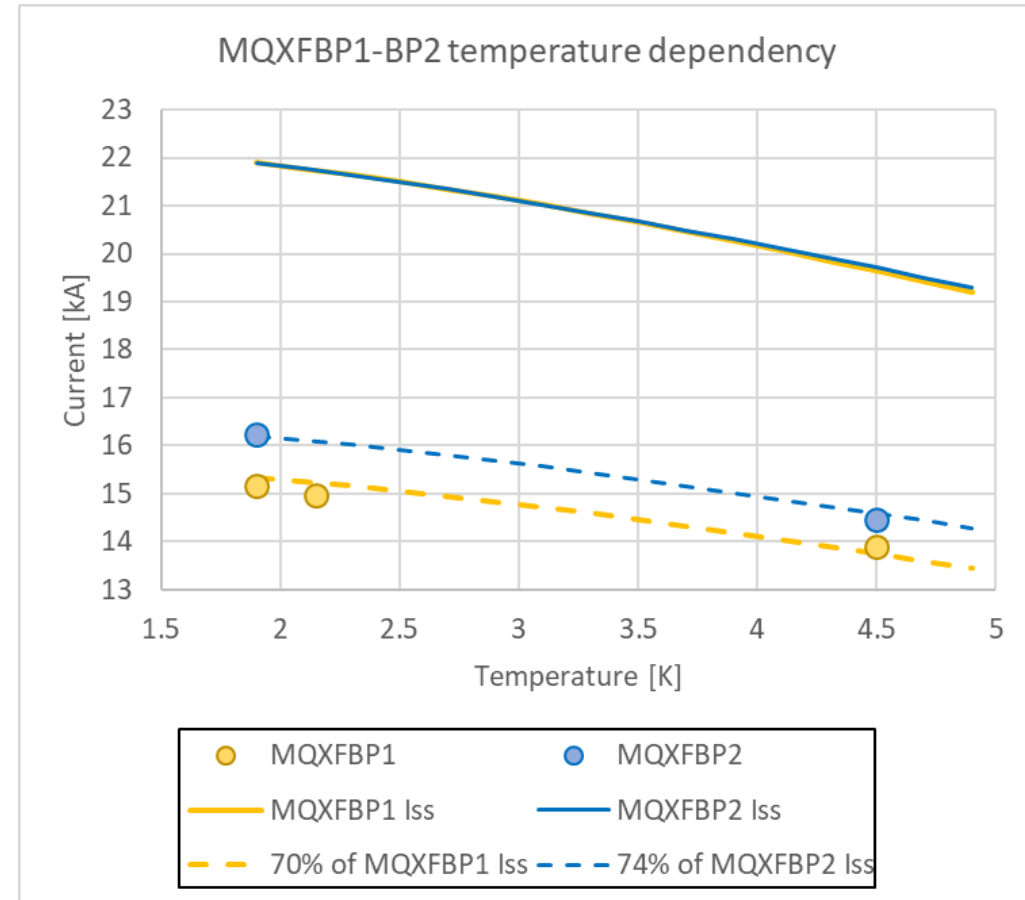
Normal temperature dependence in both magnets, -> not mechanically limited. Ramp rate dependence for BP1: insufficient data. For BP2, low RR at 4.5 K may hint at non-homogeneous defect. Ongoing R&D: Special test foreseen on a SMC with artificially degraded conductor

Temperature dependence is normal – conductor limitation, no mechanical limitation

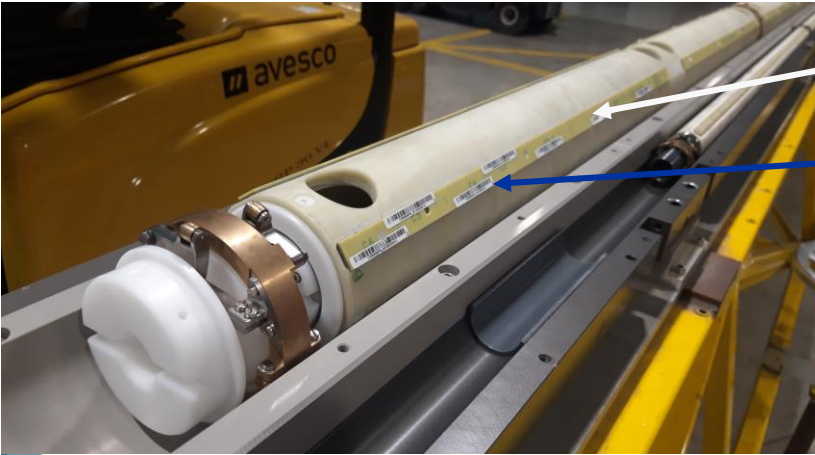
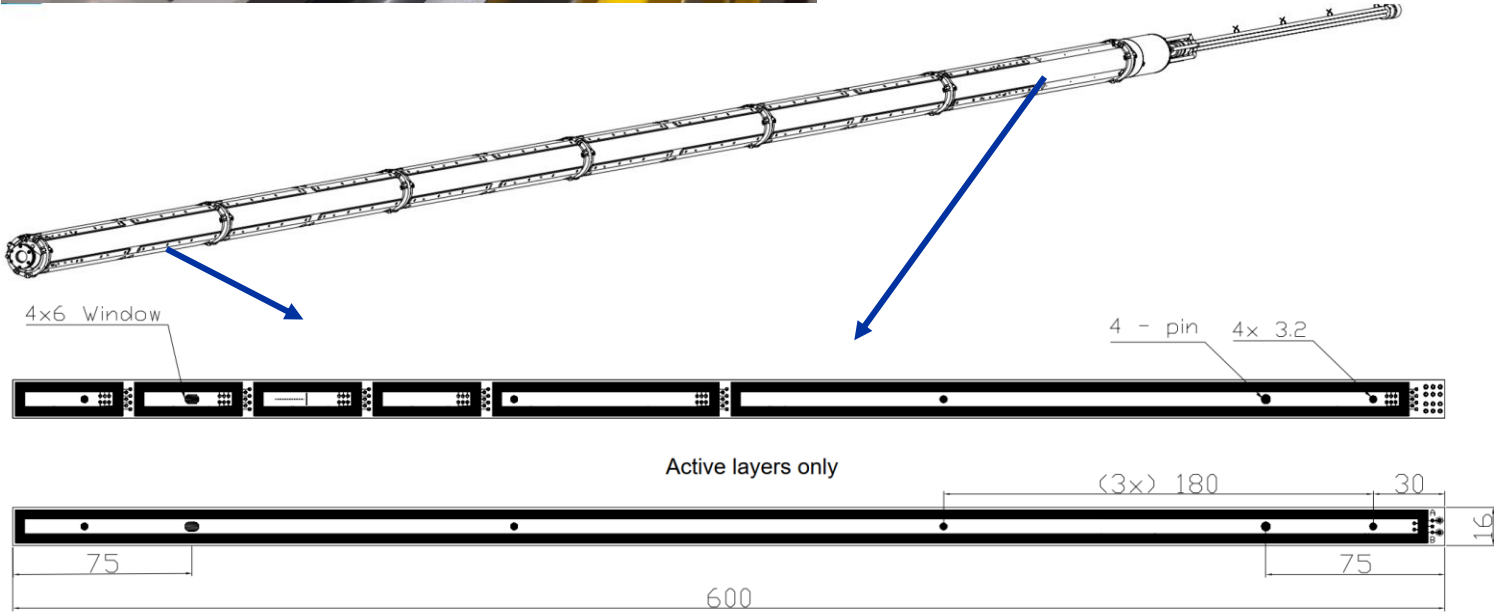
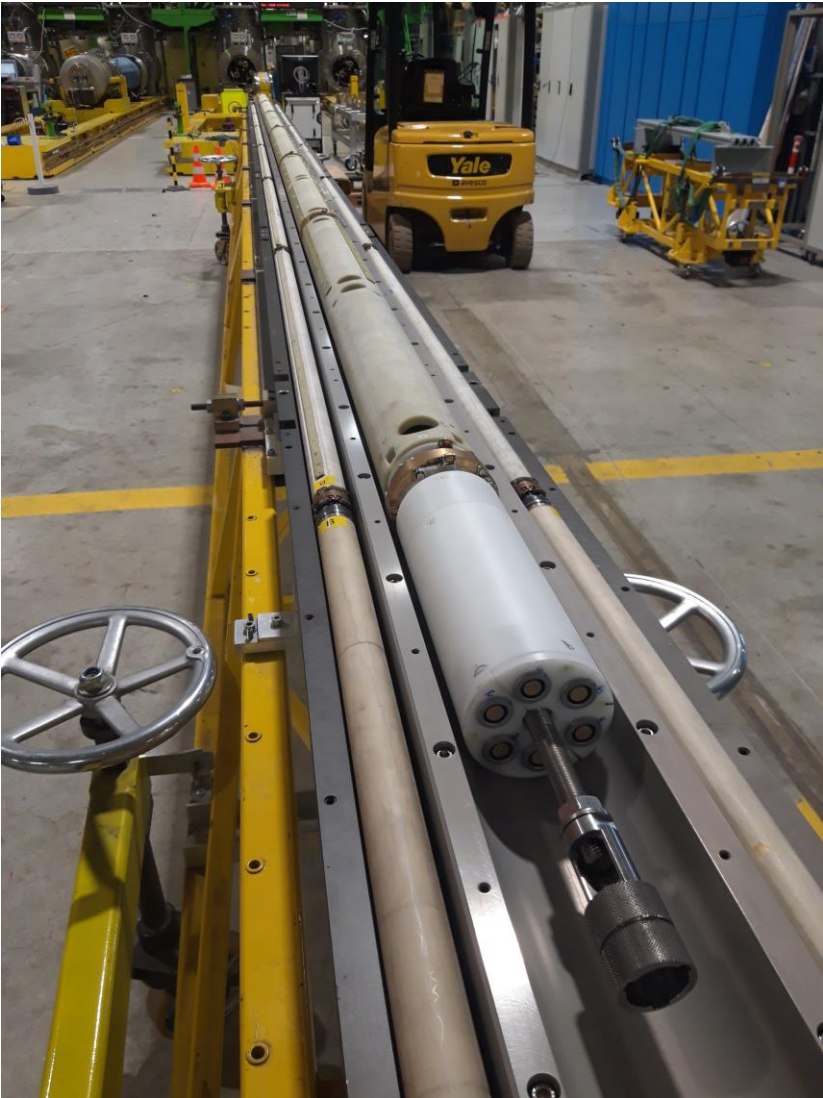
6 support tubes of 1.27 meter

4 times 11 PCB's of 0.6 meter

Standard 4-coil (B2 sensitive – 64 channels) quench antenna effective to localize the **longitudinal** quench location within +/- 45 mm for **reproducible** quench positions. Also, most probably, effective for recording field changes due to vibrations (in case of structural limitations)

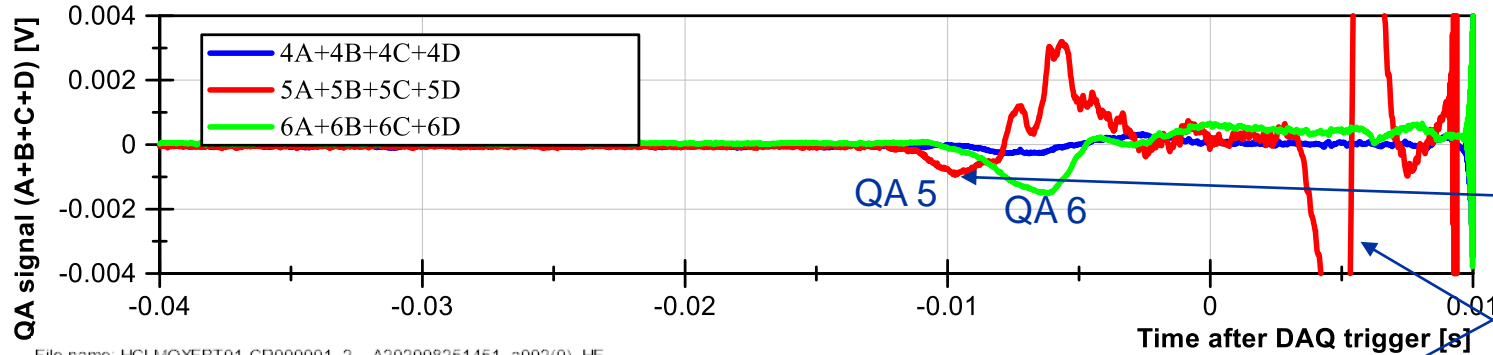
File name: HCLMQXFBT01-CR000001\_2\_A202008251451\_a002(0)\_HF  
Quench 2, CD2. QA shifted 300 mm

Six quenches with different QA position. In each, we observe where the quench starts.

- Example top: starts in QA 5
- Example bottom: starts in CF 4

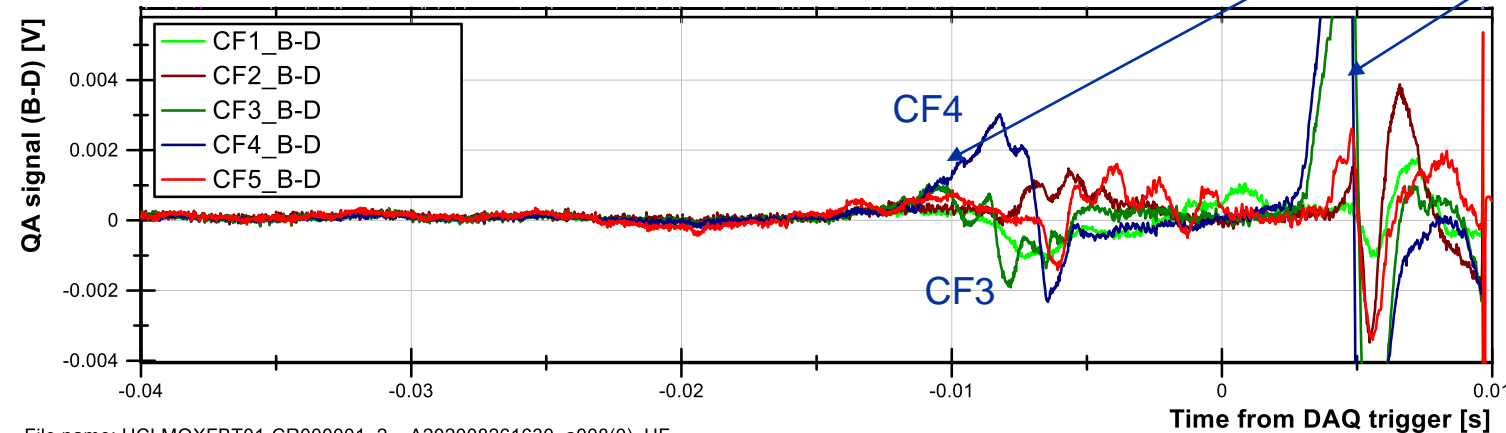
File name: HCLMQXFBT01-CR000001\_2\_A202008261630\_a008(0)\_HF  
Quench 6, CD2. QA shifted -3392 mm

After ~13 ms we see the transverse quench propagation

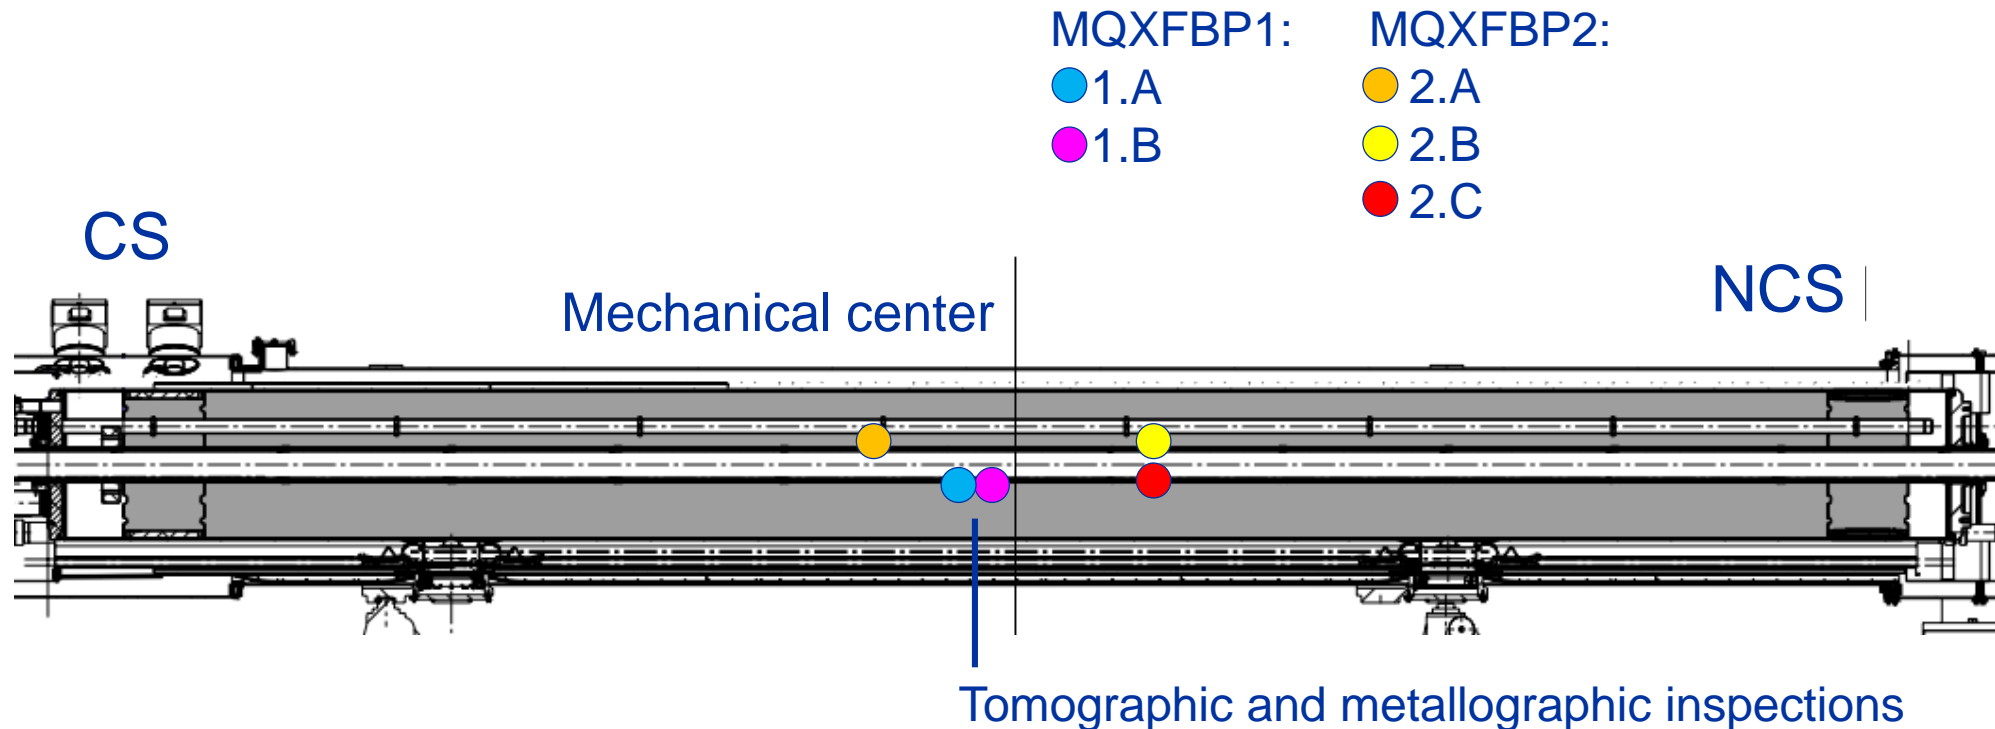
The recurring quench locations are in the inner layer, **pole turn**, straight segment, **near** the mechanical center. In MQXFBP1 in coil P3, in MQXFBP2 in coil P1.

**Longitudinal localization within  $\pm 50$  mm** from quench antenna data.

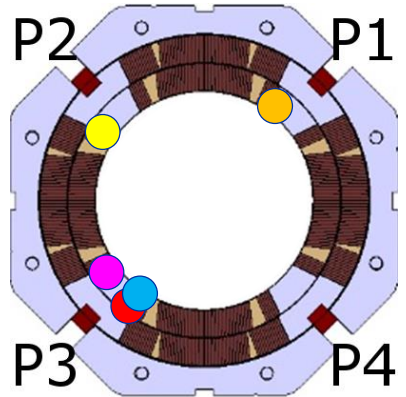
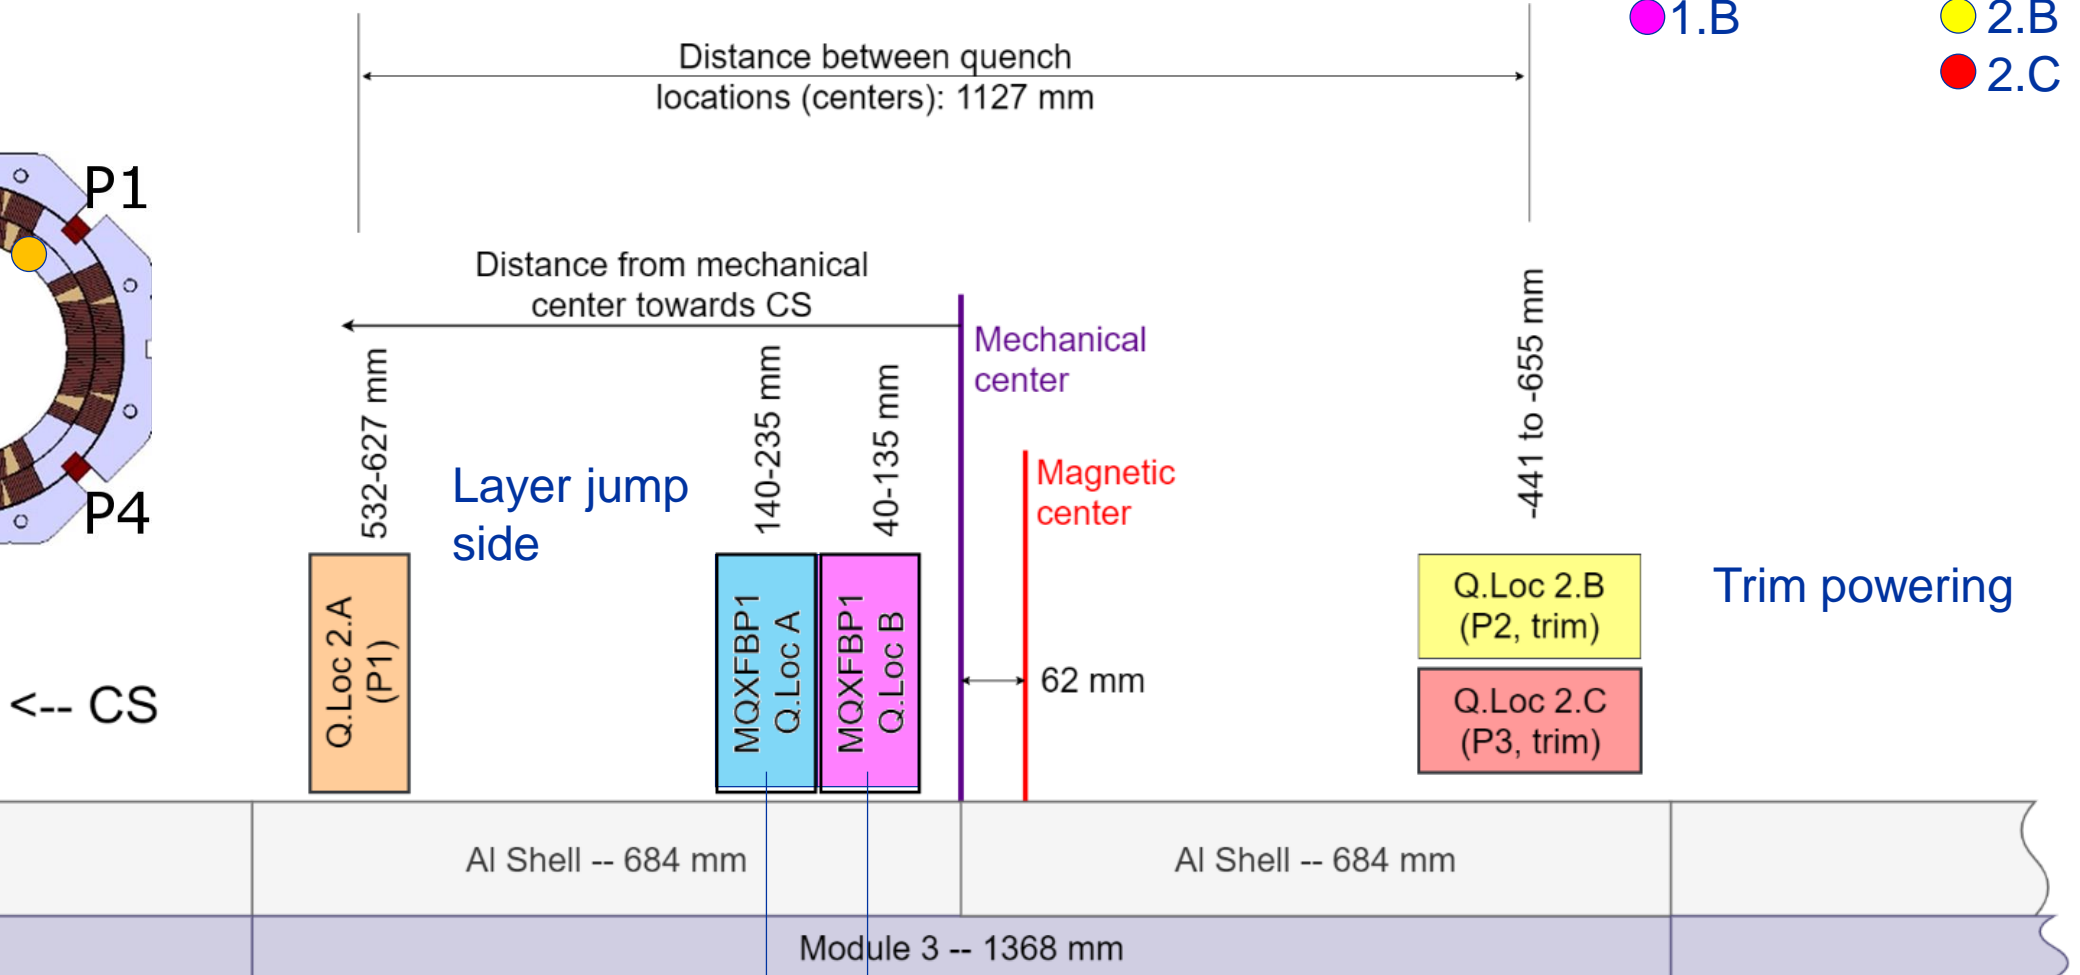
- MQXFBP1:      MQXFBP2:
- 1.A            ● 2.A
  - 1.B            ● 2.B
  - 1.C            ● 2.C

Tomographic and metallographic inspections

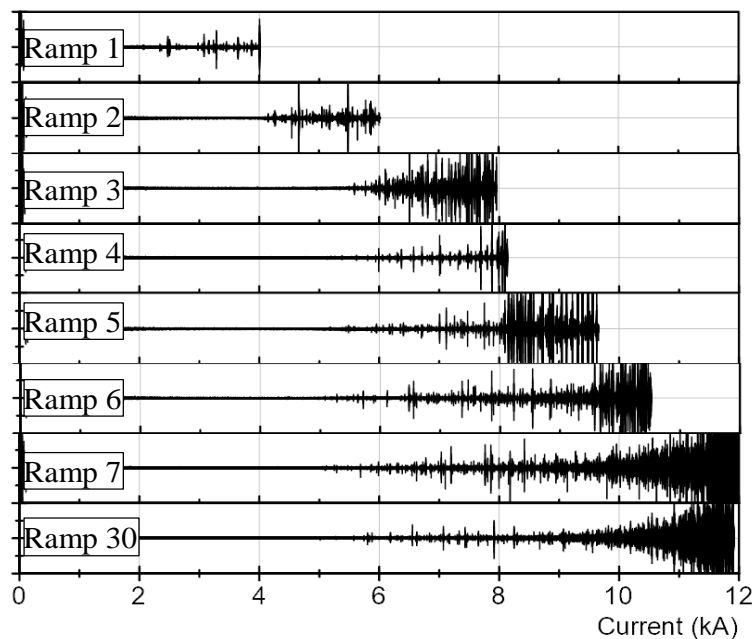
Signals for QA5

Investigation of all vibrations picked up by the MM shaft used as a quench antenna).

Training effect: less vibrations after consecutive ramps.

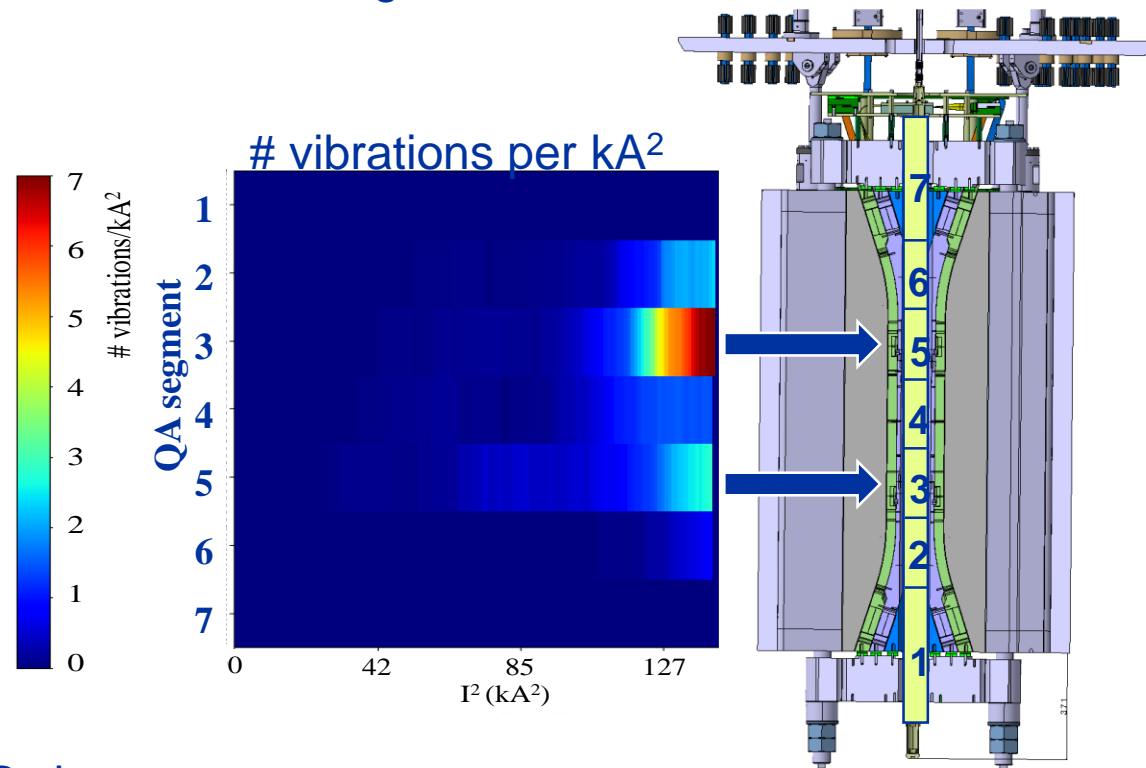
Vibration analysis fully trained magnet  
Highest activity seen by QA 5, consistent with quench locations in the magnet.

This type of analysis was not needed in the MQXFBP<sub>x</sub> because they were not limited mechanically. However, we have this tool at our disposal if needed

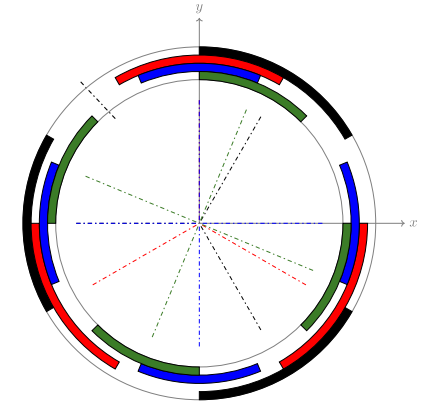
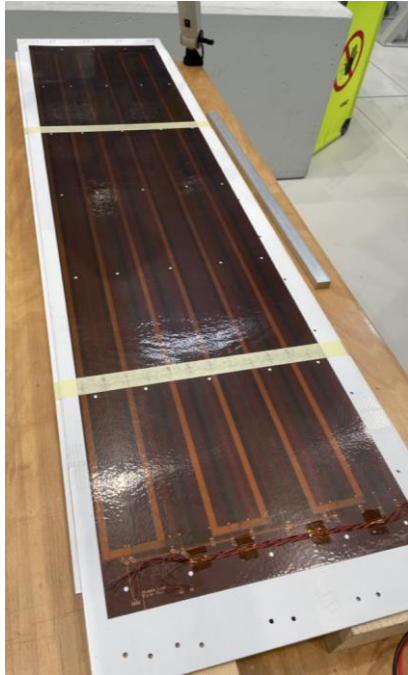
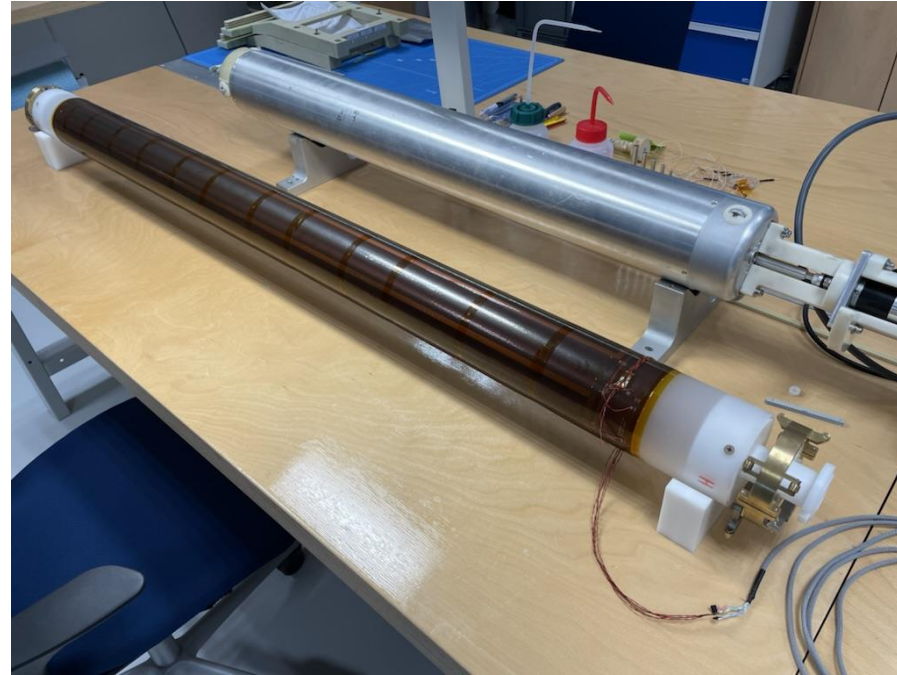
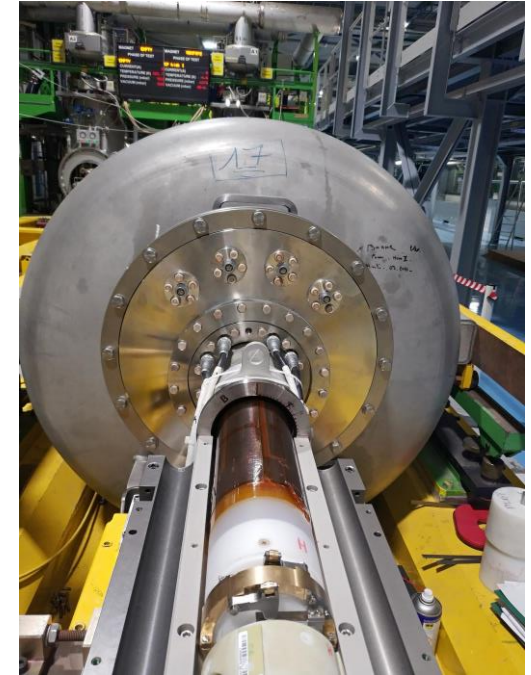
Clean B3,A3,B4,A4 sensitive through coil design  
(analogue bucking -> Flex PCB design)

Compromise between noise (PC, vibrations etc),  
resolution in radial direction, and signal strength.

Multipole quench antenna (with 12 x 600-mm segments = 48 channels) will allow us to localize the quench in the **cross section**, in particular for magnets with fewer voltage taps. If needed shorter flex PCB can be retrofitted.

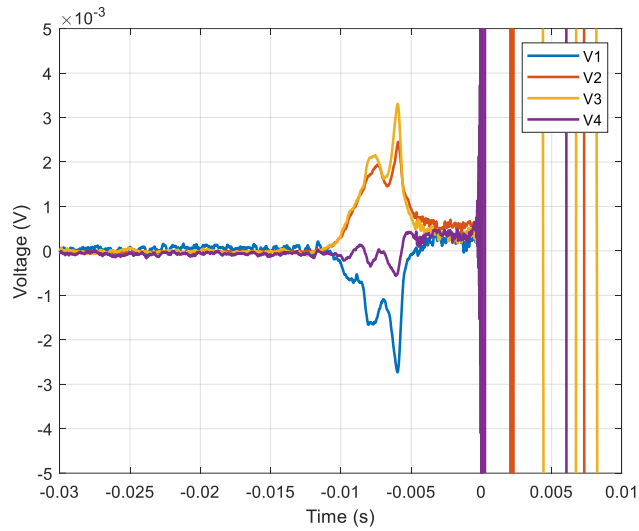
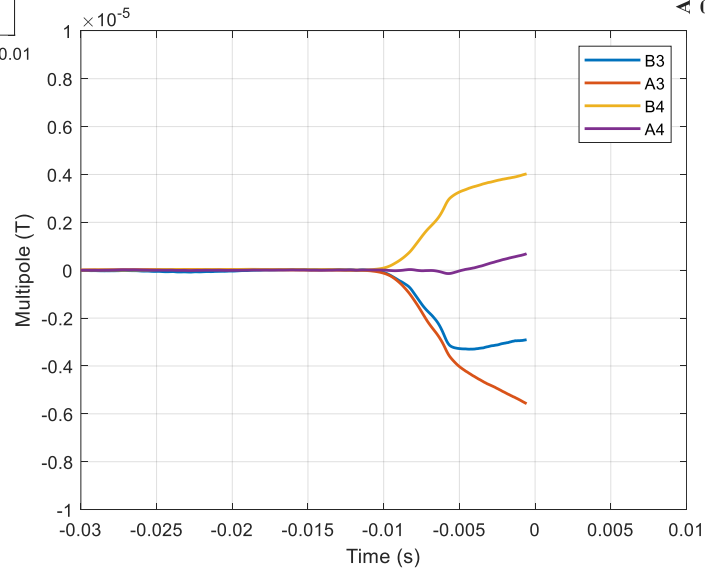
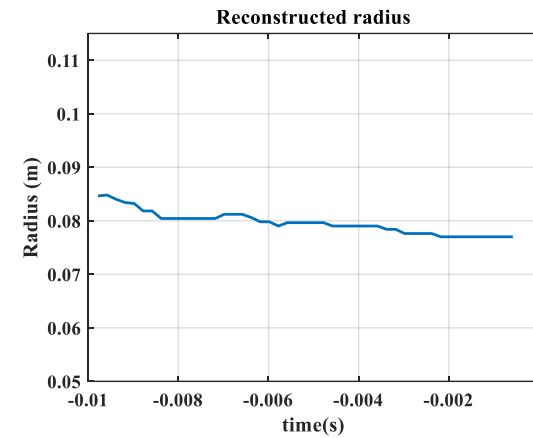
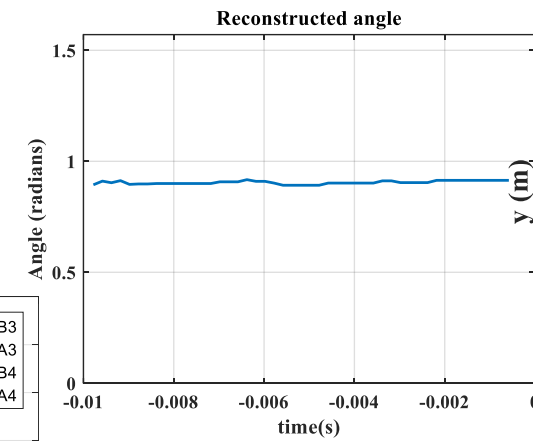
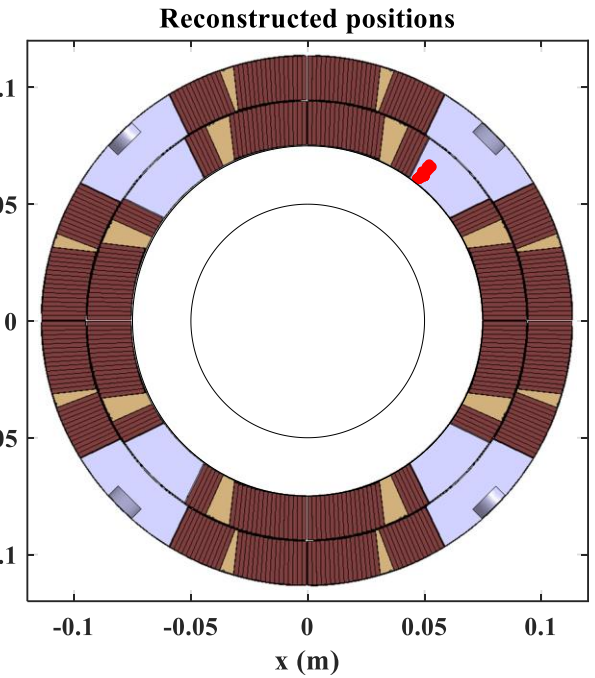
@ 4.5 K, 1 A/s,  $I_{\text{quench}} = 15455$  A,  
trim circuit **disconnected**
