# Report on Ongoing Actions for MQXFB

## New test and measurement techniques

S. Russenschuck, F. Mangiarotti, G. Willering  
with the contribution of (at least) 32 staff from TM, MSC, TE

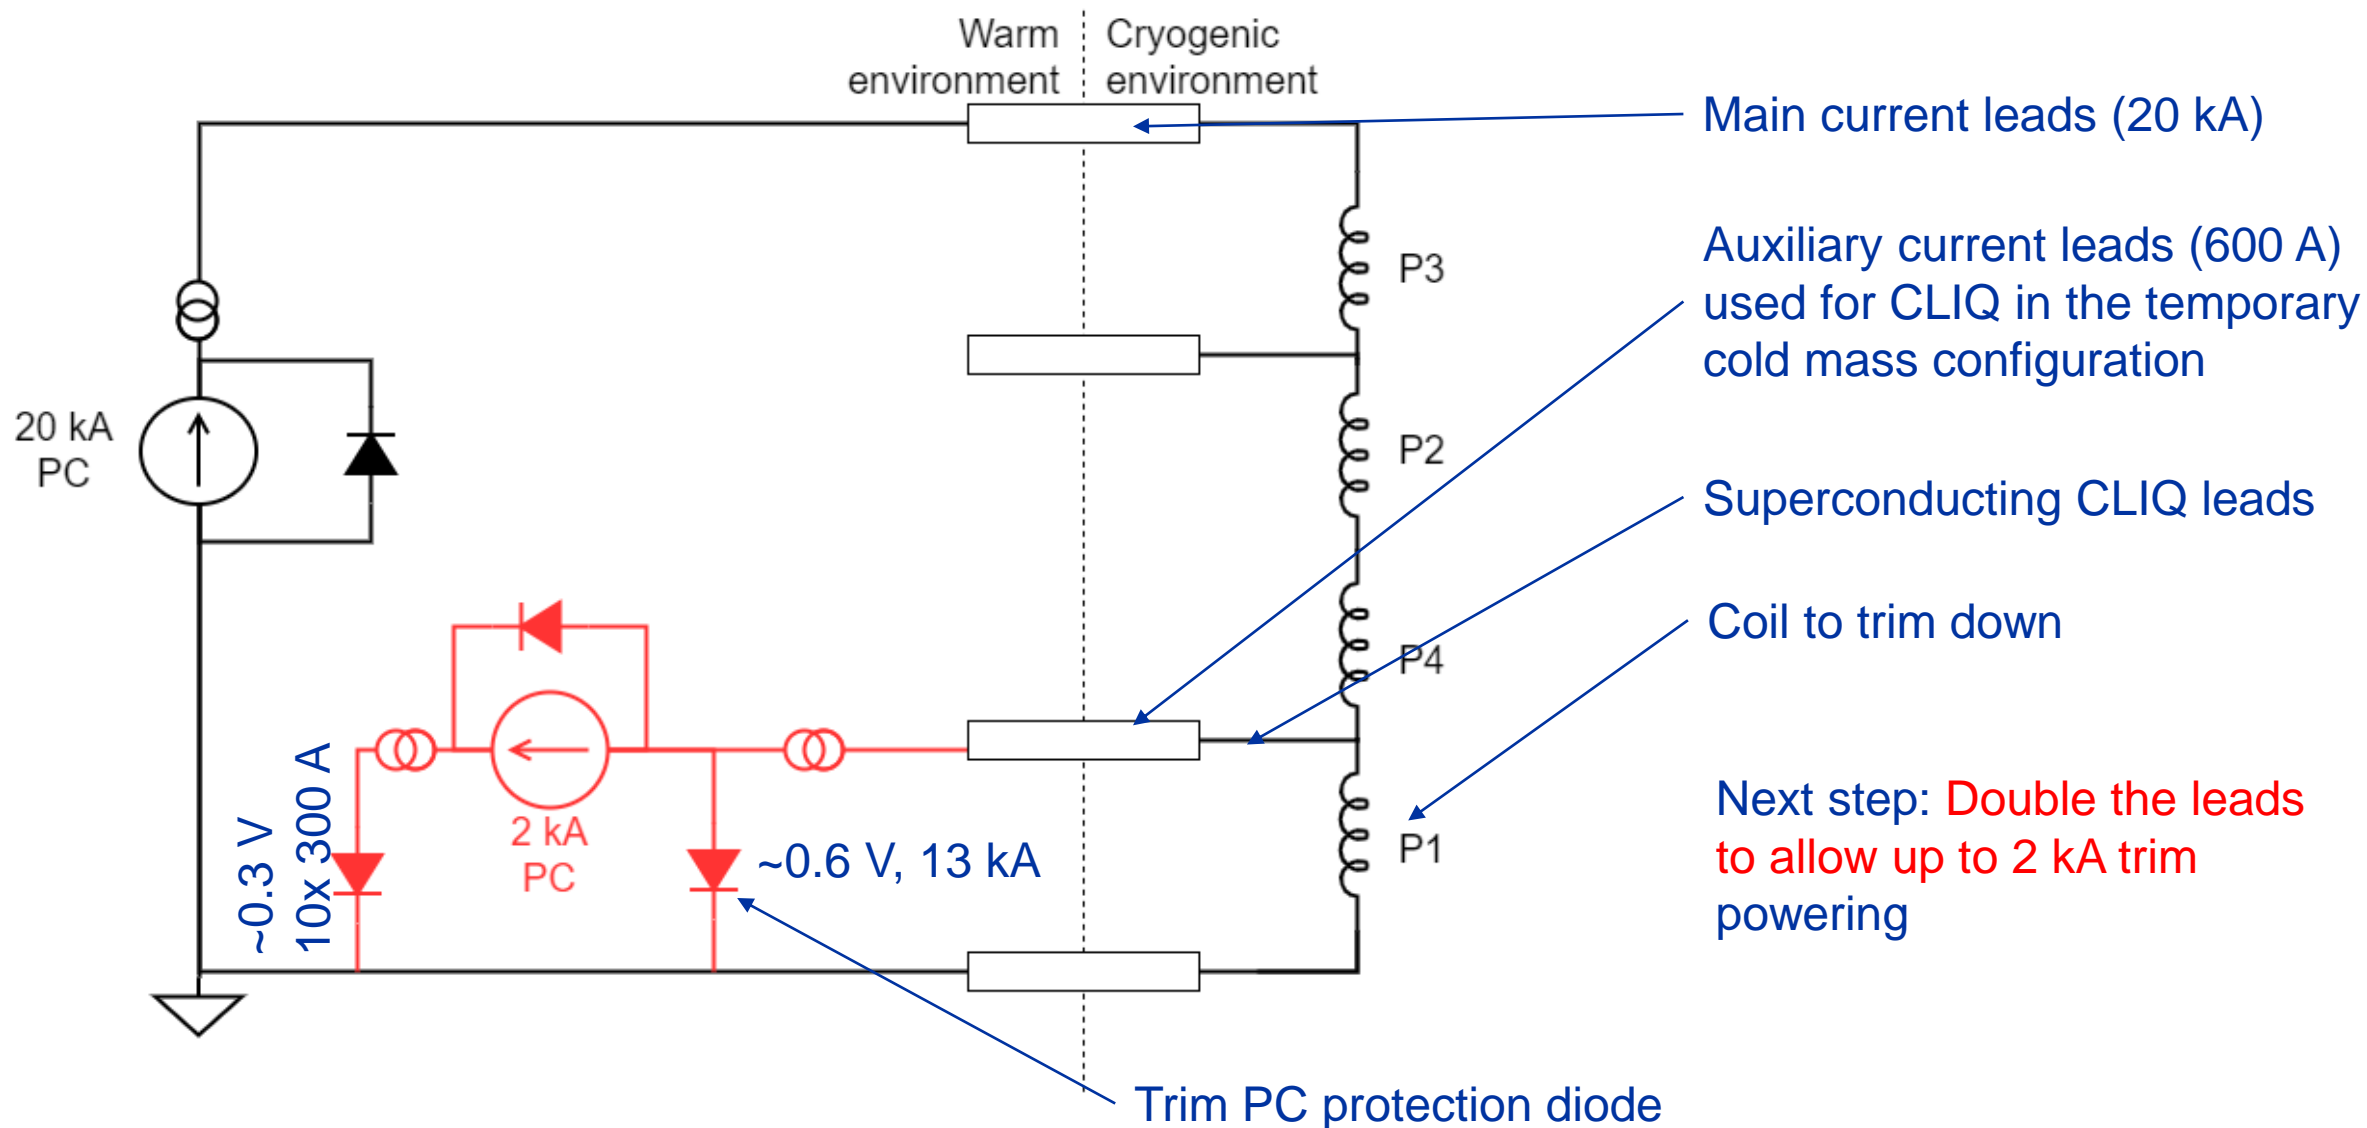
# Circuit diagram, trim powering

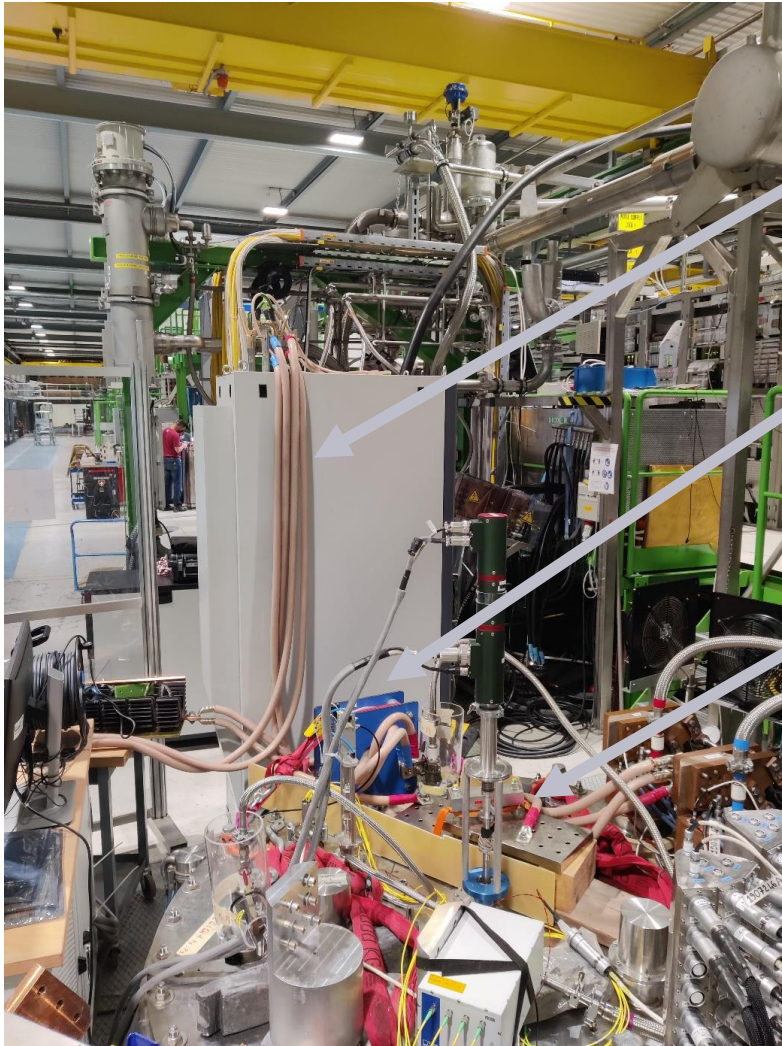
2 kA Trim PC

Additional DCCT (to measure trim current)

Protection diode

Trim powering **validated on a short model** and **implemented** in the MQXFBP2 prototype. Procedures, circuit analysis (with support from MPE), validation through short model testing, and risk mitigation measurements developed

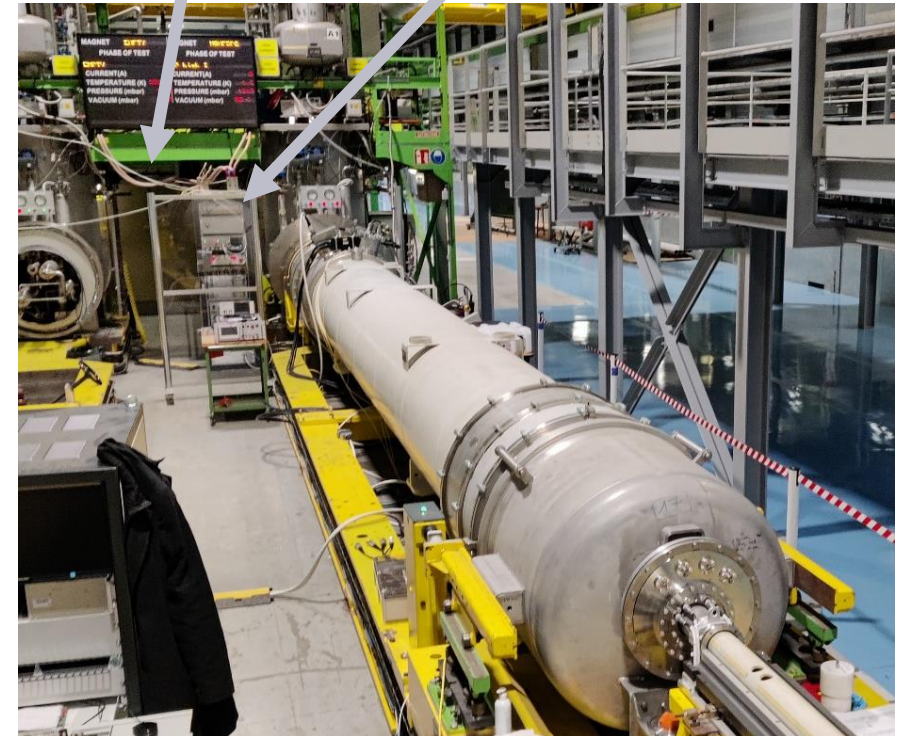
2 kA cables going to the mezzanine

2 kA Trim PC

Trimmed powering of MQXFBP2 allowed us to see the **quench limit in at least two other coils**. At least 3 limited at various levels of severity.

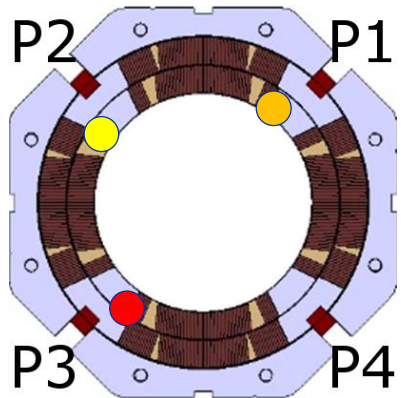
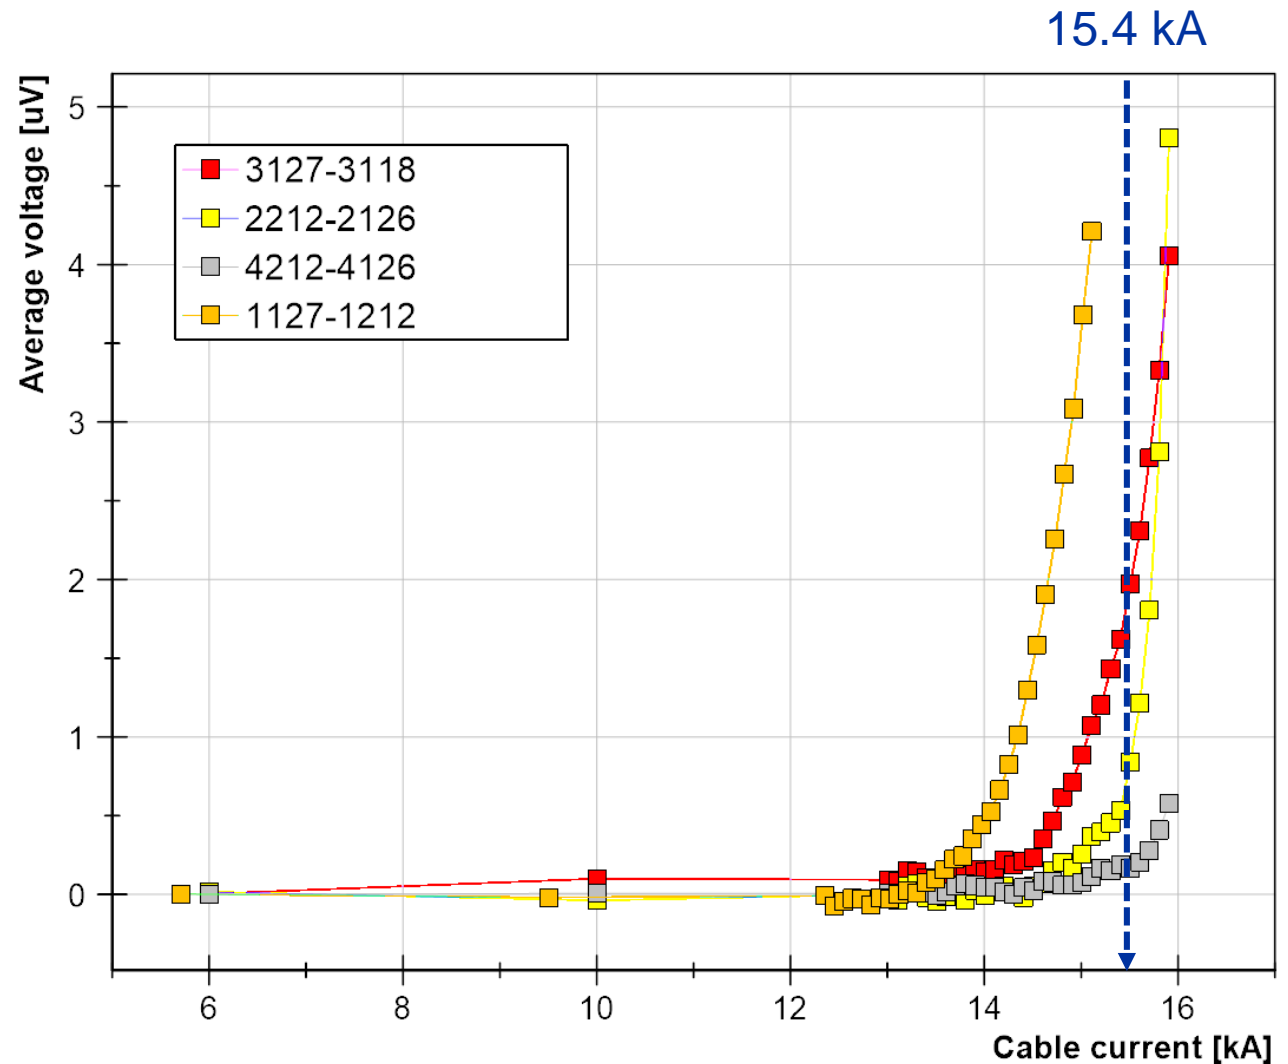
Inner pole turn segments in the four coils show same transition. In the quenching coils ~5  $\mu\text{V}$ , in P4 ~0.6  $\mu\text{V}$

N-value strongly depends on B (~60 at 10.5 T ~45 at 12.3 T) which in turn depends strongly on position in the coil

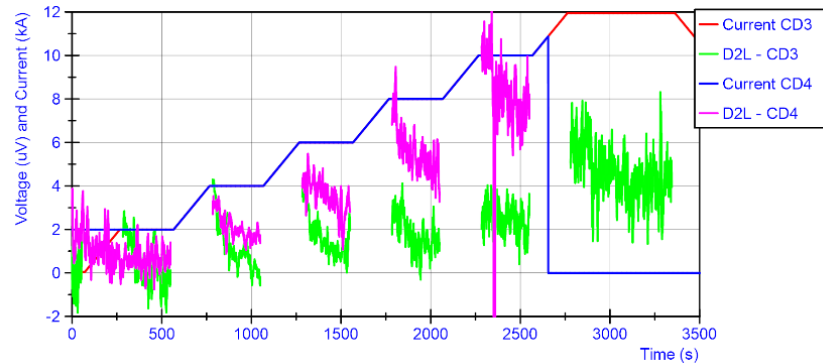
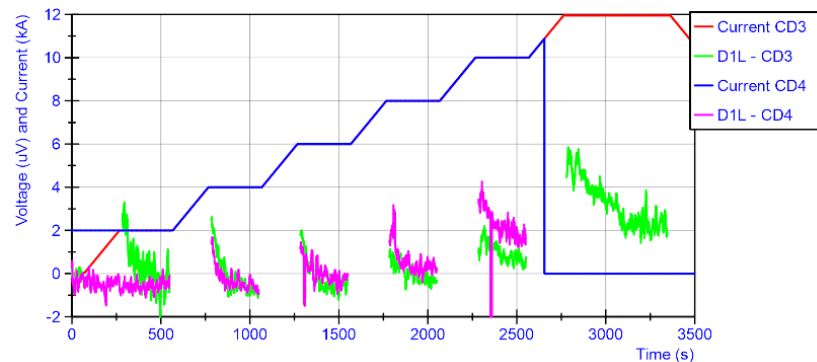
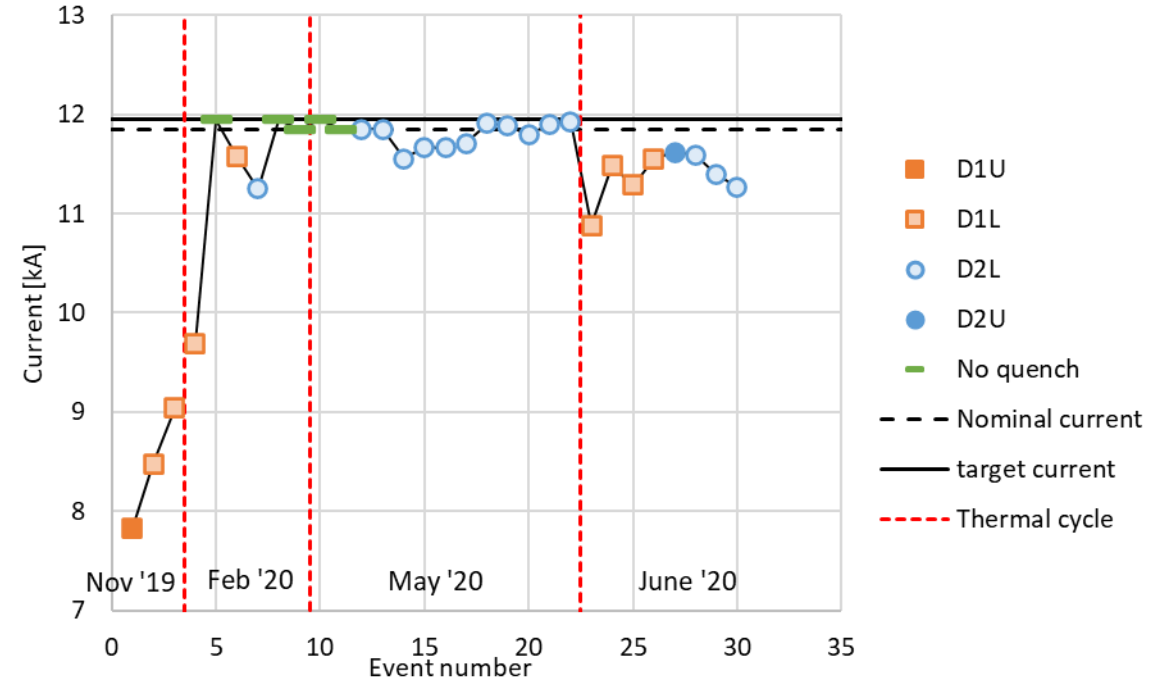
## Lower coil aperture 2

## Lower coil aperture 1

11T from 2018 to 2021: V-I over full coil gave conclusive results. MQXFBP2, april 2021: V-I measurements on full coil were disturbed. MQXFBP2, November 2021: Issue solved by putting less voltage measurements in parallel and better cable routing

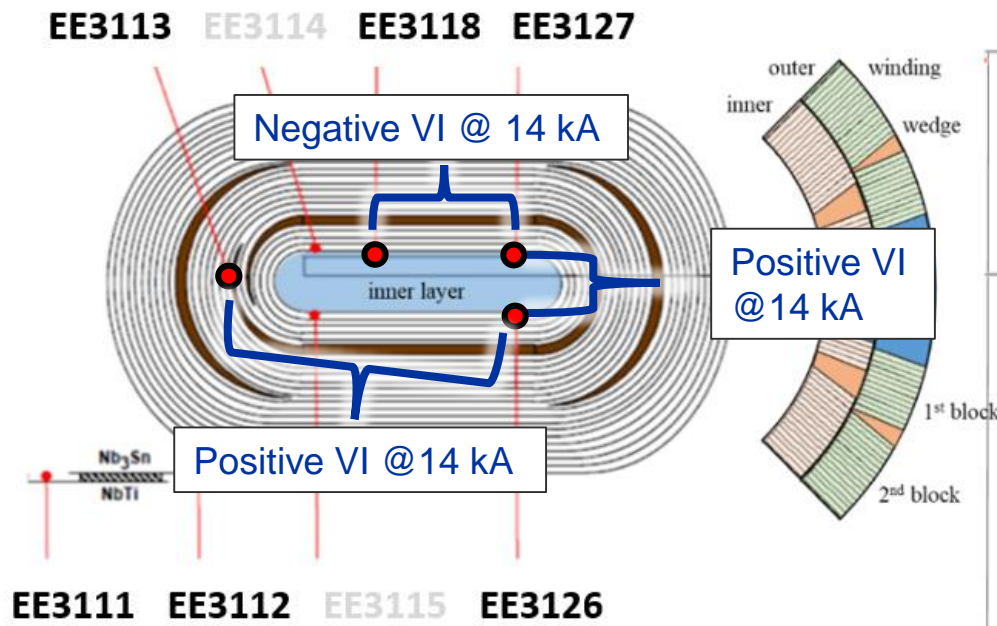
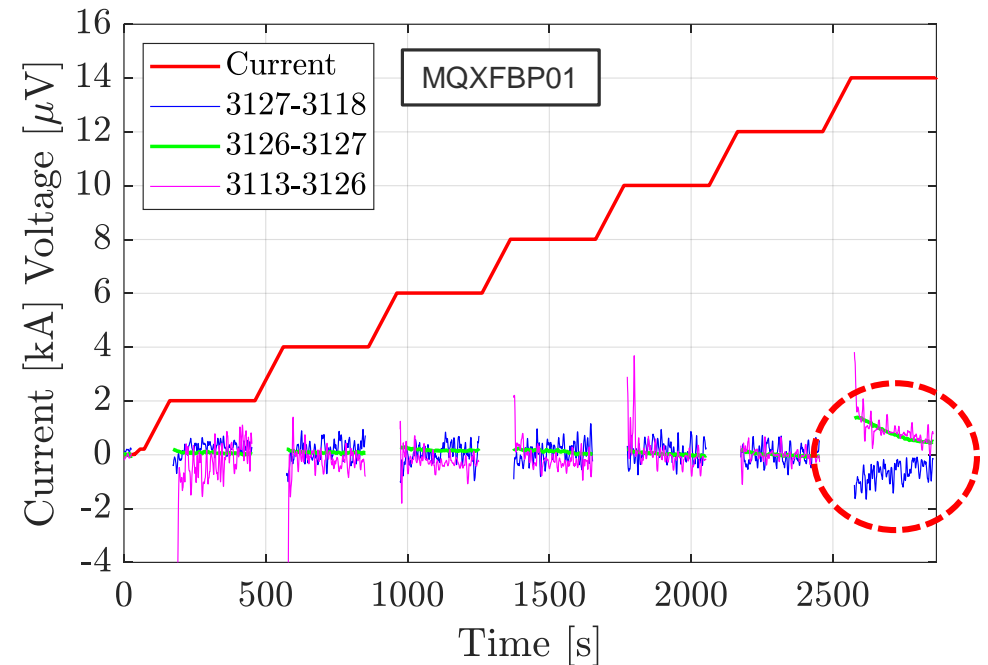
P3  
Inner  
layer  
108

Magnet always quenched at same current level: 15.1 kA (1.9 K) Voltage taps within the coil. Decaying voltage signals on current plateau of 14 kA

Negative on straight segment (3127-3118)

Positive in the head (3126-3127) and multeturn (3113-3126)

According to simulations, **negative voltage is possible when measuring in front or after the defect**. Ongoing R&D, special test foreseen on a SMC with artificially degraded conductor

Decaying signal in MQXFBP1 indicates local conductor defect, stronger at quench location 1.B (a bit closer to center) than 1.A

Numerical modelling can **qualitatively** explain the phenomenon and predicts a few broken strands. Special test foreseen on a SMC with artificially degraded conductor

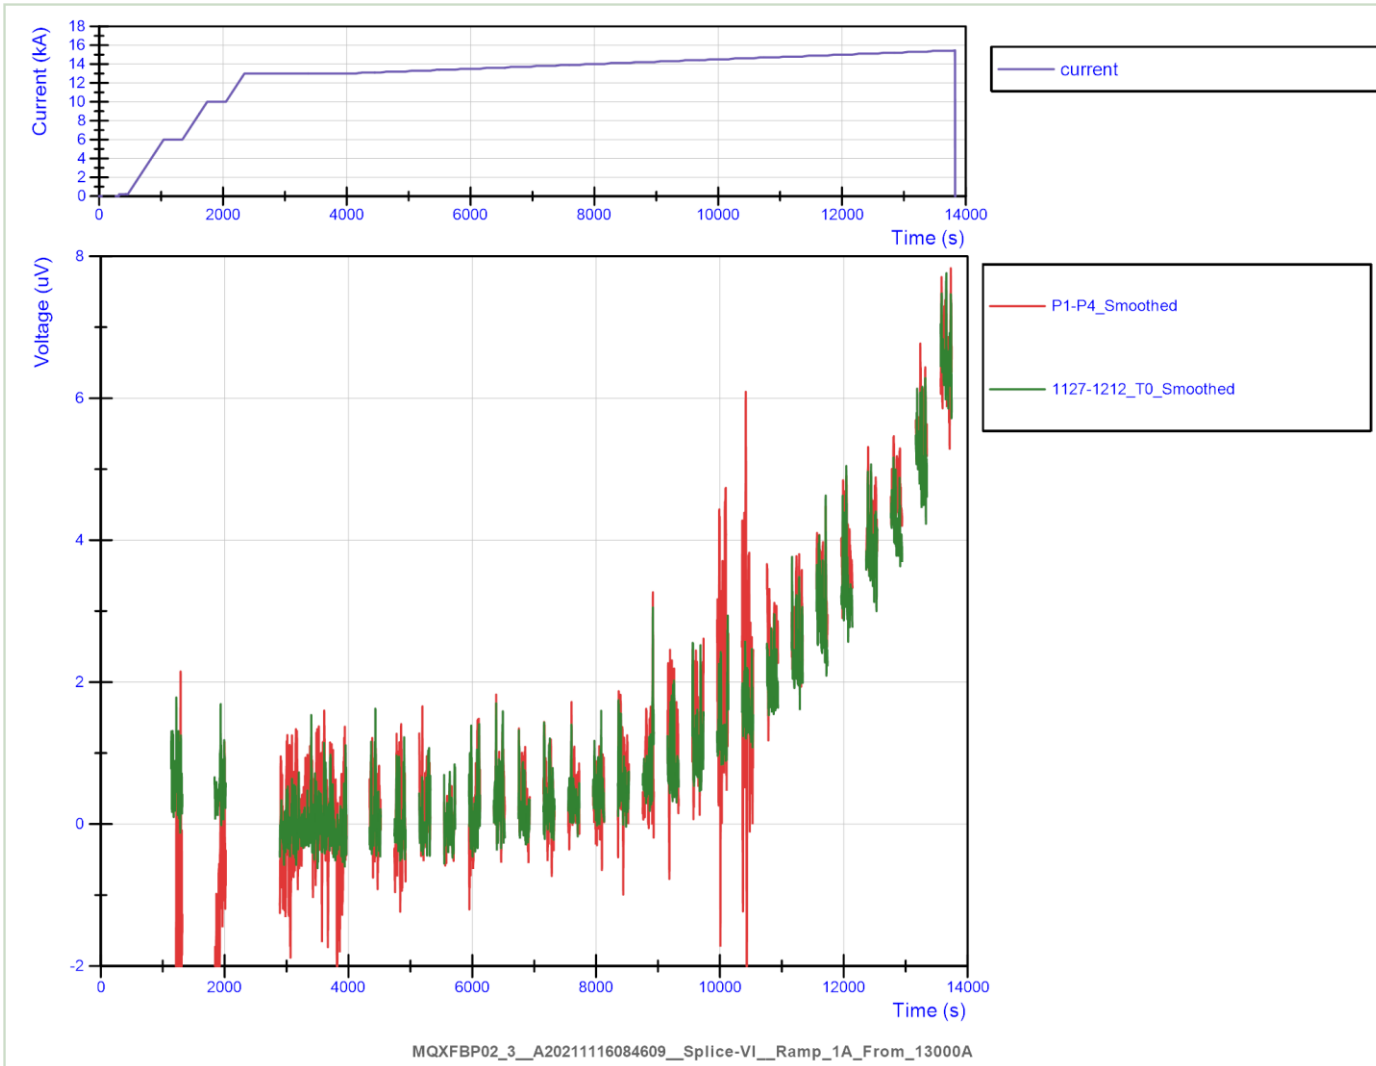
Direct measurement of the pole turn (voltage tap 1127-1212) and  $V(P1) - V(P4)$

The direct measurement has slightly less noise, but the final result is not significantly different.

For P1 all degradation is in the pole turn, not in any other turn.

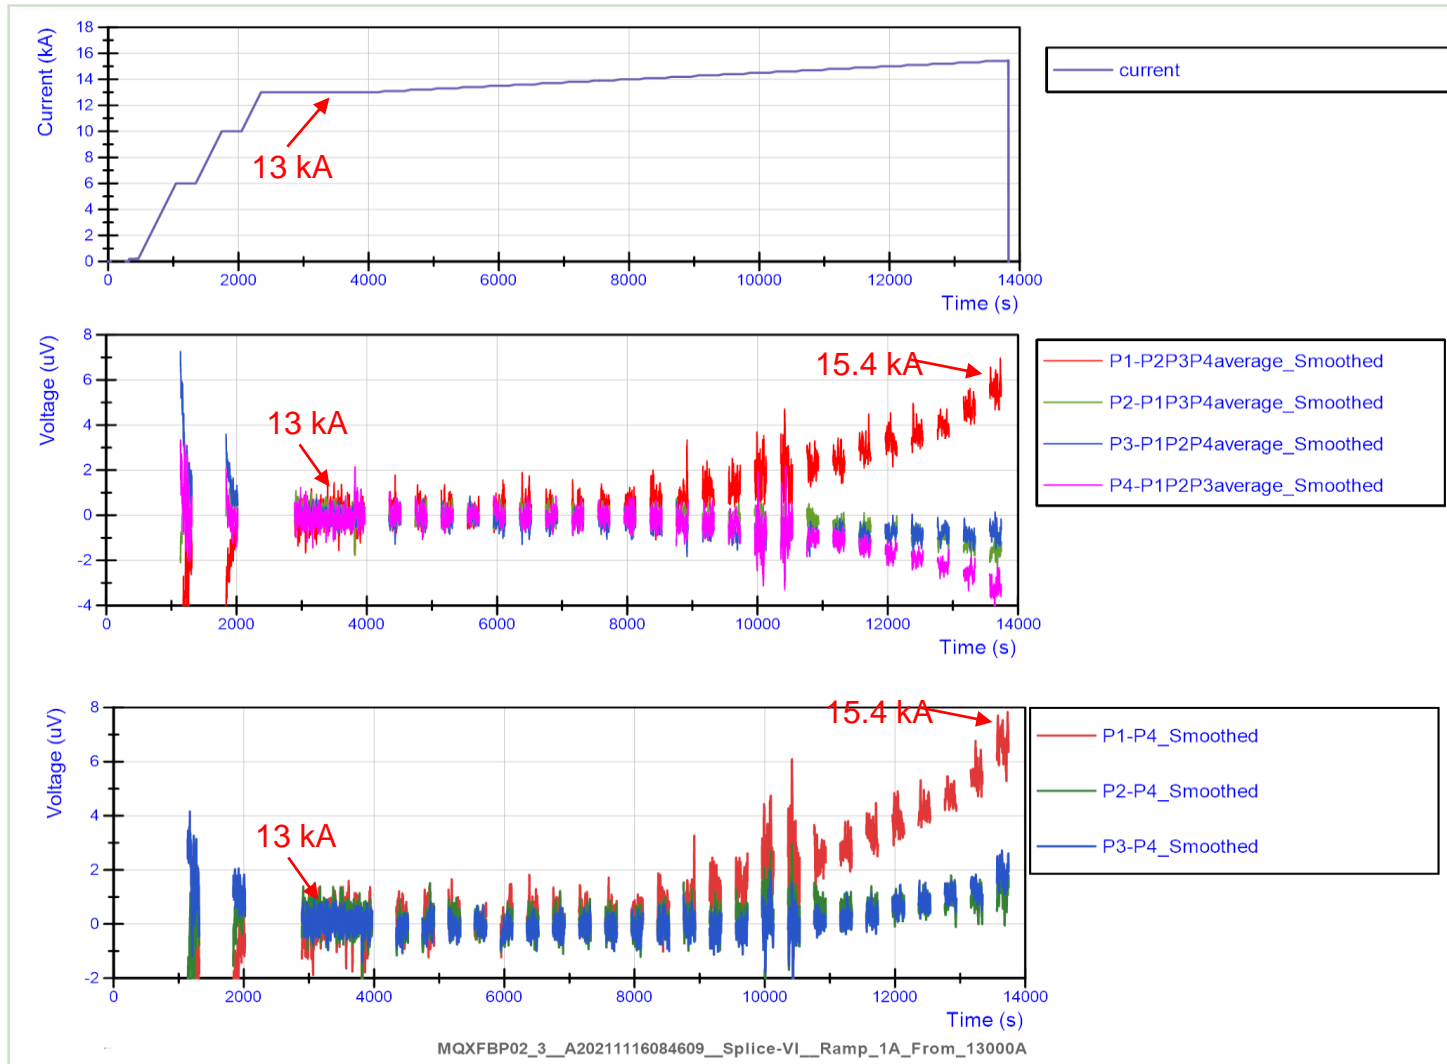
Example MQXFBP2, November 2021

Current plateaus at 4.5 K, each 100 A Ramp of 1 A/s between plateaus. (good setting for non-decaying signals; for decays use a faster ramp).

Remove inductive voltage from signals.

Identify the coil with least degradation (P4 in this case).

Buck the average voltage to this coil (removes noise, magnetization decay, noise from power converter, etc.)

P1 has the most degradation, P2 and P3 show some degradation at about 14 kA

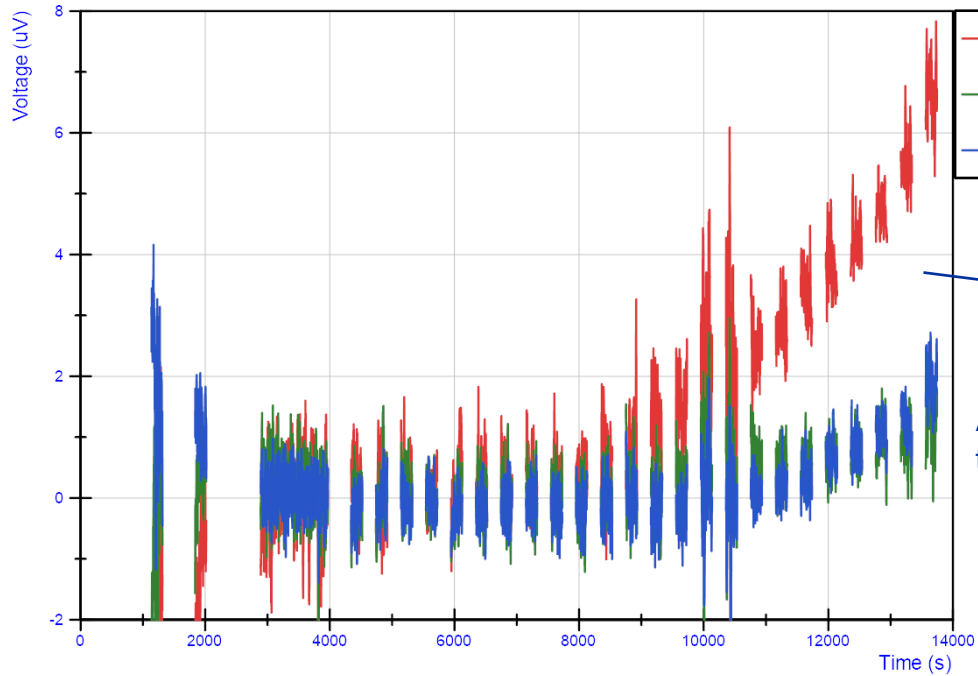
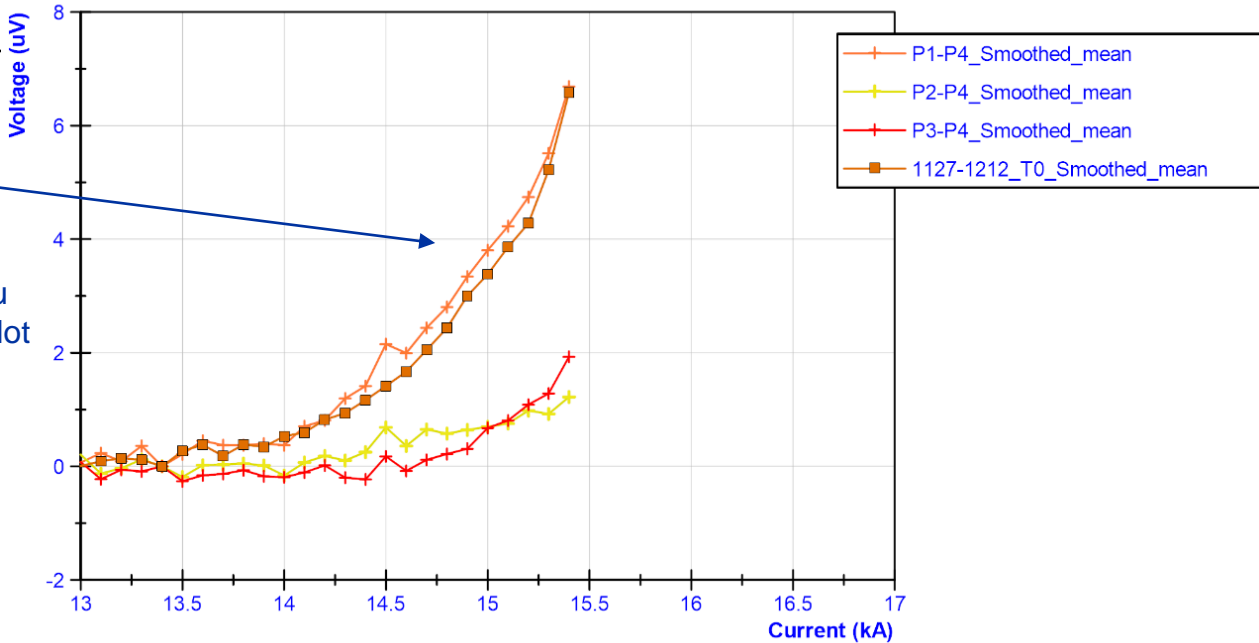
Average per plateau translates to a V-I plot

Measurements without trim up to 15.4 kA show that a voltage buildup starts also in P2 and P3 from about 15 kA.

In a test without trim, **even the full coil measurement** can show the start of voltage build up.

Assuming that not all coils are limited, **even full-coil measurements can reveal defects without trim powering.**
