The ATLAS Pixel Detector

Markus Cristinziani

Physikalisches Institut

VERTE **X**06

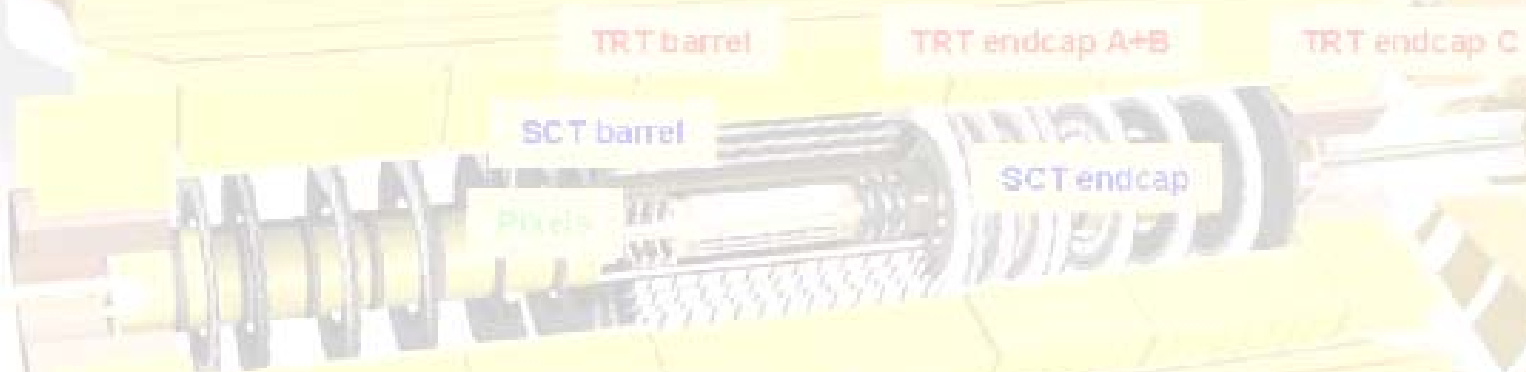
- Outermost system uses gas-filled 4mm straws
 - Contains 420k electronic channels. Transition radiation (TRT) gives particle ID

- Intermediate system is a large silicon strip tracker (SCT)
 - Four barrel layers and 9 disk layers with 61 m² silicon and 6.2M channels
- Innermost system is a silicon pixel tracker

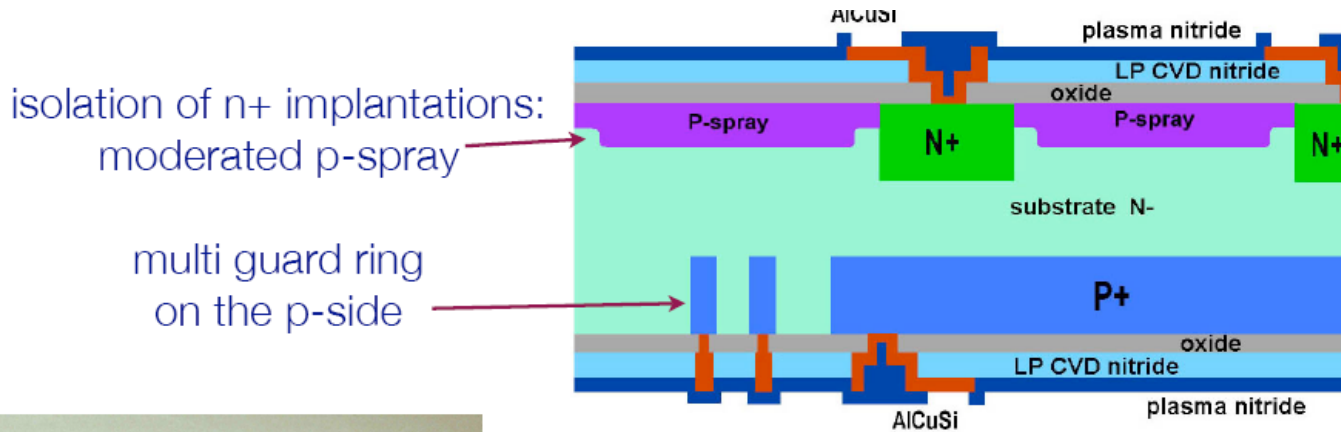
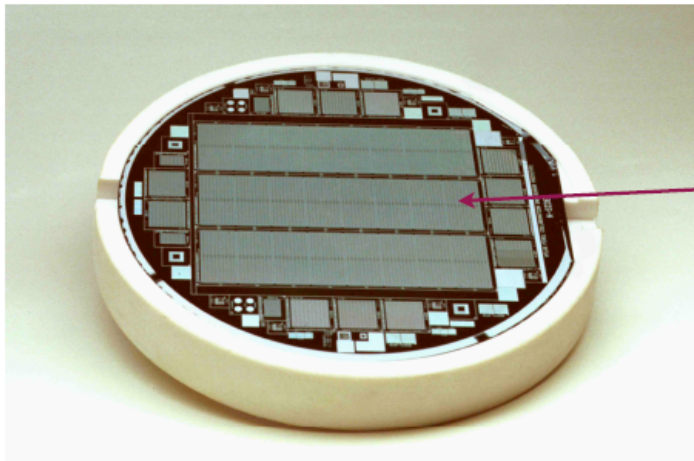
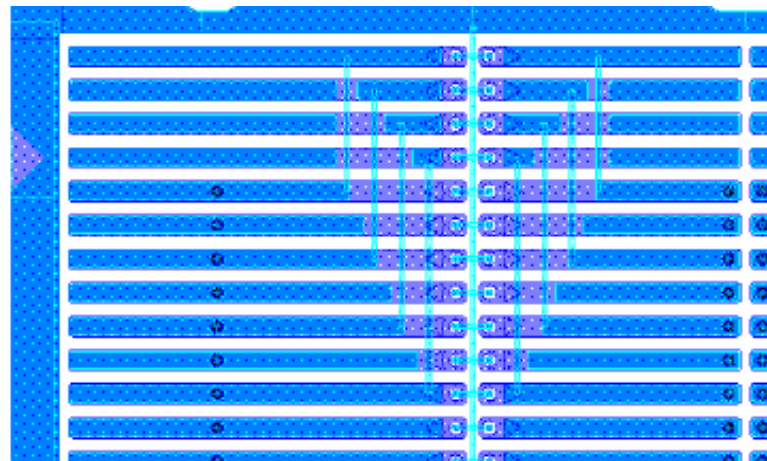
- Design driven by radiation hardness requirement
 - n^+ pixels in n-bulk (oxygenated Si) with moderate p-spray
 - 16.4 mm x 60.8 mm x 280 μm , 46080 pixels (50x400 μm^2)

Special pixels in inter-chip region

“long”, “ganged”

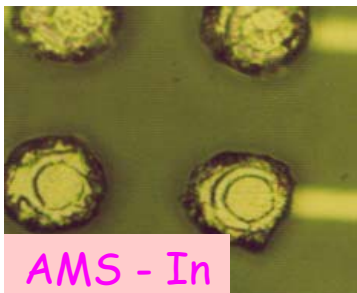
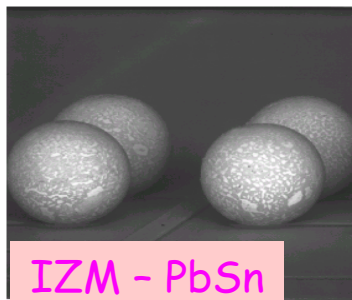
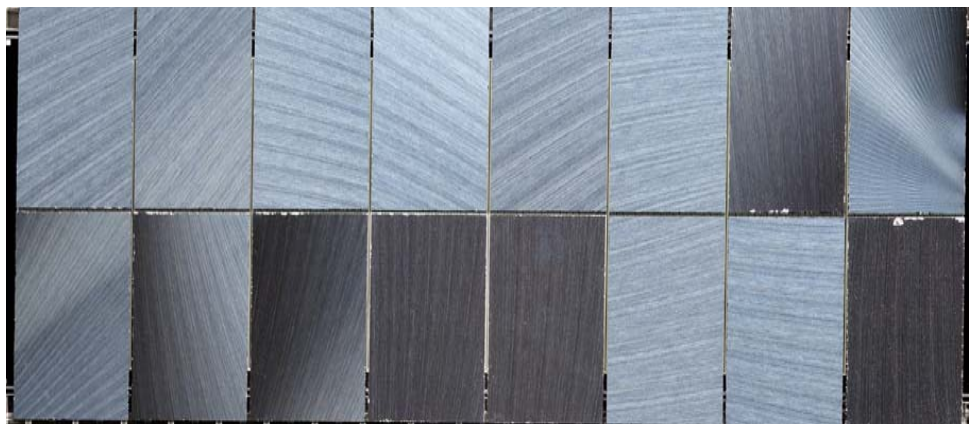
Bump bonding

- Bump bonds connect FE pre-amplifier to sensor pixel
- Two techniques, from different manufacturers :
 - **In** bumps by Selex (ex Alenia-Marconi Systems), Rome
 - **PbSn** bumps by Fraunhofer-Institut für Zuverlässigkeit und Mikrointegration, Berlin
- Bumping defects can be found before module assembly
 - production contract fixes a rejection at 0.3% faulty bumps
 - reworking techniques in place to recover FE
 - global yield after reworking is 94%

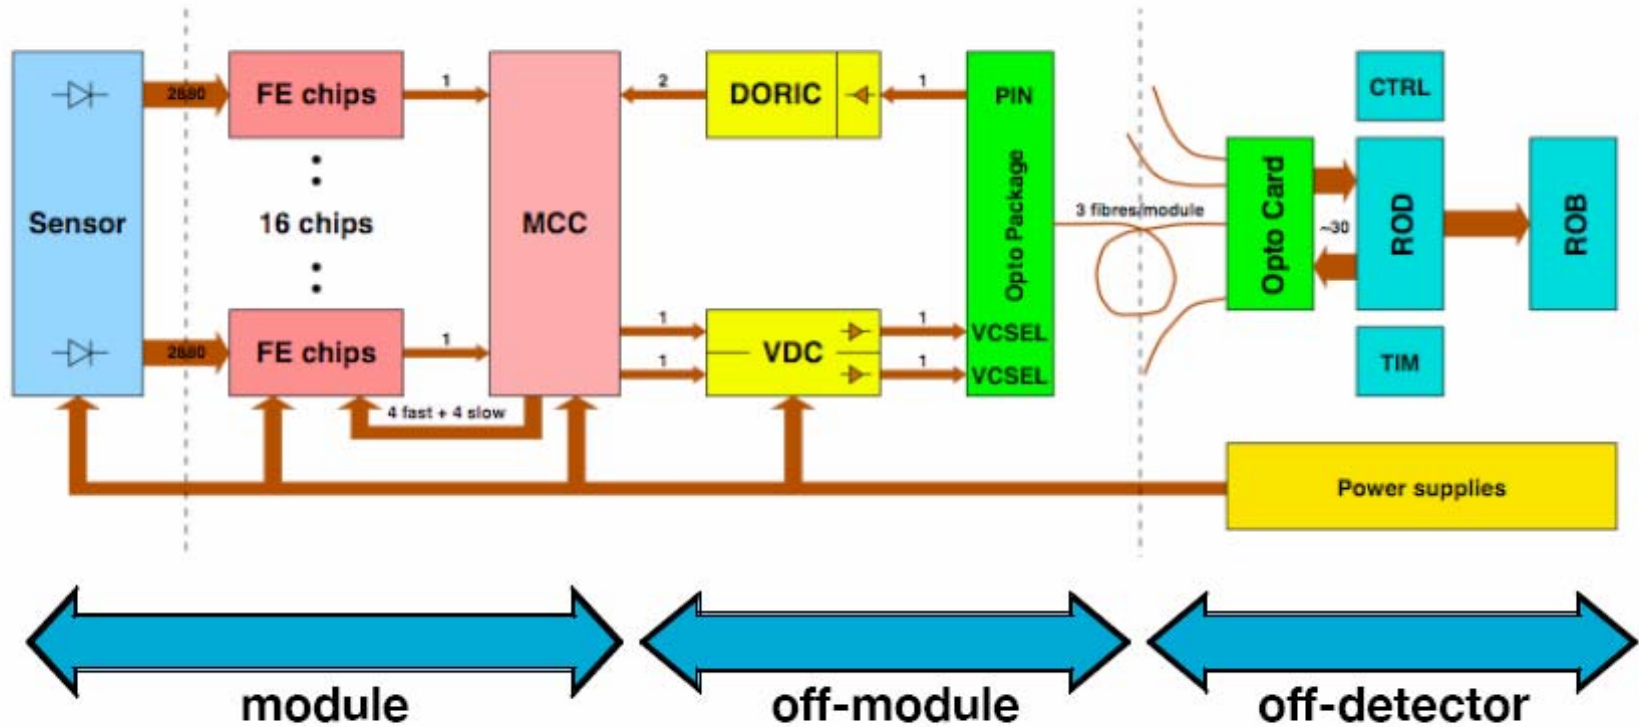
Read-out scheme

- 1 Sensor
- 16 front end chips (FE)
- 1 module controller chip (MCC)

- Optical receivers (BOC)
- Readout Drivers (ROD)
- Readout Buffers (ROB)
- Timing Control (TIM)
- Slow Control, Supplies

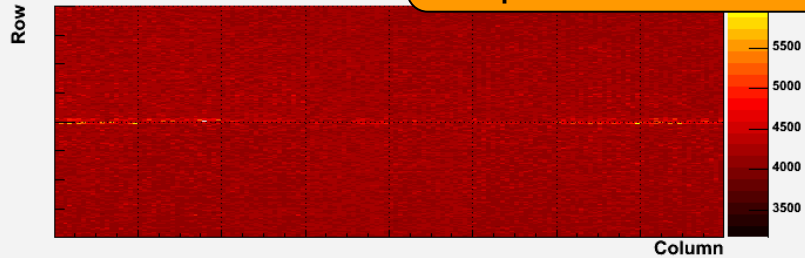
Threshold map

Threshold (e): VCAL scan internal - FLEX 1.
Module "510852"
46073 out of 46080 pixels with good fit

threshold: $4170e^-$
dispersion: $61e^-$

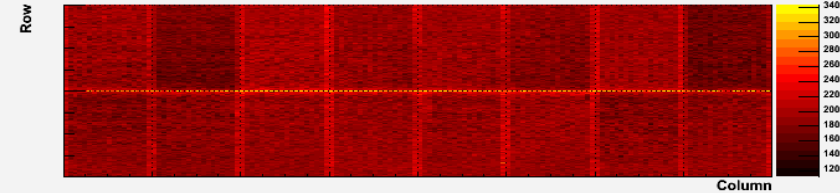
Noise map

Noise (e): VCAL scan internal - FLEX 1.
Module "510852"
46073 out of 46080 pixels with good fit

noise: $185e^-$

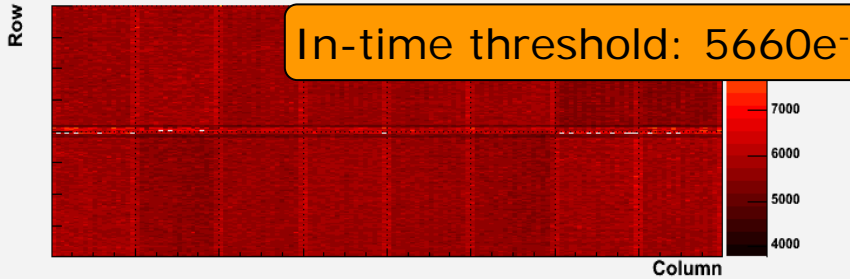
Threshold map

Threshold (e): In-time threshold scan - FLEX 1.
Module "510852"

45967 out of 46080 pixels with good fit

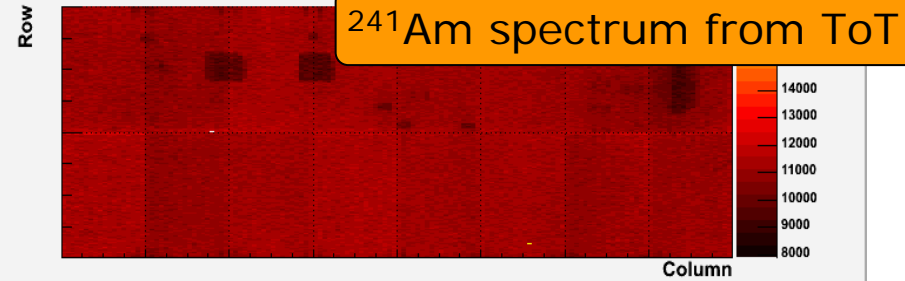
Map of avg. calibrated TOT data

Charge from ToT (e): Source scan - FLEX 1.

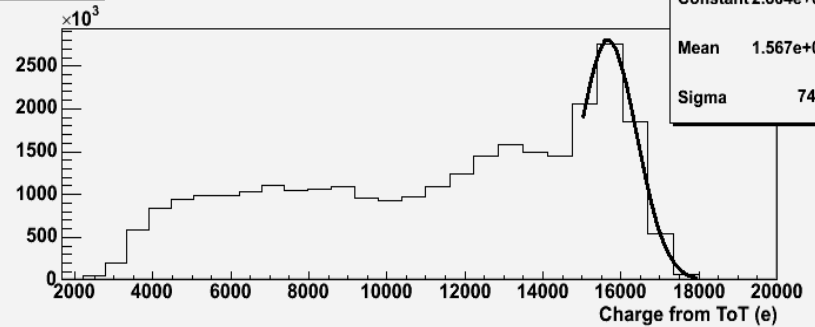
TOT-spectrum

Constant 2.804e+006
Mean 1.567e+004
Sigma 743.3

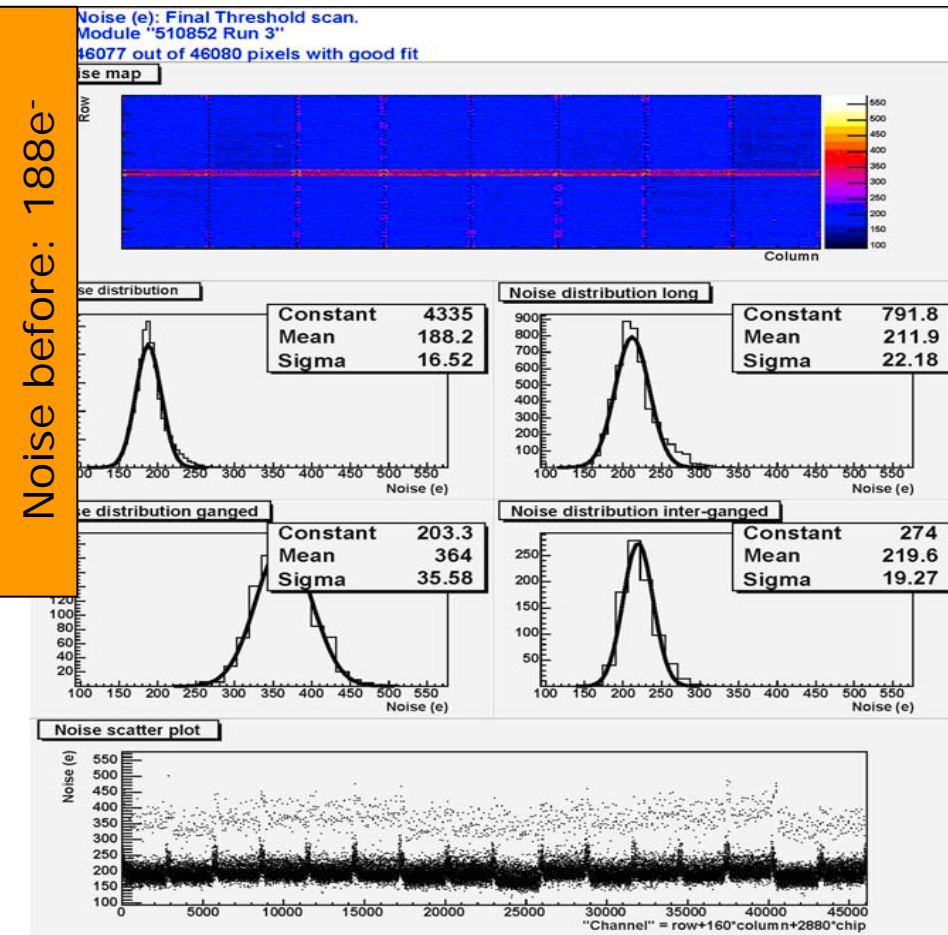
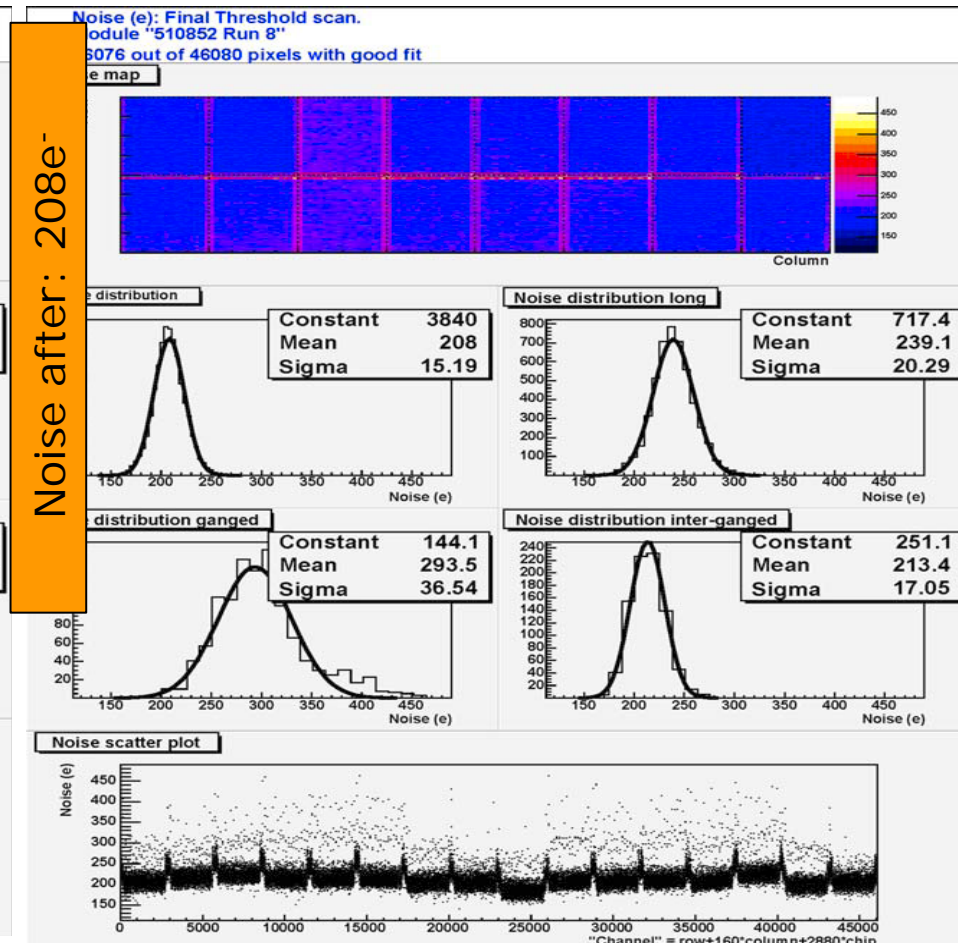
Extensive radiation studies at CERN PS, irradiation of 7 production modules to ATLAS lifetime dose (2×10^{15} p/cm² \approx 50MRad).

- Test beam 2004 to characterize production modules
- Radiation hardness
 - Sensors almost fully depleted after 3 yrs high lumi with 600V bias
 - Charge collection efficiency reduced to 80% (trapping)
 - Lorentz angle decreases with increasing bias voltage ($15^\circ \rightarrow 5^\circ$)
- Detector performance
 - In r_ϕ direction $7\mu\text{m}$ (no irradiation) to $10\mu\text{m}$ (after irradiation)
 - Efficiency: 99.9% \rightarrow 98.2% after irradiation (at 500V)
 - Pixel geometry slightly affects efficiency
 - High rate tests passed

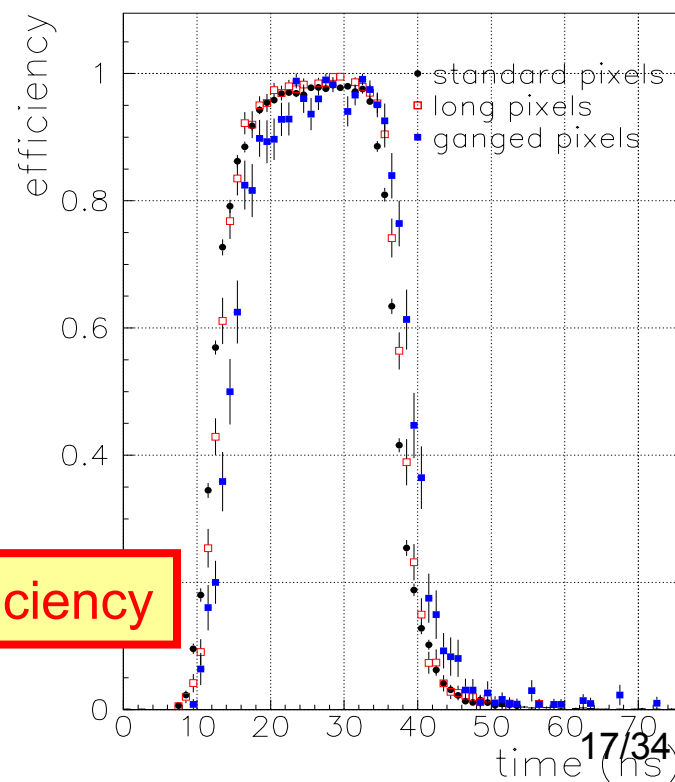
FE-13 irradiated

In-time efficiency

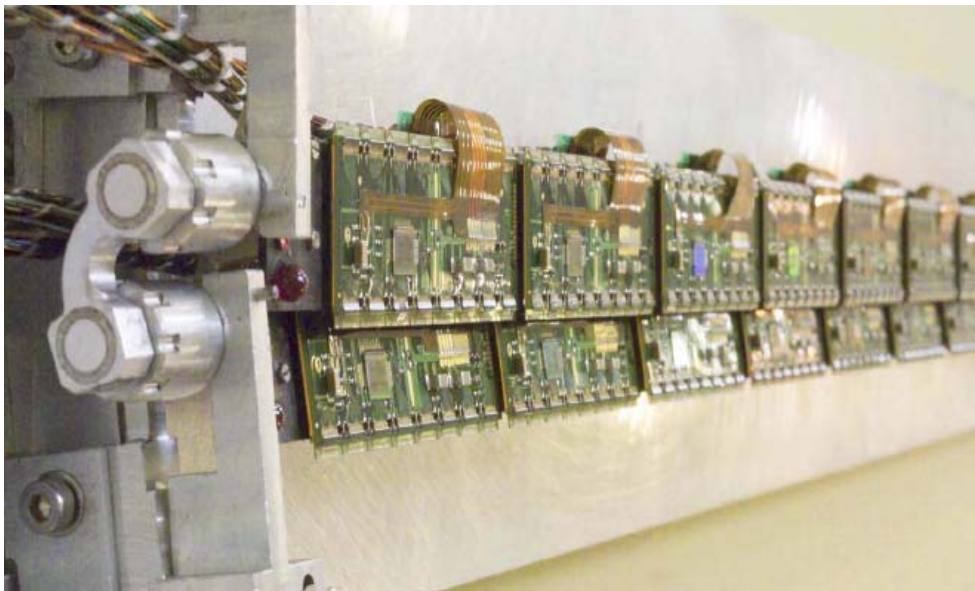
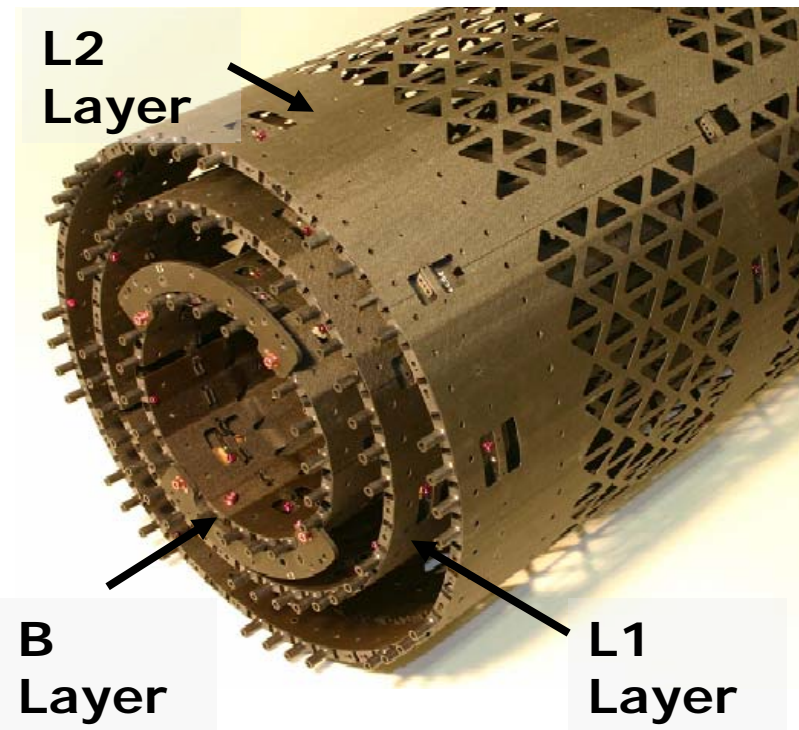
- Barrel composed of
 - barrel frame (carbon fiber laminate)
 - staves
 - 13 modules
 - Shingled carbon-carbon support
 - All identical (except cabling)

- For integration two staves are linked by a unique cooling tube (bi-stave)

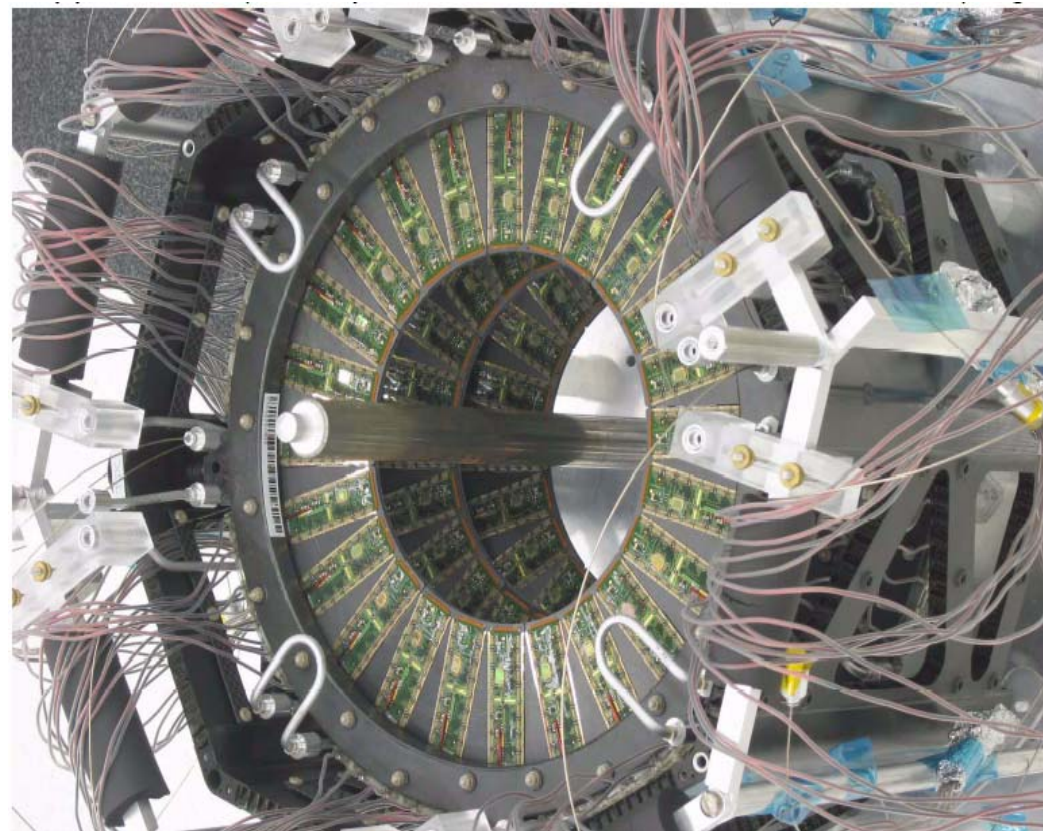
Pixel End Cap

Sector assembly (1/8 of a disk):
6 modules are mounted on
carbon-carbon plates,
sandwiching the cooling pipe.

Assembled at LBL
and shipped to CERN
for integration

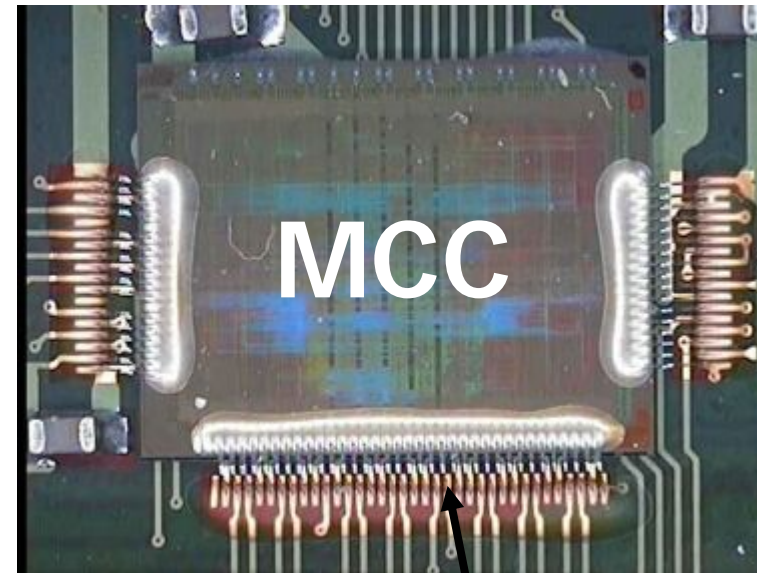
- Wirebonds on front-end chips are potted
 - avoid resonant breaking of wires
- Also MCC potted as handling precaution
- Problems appeared during “burn in”
 - infant mortality
 - 10 cycles [-30°C;+30°C]
 - Observed MCC potting detaching, breaking wire bonds
 - Related to geometry, component surface
 - No problem on FE chips after long thermal cycling
- Action: stop potting MCCs and repair
 - Anyway not critical
 - Remove potting and re-bond modules in Bonn

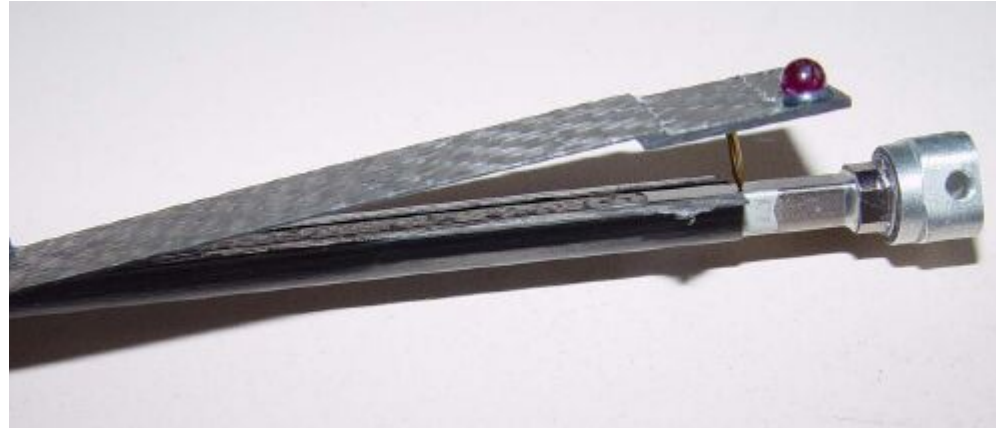
Stave delamination

- Delamination observed between CC Thermal Management Tile and Ω -shaped carbon fiber

- Gluing scheme
- Ω -shaped cooling tube favors delamination by deformation and torque
- increase of thermal impedance between tube and pixel module

- Solution: reinforcement by adding a peek collar

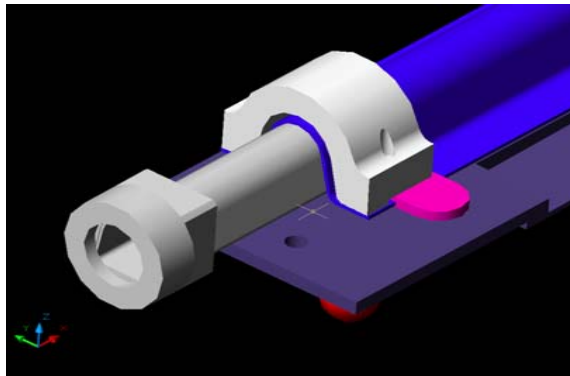
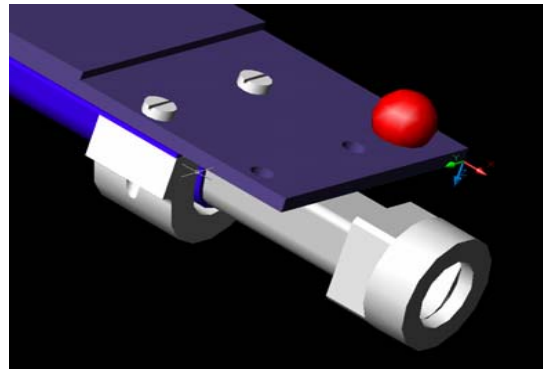
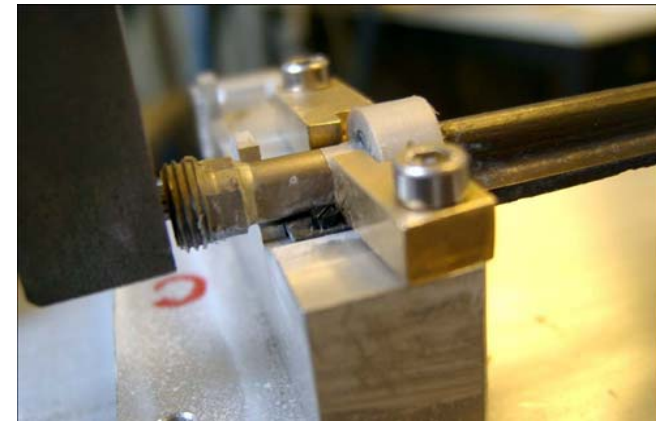
- Thermal performance is satisfactory after this modification

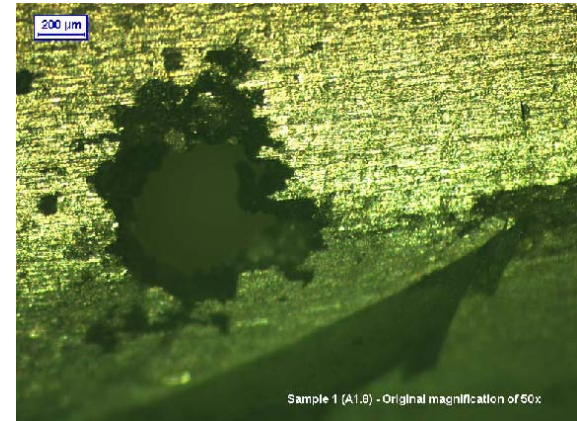
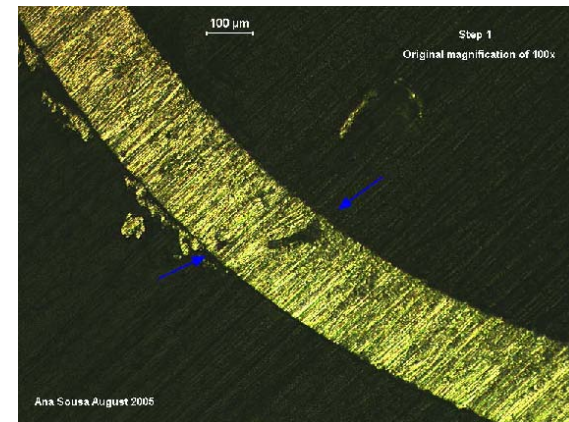
Pipe corrosion

- Serious concern (July 2005): corrosion of stave cooling pipes
 - Ni-Al galvanic pair and moisture
 - bare pipe material (Al)
 - Ni plating used to allow for brazing of the pipe fittings
 - no proper drying procedure → water
 - already ~15% of pipes leaky
 - experts consulted agreed on the need to change all the pipes
- Six months delay in schedule
 - repair the 43 (30%) loaded staves with a pipe-inside-the-pipe
 - production of new staves with new Al compound and laser welding
 - repair of bare staves (~100)

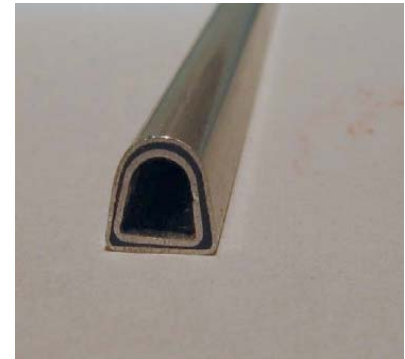
- Pipe insertion fix to avoid corrosion of inner pipe
 - D-shaped pipe inserted, stycast adhesive, fittings glued
 - additional thermal impedance ($\sim 10\%$)
 - smaller hydraulic diameter of cooling circuit
 - extensive studies performed

- Staves are paired (bi-staves) and served by one cooling circuit. Tests with evaporative cooling indicate that:
 - (1 repaired + 1 new) stave can be cooled when dissipating 190W, i.e. can reach end-of-lifetime
 - Only outer barrel layer consists of these kind of bi-staves (\sim half dose than intermediate layer).

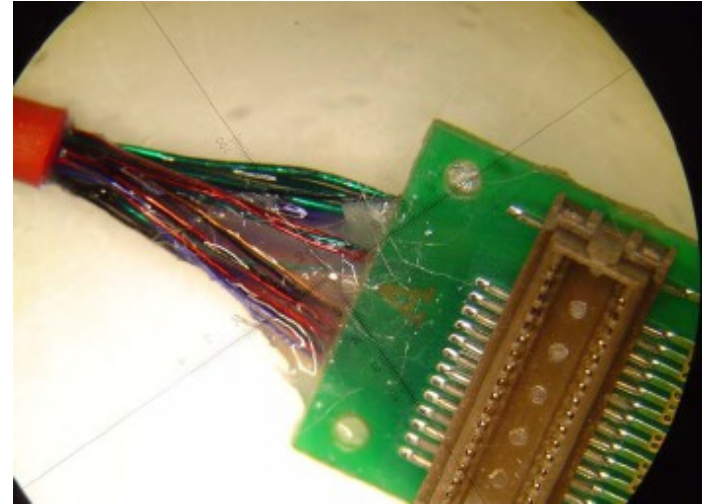
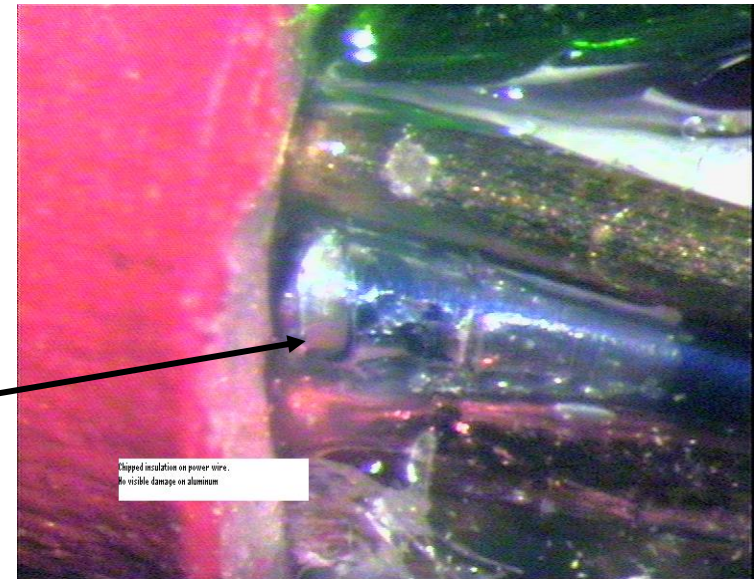
- Barrel aluminum signal and power cables
 - 100 μm wire for signal
 - 300 μm for power
 - 21 wires in a bundle
 - wire-bonded on a small PCB

- Defective cables discovered during integration
 - cable stressed during manipulation?
 - strain relief
 - systematic check (visual inspection and electrical tests):
 - ~50% of the 2000 cables affected
 - cracks in insulation
 - cause signal wire breaking

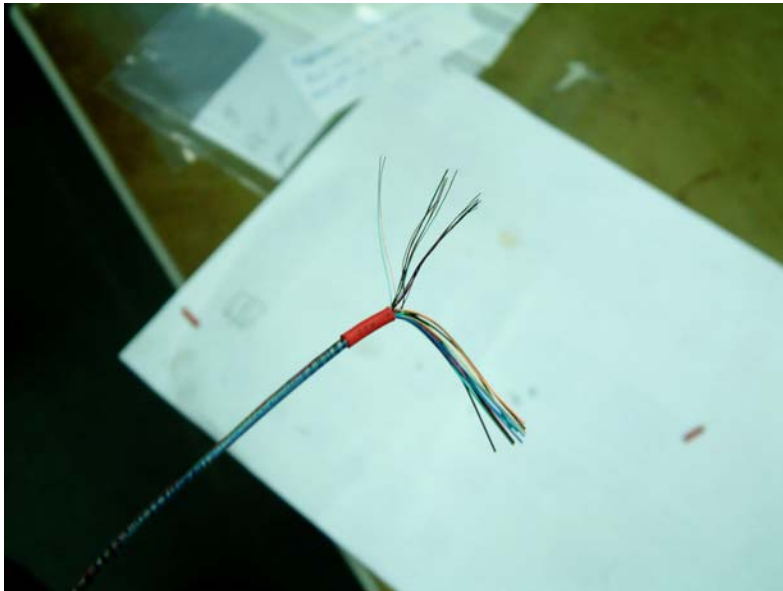
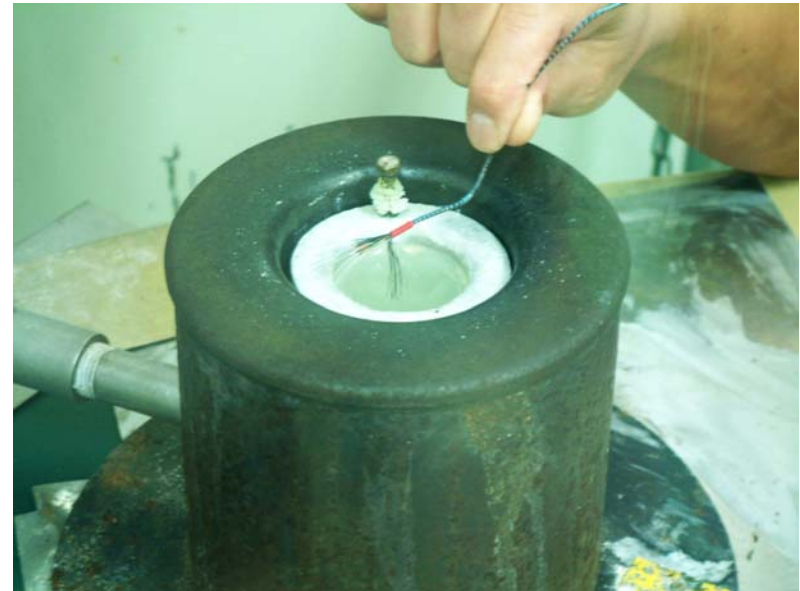
Cable problem solution

- Production process in Taiwan inspected
 - Wires are bent and immersed in 400°C NaOH for stripping
 - Excessive bend and high T can damage the insulator

- Problem caused ~3 months delay in already dense schedule
- Procedure corrected: now cable yield ~90%
- Expect all cables produced by October 1st

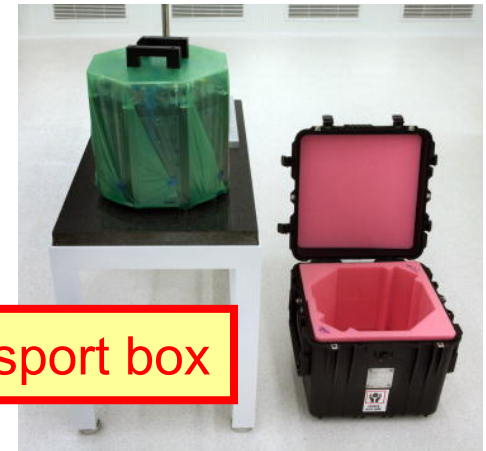
- Both Pixel End Caps are not at CERN
 - Were fully assembled in LBL
 - dead channels at few per mil level
- Preparing for cosmic tests in November
 - test DAQ chain, services and software
