21st July, 2022, WCTE Collaboration Meeting

MOHIT GOLA, THOMAS LINDNER, MARK HARTZ

MPMT MECHANICAL UPDATE

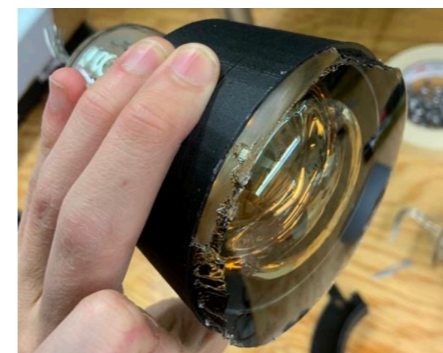
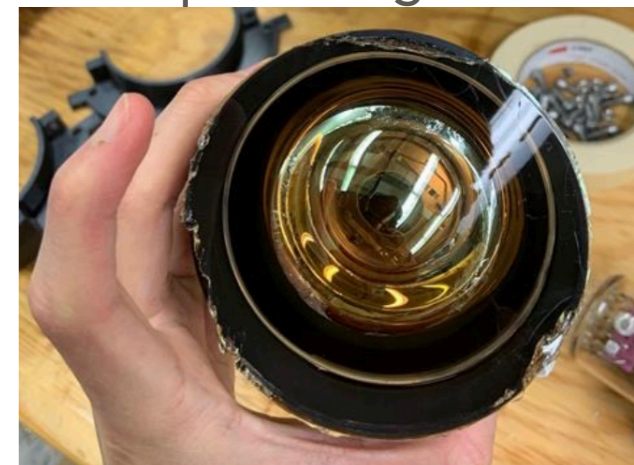
3D printed new gel jig

- The jig has been tested for the gel ratio of 9:1.
- Observed tore edge mainly due to the extra gel in mould and rubber material used for gasket was insufficient to prevent gel leakage.

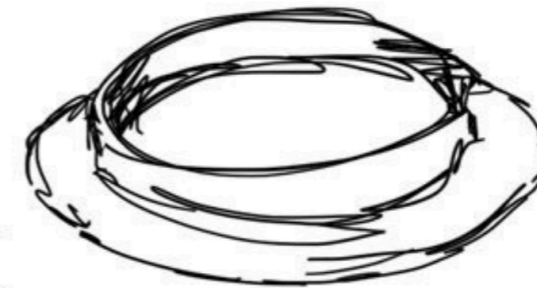
- A gasket has been developed with the sleeve design in order to improve the alignment and no direct contact of the cup with the base plate. Helps in easy de-moulding without tearing gel. Also controls the leakage of the gel.

Gel=96:4

Capable of protecting gel during de-moulding and further reducing gel leakage in the mould design

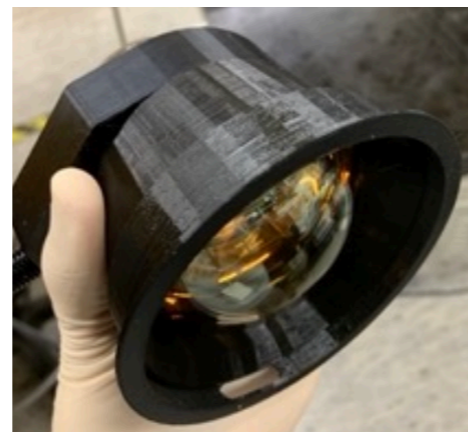
Some relevant modifications in the jig design

- Moved alignment groove from mould to gasket.
- Increased the distance of the cup adapter from the base by 0.7mm to maintain the gel thickness of 7.5mm
- Added overflow trough to outflow spout.
- Added height indicator to inside of inflow spout

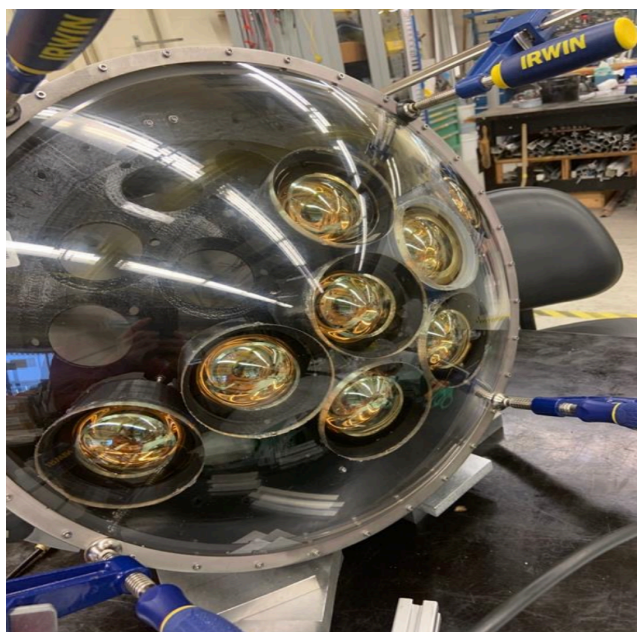
April

Matrix has been centred, gel ratio of 96:4, standard poron thickness, only newly gelled PMTs.

Full contact has been achieved with the newly gelled PMTs in the isolation.

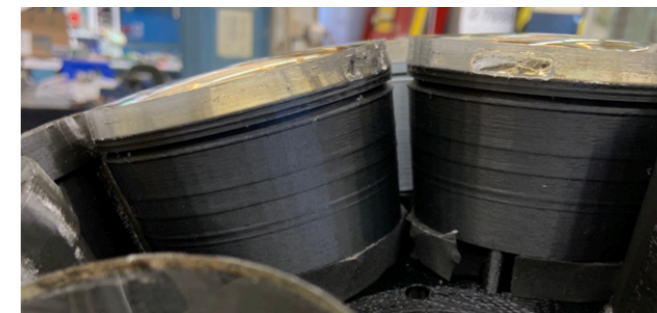
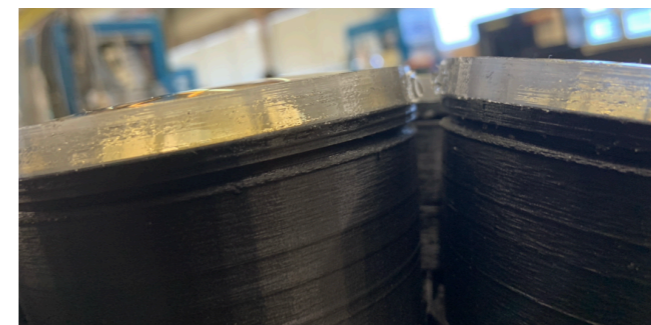
Proper PMT seating

Improper PMT seating

A large gap between gel and PMT cup results in improper adhesion with dome under vacuum. Due to PMT tilt edge delamination has been observed

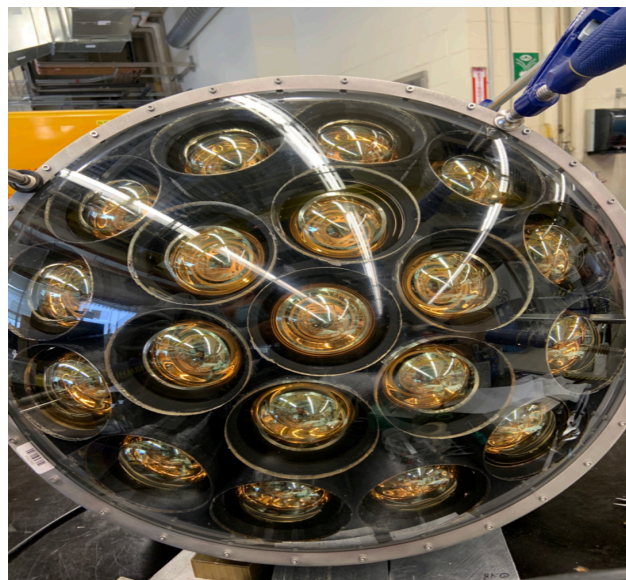
June

A full contact has been achieved for both the FORGELAB and TRIUMF printed matrix.

- An additional 1mm of height added to matrix pillars was sufficient to improve contact on both the Forgelabs and TRIUMF matrices. Both single-PMT and full assemblies show sufficient contact prior to vacuum application.

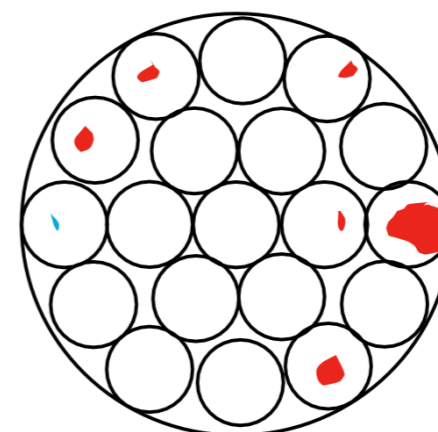
Pre-vacuum

TRIUMF matrix PMT seating is heavily constrained by pin inaccuracies and could potentially use widening of pin holes for more consistent seating

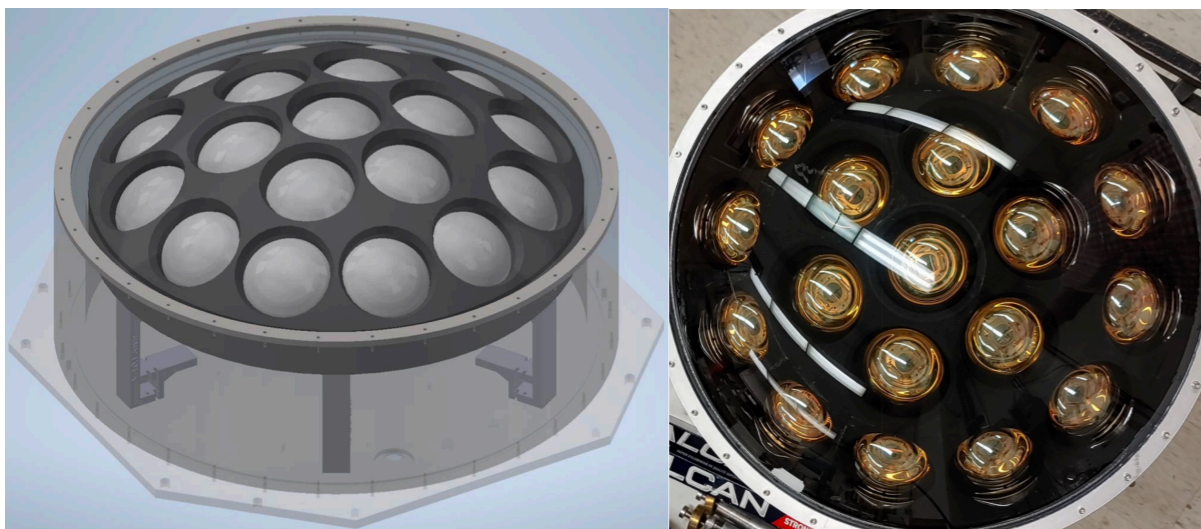
In general, the test resulted in a very good gelling but few imperfections are present

->Systematic air pocket at the exterior edge of each PMT hole in the 2nd ring

->One similar air pocket for a single PMT from the first ring

->These issues seem systematic and we do have options to fix such air trapping

->Suspect this issue has been artificially generated by excessive application of silicone

- Used the 612 gel prepared with the hardest manufacturer-recommended ratio A/B of 3/2
 - >Encountered some technical difficulties during the vacuum degassing step leading to delay and then losing part of the gel because it became too viscous
 - >**We estimate to have used about 2.5 kg**
 - > We have used removable silicone to pad the PMTs to set those which were loose

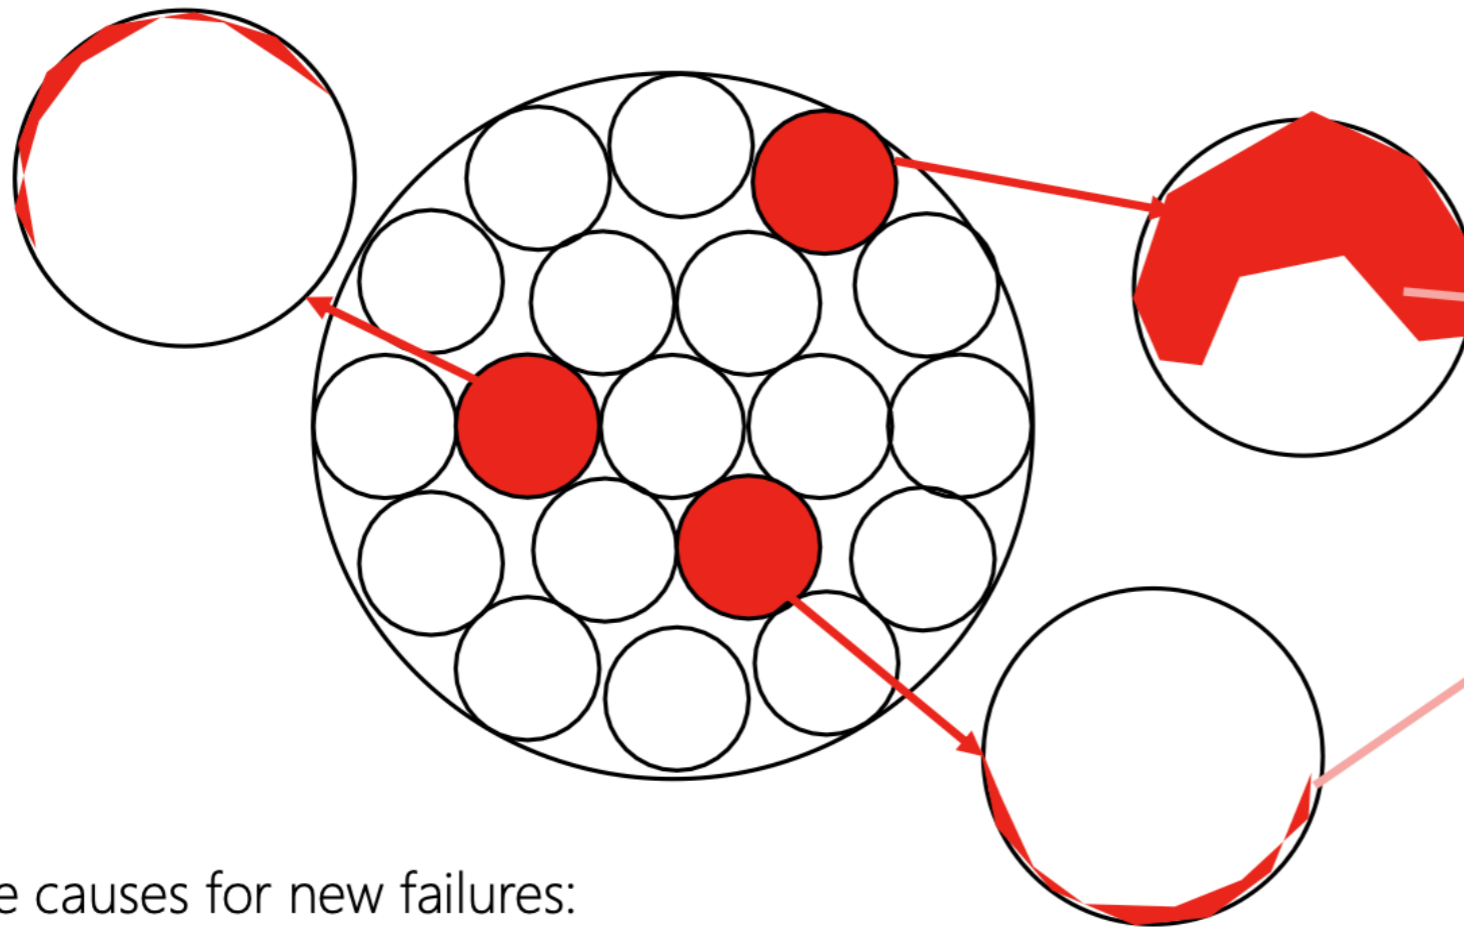
ANALYSIS

Possible causes for new failures:

- Acrylic plate has the wrong dimensions (in 3rd row PMT)
- New built-in adapter cup may have incorrect dimensions (3rd row)
- New PMTs are controlled at 7.5mm. This may be too thin for full contact, will consider increasing thickness on future iterations
- Underlying matrix deformities exacerbated by thin gel
