Mechanical Properties and Damage Development in GlassFiber Epoxy Laminates Subjected to Tensile Loading at Sub-zero Temperatures

A. Krzak¹, Z. Al-Maqdasi², G. Matula¹, Agnieszka J Nowak¹, R. Joffe²

The study focuses on mechanical behavior of glass fiber (GF) composite laminates at different temperatures (room and sub-zero). The laminates are subjected to loading-unloading tensile tests. The degradation of stiffness during the loading due to the micro-damage accumulation is observed. The purpose of this work is to identify the most suitable epoxy system for use in low-temperature environment.

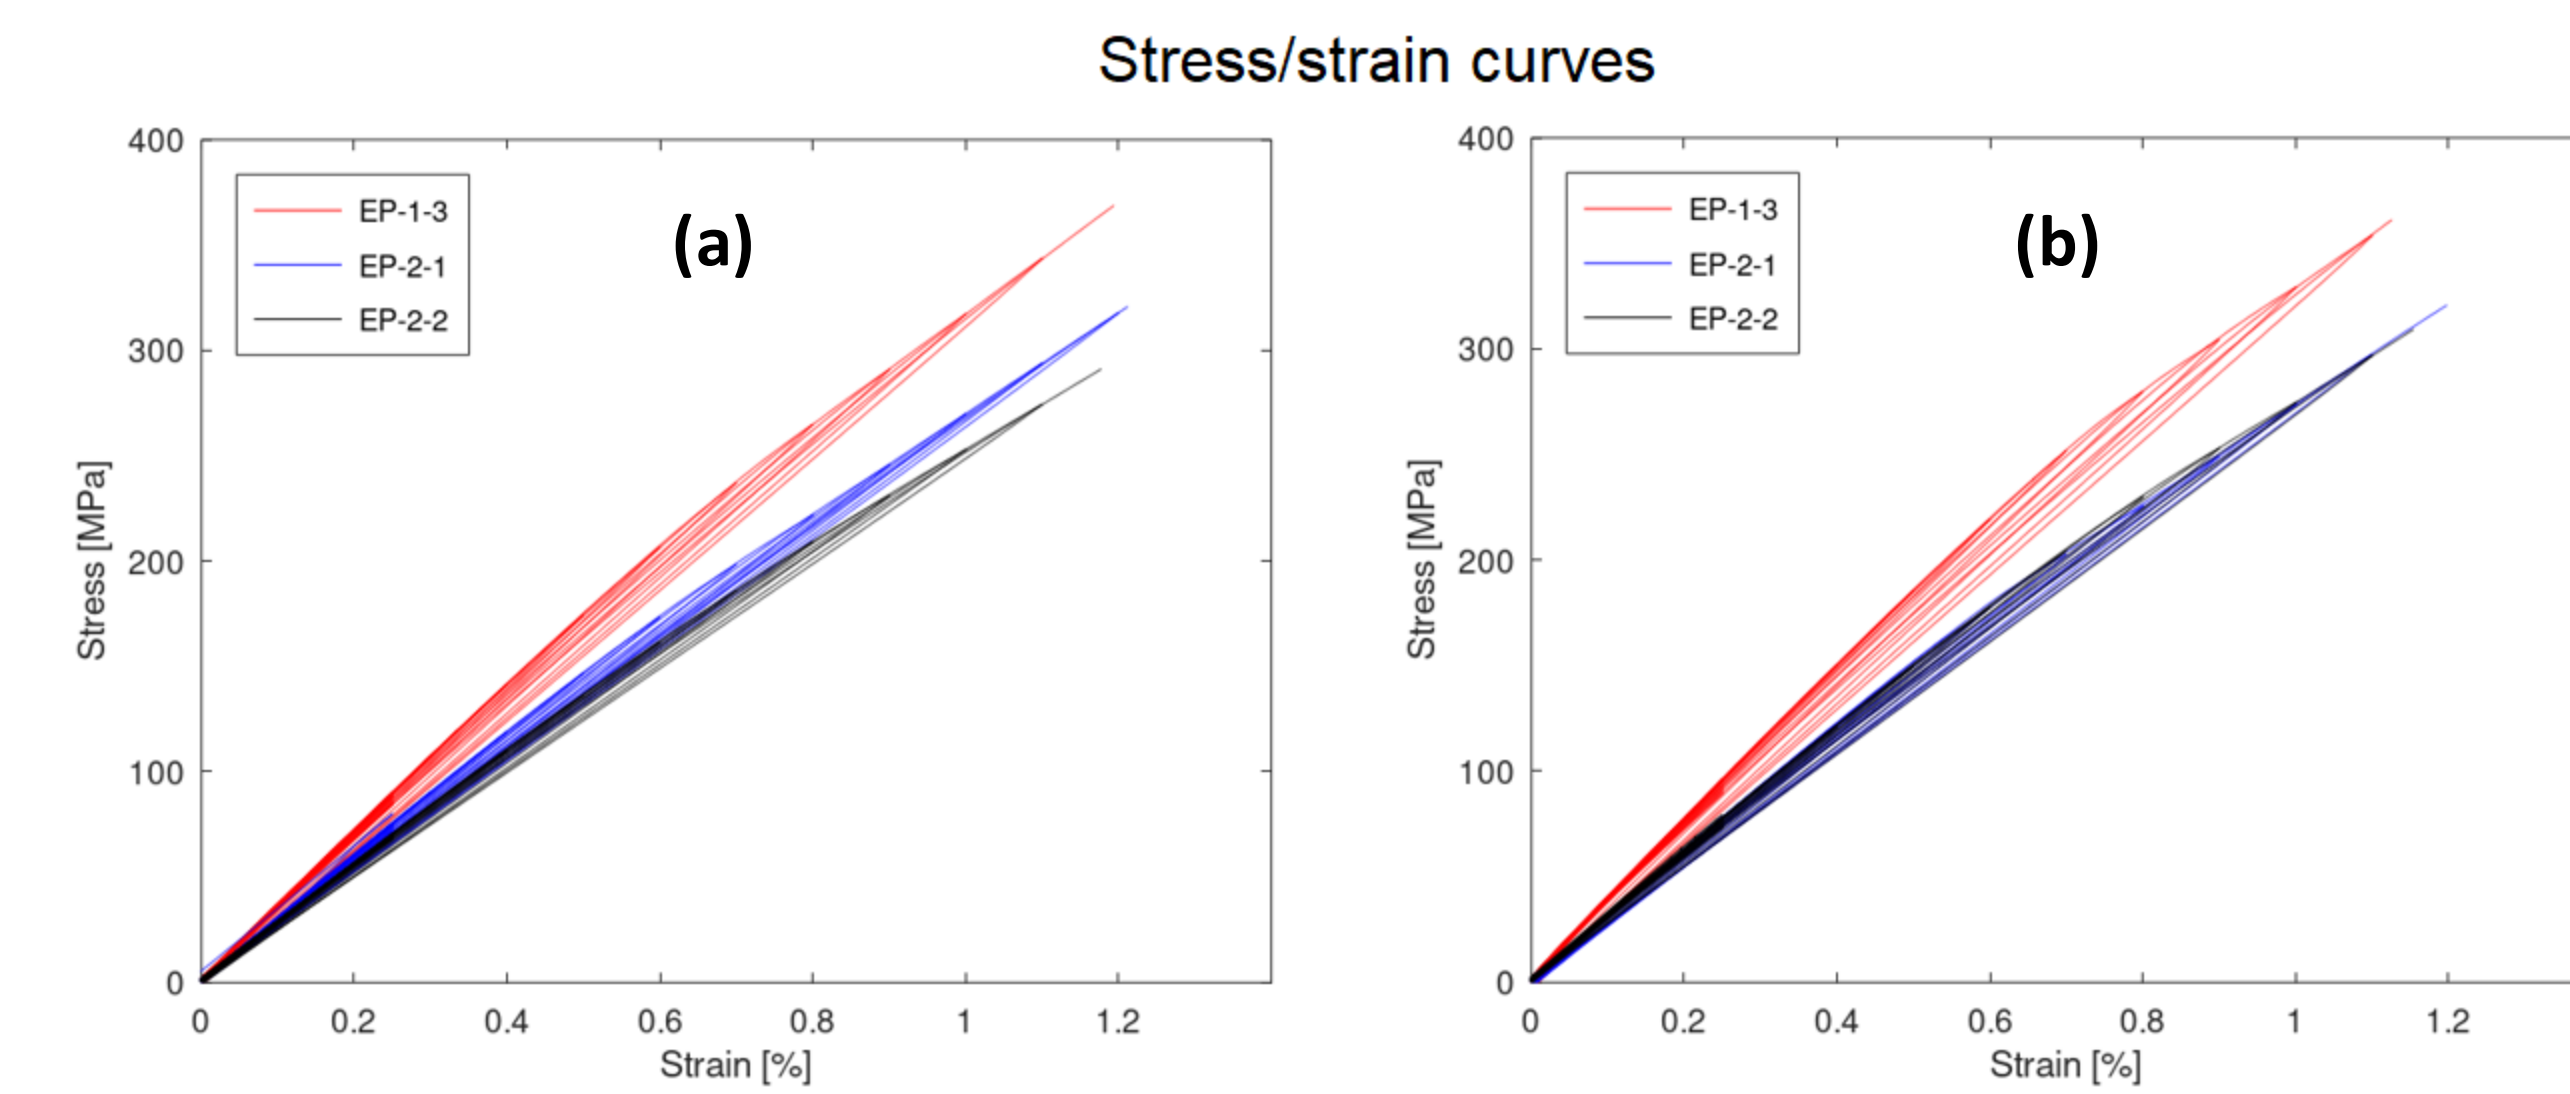
Figure 4. Stress-strain curves of materials at RT (a) and at -50°C (b)

Symbol	Material composition	E_0 (GPa)	
		RT	LN
EP_1_3	YDPN 638A80 + DDS	35.6	37.7
EP_2_1	YD128 + NOVOLAC	29.8	29.8
EP_2_2	YD128 + DICY	27.7	30.7

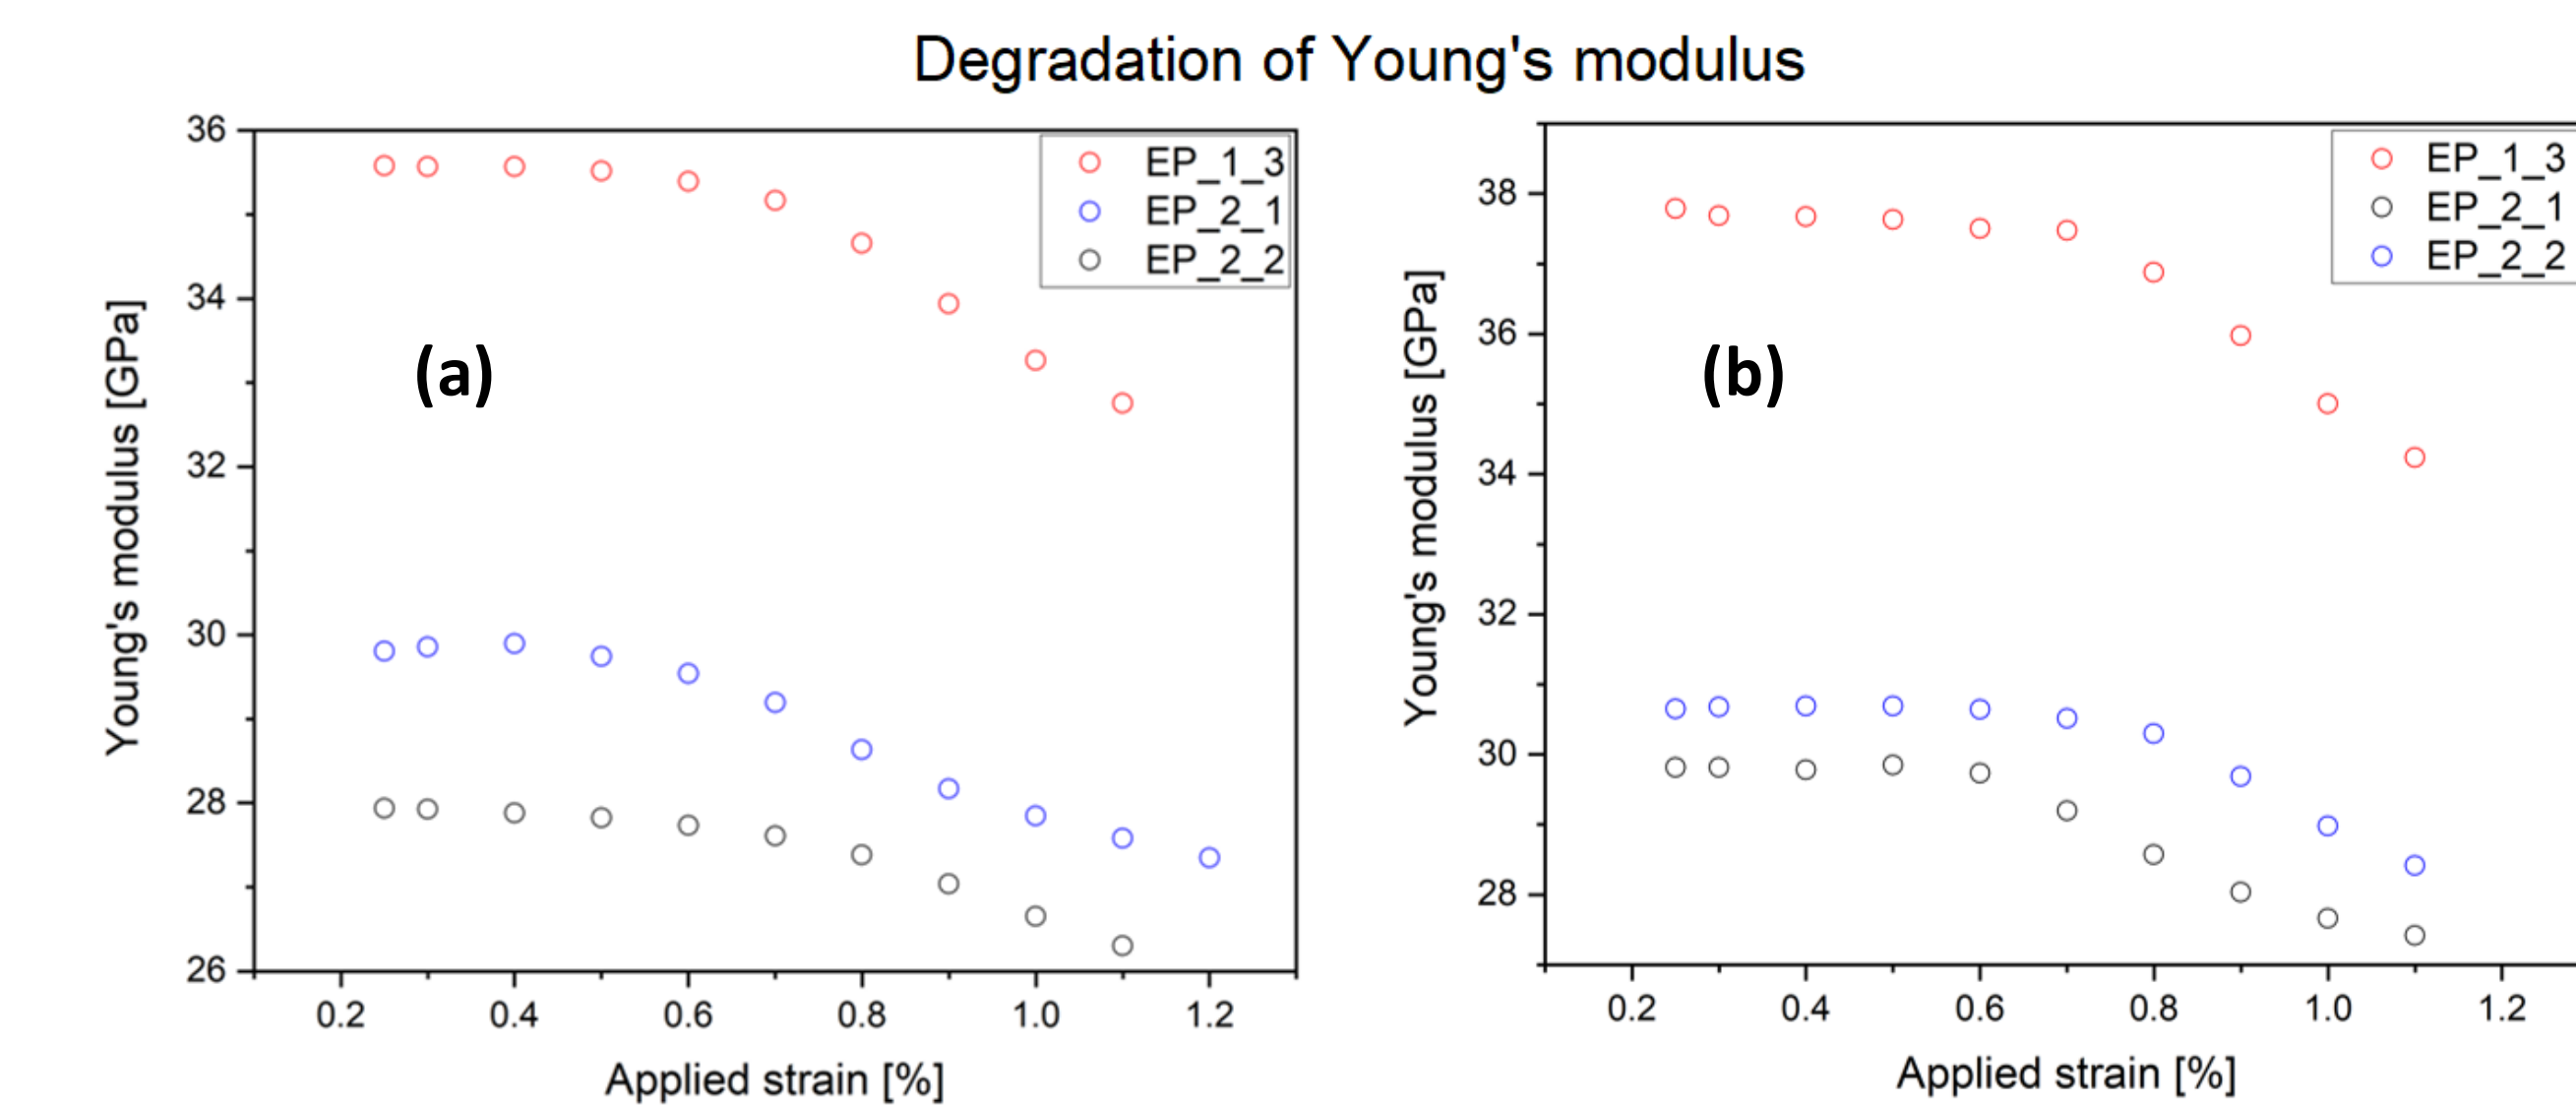
Figure 5. Degradation of Young's modulus of GF/EP laminates with increase of applied strain at RT (a) and at -50°C (b)

- The stiffness degradation was observed in tested laminates ($\approx 10\%$). This indicates that there may be rather significant amount of damage. Materials with different epoxy matrix show some differences in initial stiffness but not so much in degradation of it during the loading. The laminates tested at -50°C showed somewhat higher initial stiffness of the laminates compare to RT but only slightly larger (and more rapid) decrease of stiffness.
- The EP_2_1 (YD128 + NOVOLAC) exhibits greater stability both at RT and -50°C compared to other materials.
- Due to the complex micro-structure of laminates as well as challenging test conditions it was not possible at this stage to quantify amount of damage (number of cracks). This part of the study should be carried out in the future.
