Nitrogen Precooling Heat Exchanger replacement and control system upgrade in Superfluid Cryoplant at CMTF

CEC/ICMC 2023

FERMILAB-SLIDES-23-159-TD

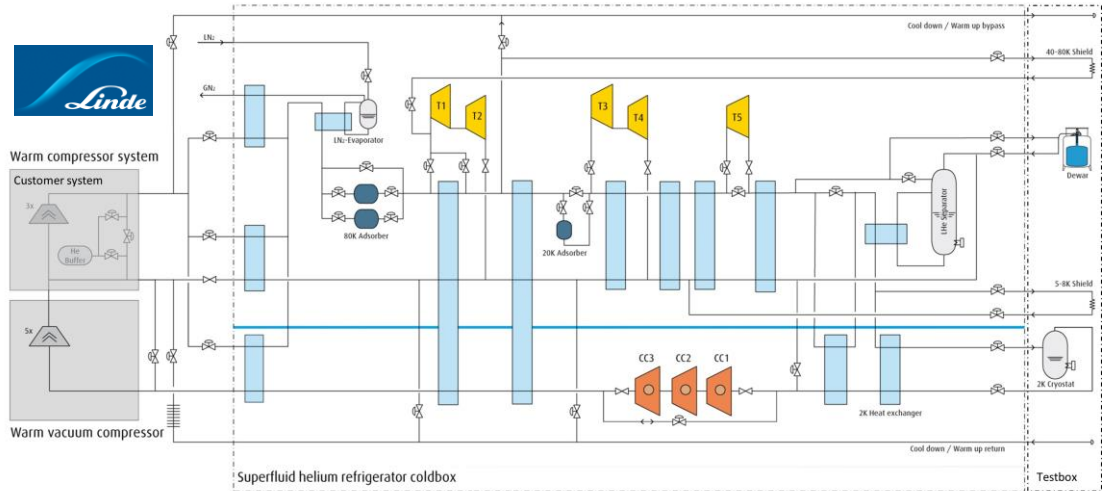
Figure 1: Simplified schematic showing CMTF Cryoplant (Image courtesy: Linde)

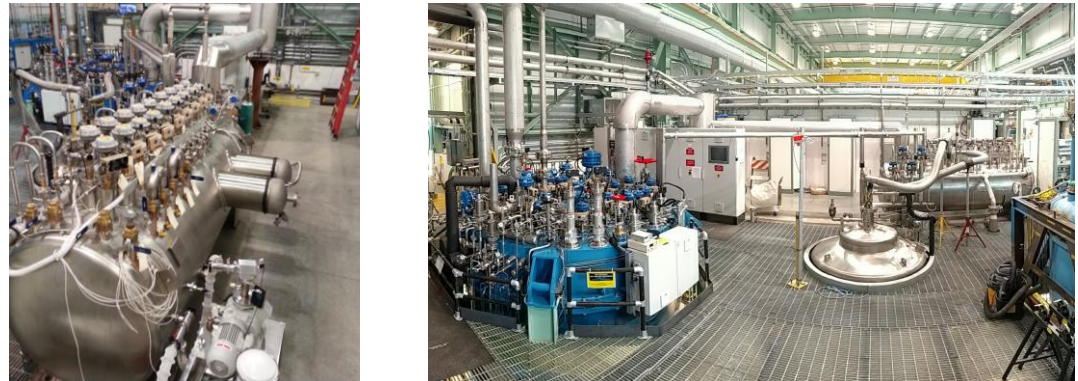
Figure 2: Pictures showing cryogenic distribution box, coldbox and Helium dewar at CMTF.

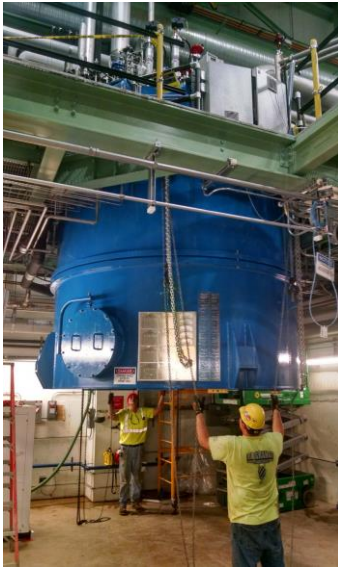
Figure 6: Removal of coldbox heat exchanger E3120

- Heat exchanger was removed from coldbox once the leak was confirmed.
- Due to significant lead time of new heat exchanger and operational support requirement of projects, modification was made in the system to operate without Nitrogen precooling heat exchanger.
- In place of heat exchanger, 4000 W inflow heater and two 1425 W band heaters were added on Nitrogen circuit which would generate Nitrogen vapors to cooldown Helium in recuperative heat exchanger E3115.

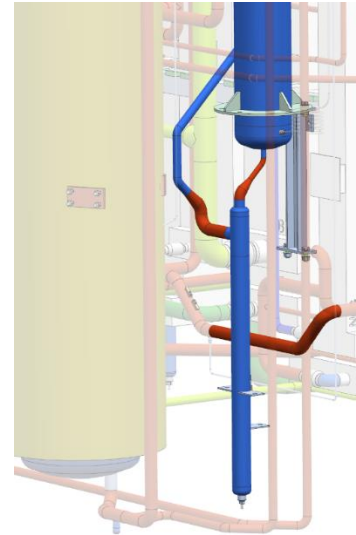
Figure 8: 3D model showing configuration after installation of heaters

- Over-temperature protection was used for the heater bands and temperature sensor was installed in the heat exchanger Helium outlet.
- While not an efficient solution, the configuration provided a way to get the system operational with acceptable capacity to keep cryogenic test programs on schedule.
- Addition of these heaters generated about 44 % more liquefaction capacity than without use of Nitrogen precooling.
- The Cryoplant was operated in this configuration for 2 years until the replacement heat exchanger was delivered and shutdown window became available to install final replacement.
