GROUND-BASED CRYOGENIC LEAK TEST OF FITTINGS FOR CRYOGENIC FLUID MANAGEMENT

Cryogenic Engineering Conference

July 12, 2023

NASA Kennedy Space Center
KSC, FL 32899 USA

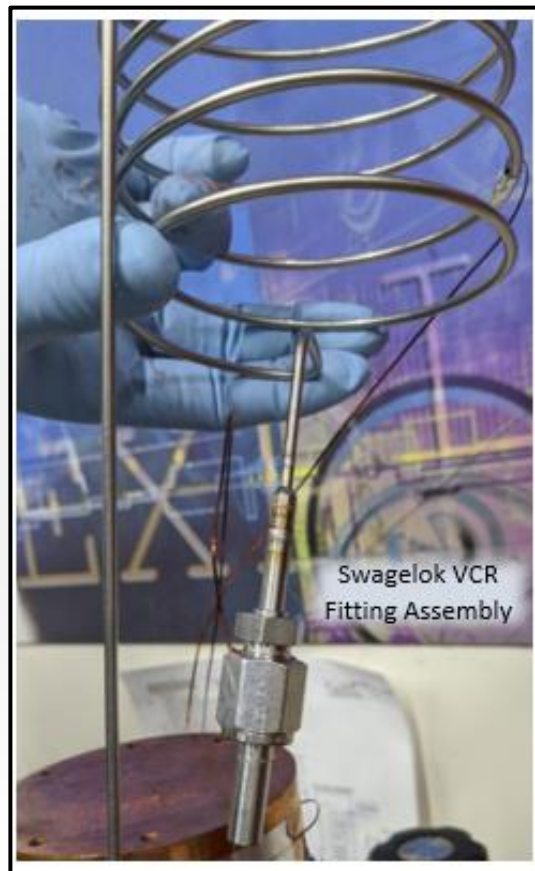
**Test fitting assembly
prior to TVAC
installation**

- Chamber attached to Cryocooler and pumped down to vacuum
- Fitting pressurized with gaseous helium (GHe)
- Leaks into vacuum chamber measured with calibrated helium leak detector (Inside-out method)

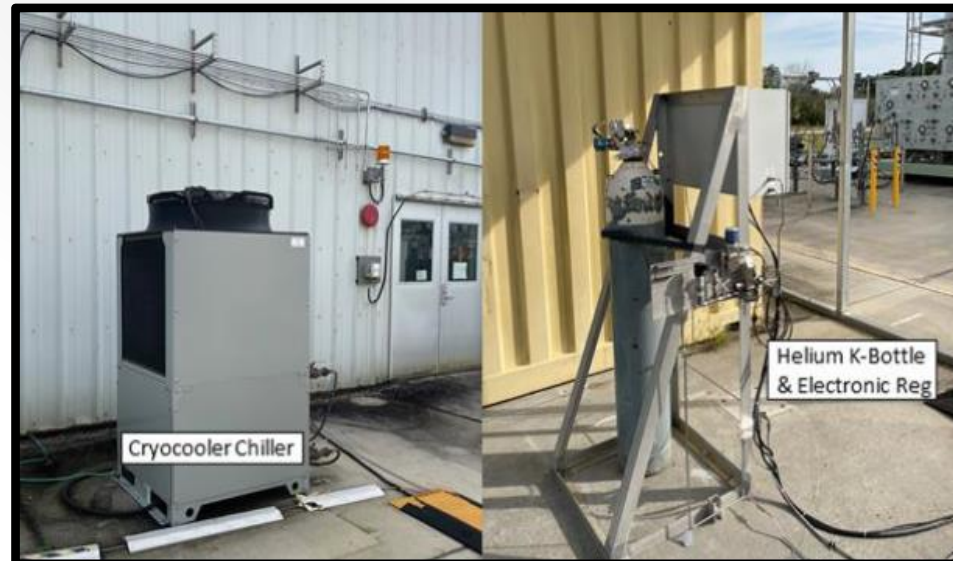
- Internal Components
 - Cryocooler
 - Vacuum Pump
 - Helium Leak Detector (Mass Spectrometer)
 - Vacuum Test Chamber
 - Data Acquisition System (DAQ)
- External Components
 - Cryocooler Chiller
 - Helium K-Bottle w/ Electronic Regulator

Test Setup
(External)

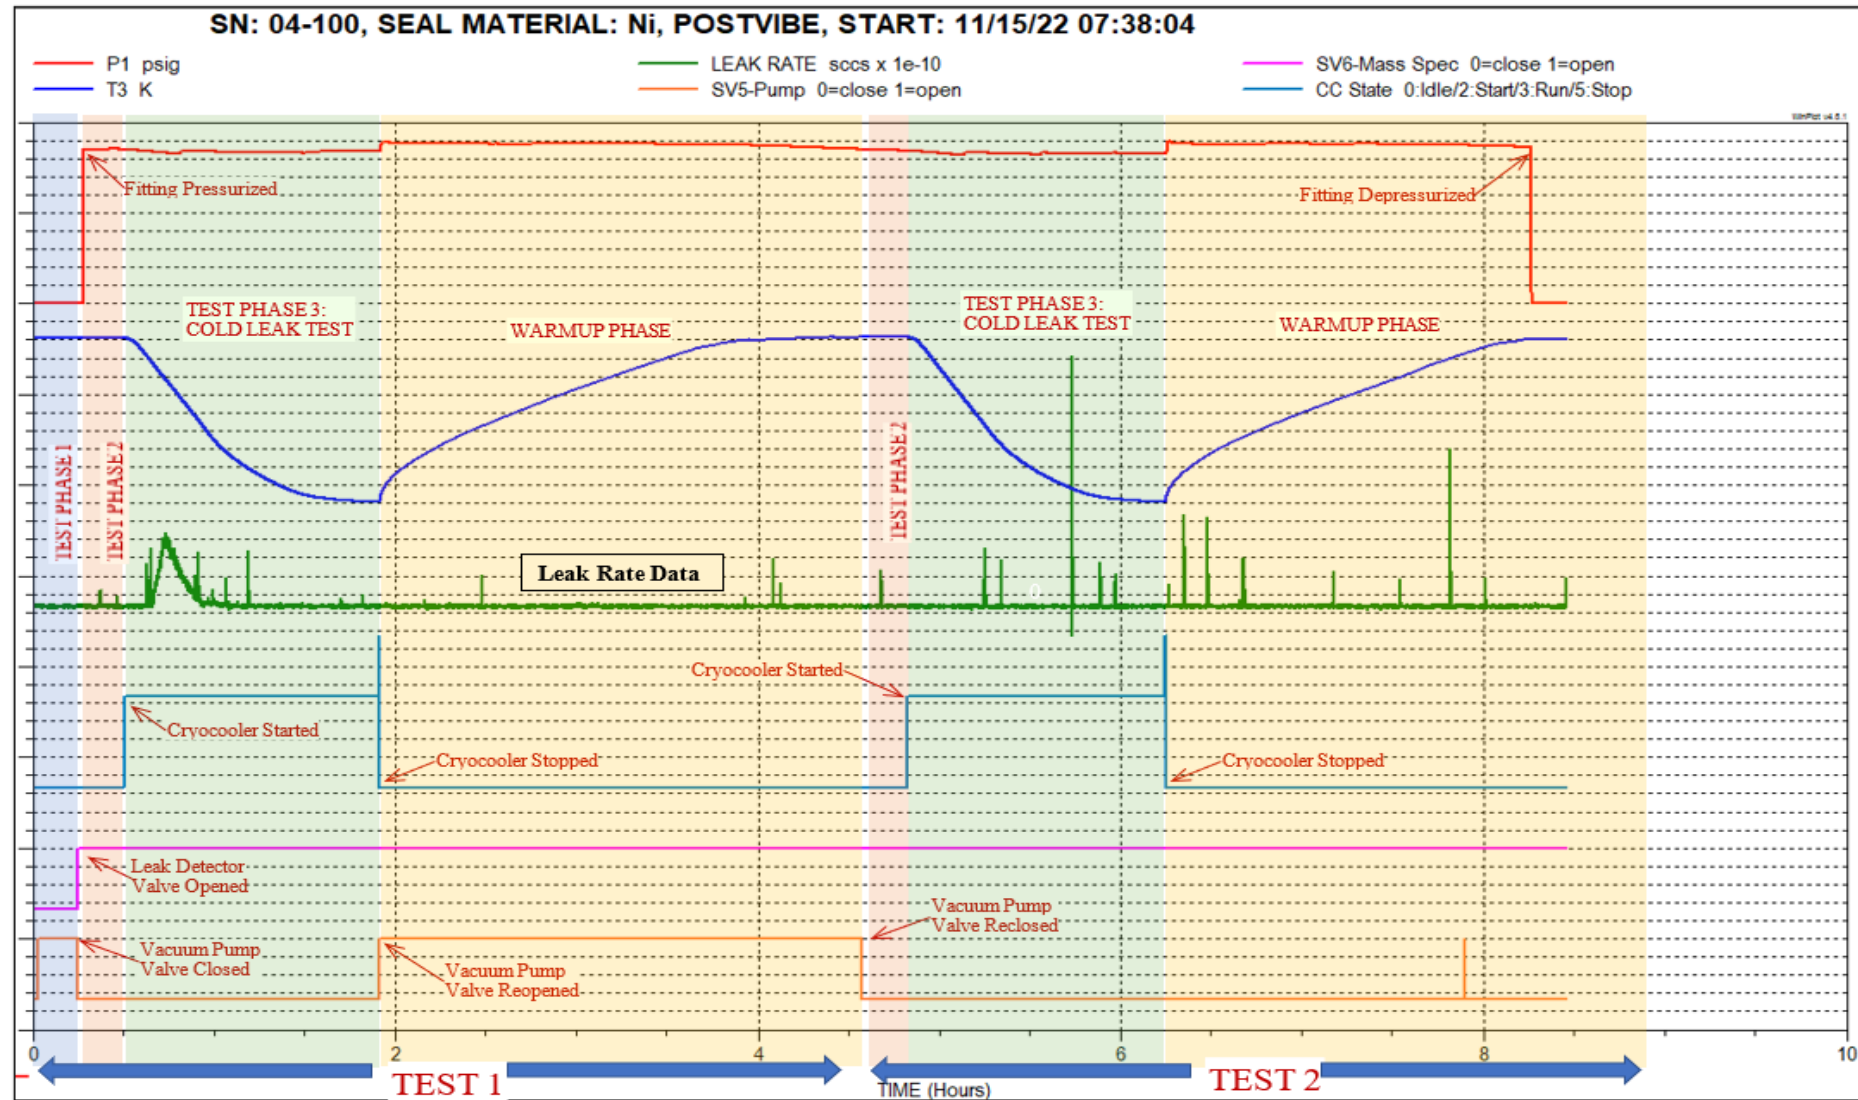
- **START OF COLD LEAK TEST**
 - Chamber evacuated
 - Fitting pressurized
 - Leak detector valve opened
 - Cryocooler started
 - Cryocooler stopped
- **END OF COLD LEAK TEST**
 - Warmup

Typical automated TVAC test, 2 ambient-cryo cycles

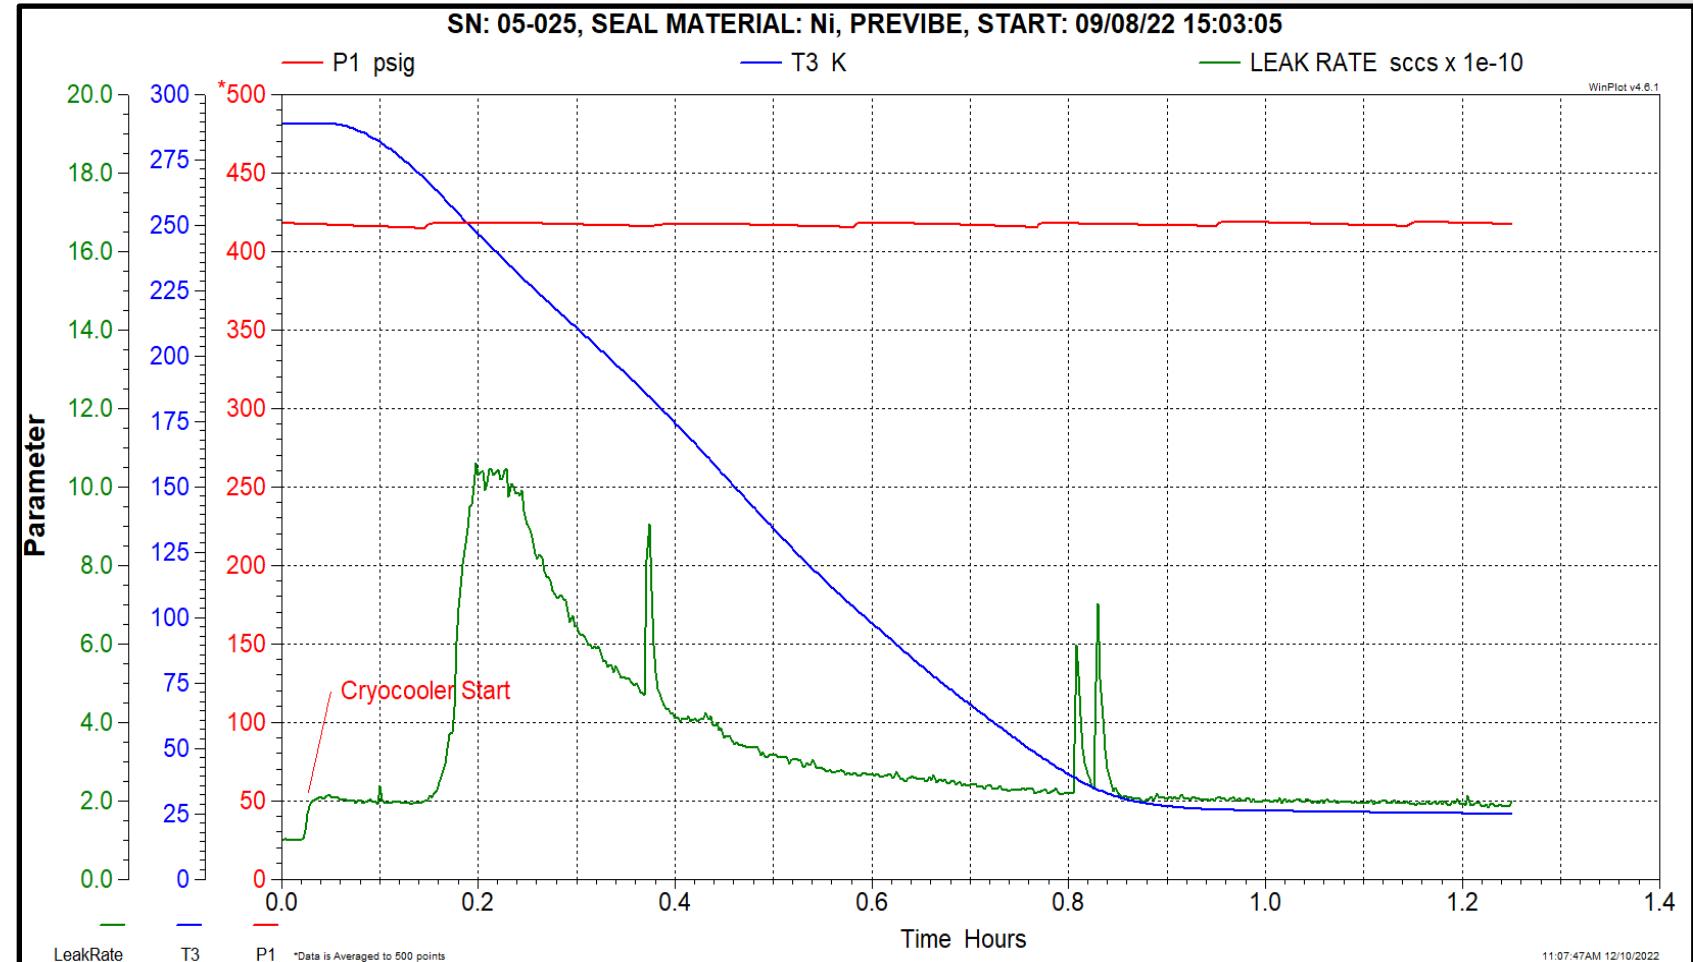
- 1/4" Fitting
- Silver-Plated Nickel Seal
- Pre-Vibe Run
- **Pressure (P1)**
- **Temperature (T3)**
- **Leak Rate (max)**
 - 10.5×10^{-10} sccs

Representative TVAC data run

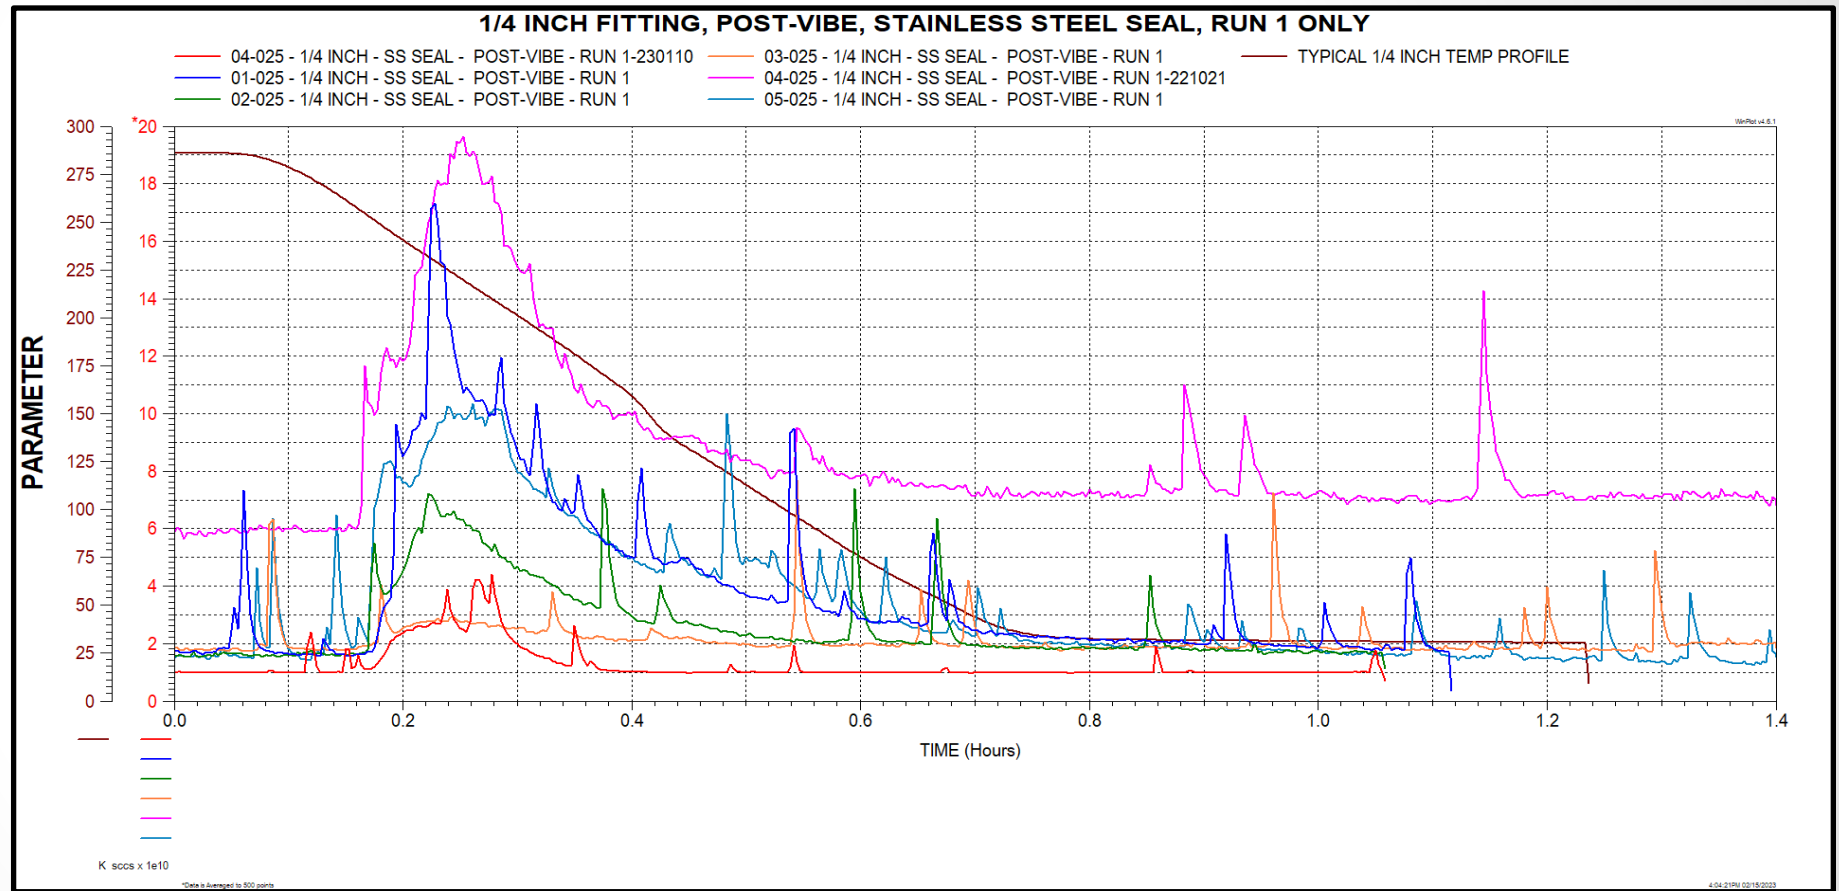
- 1/4" Fittings (5)
- SS Seal
- Post-Vibe test

- Max observed leak rate:
19.6 x 10⁻¹⁰ sccs
- Max allowable leak rate:
1 x 10⁻⁶ sccs

TVAC data run

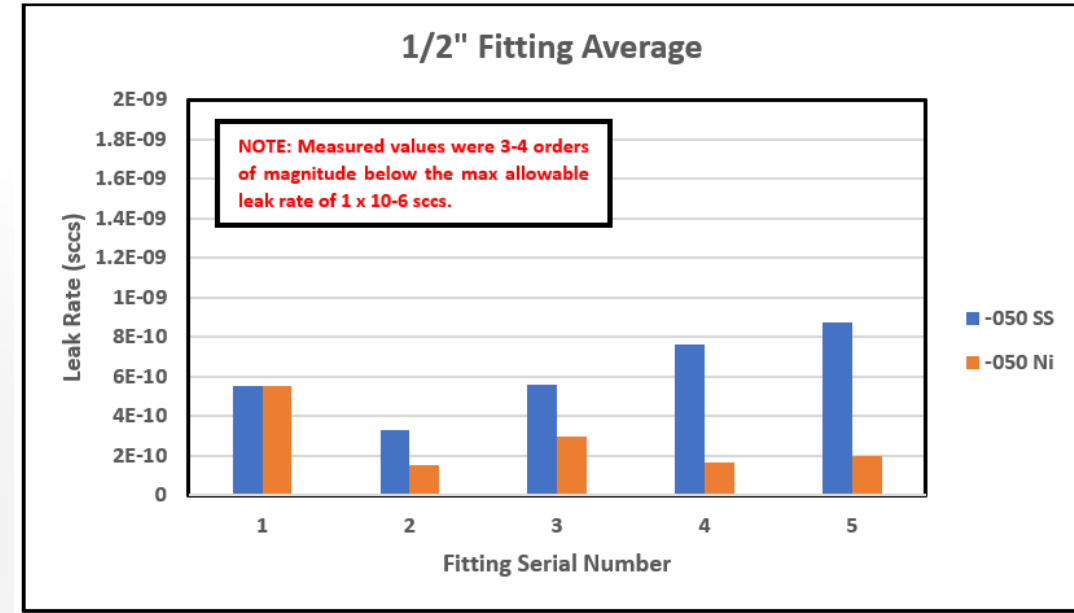
Maximum Helium Leak Rate Comparisons
(NOTE: Plotted values are the average of 4 tests: 2 pre-vibe and 2 post-vibe.)

- The measured GHe leak rates for 30 fitting/seal-pair test samples were typically in the range of 10^{-9} - 10^{-10} sccs during both Pre-Vibe and Post-Vibe TVAC cycles.
- The fittings remained leak tight at cryogenic temperature (20-30K)
- The fittings survived launch vibrations and remained leak-free under extreme thermal cycling.
- The Silver-plated Ni seals had lower leak rates, but the Stainless-Steel seals were more rugged.
- There were two deviations where damage to the Silver-plated Ni seal ring (scratches) during assembly resulted in a leaky fitting.
