Operation of the Cryogenic Plant at NSLS-II Problems and Solutions

July 11th, 2023

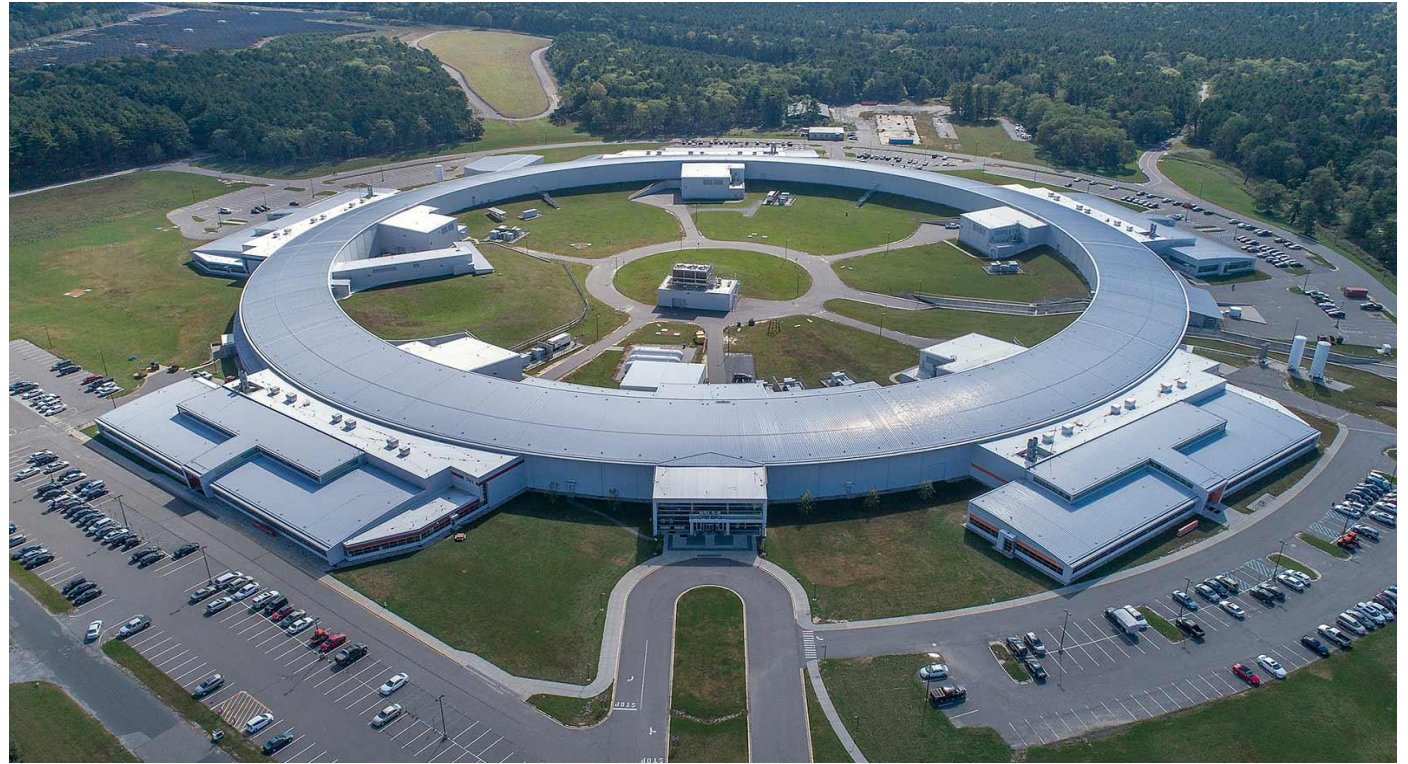
Two 500 MHz Cavities

The cryogenic system at NSLS-II is operating 8,700 - 8,760 hrs per year (10 years) and feeding three 500 MHz superconducting Radio Frequency cavities with liquid Helium.

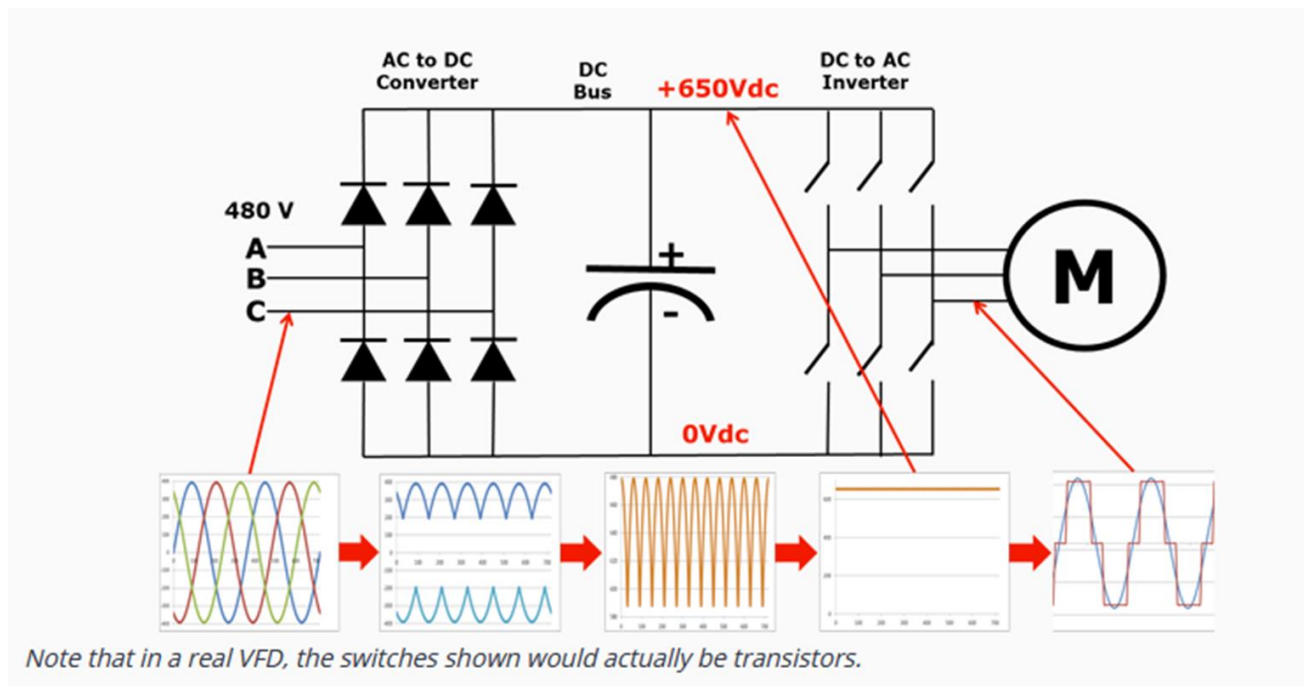
Added during April 2021 shutdown Ultracapacitor UPD (Uninterruptable Power for Drives) “Ride-Thru System” and it paid off at least 2 times during 2022 so far. Ultracapacitor can help the compressor (250 kW) ride through 100% power dip not exceeding 2 seconds.

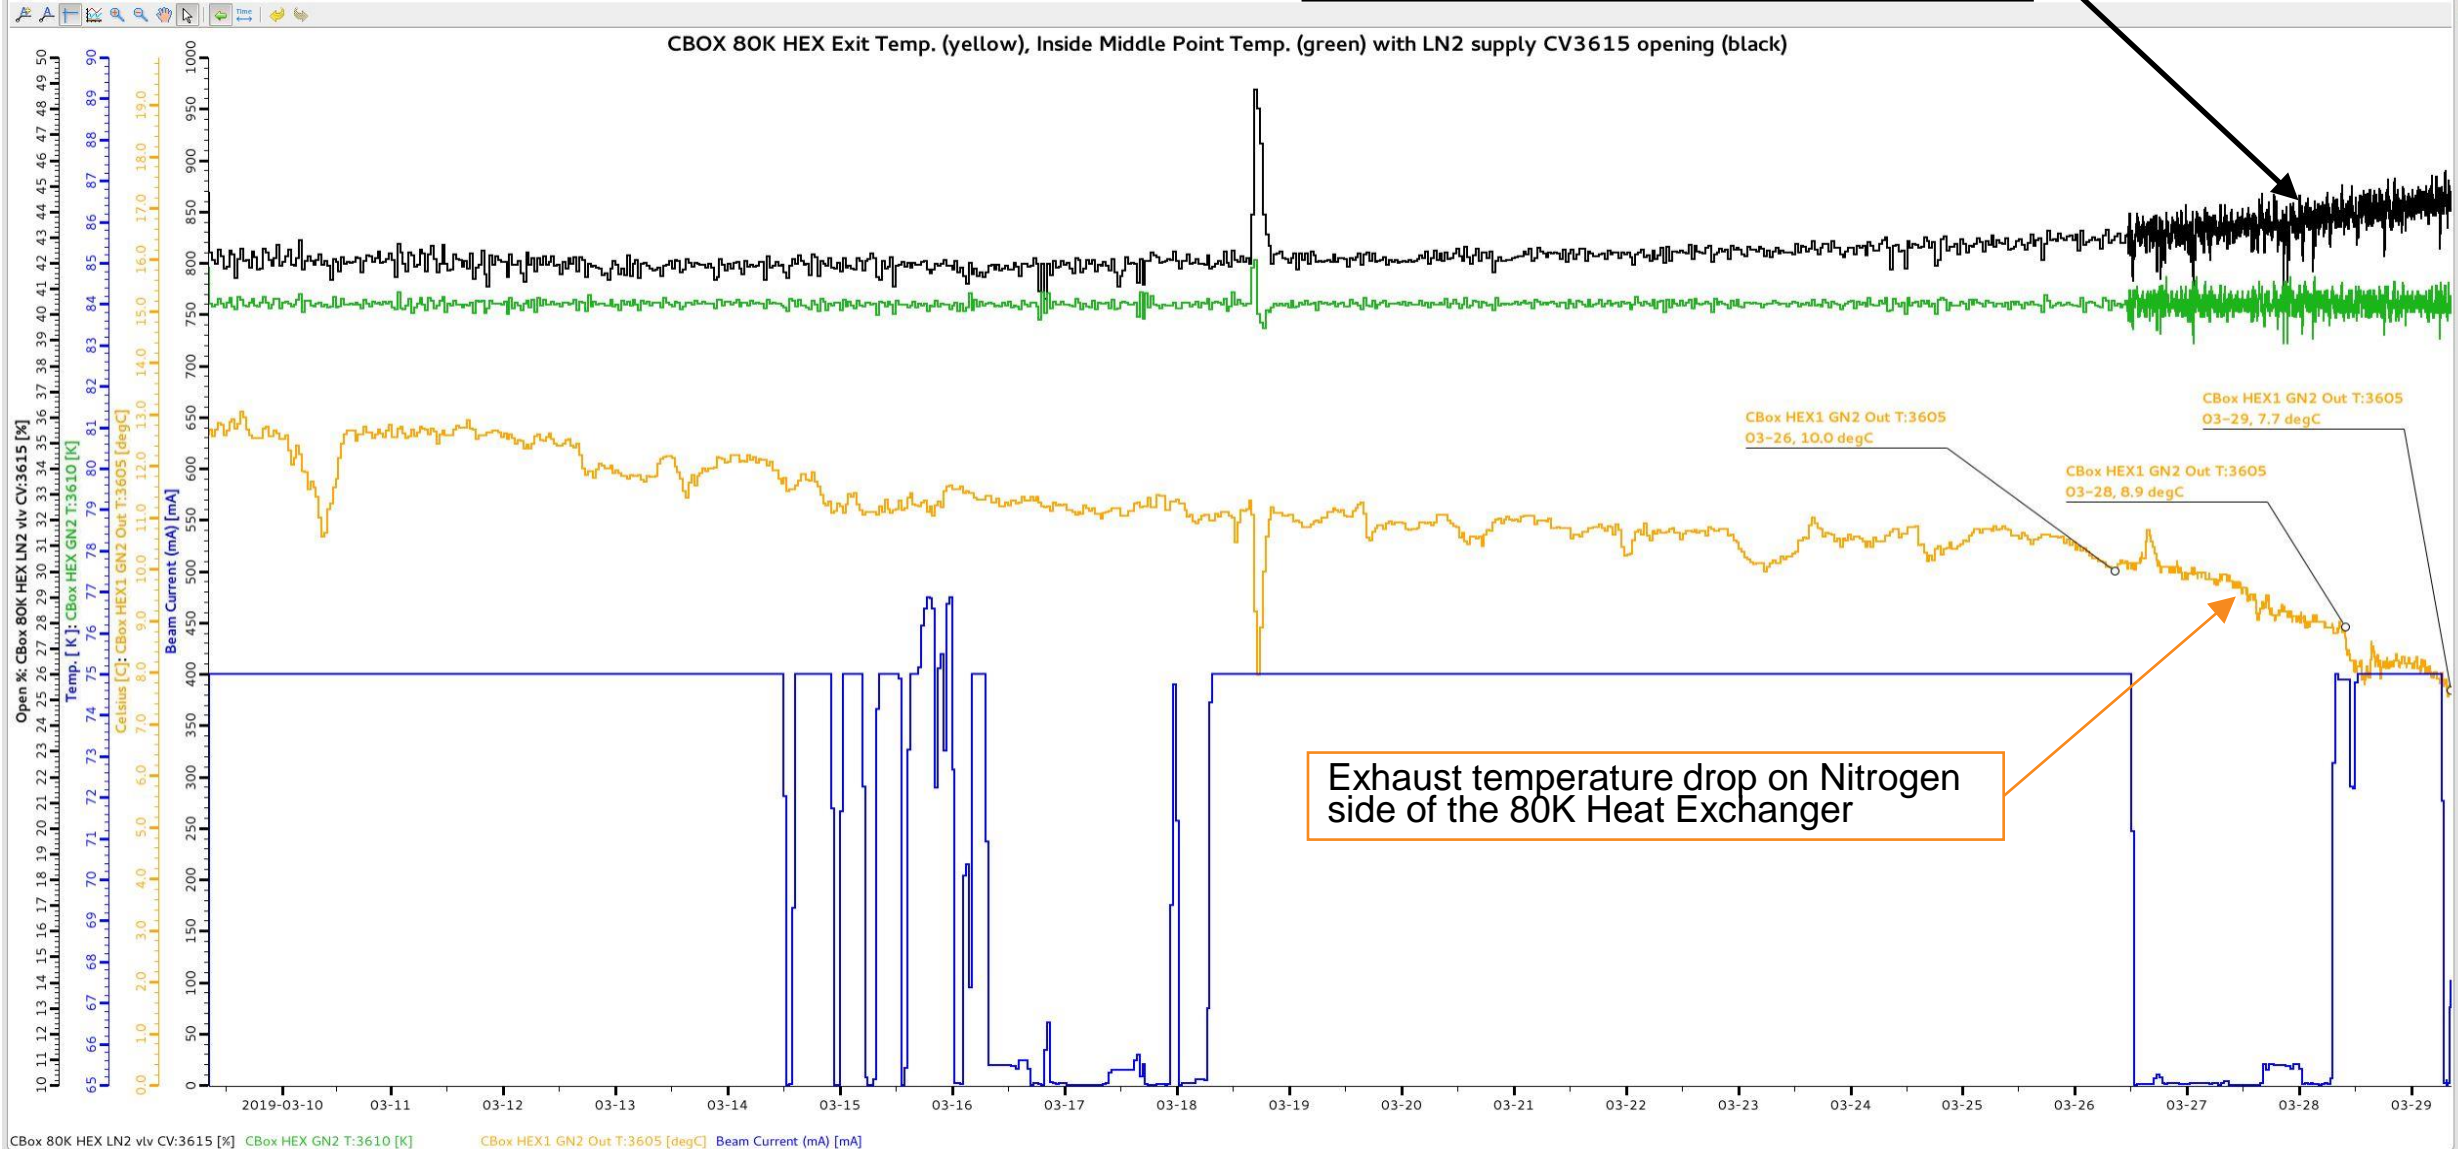
20 days plot example

LN2 supply valve is opening gradually to compensate the loss of the heat exchange

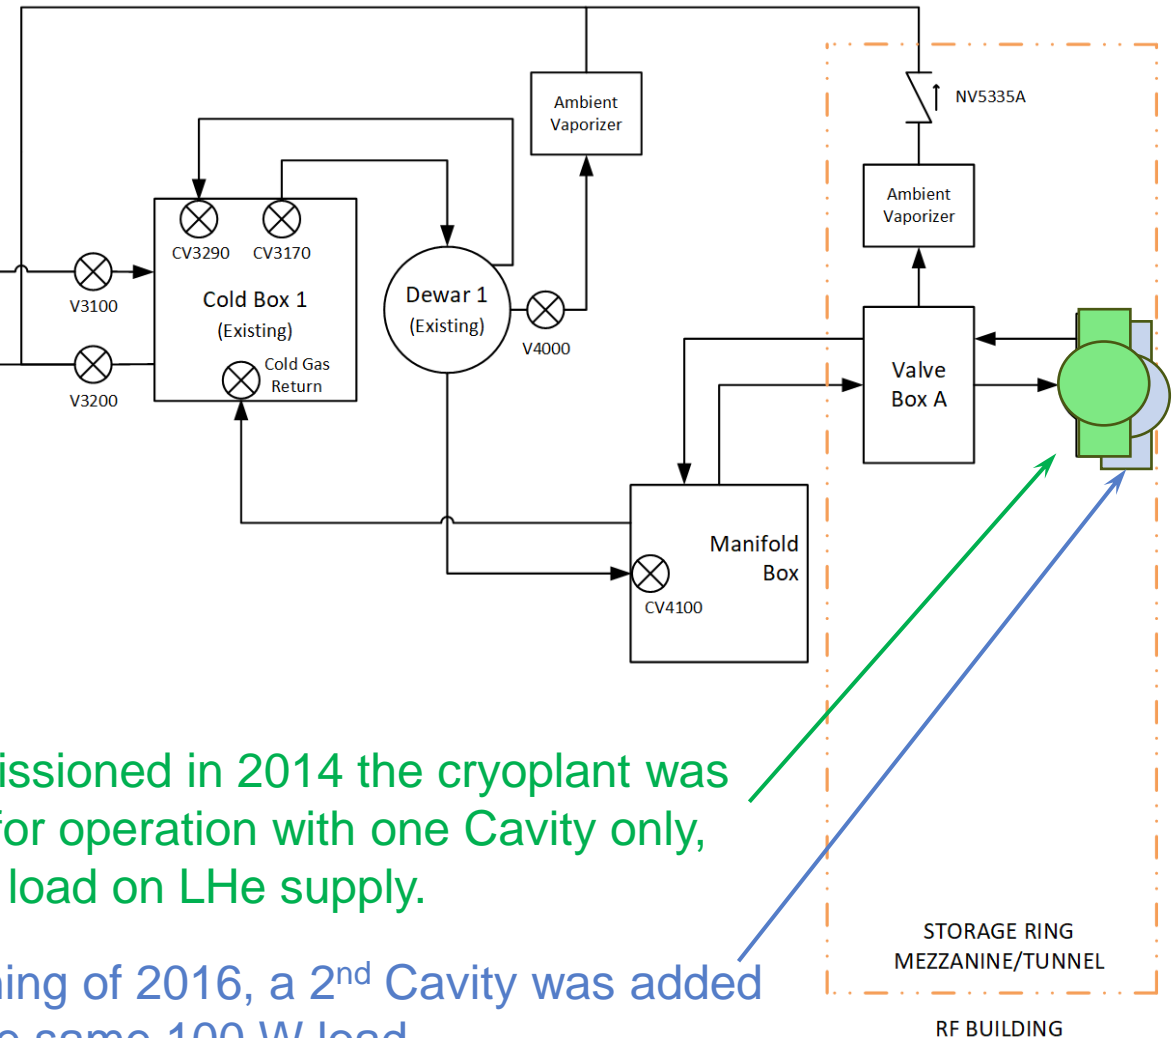
Original cryoplant configuration

Commissioned in 2014 the cryoplant was tuned for operation with one Cavity only, 100 W load on LHe supply.

Beginning of 2016, a 2nd Cavity was added with the same 100 W load.

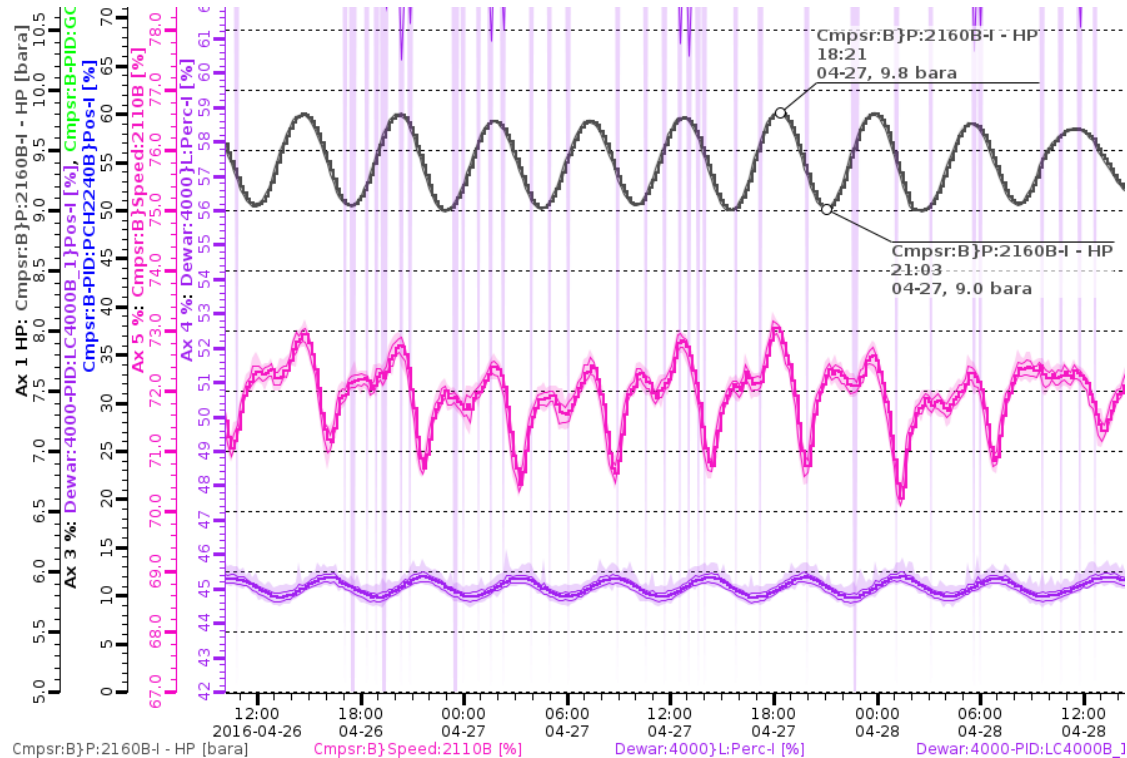
After Cavity D was added, the high-pressure oscillations appeared, up to 0.8 bar. The solution was to adjust the heater power in Dewar from 270 W down to 210 W to rebalance the load between Dewar and Cavity D.

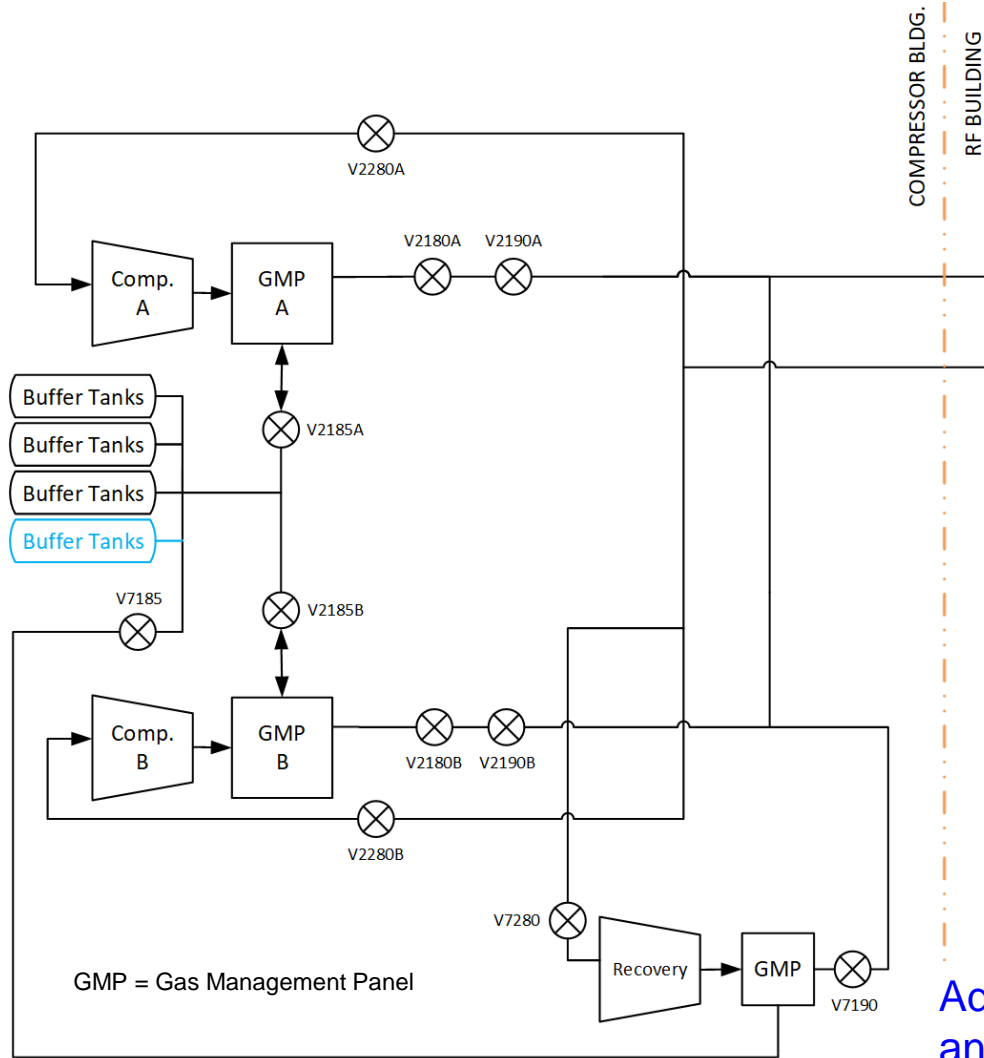
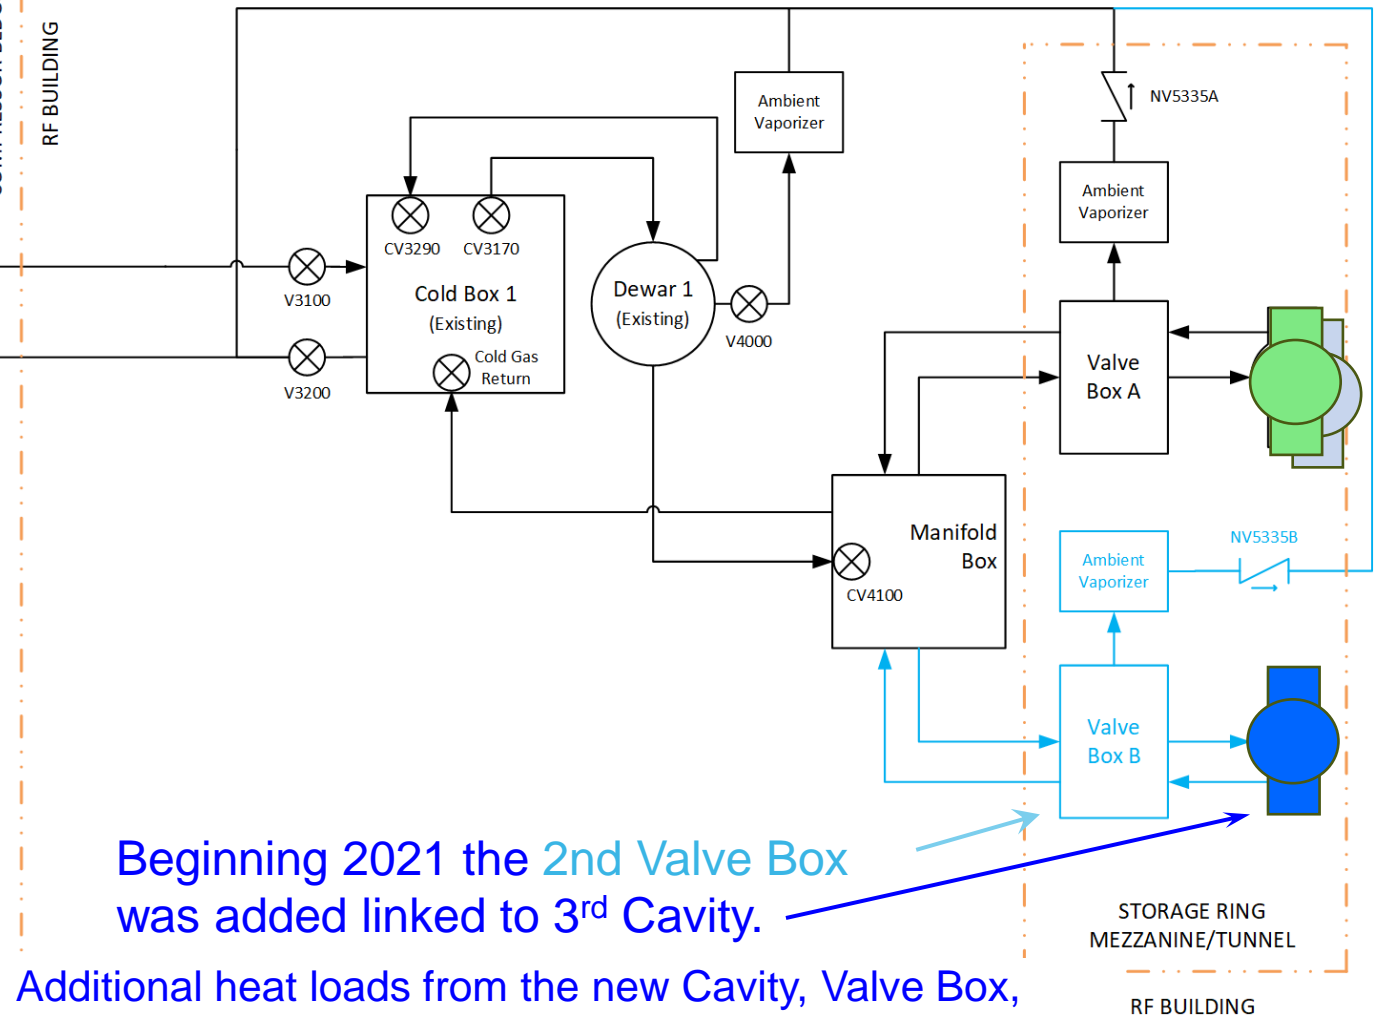
Beginning 2021 the 2nd Valve Box was added linked to 3rd Cavity.

Additional heat loads from the new Cavity, Valve Box, and its 128 feet cryogenic transfer lines appeared.

To avoid HP oscillation the heater power in Dewar was adjusted from 210 W down to 80 W, but this wasn't enough. The operating pressure set point increase from 9 bara up to 10 bara was required also.

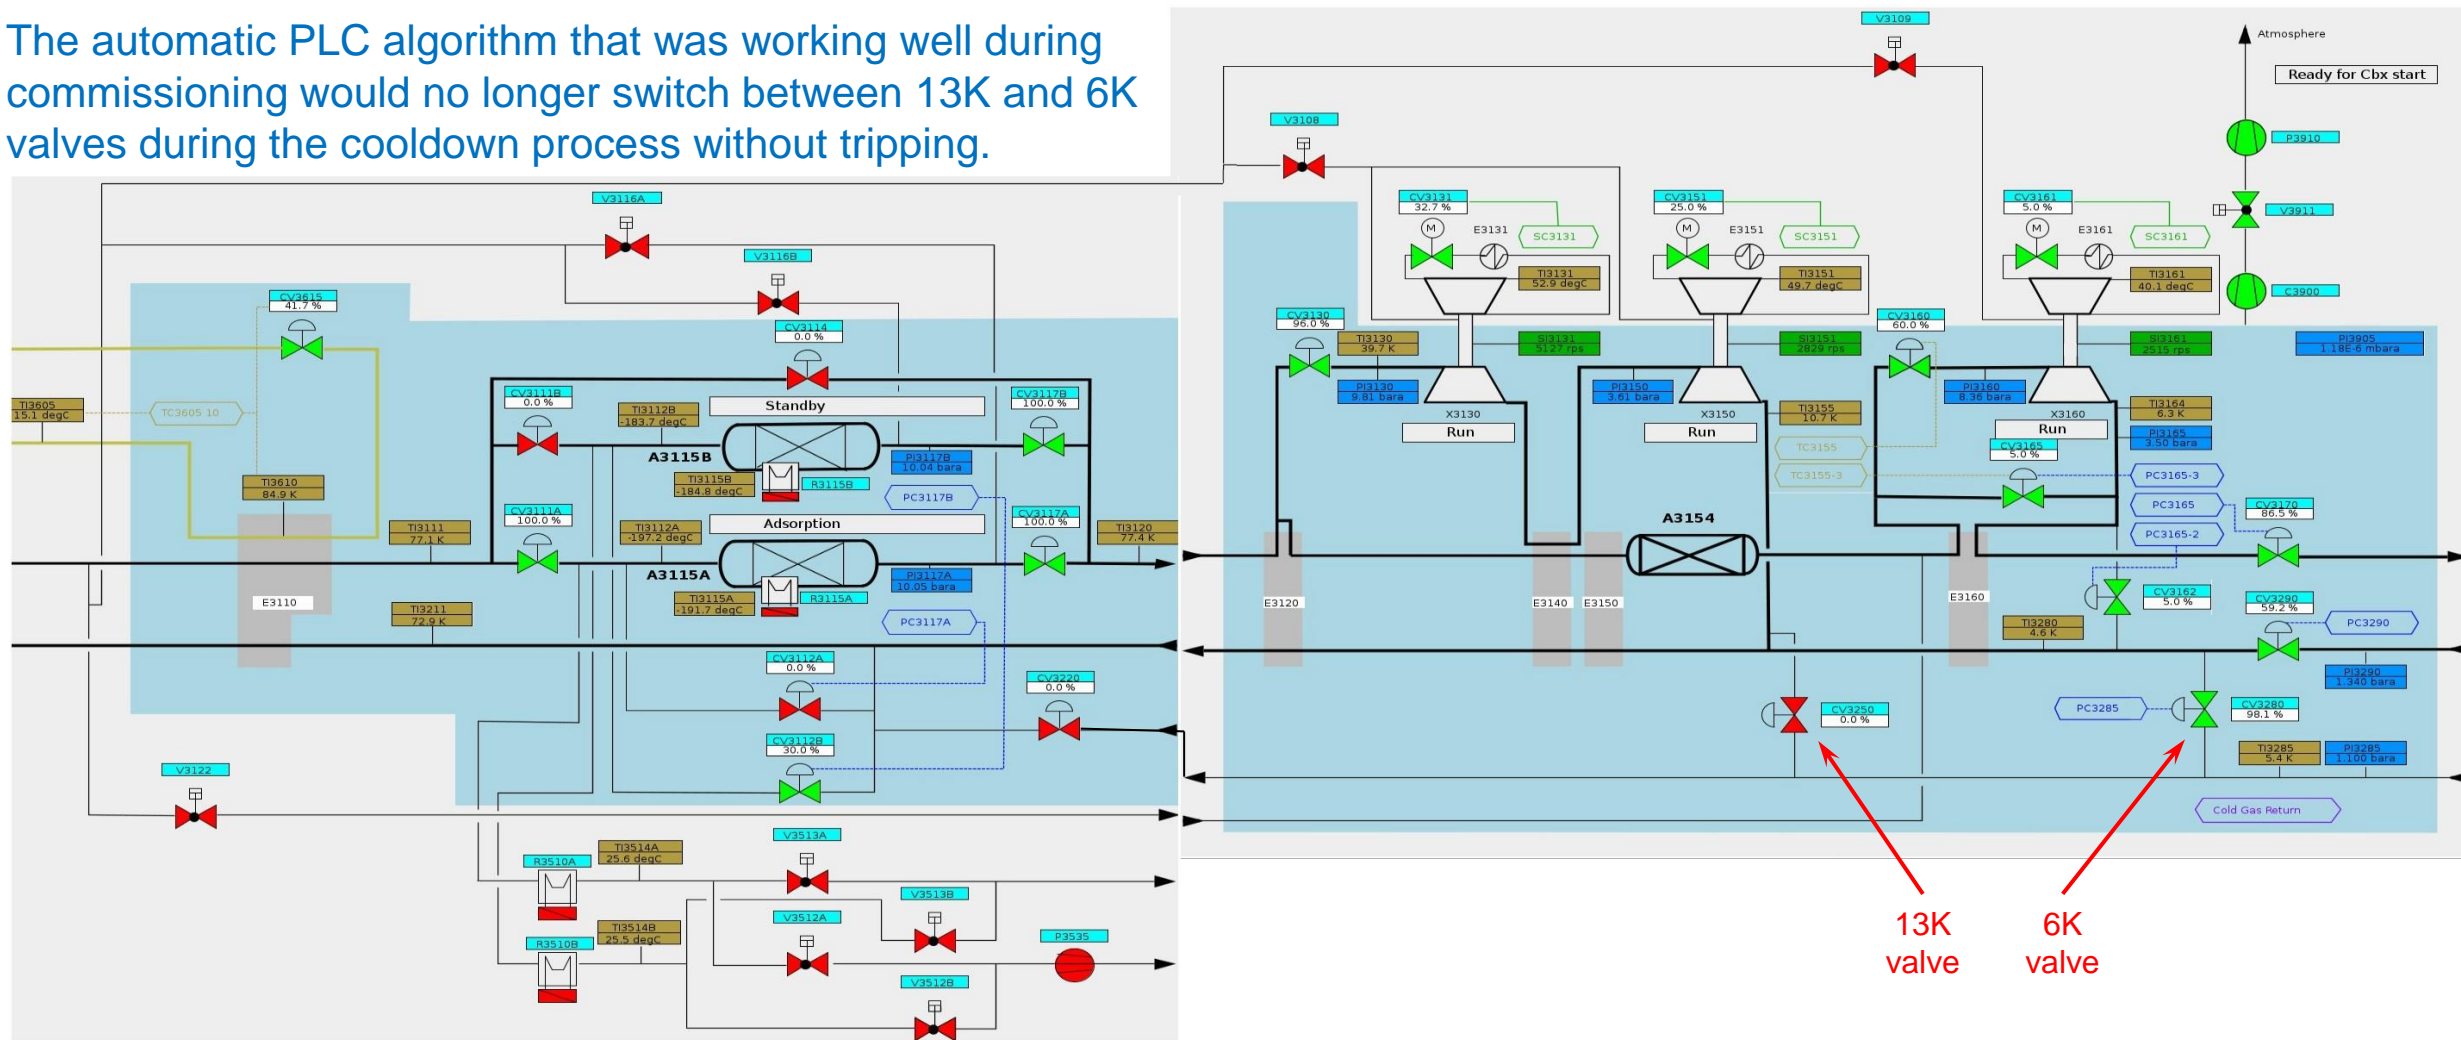
transition from 13K valve to 6K valve during cooling down

After cryoplant 2021 expansion there was another issue that was discovered. The increase of the LHe supply proportionally increased the gaseous Helium return to the cold box, almost doubling it.

The automatic PLC algorithm that was working well during commissioning would no longer switch between 13K and 6K valves during the cooldown process without tripping.
