Michael Reh  
11 July 2022  
University of Colorado Boulder  
Michael.Reh@colorado.edu

# Penn Light Barrier: Black Sheet

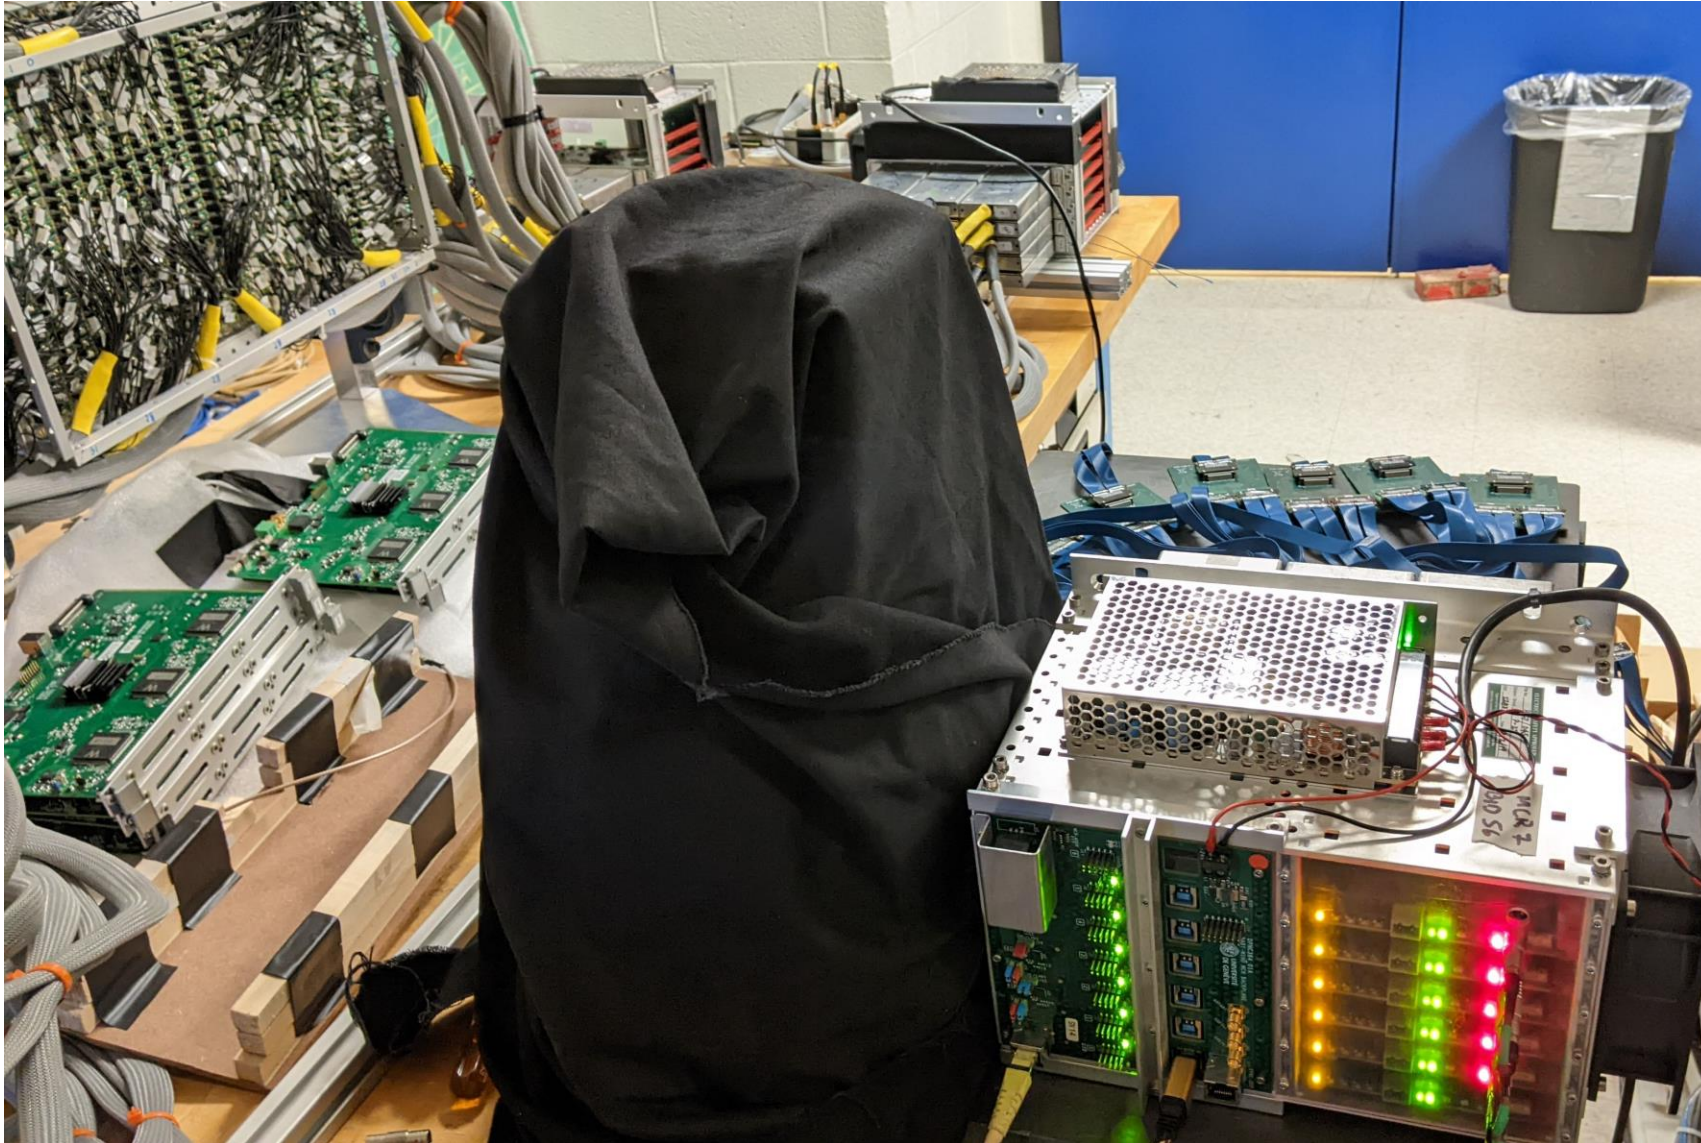
Two layers, black plastic and black cloth, wrapped and tucked around the detector

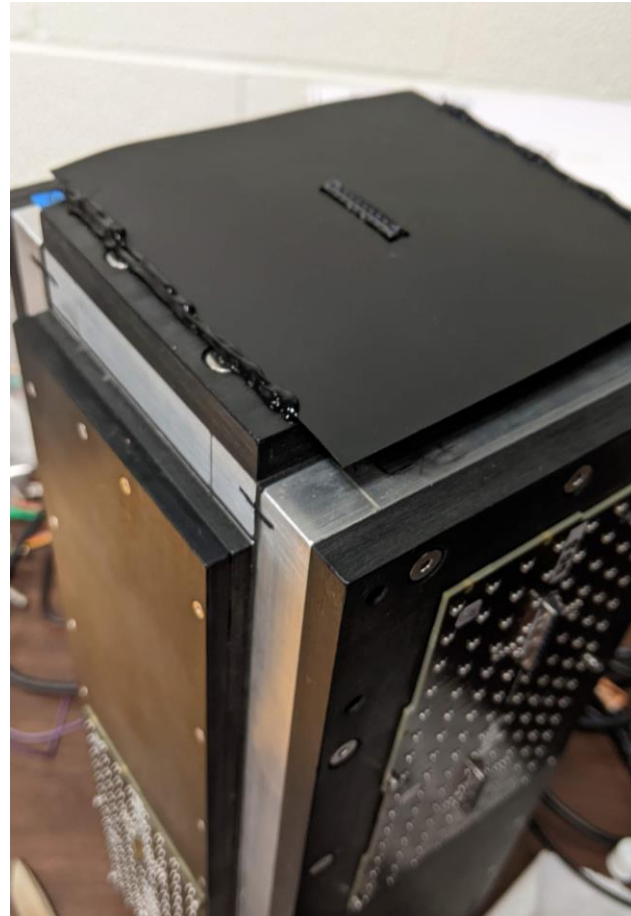
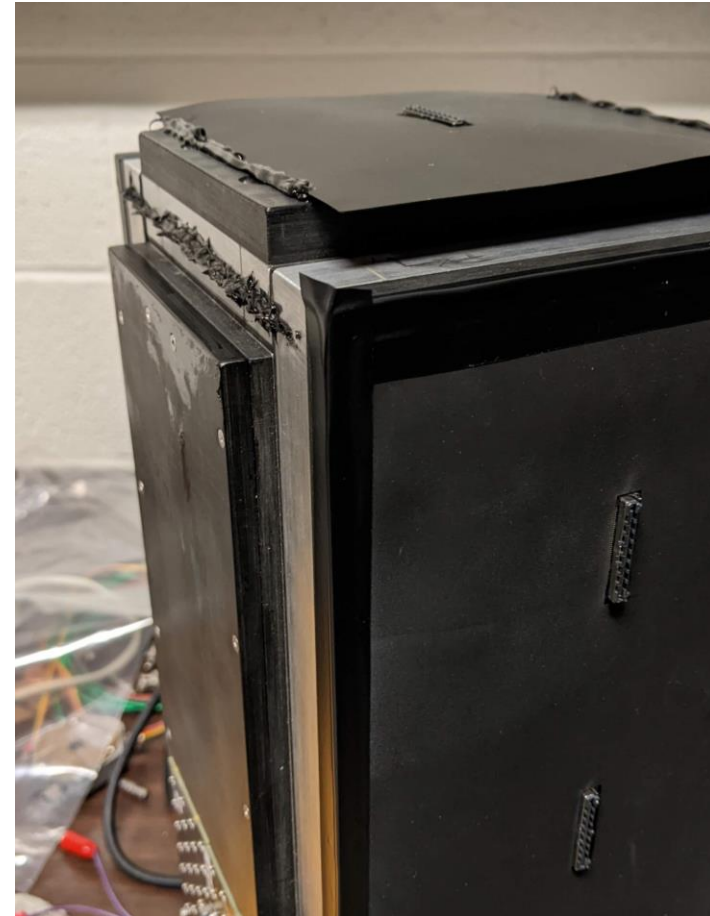
- Initially tried to attach the polyester to the detector using black RTV
  - Takes a long time to bond, very messy

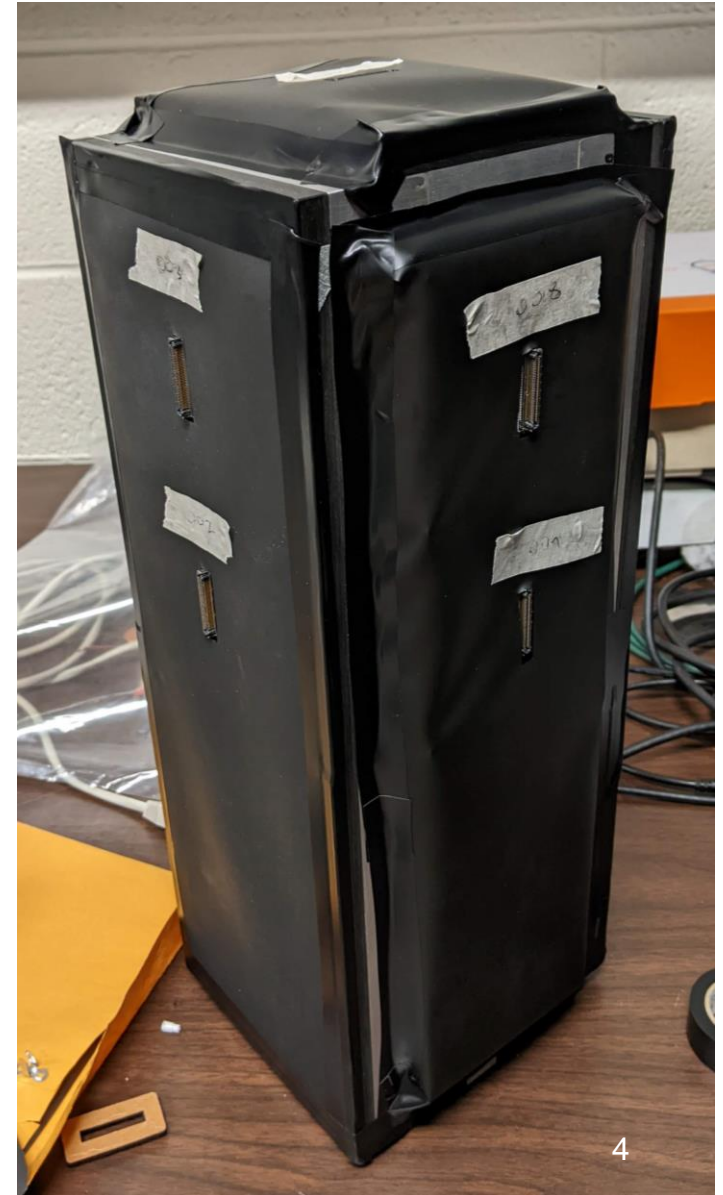
- Gave up on RTV, switched to electrical tape
- Pros:
  - Much easier to apply and change as necessary
  - Tape can cover any remaining exposed area
- Cons:
  - Might not have sufficient bond strength for the long-term
    - May need to use both electrical tape (for easy mounting) and RTV (for a long-lasting bond) for the finalized light barrier
  - Had some problems with the light barrier not lying flat → need more edge material for mounting

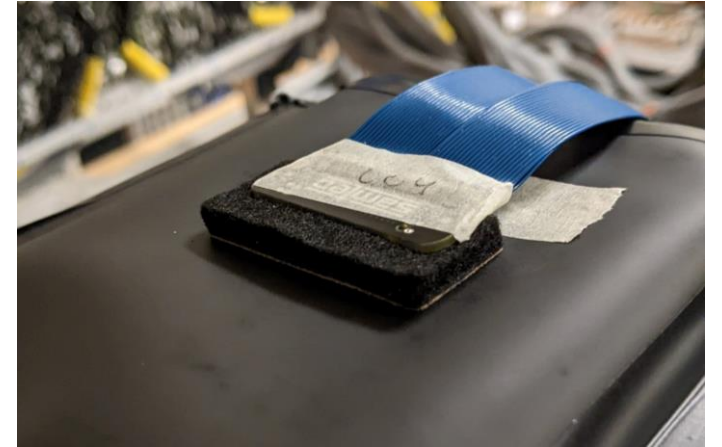
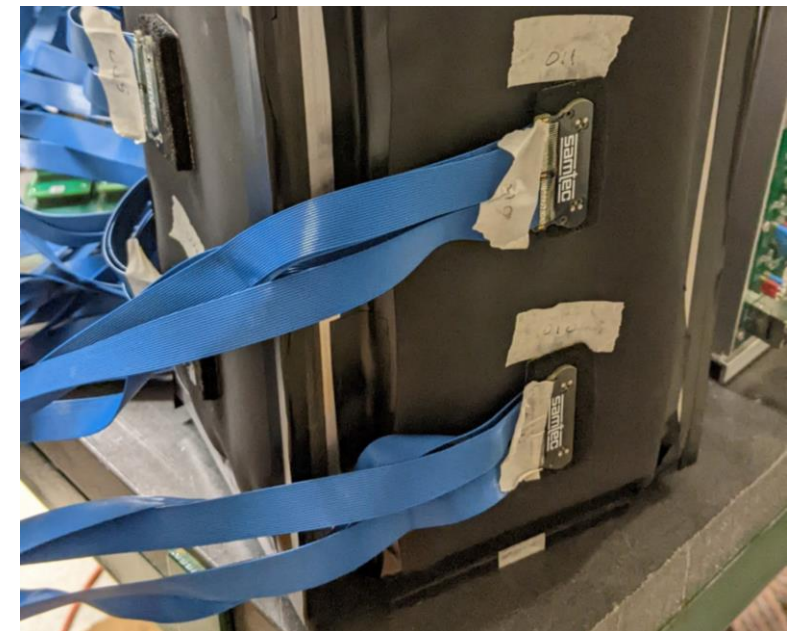
- Felt rings did not appear to affect detector performance (no new dead/hot channels, no difference in dark rate observed)
- Some difficulty when plugging in Samtec cables
  - No compression issues, but difficult to align cable with PCB connector (blind plug)
- Did not use sticky-backing (wanted to be able to easily take them on and off)
