Status of Pb/Nb coatings for photocathodes

R. Nietubyc, J. Sekutowicz and P. Kneisel

Motivation

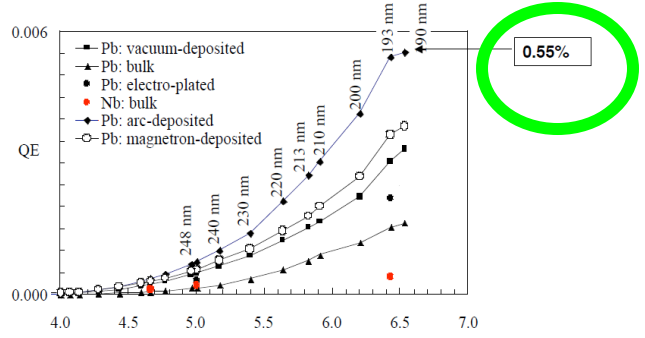
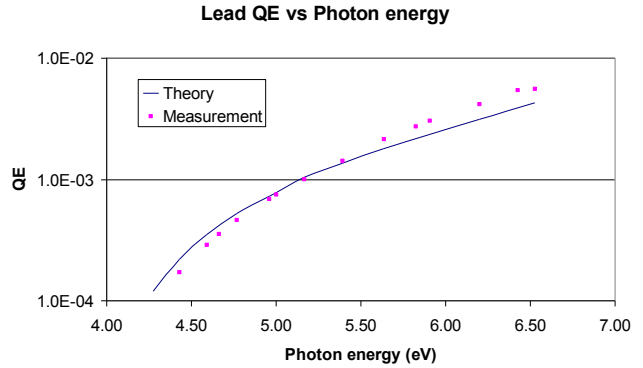
Samples surface was cleaned with KrF 10 ns 20 Hz pulses 248 nm 0.3 mJ/mm laser pulses, next QE was measured

Arc deposited layer showed the highest QE

Experimental results confirm the calculations

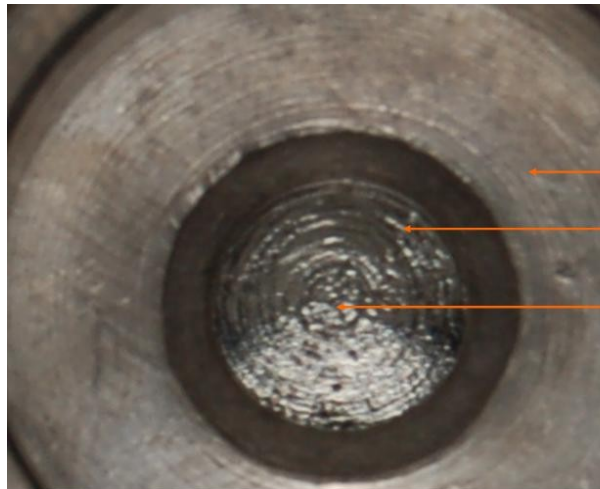
mask
cavity back wall
centre of circles remain after spinning (a centre back wall)

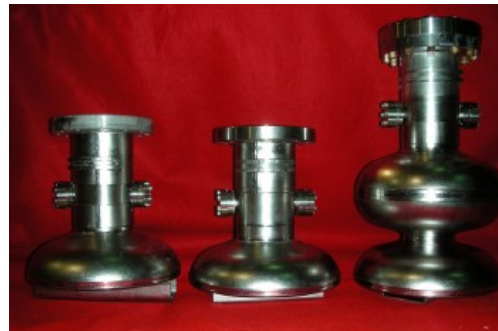
$\frac{1}{2}$ and 1.6-cell cavities

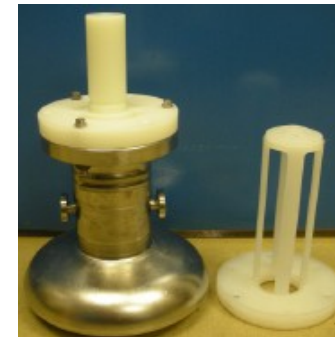
mask for BCP
treatment

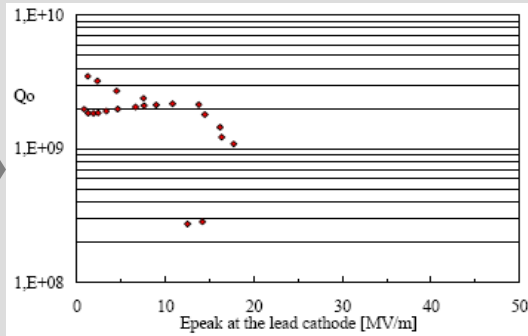
1,6 cell cavity with lead spot

Q decreases caused by hydrogen, which got into the walls during the deposition

Multipacting caused by insufficient BCP+HPWR

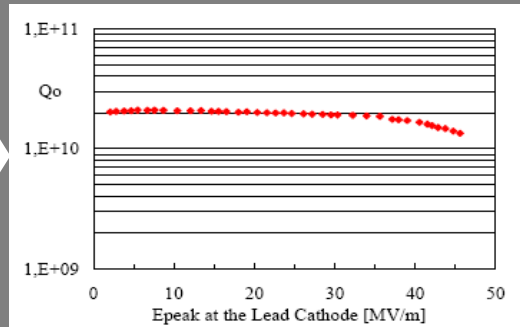
2nd Test of 1,6 cell cavity

46 MV/m

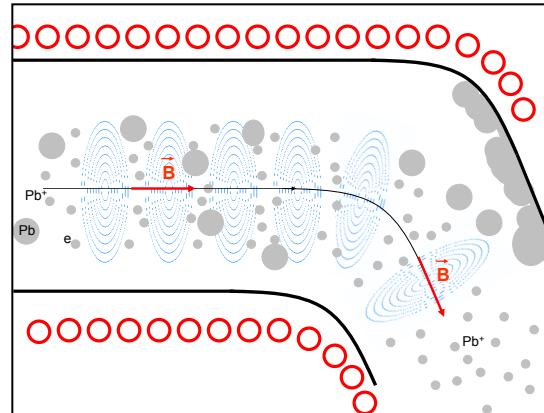
The arc carries not only ions but also droplets of few micrometers size. The cause a surface roughness which may results in angular divergence of emitted electrons

Micro-droplets can be filtered by bending the arc channel with magnetic field but in cost of transmission

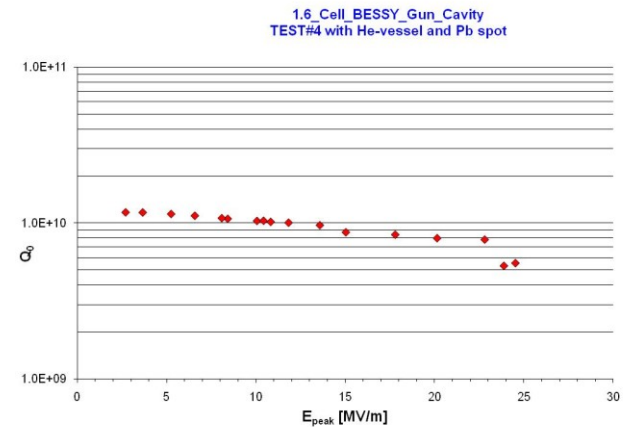
Q vs E_{acc} measurements at $T=2.2$ K

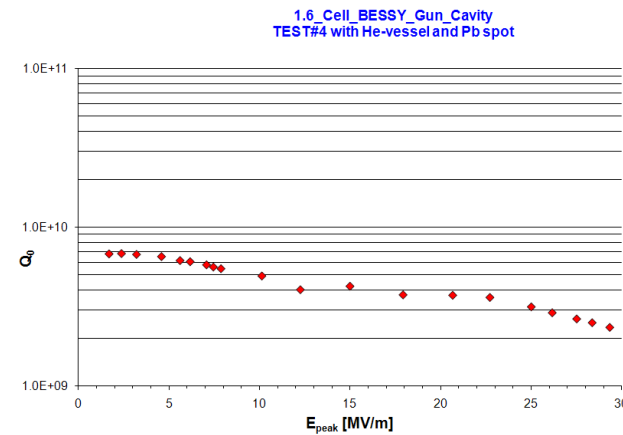
Q vs E_{acc} measurements at $T=2.0$ K

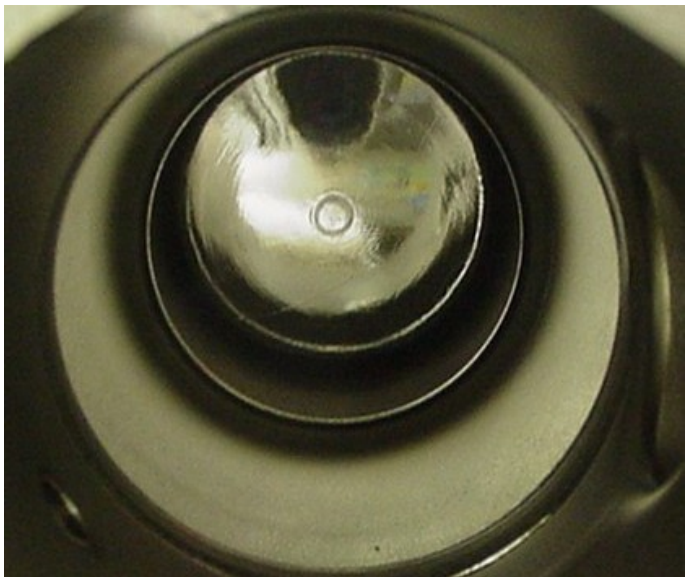
Ring

A ring of 10 mm diameter after 10 mm BCP and next 8 min BCP at bacv wall only → another 20 mm

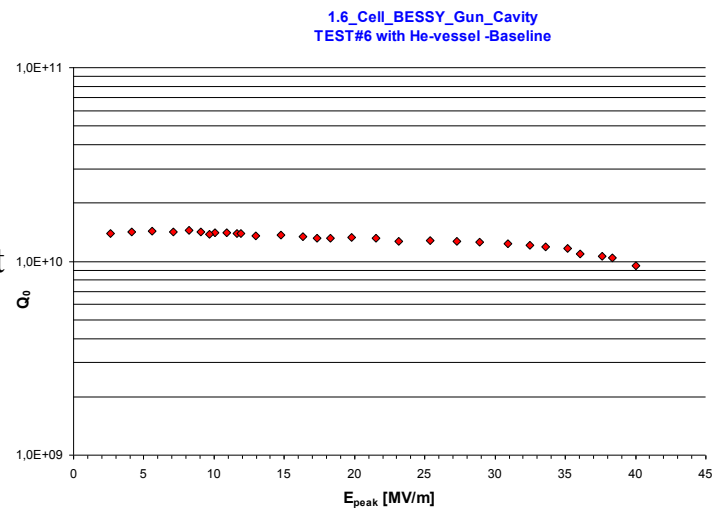
Q vs E_{acc} measurement

$9.3 \cdot 10^9$ at 40 MVm^{-1}

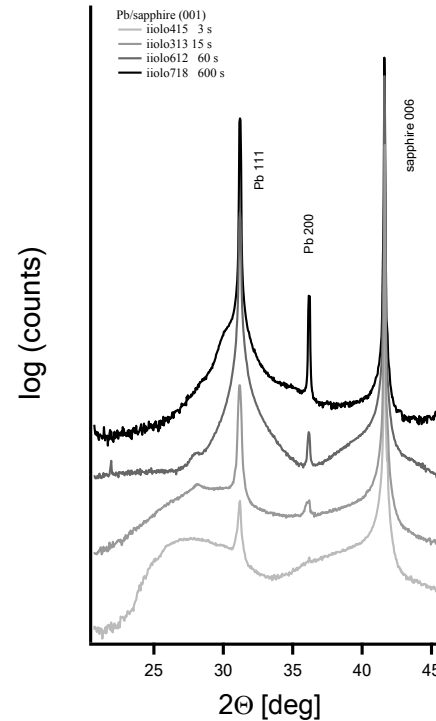
Pb/Al₂O₃ (001)

Nano-crystalline Pb phase occurs in the interface with single crystal Al₂O₃ but not in Pb/Nb (poly)

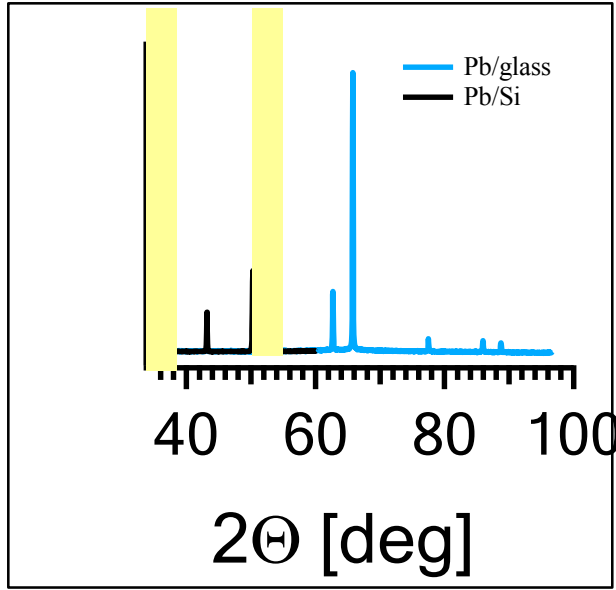
Orientation of Pb grains depends on the substrate
