Long-term humidity exposure of ATLAS18 ITk strip sensors

Abstract

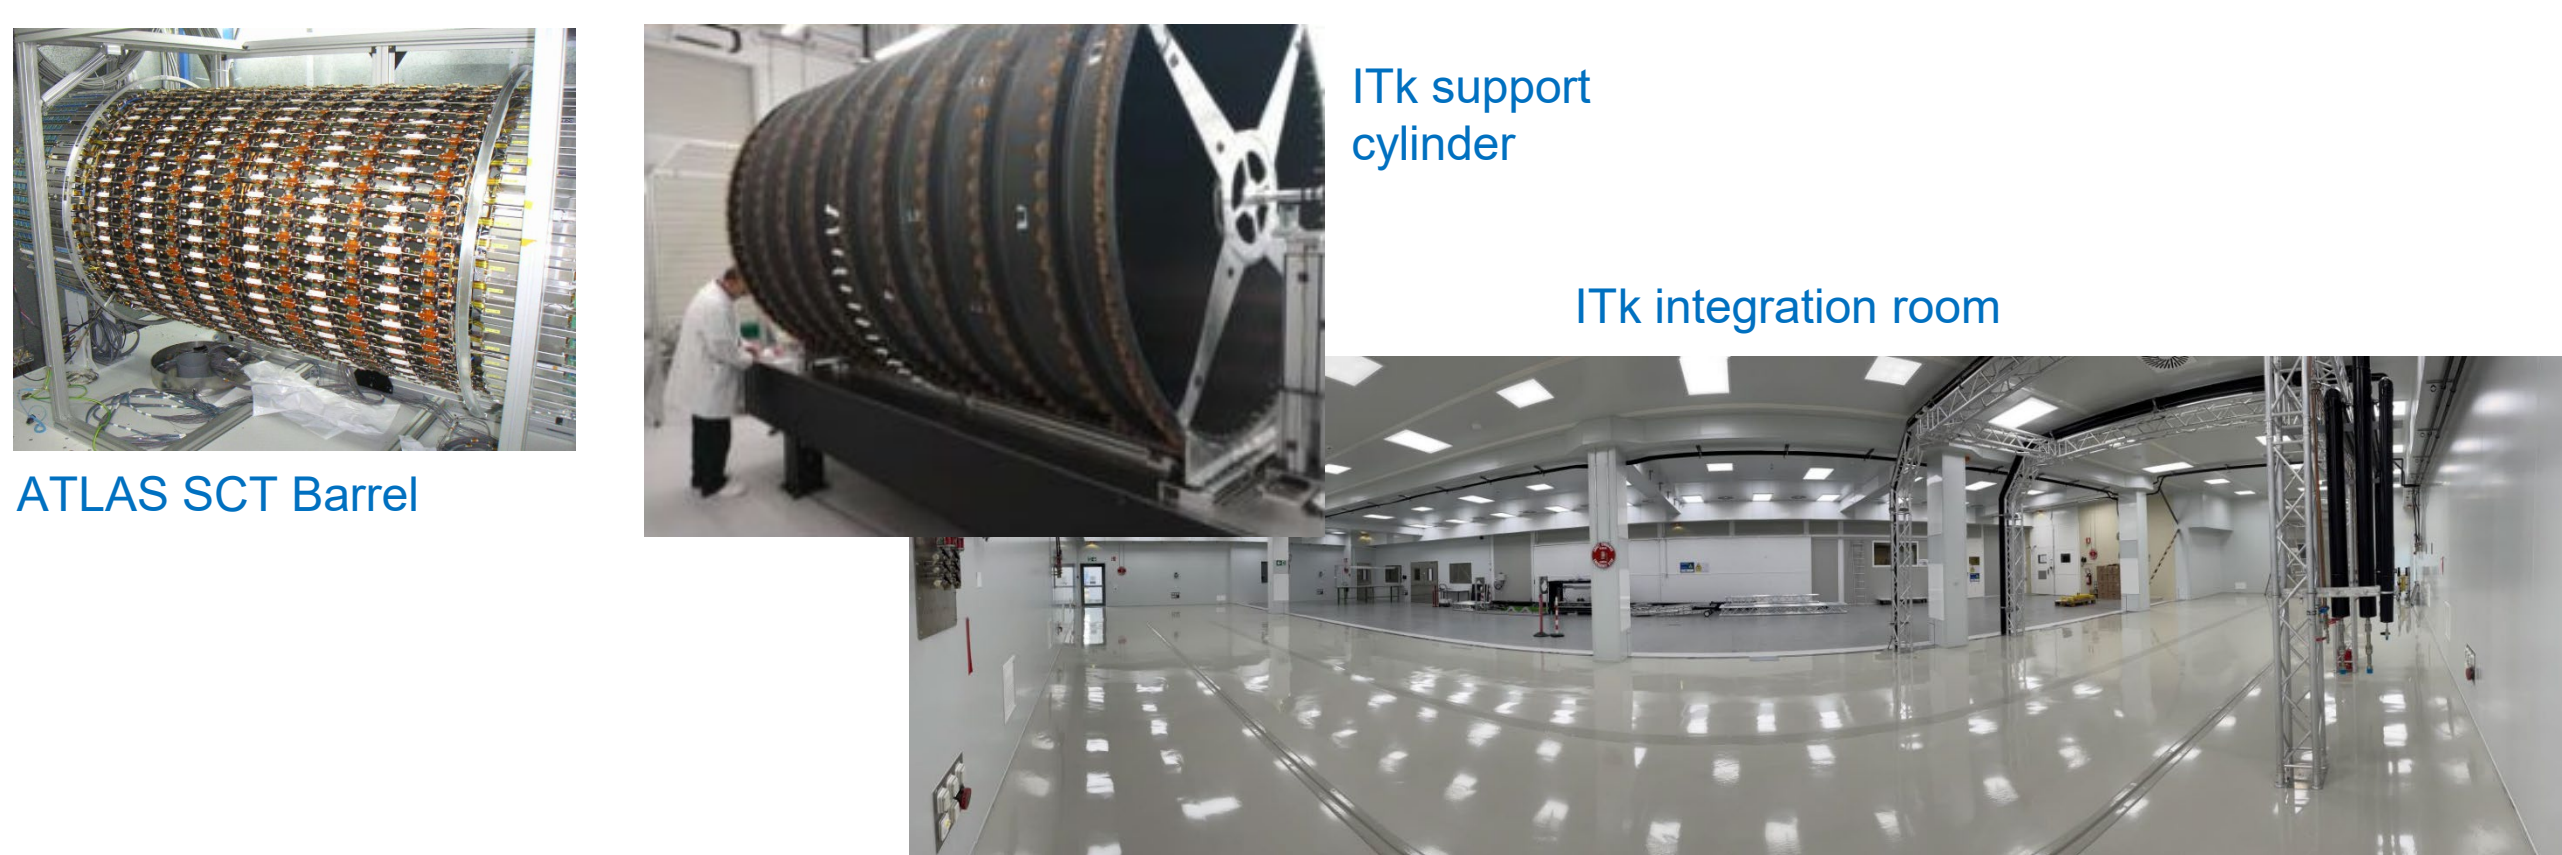
The setups for the large-scale tracker objects, such as disks and cylinders, are different. They need large cleanroom volumes, which are impractical to keep dry at all times. Therefore, it is important to investigate a question of the long-term sensor tolerance to the ambient humidity. Given the Specifications for the cleanrooms and the construction plans, we formulate the question in the following way: **After a several months long exposure to RH of 50% to 70%, would the ATLAS18 sensors still have the acceptable Vbd > 500 V, as shown by the IV tests performed in a dry environment (RH<10%)?**

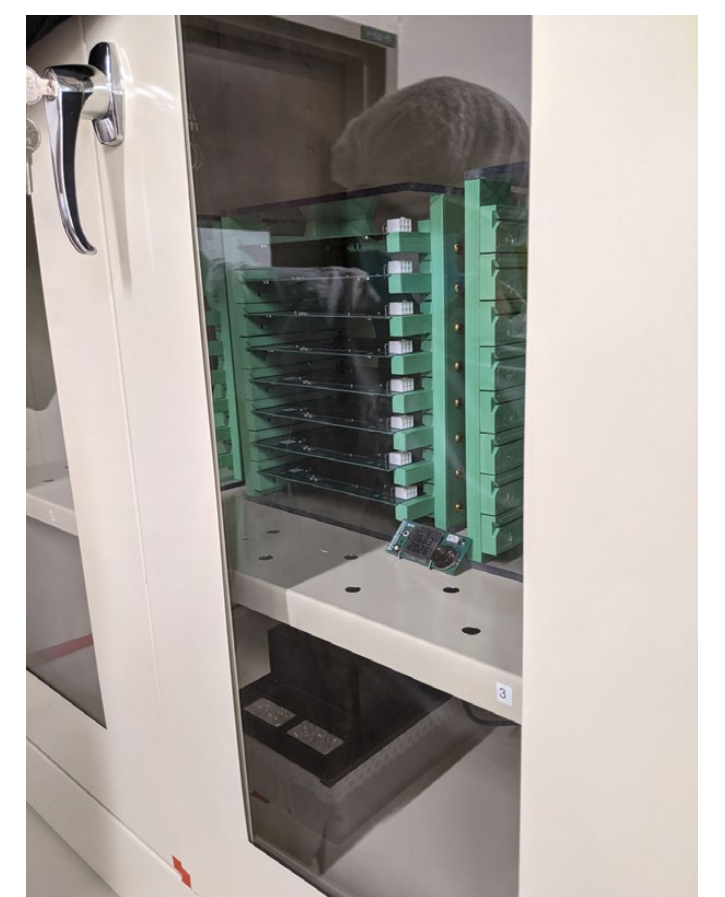
The setups:

- For the first 4 months, the "flatbed" setup was used. It was not scalable to the larger quantity of sensors.
- A dedicated hermetized cabinet was commissioned and used for the rest of the exposure, to scale up the total number of sensors to 24. They were arranged in vertical holding shelves.
- To control the humidity, Oasis Humidor unit was used with a set point at 75% RH, above the expected humidity range. The setup temperature varied between 19 C and 23 C.

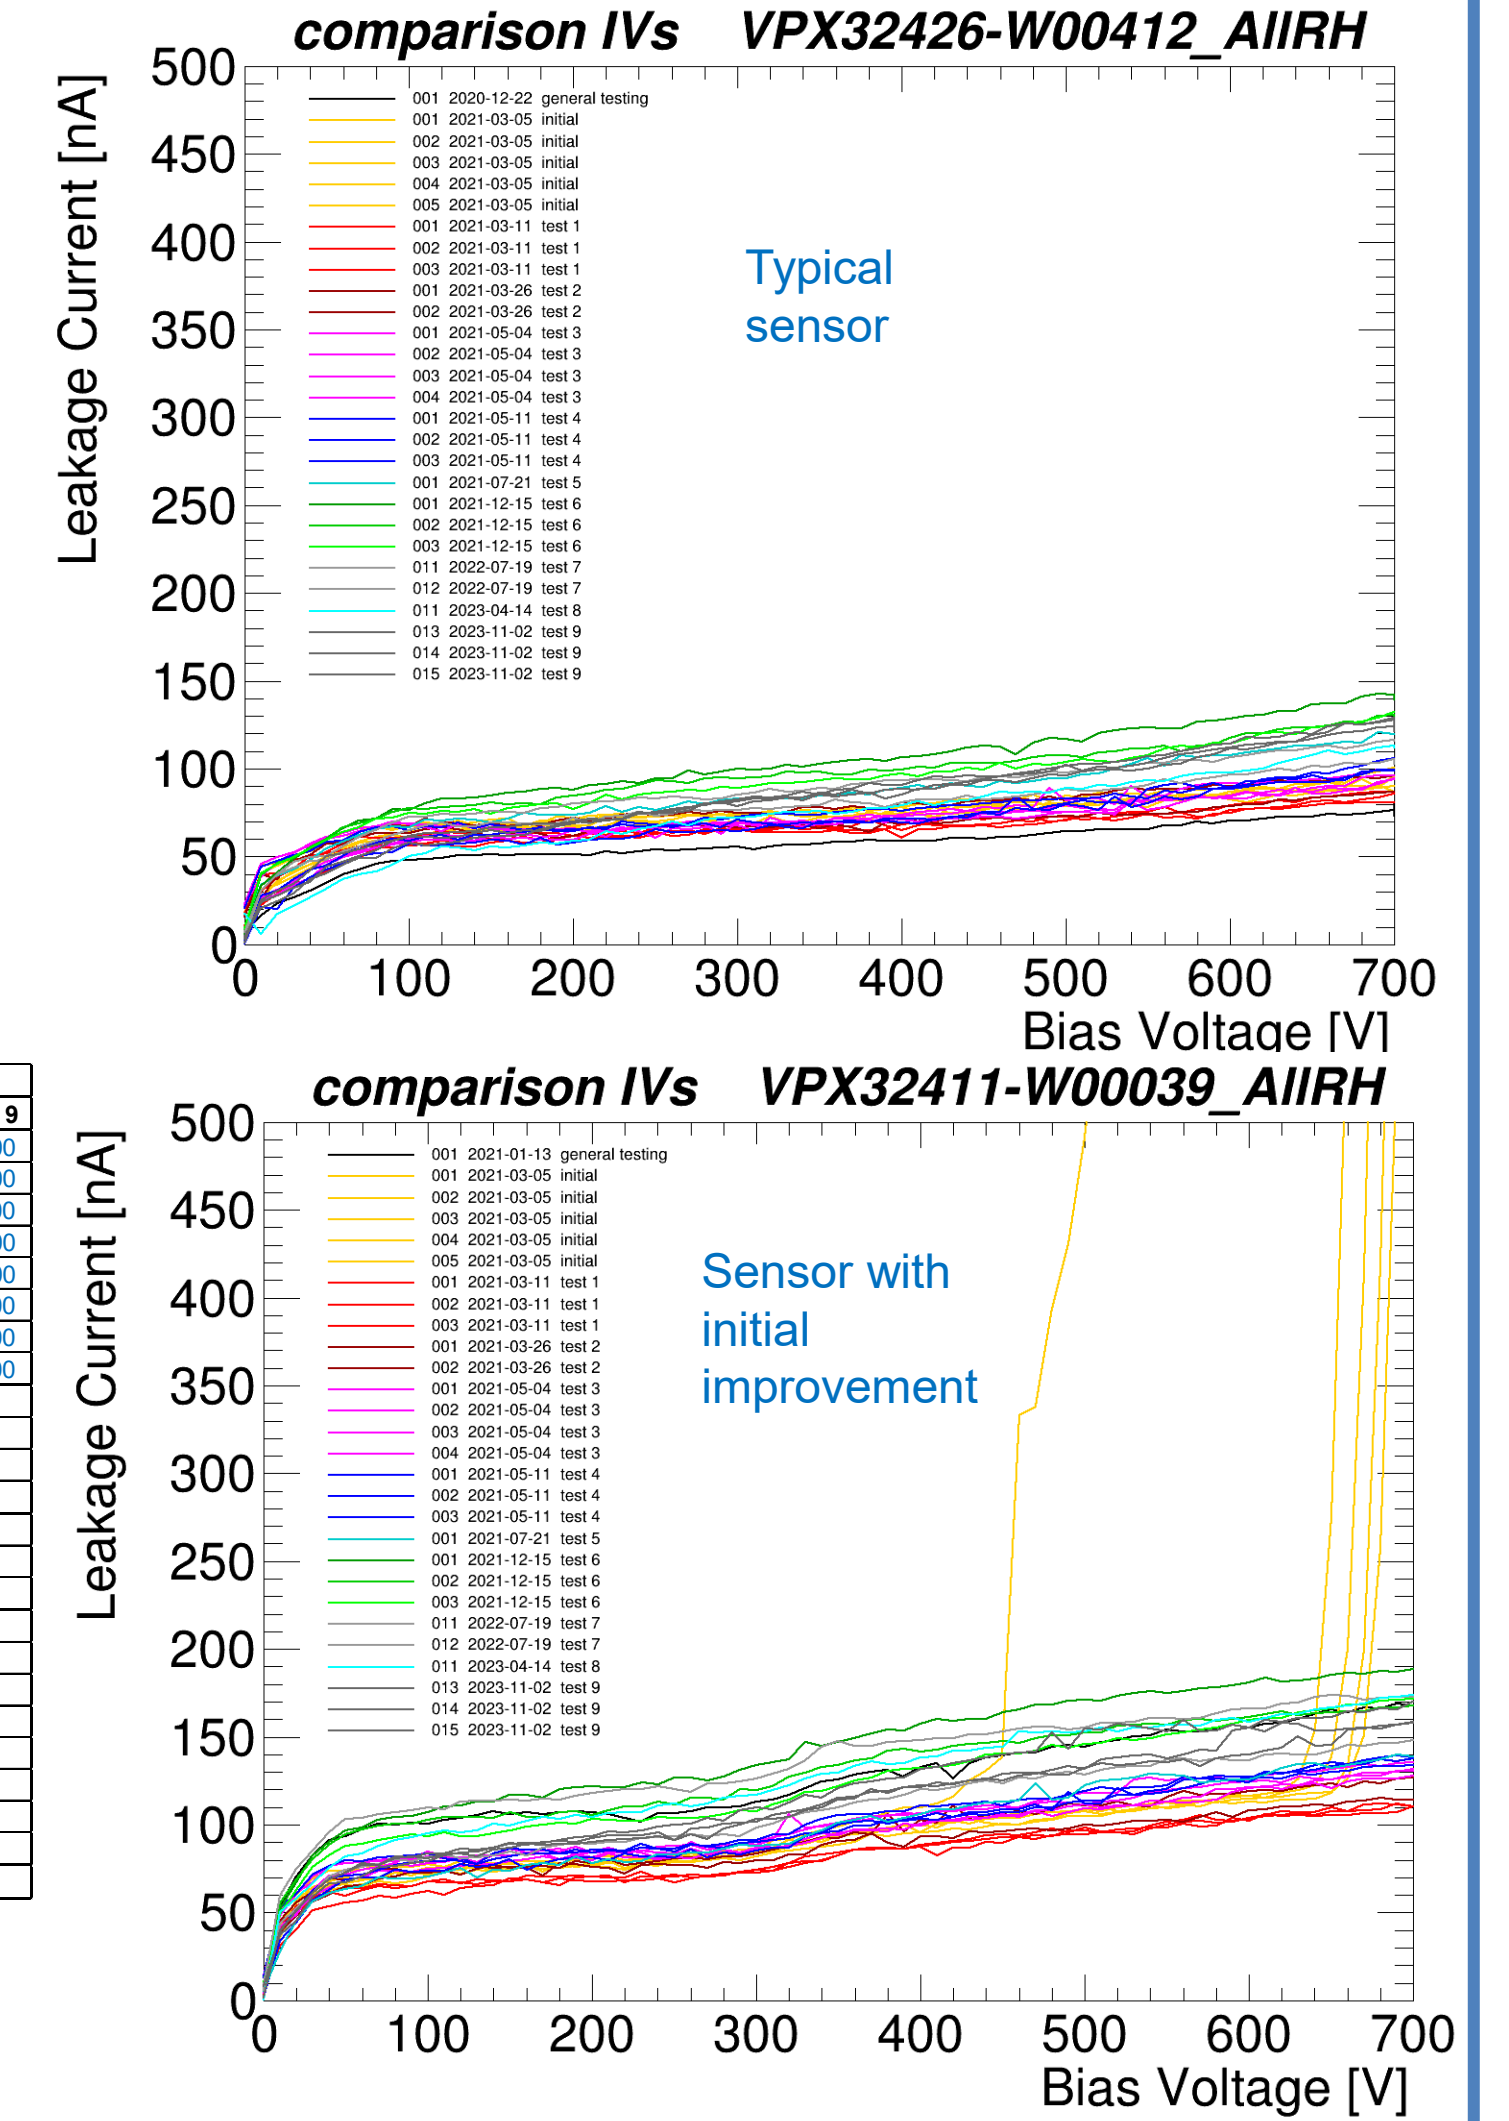
The repeat IV tests are the main method in our investigation. They were done for our sensors at several stages: during the usual sensor QC verification, after performance recovery attempts (if any), before the humidity exposures, after each exposure. We observed the effect of the performance recovery work, and, in some cases, the initial Vbd improvements with repeat tests, a typical occurrence. However, Vbd in dry environment was very stable in the course of the repeat humidity exposures.

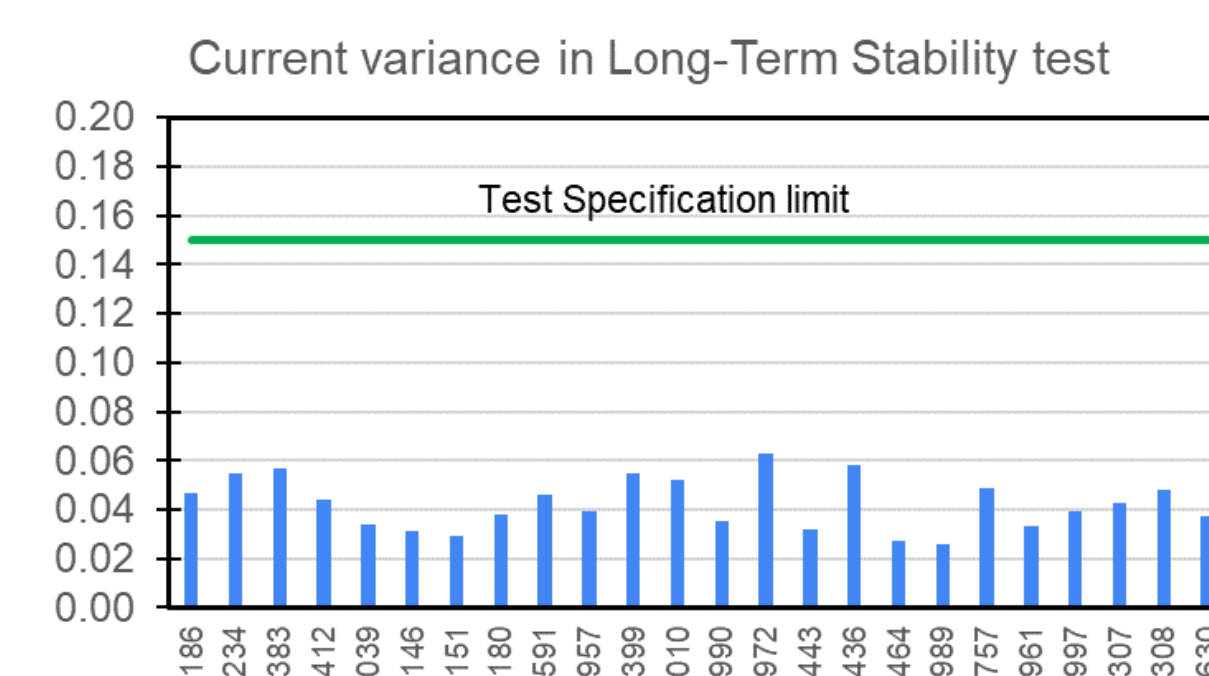
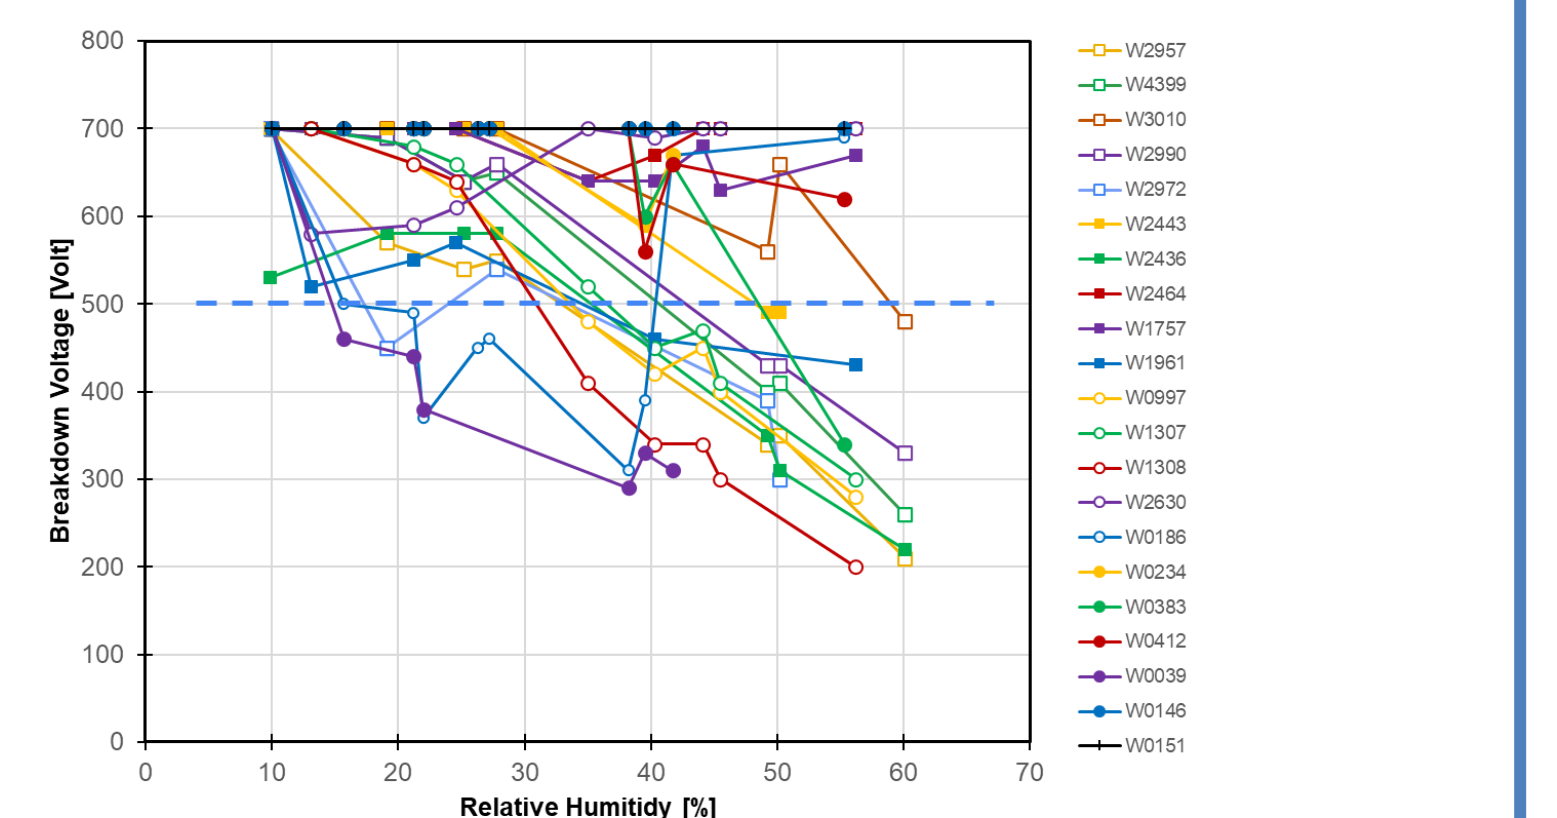
Humidity dependence:

- During some of the testing periods we varied the humidity environment in the test enclosure to re-assess the influence of the humidity on Vbd. As expected, Vbd typically is reduced at higher RH values, although non-uniformly.
