INAF - OSSERVATORIO ASTRONOMIC DI CAPODIMONTE

2° generation gravitational waves detectors beam pipe system

March 27th 2023, CERN

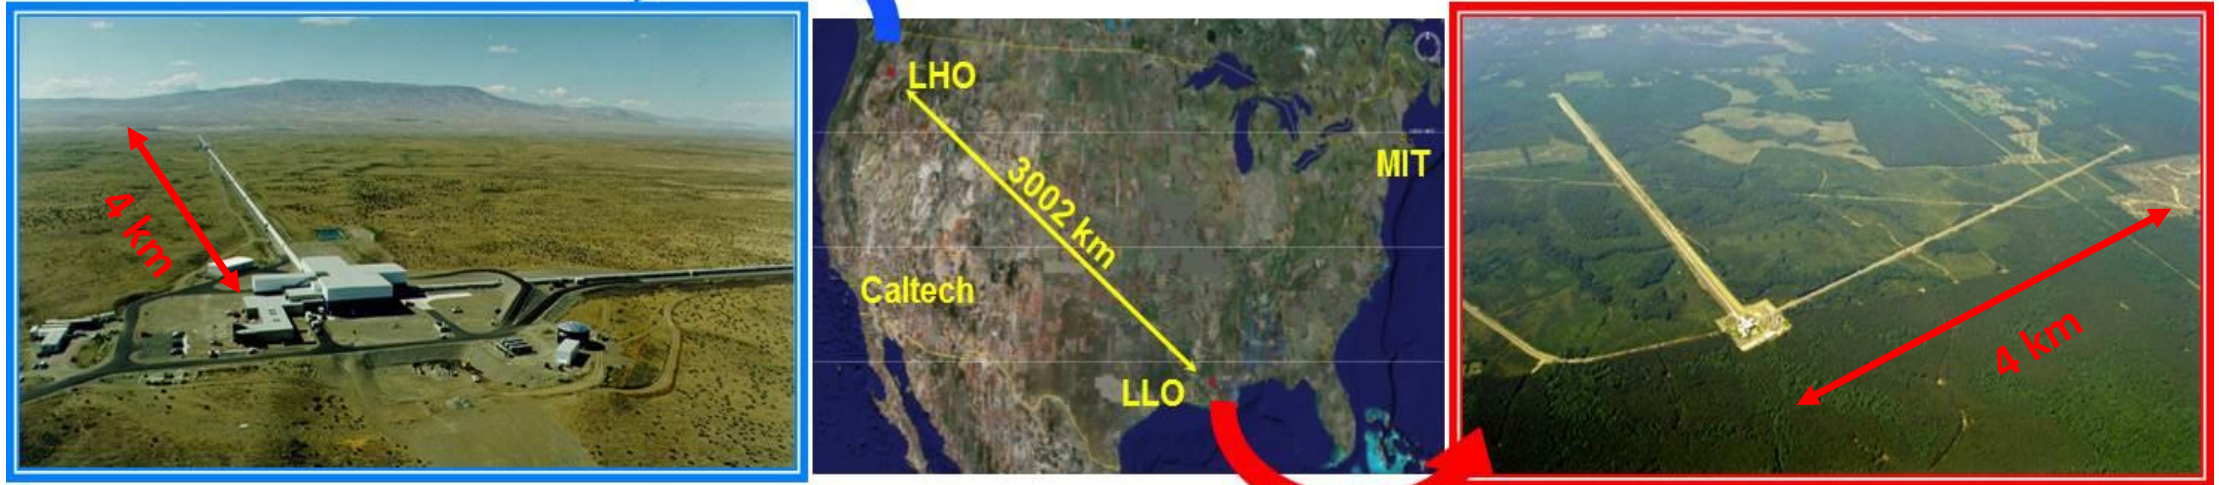
Ligo HANFORD and Ligo LIVINGSTON

For each detector

- 2 x 4 km beam pipe
- 1.2 m diameter
- 9047 m³ volume
- 3x10⁴ m² inner surface
- ~ 10⁻⁹ mbar

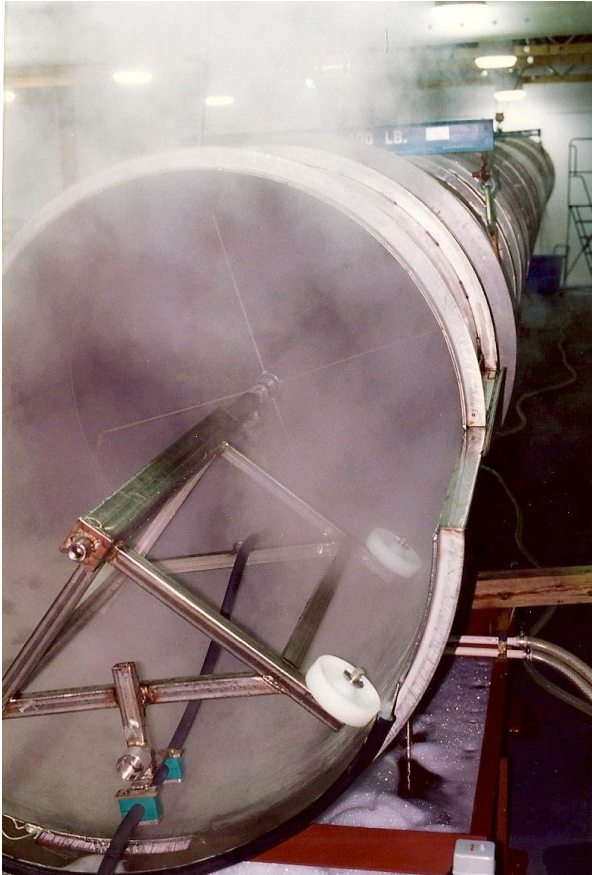
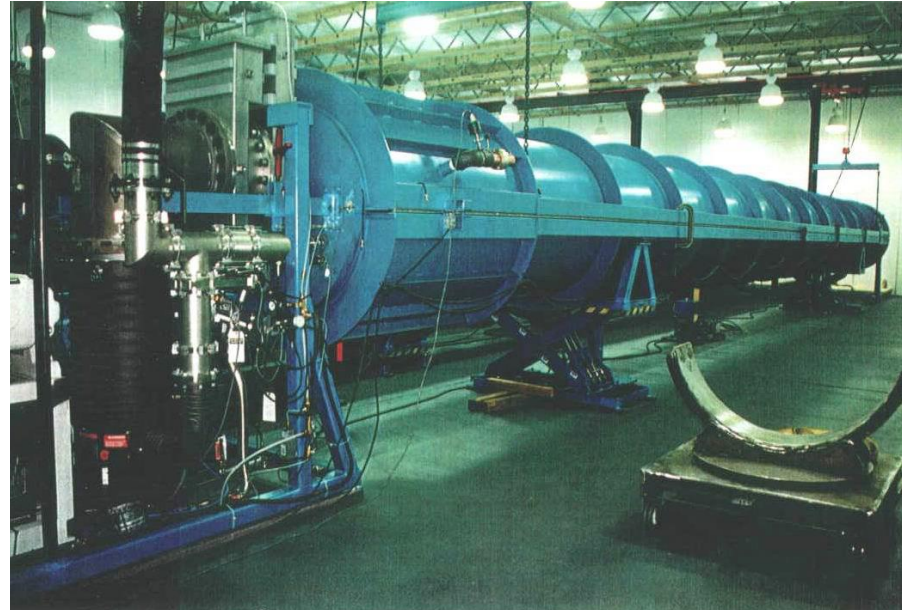
Helium leak test of module

Each module leak tested to better than 1×10^{-10} mbar l /s. Around 8 hours needed for each test!!

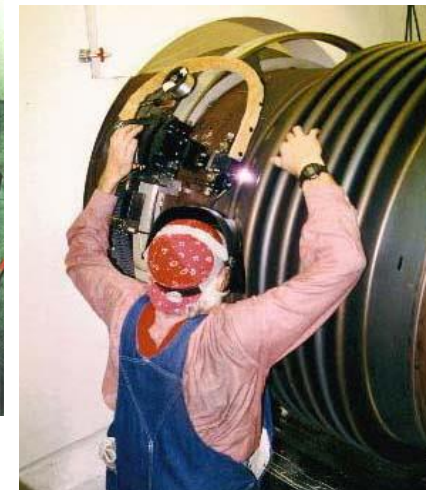
Sections butt welded in travelling clean room

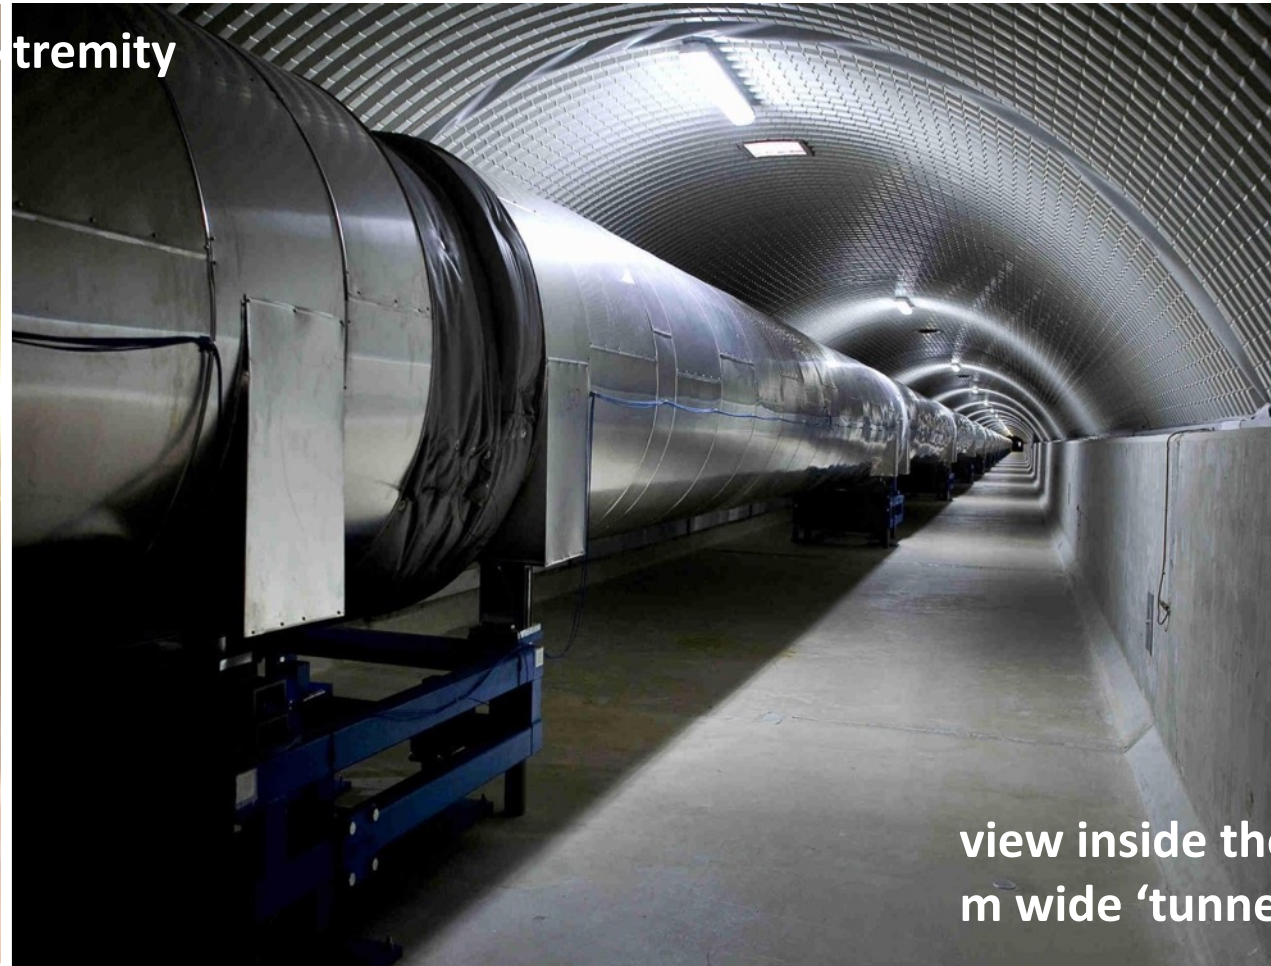
Inner view at one extremity
Ø = 1.2 m

view inside the 3 km wide 'tunnel'

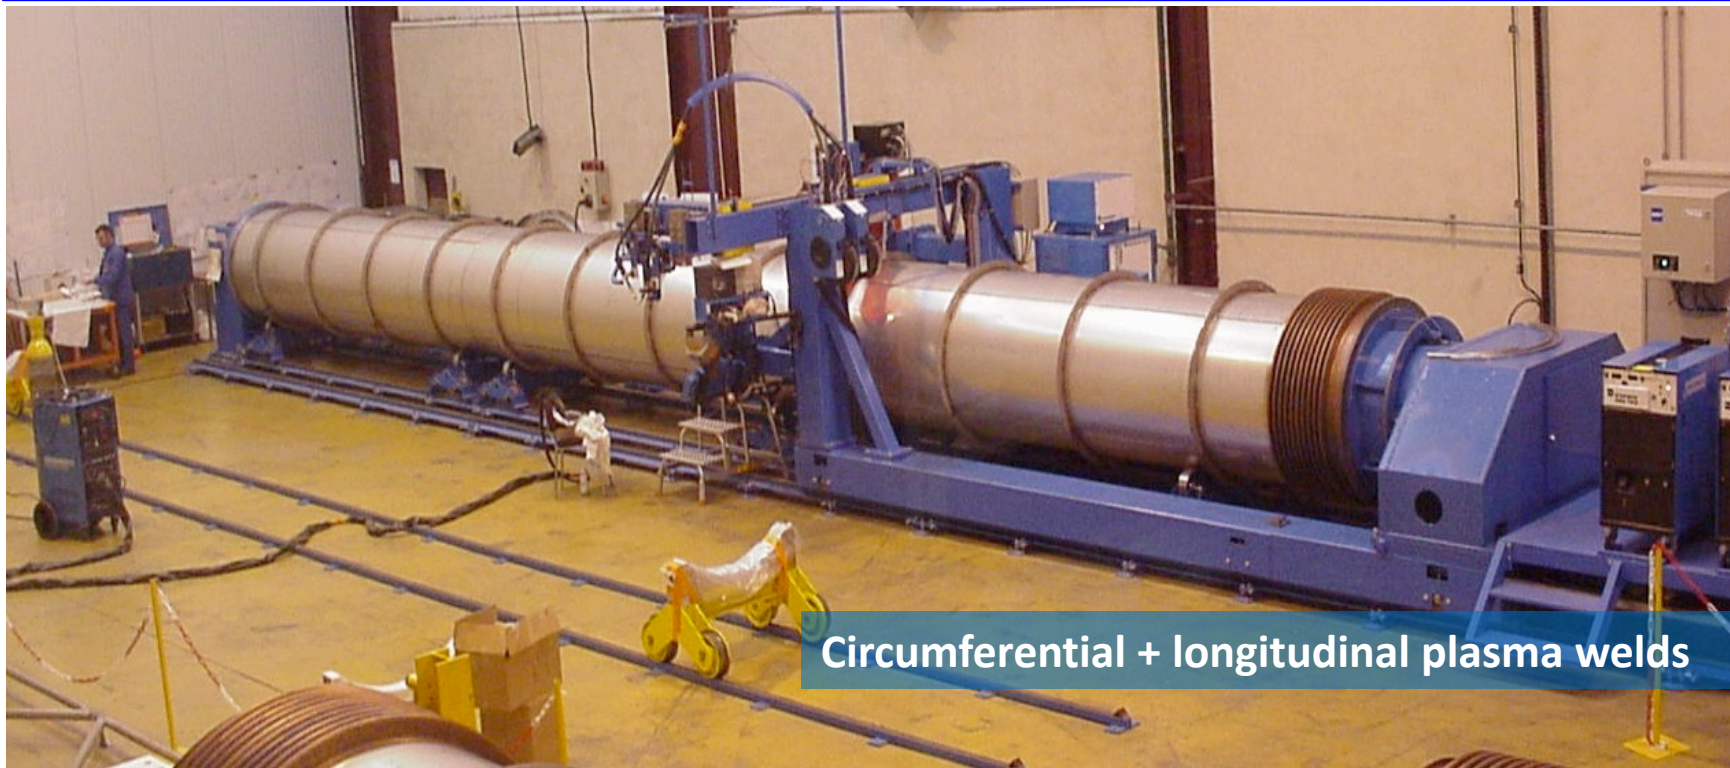
DUST CONTROLLED WORKSHOP

- section realized in 3 consecutive cylinders plus the hydroformed bellows.

- UHV recipes (specific machining oil, dirt free rolling, separated halls and tools, ...)

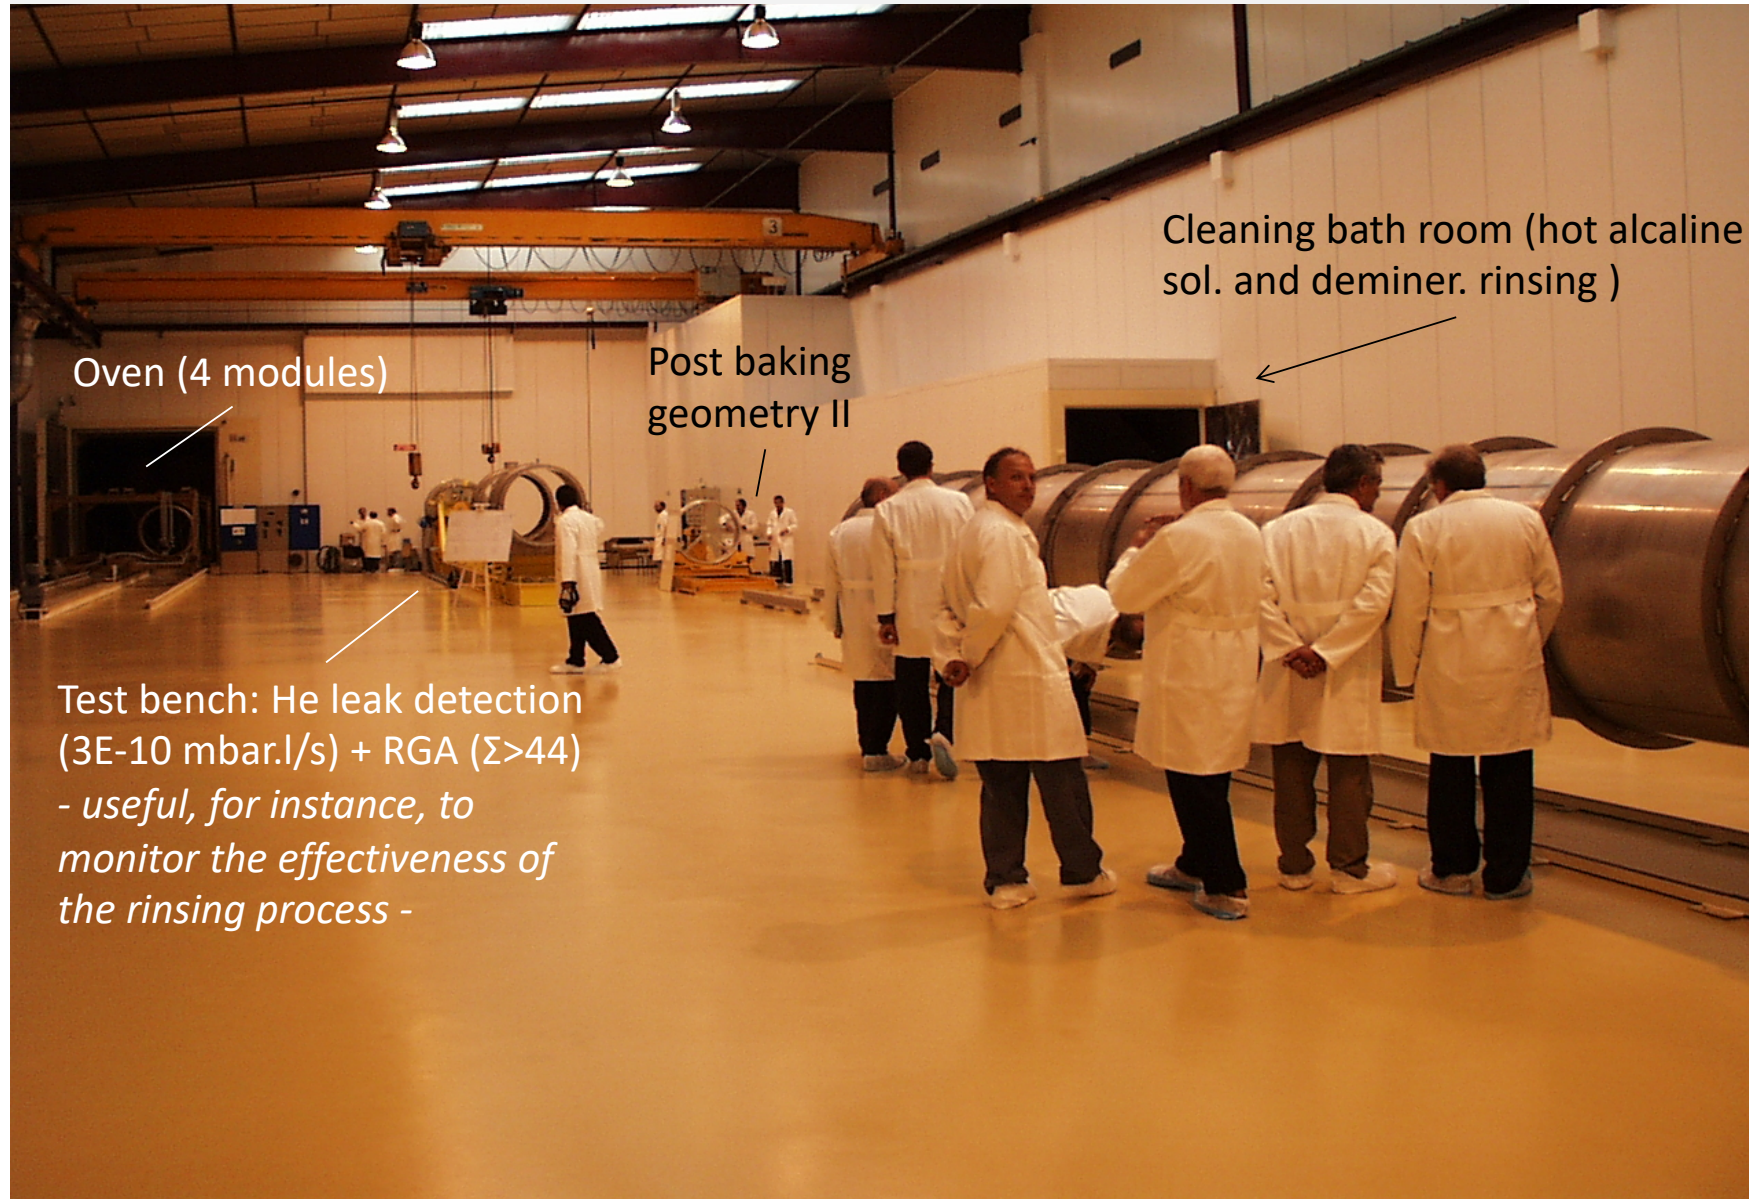
Oven (4 modules)

Cleaning bath room (hot alkaline
sol. and deminer. rinsing)

Test bench: He leak detection
($3E-10$ mbar.l/s) + RGA ($\Sigma > 44$)
- useful, for instance, to
monitor the effectiveness of
the rinsing process -

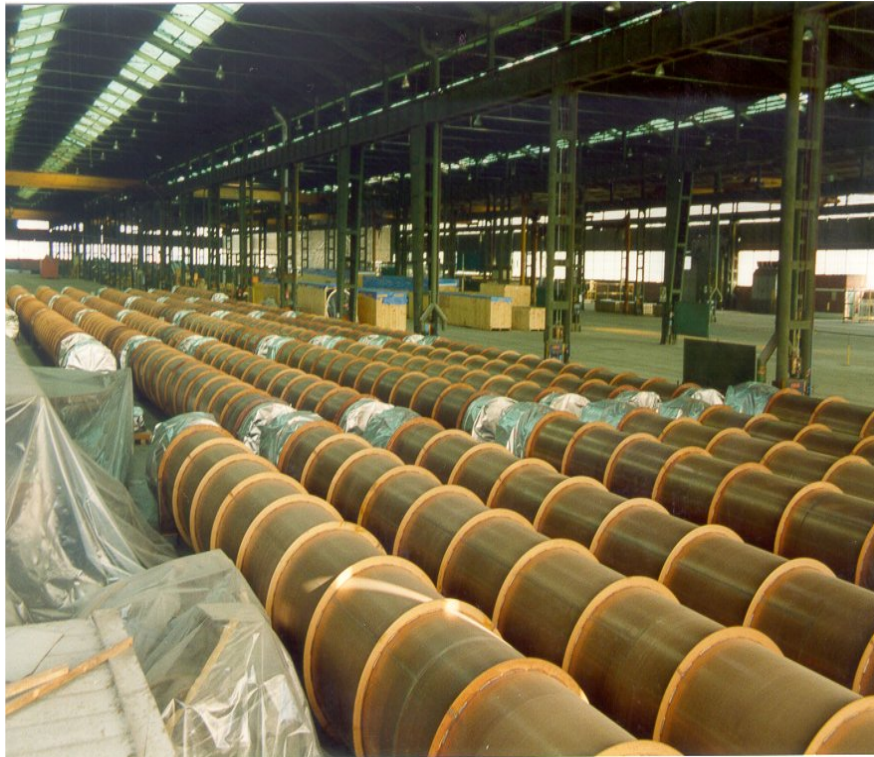
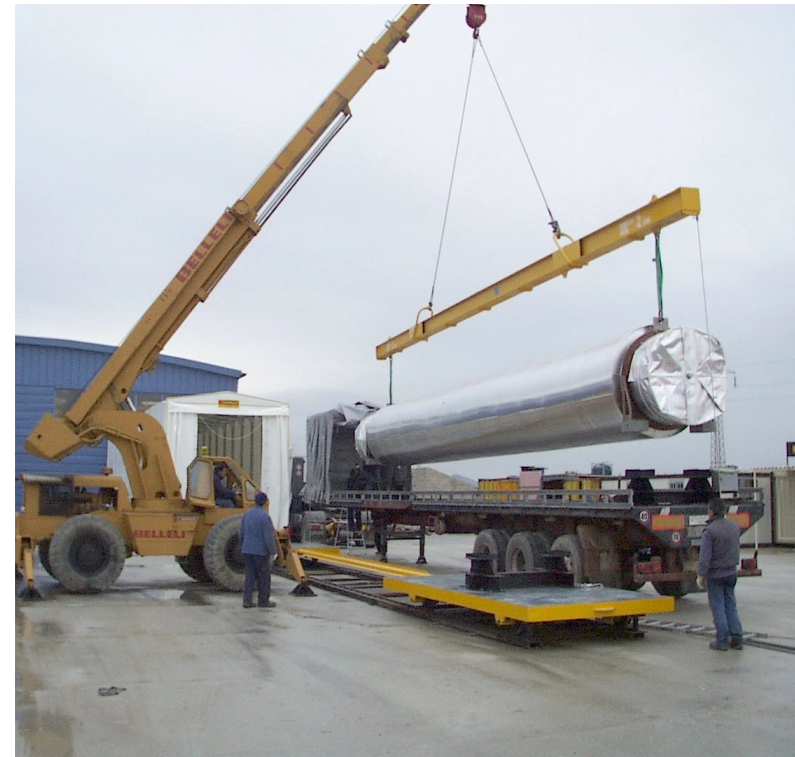
Virgo TUBES: BAKE-OUT in situ

- Chamber at 150°C uniform and at a controlled rate (~1 week for SAT stage)
- 1 Mwatt to heat one tube (15 cm thick thermal insulation)
- Joule effect: 2000 A flowing through tube walls
- diesel generators: ~ 10⁵ litres of fuel to bake one tube

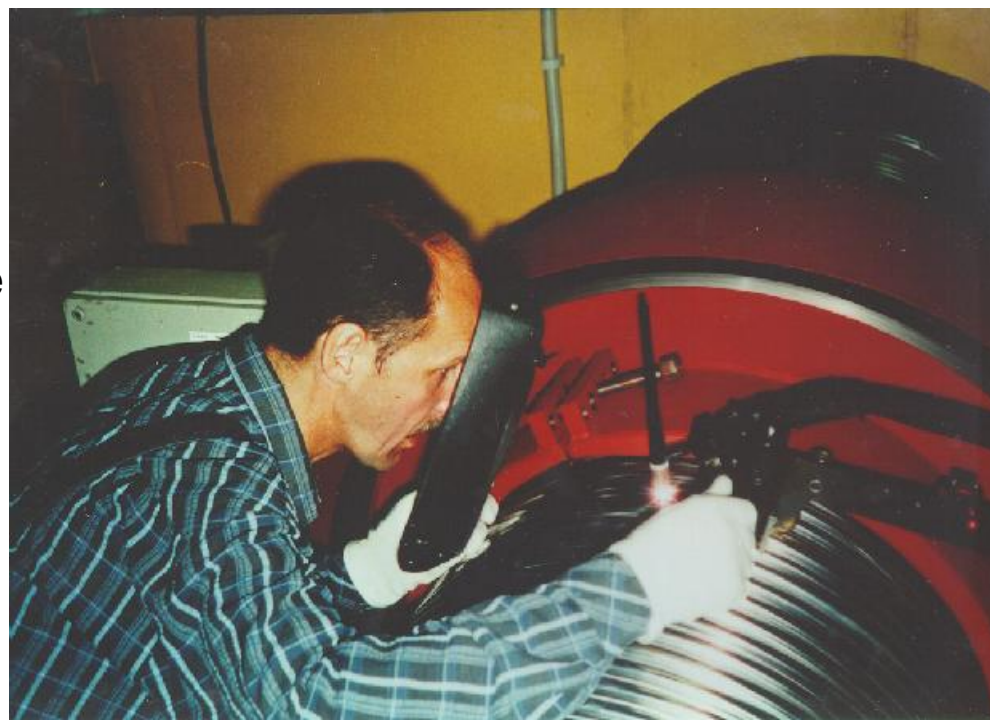
Orbital welding machine
Welding tool fixed
Tube rotating

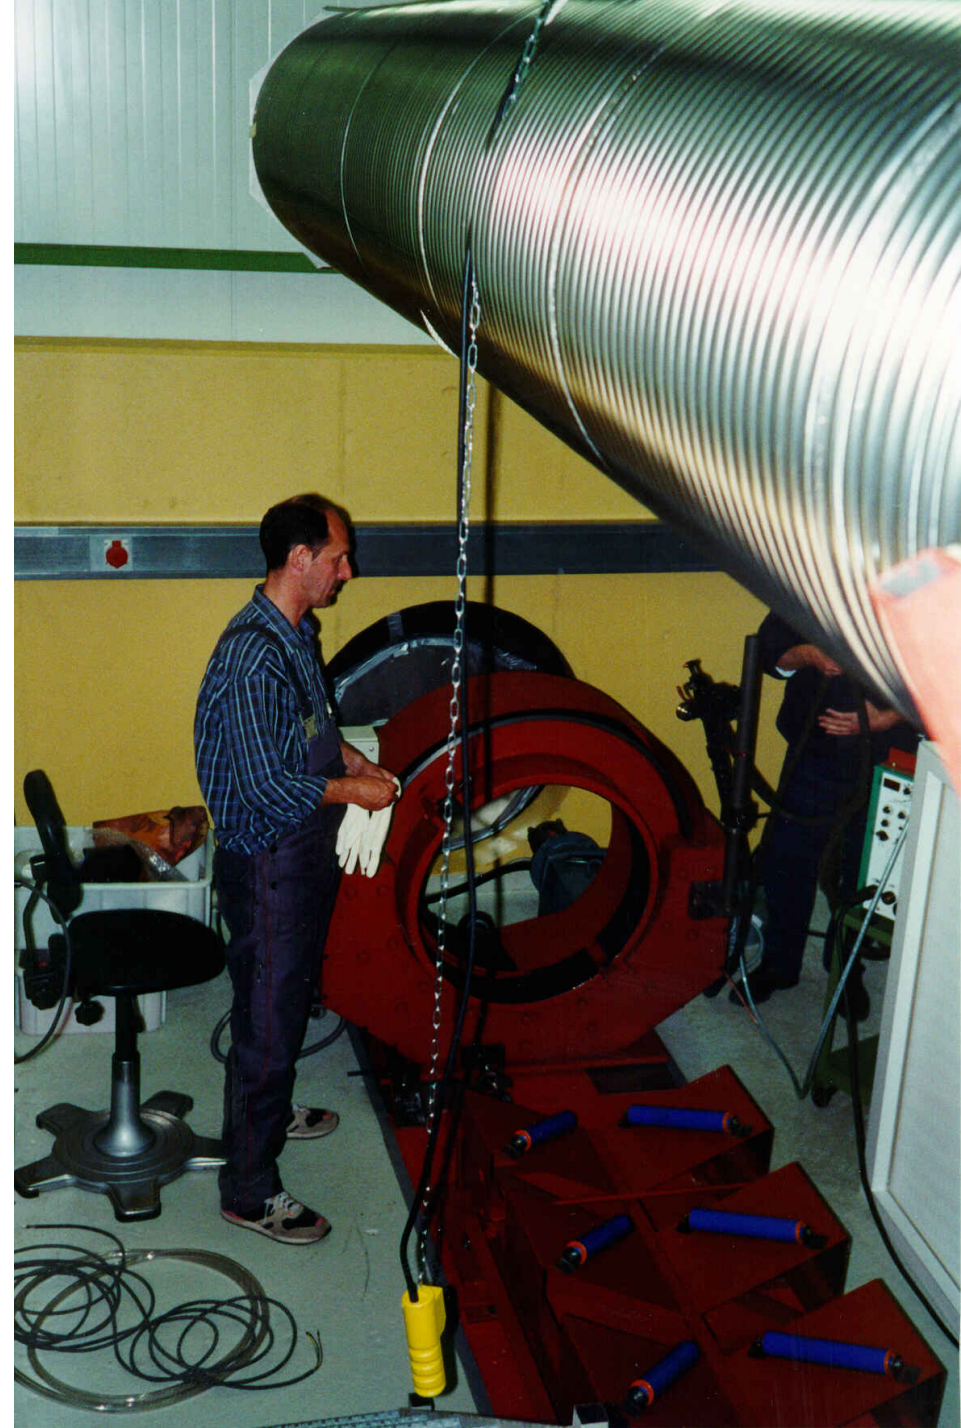
Only 85 kg
per module

Trolleys on an aluminum
rail to allow pushing
outwards the tube after
section welding

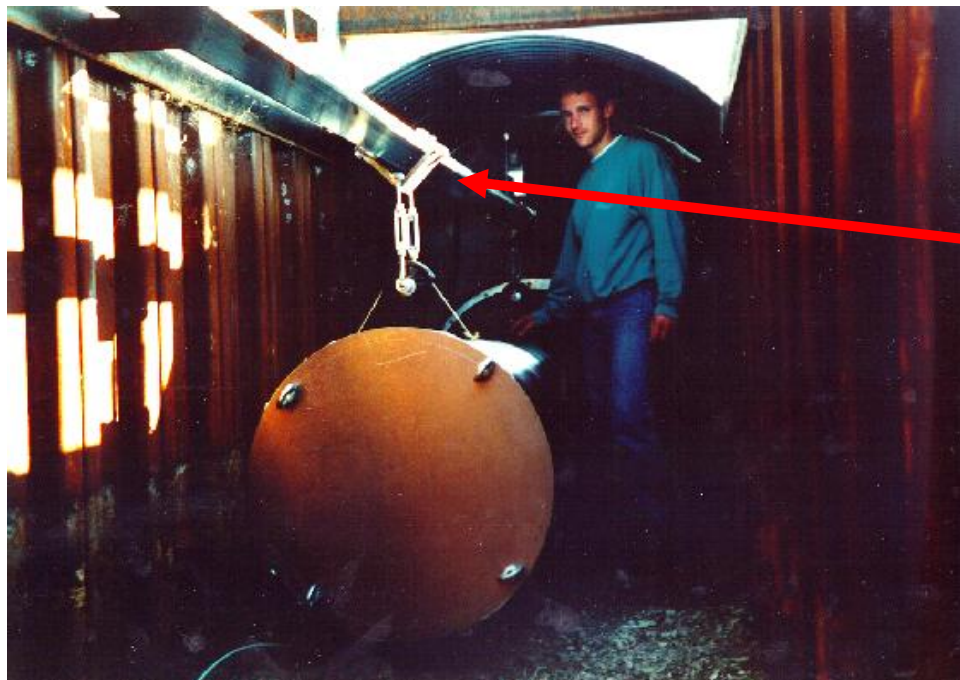
Installation of the tubes

First segment of
tube being
pushed into the trench

June 1996

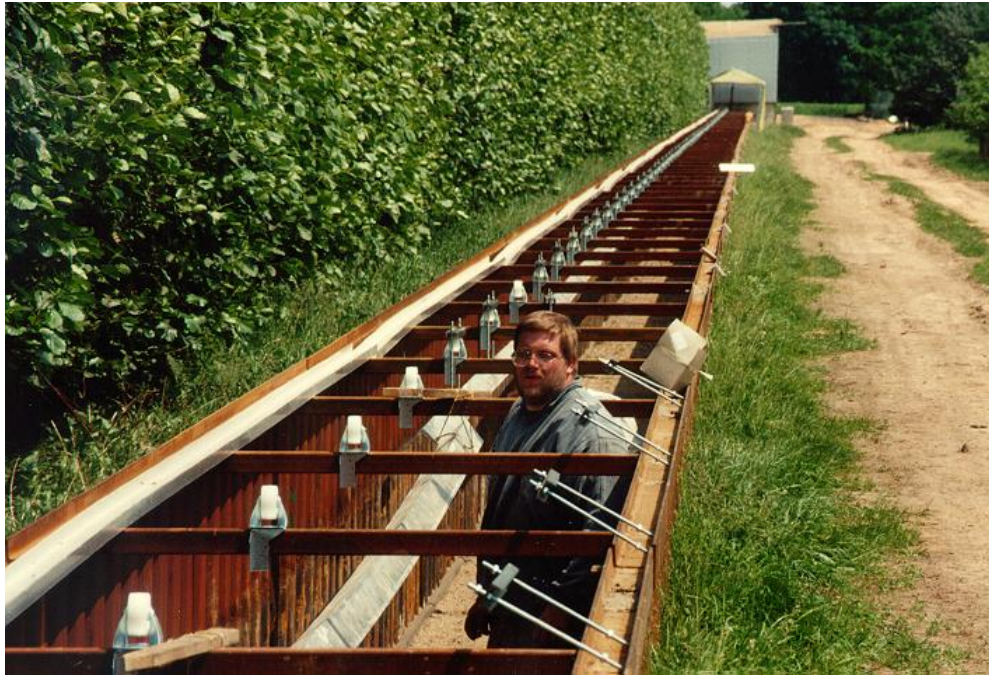
600m rail

(later used as current return path
during bake out)

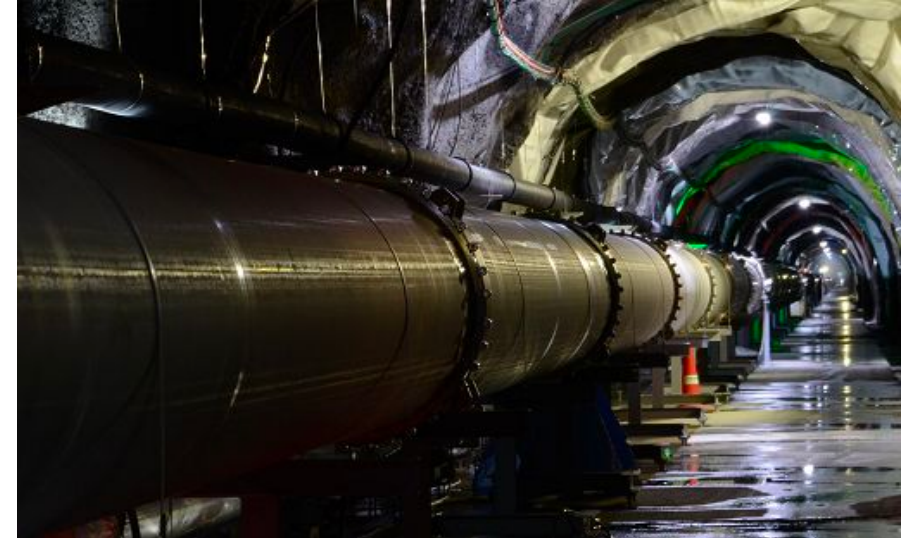
flanged modules
electropolishing

- 500 x modules 800 mm diameter, 12 m long, 8 mm tick with flanges and bellows
- To reduce outgassing: “*surface passivation process*” of stainless steel prior to installation was done by applying ***electro-polishing***, and then followed by ***pre-baking treatment***

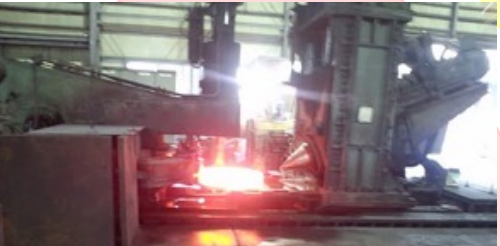
flange; SS F304, Rotary forging

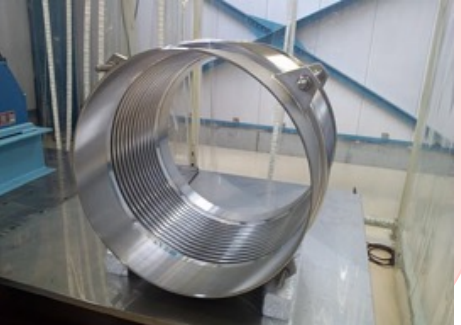
hydro-formed bellows; SS316L, 0.6 mm thick, chemical polished

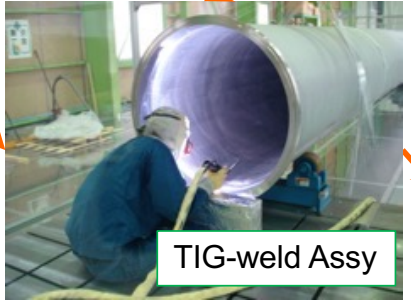
TIG-weld Assy

removing 25 μm of outermost layer

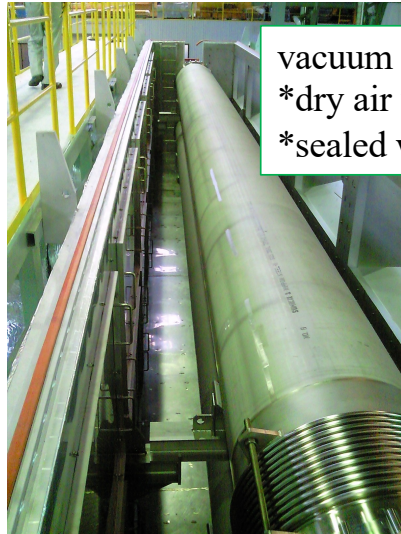
vacuum baking at 200°C for 20 hrs;
*dry air venting (-40°C dew point)
*sealed with blank flange (EPDM gasket)

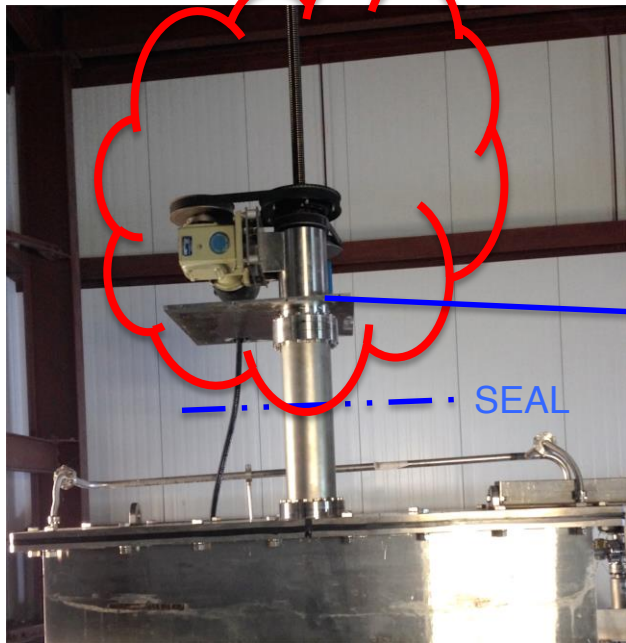
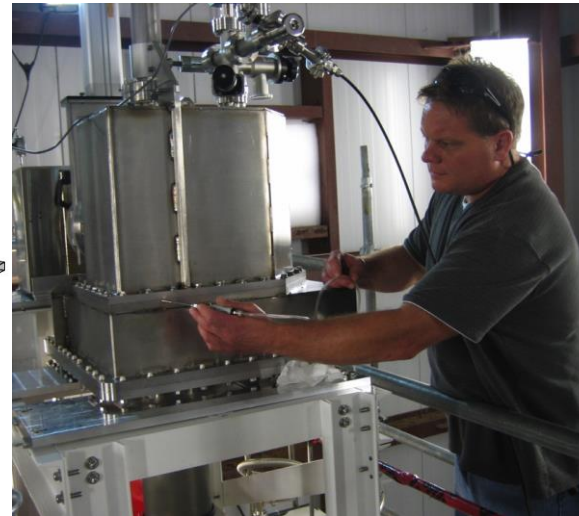
GV7 sarcophagus concept

~ 4e-5 TL/s leak

Odd time constant.... leaking through grease?

There is no mechanism to vent a beam tube, repair a valve and rebake, so what to do?
 Answer....design and install an enclosure to evacuate the volume *outside* the valve screw drive mechanism. Leak reduced, but valve now permanently inoperable (located at 2 km “mid-station”) in open position. Luckily.... this valve could be abandoned w/o compromising operations

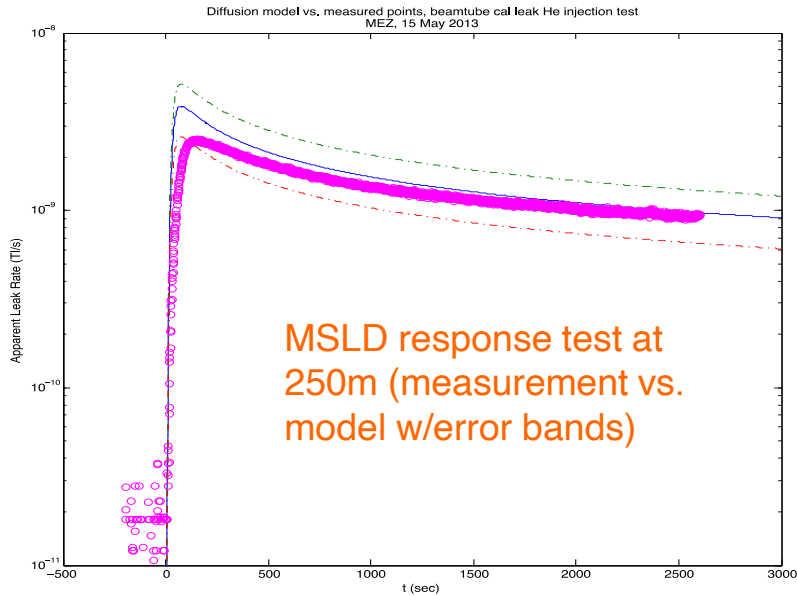
Figure 2: Leak detector response to 30 second calibrated injection of helium test gas at $z = 250$ meters (pink circles). Also plotted is predicted response from diffusion model (solid blue) and approximate standard error margins (dash-dot red and green).

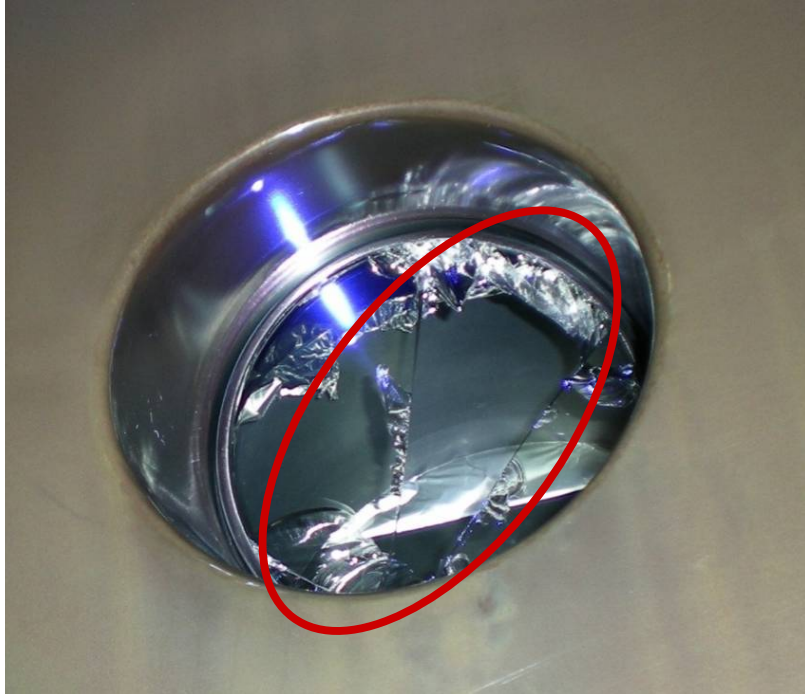
Broken Viewports

From inside

Problem due to initial defect + weak design

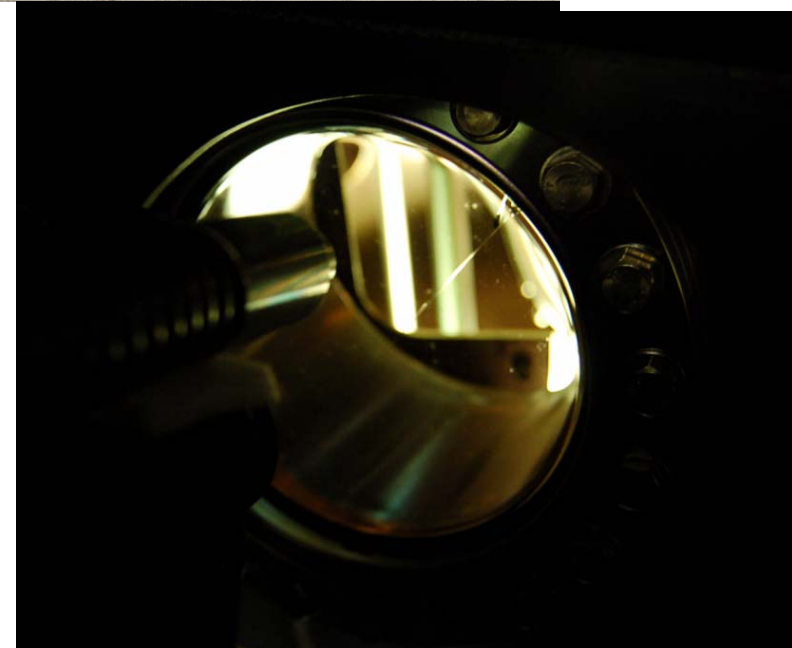
first failing

secondary

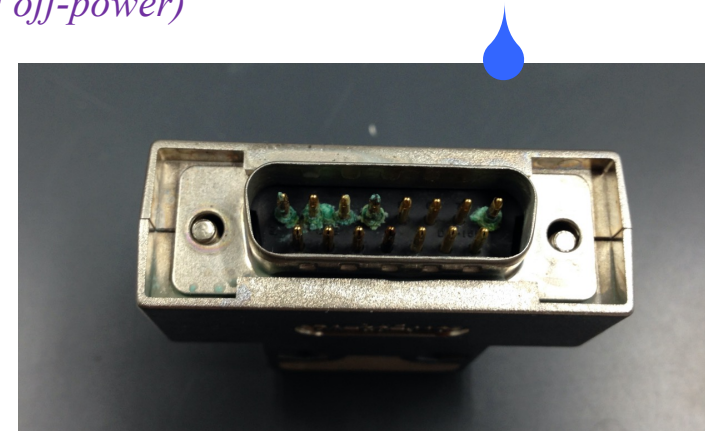
- ** durability test for metal gasket
 - * helical spring with aluminum lining >> failed
 - * Ag-coated stainless steel tube >> OK

humidity: 50C, 95%up, 240hrs
neutral salt spray: 180hrs
