Improvement in cold mass assembly

Report on Ongoing Actions for MQXFB

Observations during LMQXFBT4 disassembly

Dismantling report LHC-LMQXFBT-RPT-0002

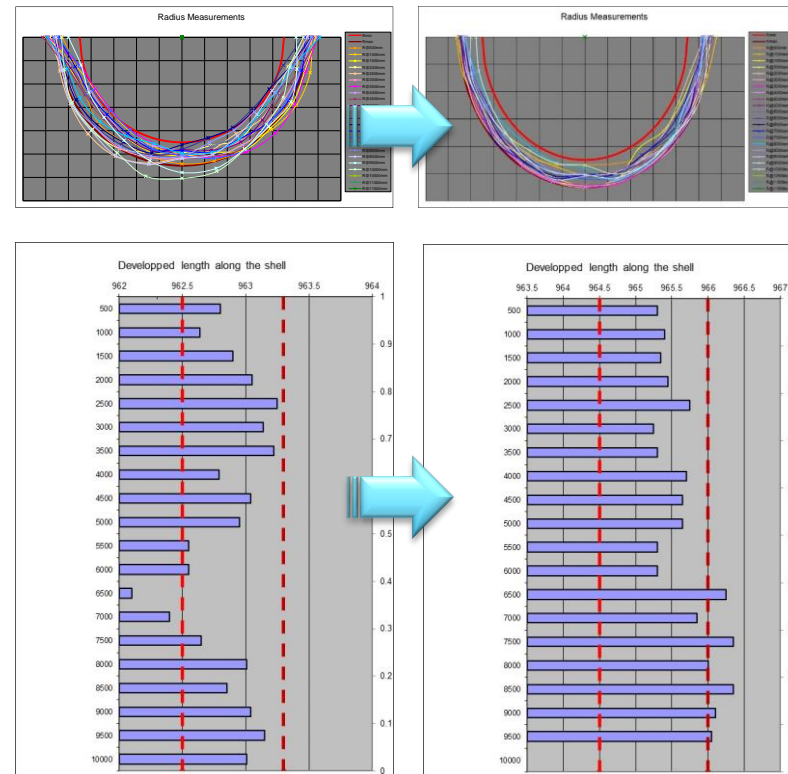
Following our visit in May and thanks to weekly meetings, very encouraging results were obtained:

- in terms of shell production rate, the company demonstrated its ability to produce at least one shell per week,
- shaping accuracy was significantly increased thanks to a new technician hiring to calibrate the profile machining,
- developed length with lower variations and with the minimum guaranteed,
- 14x 10m shells are available at CERN for the next cold masses, pairing simulations were computed to reach a minimum developed length value above 1929mm for MQXFB cold masses and minimise deviations,
- Common developed length measurement tooling has been developed and is being prepared

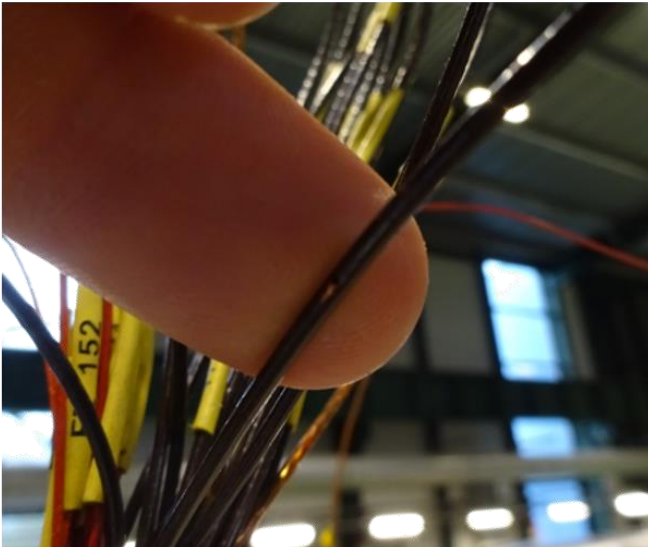
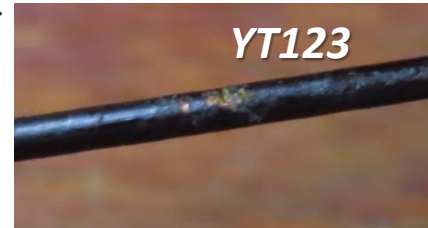
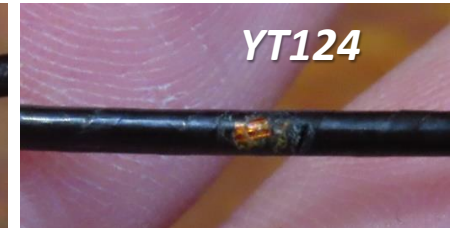
1 INSPECTION OF THE WIRES YT123 AND YT124, NCR 2773498

The inspection after the decryostating showed few scratches but no clue of missing insulation.

➤ *New electrical test protocol before inserting the instrumentation wires inside the IFS capillary under development:*

- ⇒ aluminium sheets
- ⇒ thin wires comb
- ⇒ Water immersion

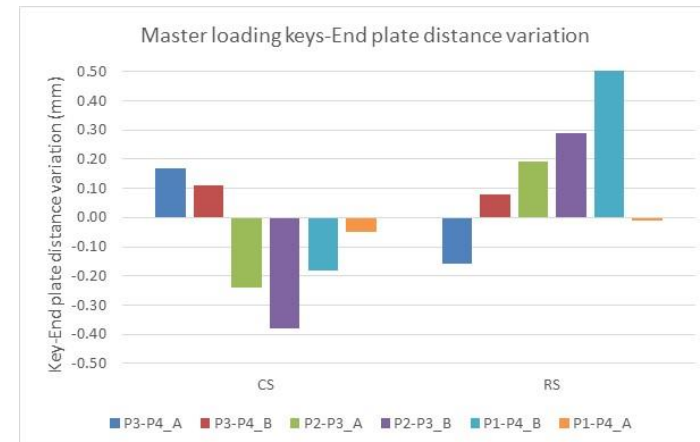
6.2 Measurement of the end plate – master loading keys distances

The distance between the master loading keys and the end plate was measured for 6 master loading keys (the values for the lower keys are never measured due to lack of access).

The measured values are presented on the chart hereunder and compared to the ones measured after the removal of the half shells from HCLMQXFBT01-CR000003 for their replacement.

Position	Distance Master loading key – End plate, mm			
	CS		RS	
	After half shells removal	After cold tests	After half shells removal	After cold tests
P2-P3_A	23.12	23.29	23.36	23.20
P2-P3_B	23.03	23.14	22.77	22.85
P3-P4_A	23.02	22.78	23.50	23.69
P3-P4_B	23.07	22.69	22.97	23.26
P1-P4_B	23.30	23.12	22.97	23.58
P1-P4_A	23.30	23.25	22.66	22.65

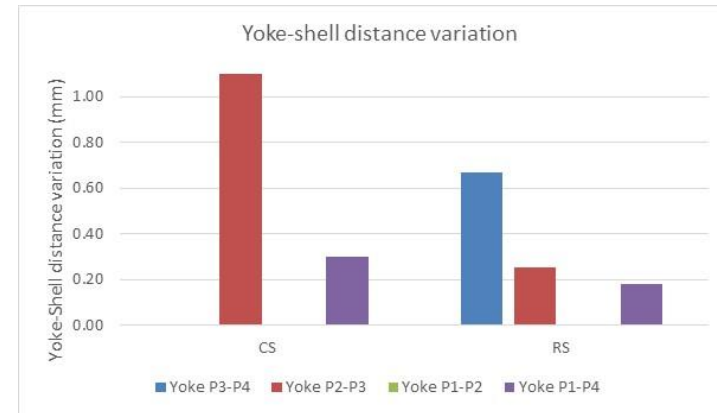
6.3 Measurement of position of the aluminium shell with respect to the yokes at the extremities

The position of the aluminium shells with respect to the yokes was also measured after cold tests.

The comparison of the values is presented on the chart below. Positive values imply that the yoke does not exceed from the shell.

Position	Distance Yoke - Shell, mm			
	CS		RS	
	After half shells removal	After cold tests	After half shells removal	After cold tests
Yoke P3-P4	1.16	1.15	0.75	1.42
Yoke P2-P3	-0.55	0.55	-0.30	-0.05
Yoke P1-P2	0.62	-	0.91	-
Yoke P1-P4	-0.10	0.20	1.32	1.50

Max 1.1mm
Max 0.7mm

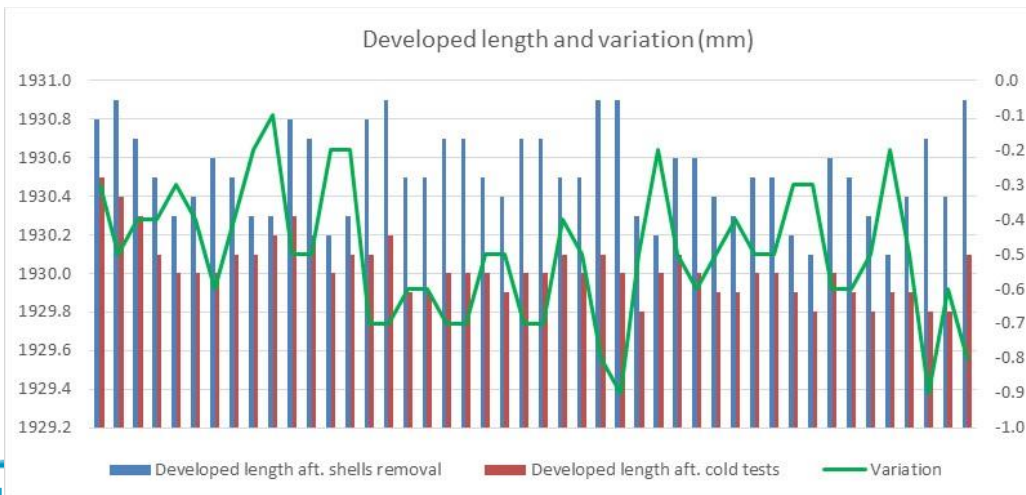
6.4 Measurement of the aluminium shells developed length

The developed length of the aluminium shells was measured with a pi-tape.

In the chart below, the values are presented, as well as the average. A column with the average values after the removal of the half shells for their replacement is also included to show any changes.

Max 0.9mm circumferential
 ↳ 0.13mm radially
