The industrial production of Micro Pattern Gaseous Detector: experience from the ATLAS Micromegas

Paolo Iengo

The 7th International Conference on

**Micro Pattern Gaseous
Detectors 2022**

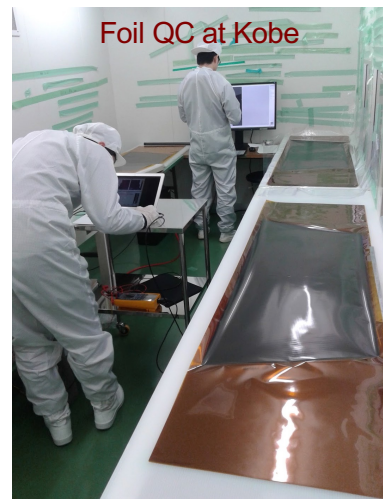
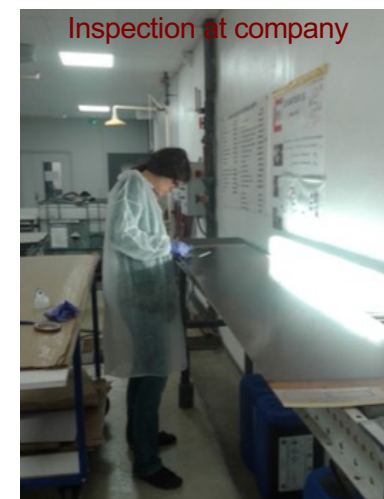
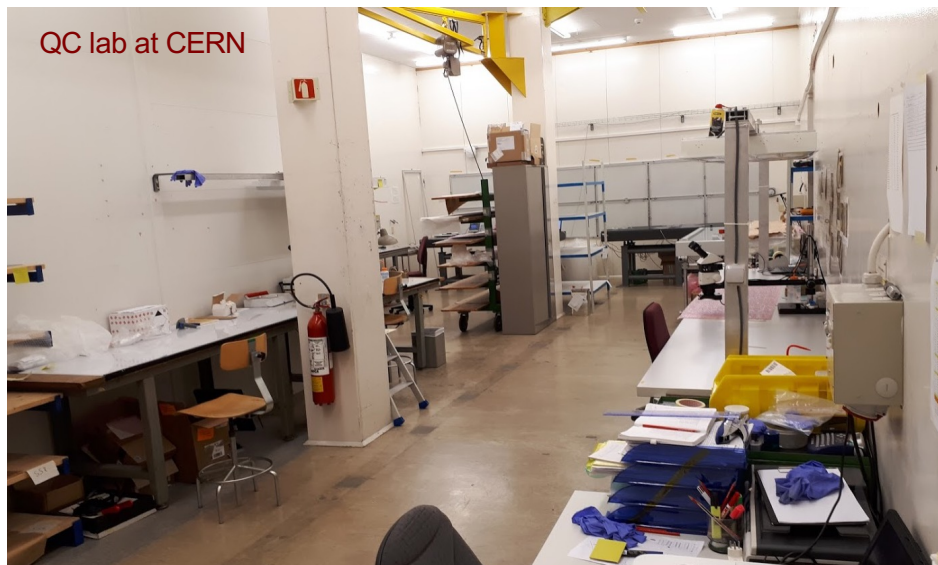
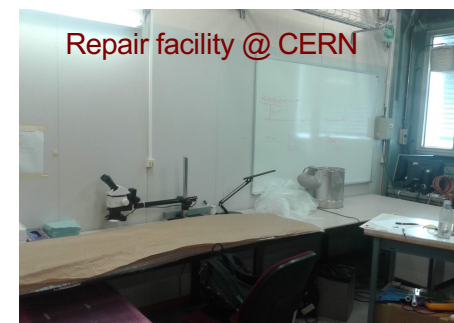
- QA/QC lab for foils at Kobe
- First QC at the manufacturer premises
- Dedicated lab set-up at CERN
 - 7 test stations
 - Each board tested according to QC protocol
 - Online form interfaced with QC DB to guide through QC
- Repair facility in a separate room

- Dedicated lab set-up in 188
 - 7 test stations
 - Each board tested according to QC protocol
 - Shift work (2 FTE) + experts
 - Online form interfaced with QC DB to guide shifters through QC
 - Repair facility in a separate room

0. shelf & table unwrapping
1. computer table logistics
2. tool chest
3. top light table
visual inspection, electrical tests, repairs
4. back light table
agreement btw. holes & Cu pattern, edge precision & straightness, pillar pattern
5. rasmask granite table
absolute dimensions & shape $O(30\mu\text{m})$
6. granite table
pillar height measurement
7. table
resistivity mapping
8. table
strip capacitance measurement
9. self
storage of boards when QC has finished

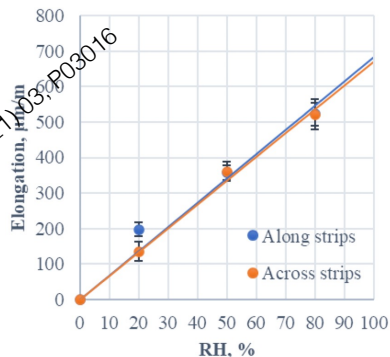
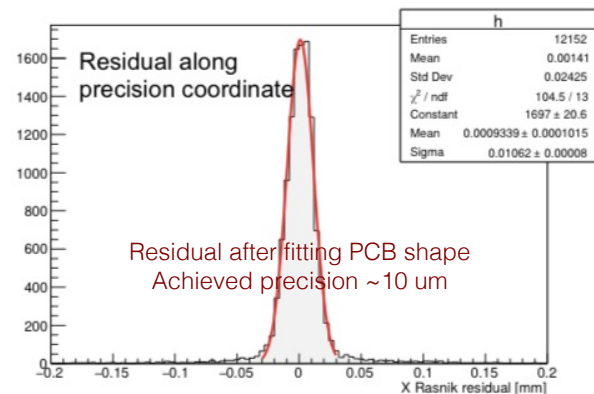
Residual after fitting PCB shape
Achieved precision $\sim 10 \mu\text{m}$

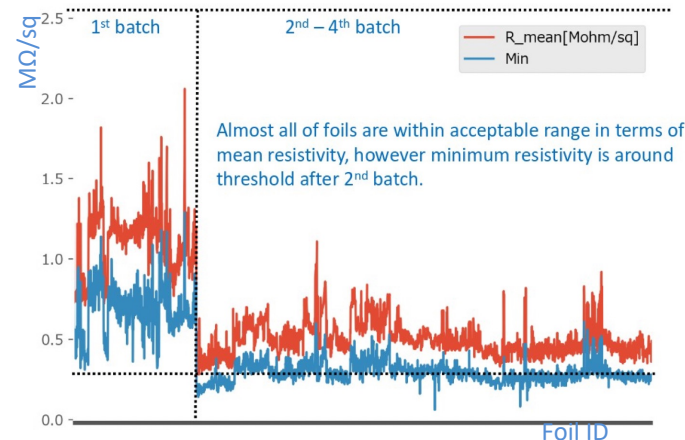
Surface resistivity vs foil ID. Reduced resistivity correlated with the change of batch of resistive paste

1. 2016: Resistivity 10x higher then expected, finally understood in a change of solvent.
2. 2016: Reported from PCB company low adhesion of resistive strips during PCB manufacturing. Reason found in insufficient curing at foil printing company (Matsuda, JP).
No information propagated to us → it took time to reconstruct the full story
3. 2019: Paste production was moved from Germany to UK (after Ferro acquired ESL). Delivery of the last batch postponed for months.
Not able to produce usable paste.
Strong push from CERN to find a solution. Finally, the German expert was sent to UK to supervise the production. Costed months of delay and required tuning of the pressing condition at the PCB companies

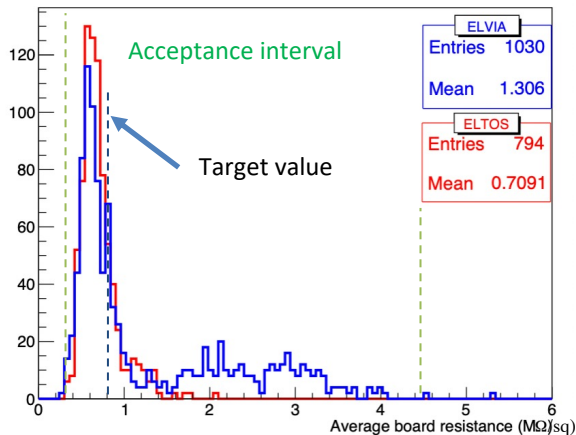
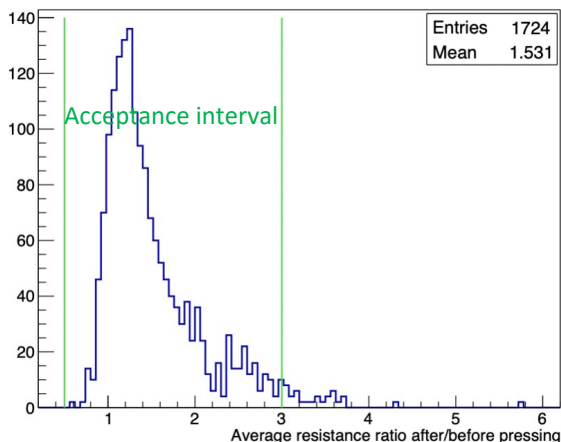
Surface resistivity measurement tool

Surface resistivity map of a board

- Resistivity foils measured at Kobe after production
- Final resistivity of the boards measured at CERN
- Resistivity map measured for each board
- Comparison after/before board production
- Dedicated tool developed and used in both sites

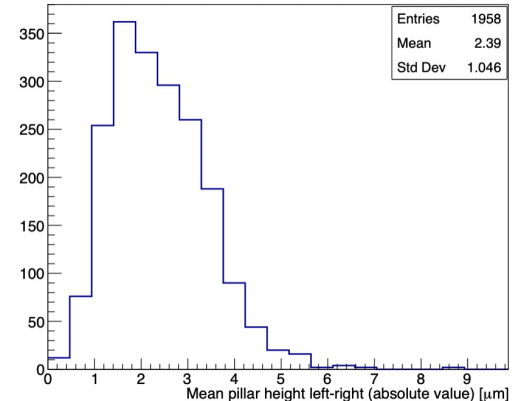
- Pillar height map measured for each board
- Precision of the tool: $\pm 0.5 \mu\text{m}$
- Systematic difference ($2 \mu\text{m}$) between the two companies
- RMS $\sim 2 \mu\text{m}$; L/R asymmetry $\sim 2 \mu\text{m}$
- Average value: $120 \mu\text{m}$ (expected $128 \mu\text{m}$)

Pillar height measurement tool

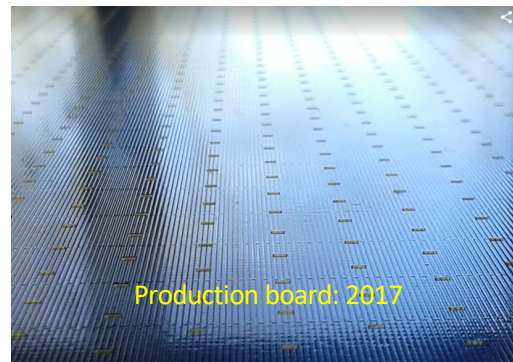
Production board: 2017

Great improvement thanks to:

- Technology transfer
- Procedure and work-flow optimization
- Cleanliness during gluing

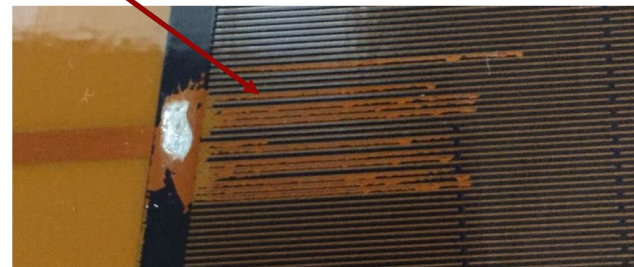
- Unexpected problem observed at the pre-series boards
Affecting some boards of both companies:
Cu lines cut at the edge of the kapton foils
(excess of micro-etching during Ag plating)
→ problem understood and solved
- Capacitance between neighboring strips or strip and HV line is a good indicator for interruptions and cuts
- Automated tool developed for capacitance measurement
