Cold Plate Upgrade at the SNS

Yugang Tan

June 1st, 2023

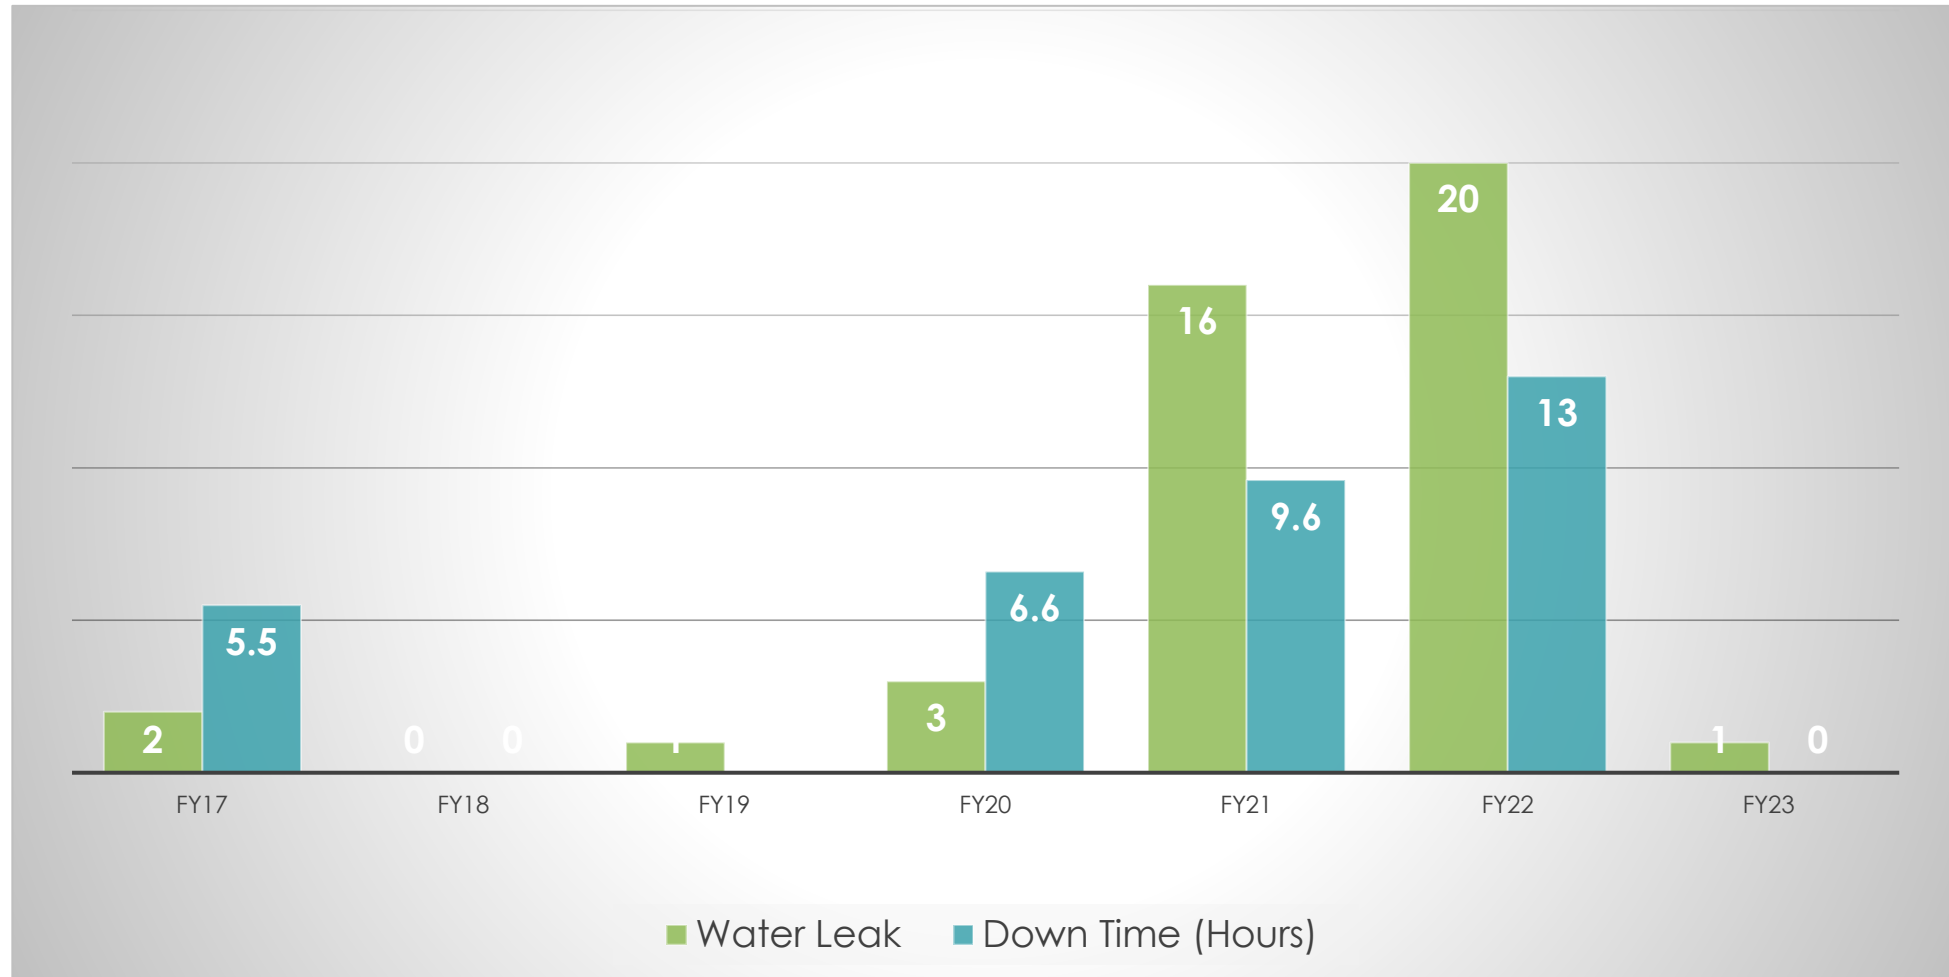
Water Leaks in Recent Years

- Cold plate water leak caused many hours of downtime, especially in FY 21 and FY22.

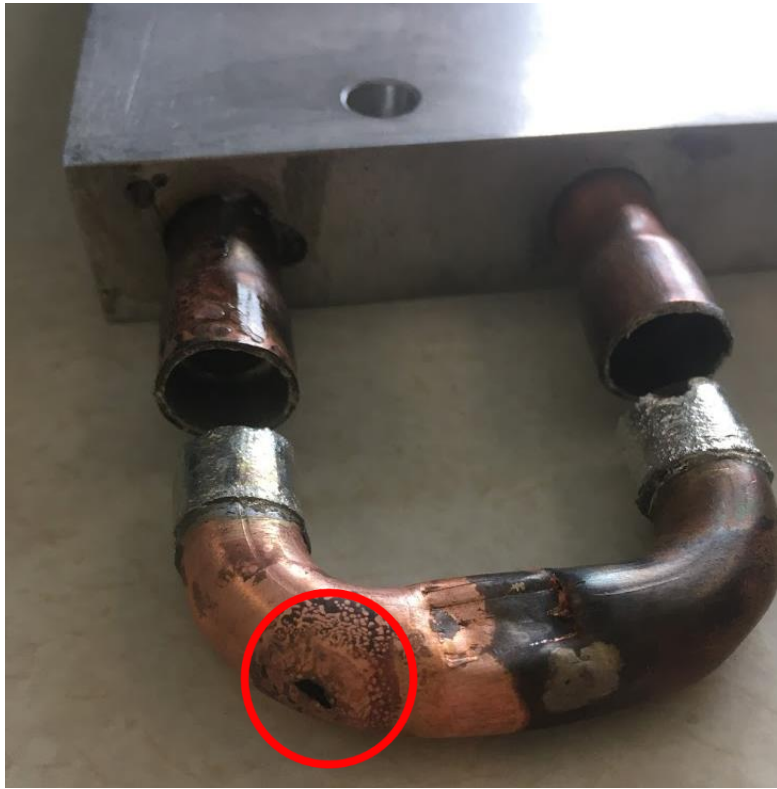
- It is more than pin hole damage.
- Repair is a temporary remedy.

The corrosion is severe. The wall is too thin to be brazing sealed.

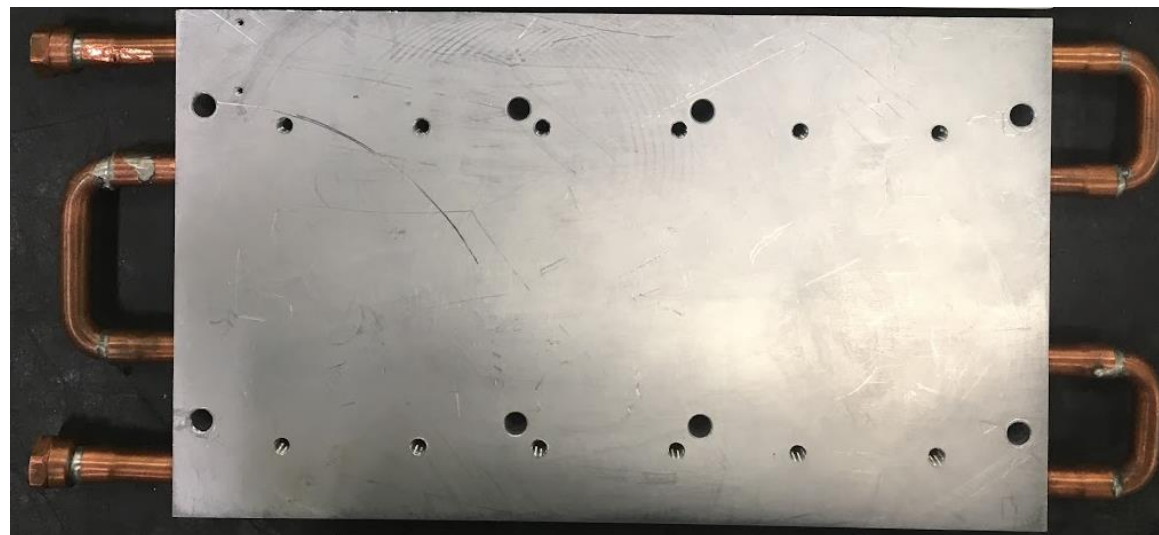
Existing Cold Plate Copper Tube OD=0.45"

Multiple copper pieces brazed together. Tube in the middle of cold plate.

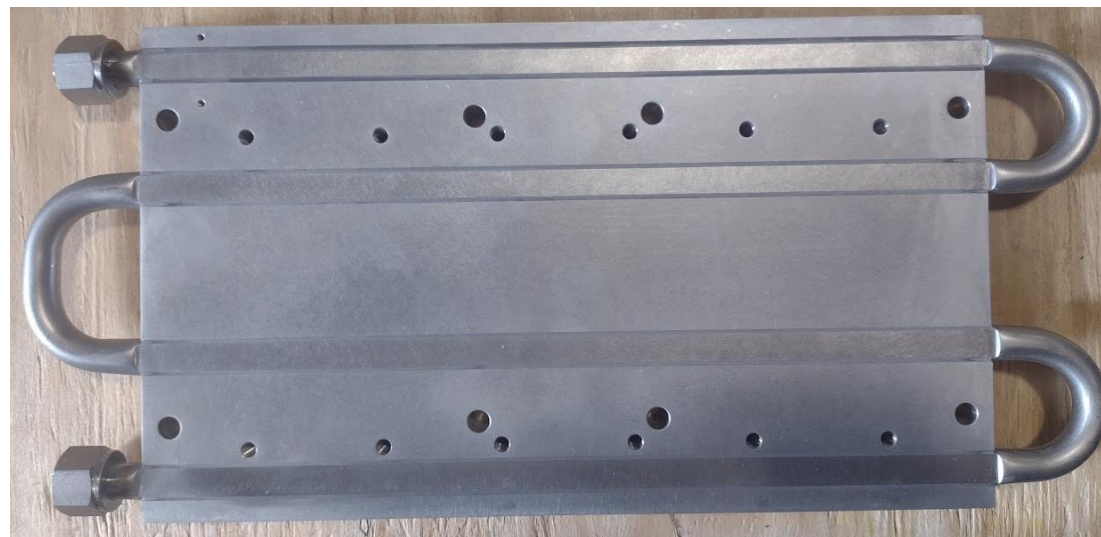
Vendor#2 Cold Plate 1/2" SS Tube

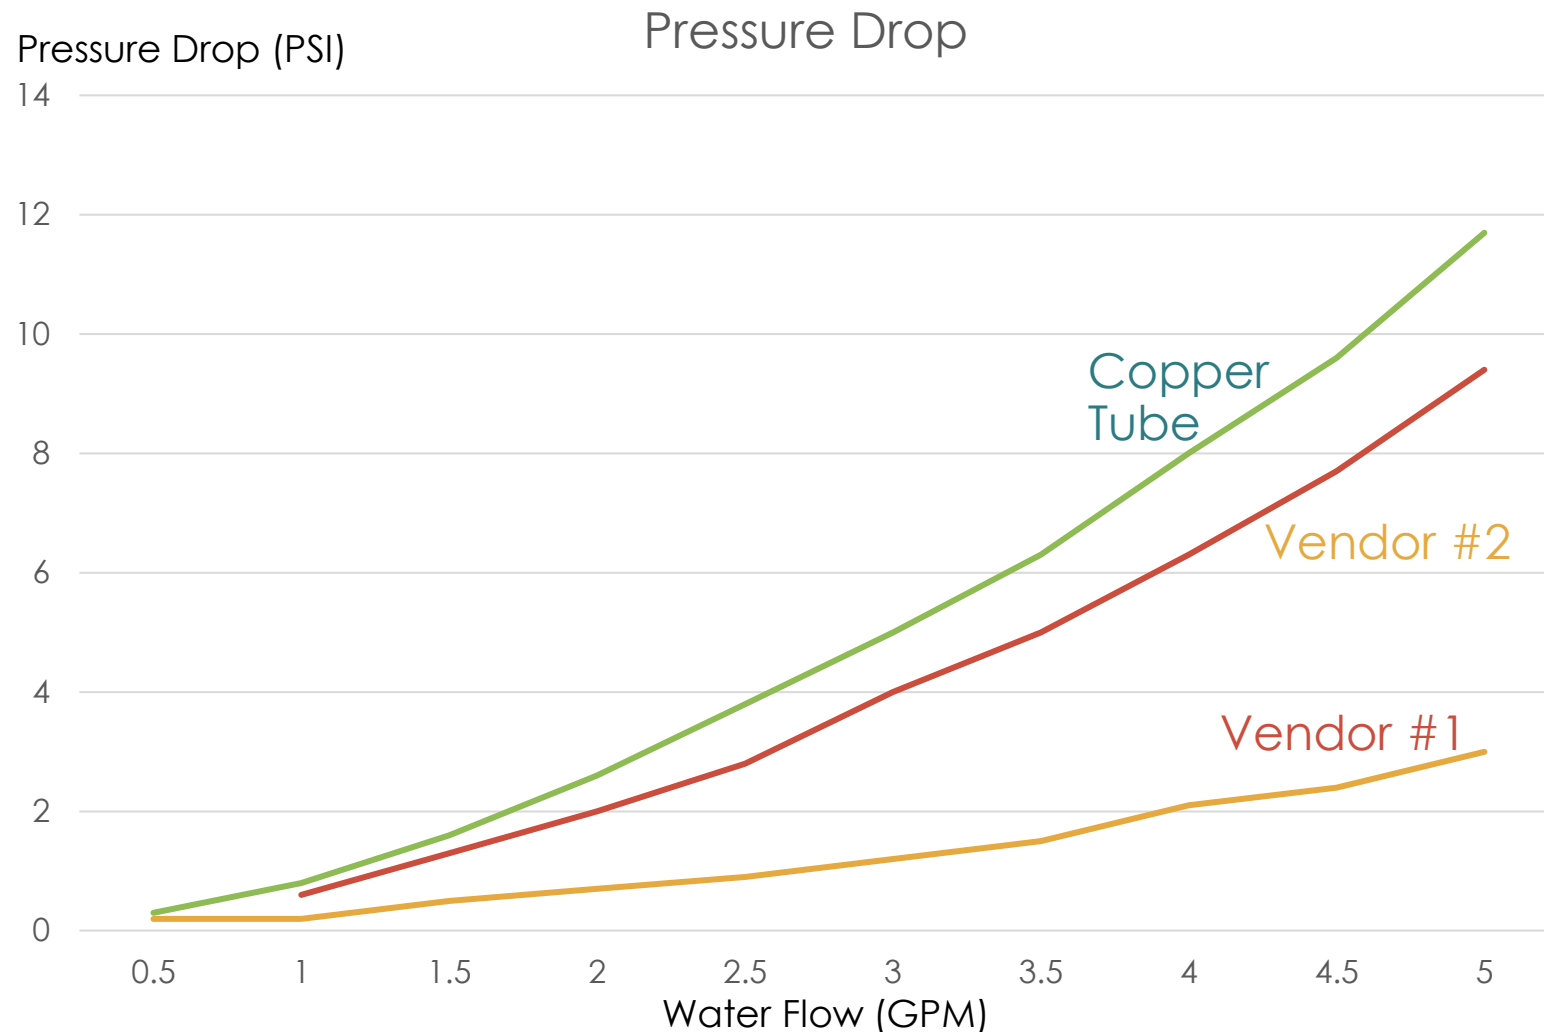
Pressure Drop Test

Flow (GPM)	ΔP (PSI) Copper	ΔP (PSI) #1 1/2" SS Tube	ΔP (PSI) #2 1/2" SS Tube
0.5	0.3	0.2	
1	0.8	0.2	0.6
1.5	1.6	0.5	1.3
2	2.6	0.7	2
2.5	3.8	0.9	2.8
3	5.0	1.2	4
3.5	6.3	1.5	5
4	8.0	2.1	6.3
4.5	9.6	2.4	7.7
5	11.7	3	9.4

Copper Tube OD=0.45" ID=0.38"

Vendor#1 Tube SS304 OD=0.5" Wall=0.028" ID=0.444"

Vendor#2 Tube SS304 OD=0.5" Wall=0.049" ID=0.402"

Vendor#1 and Vendor #2 cold plates have less pressure drop than the copper tube cold plate.

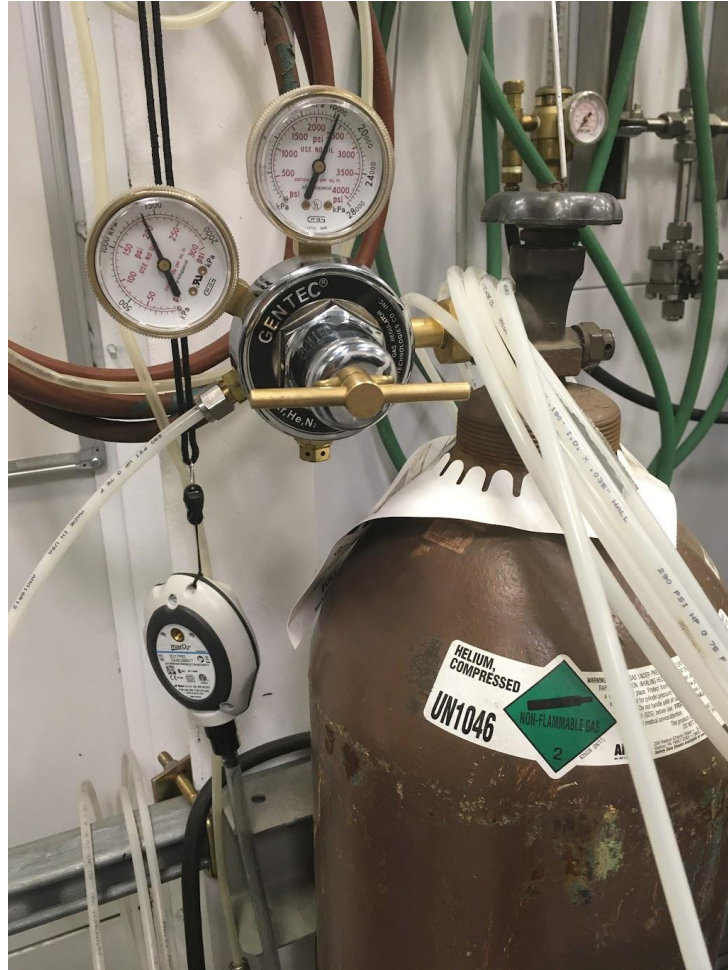
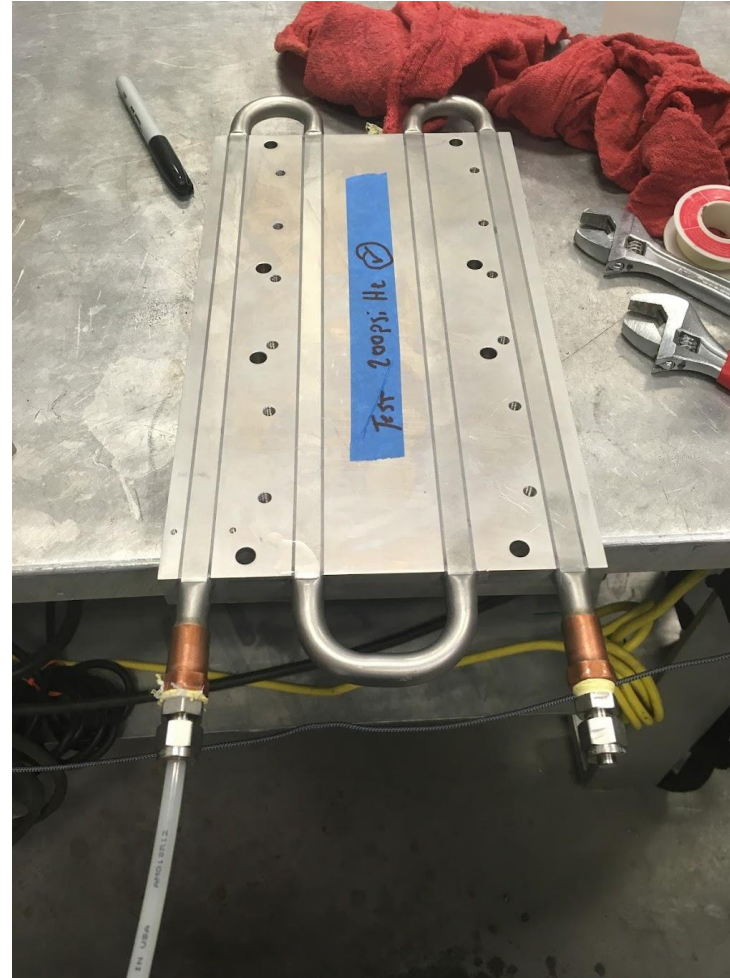
Pressure Hold-off Test

Operating pressure=80 PSI.

Both cold plates passed 200PSI, 1 hour test, 2.5 times of the operating pressure.

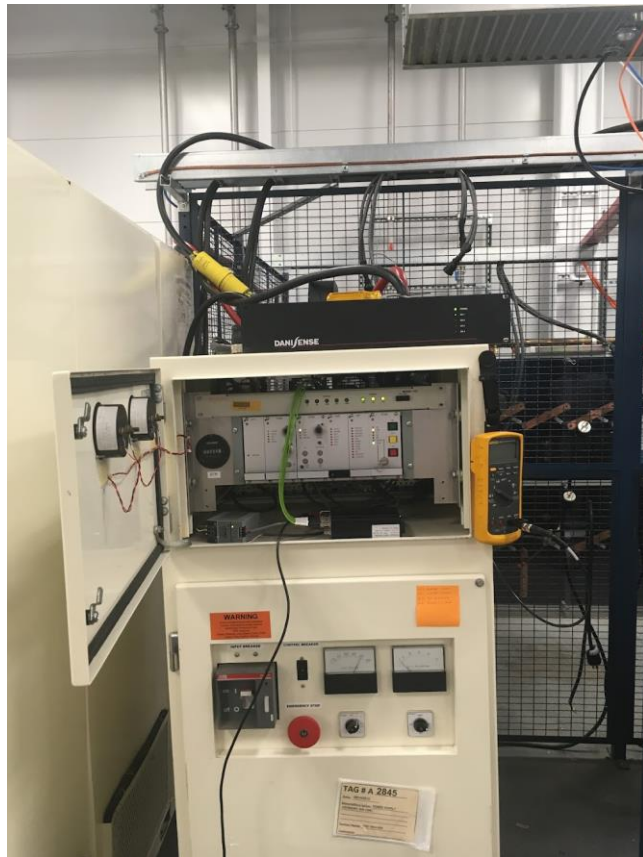
Cold Plate Thermal Test

- The test was conducted on a spare power supply in the power supply test stand so we could acquire data quickly.
- Two cold plates (CP1 and CP2) are in use.

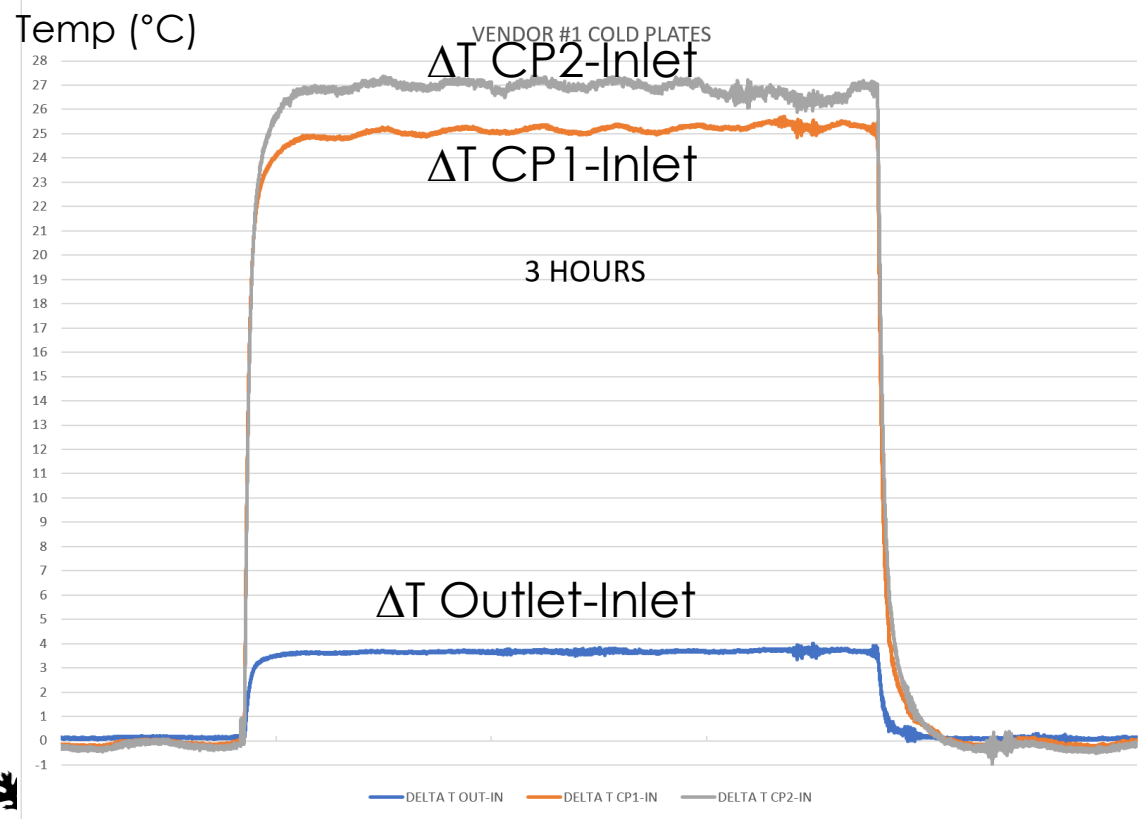
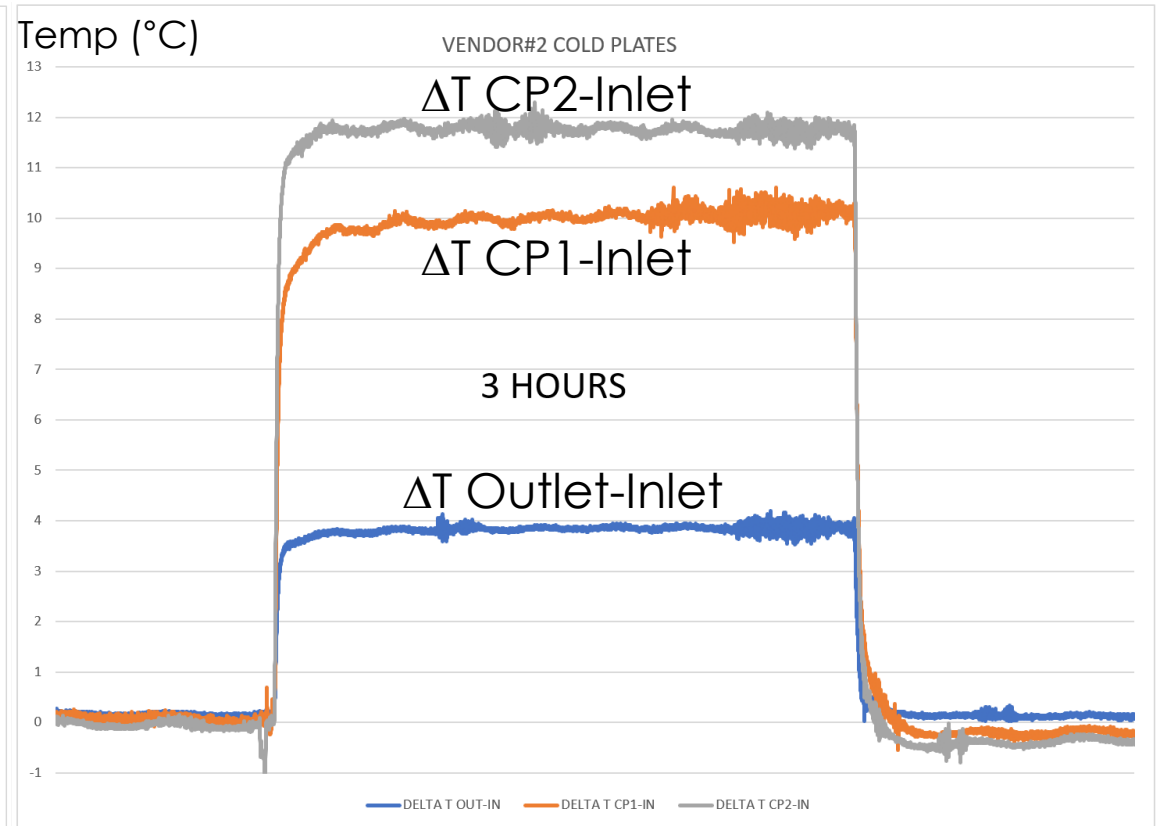
Test Data

Flow=2.1GPM PS Output 500A 18V	Cold Plate with Copper Tube	Vendor #1 Cold Plate with 1/2" SS Tube	Vendor #2 Cold Plate with 1/2" SS Tube
ΔT Outlet-Inlet ($^{\circ}\text{C}$)	4.2	3.7	3.9
ΔT CP1-Inlet ($^{\circ}\text{C}$)	8	25	10
ΔT CP2-Inlet ($^{\circ}\text{C}$)	10	27	12

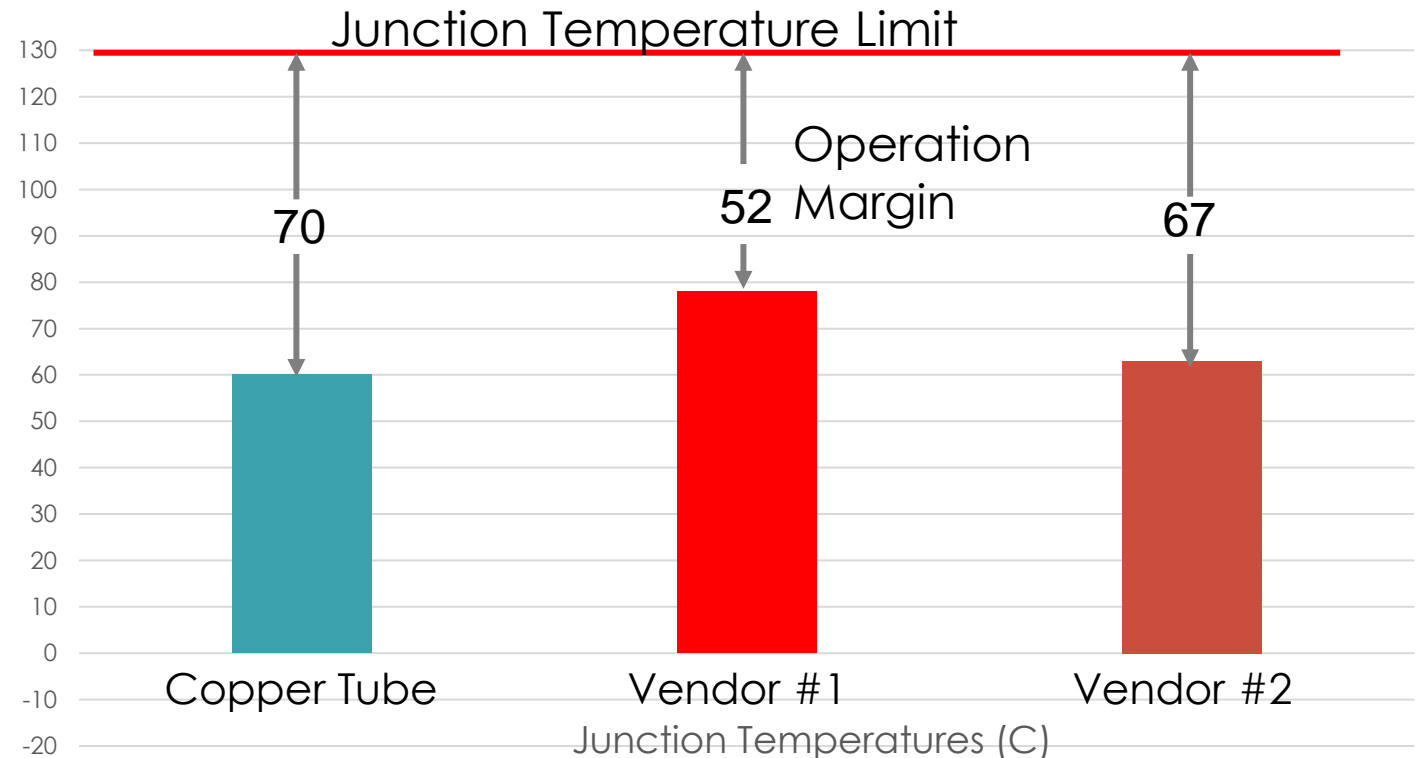
Test Results

- Both Vendor #1 and Vendor #2 cold plates have sufficient design margin under normal operating conditions.
- Vendor #2 cold plate has better thermal performance than Vendor #1 cold plate.
- Vendor #2 cold plate runs slightly hotter than existing cold plate under same conditions.

Flow Q=2.1GPM I=500A V=18V	Copper Tube Cold Plate	Vendor #1 Cold Plate	Vendor #2 Cold Plate
Inlet Temperature (°C)	33	33	33
ΔT CP2-Inlet (°C)	9	27	12
CP2 Probe Temperature (°C)	42	60	45
CP2 Maximum Temperature (°C)	45	63	48
SCR Junction Temperature (°C)	60	78	63

After the test, 5 Vendor #2 cold were installed in operational power supplies and ran for over 6 months with no issues.

Vendor#2 has been selected as the path forward.

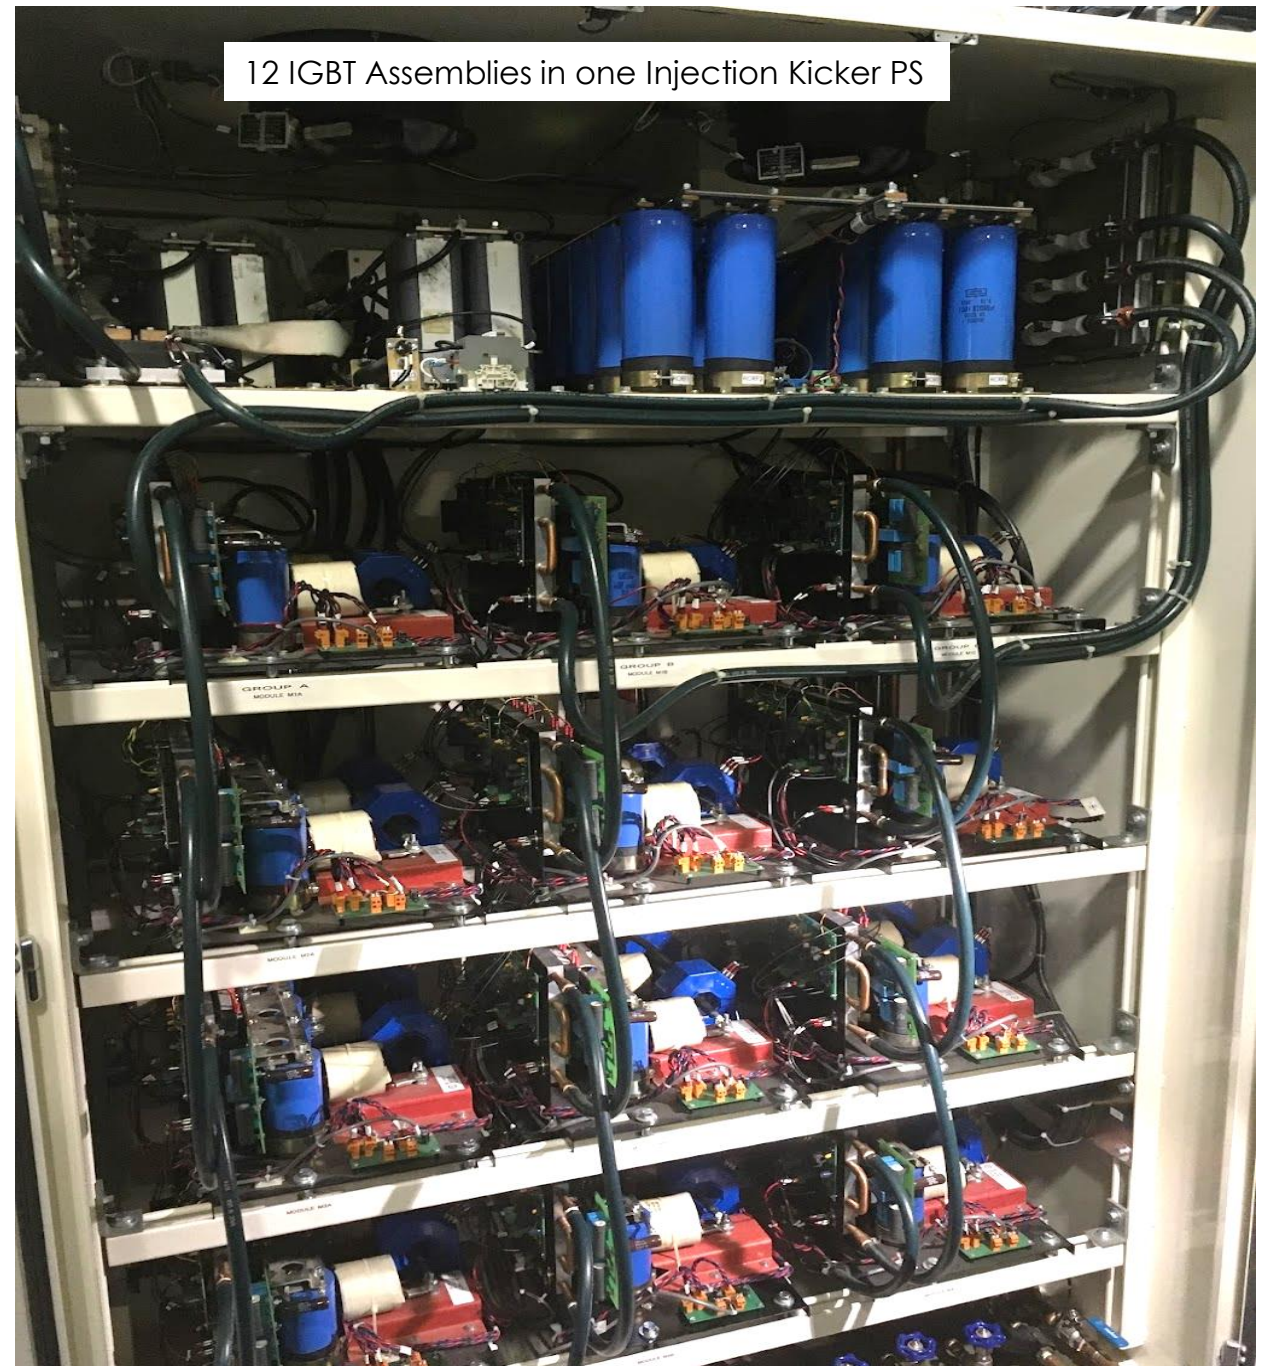
12 IGBT Assemblies in one Injection Kicker PS

- All leaks happen in Ring Service Building (RSB).
- Most occur in Injection Kicker power supplies because each injection kicker power supply has 15 cold plates while other IE power supplies have two cold plates each.

- Complete RSB first, then RTBT service building, HEBT service building, Klystron building.
- Most installation will be done in FY23B outage.
