FoCal-E pad in Japan

14th of March, 2023.

Motoi INABA

Topics - Recent activities in Japan

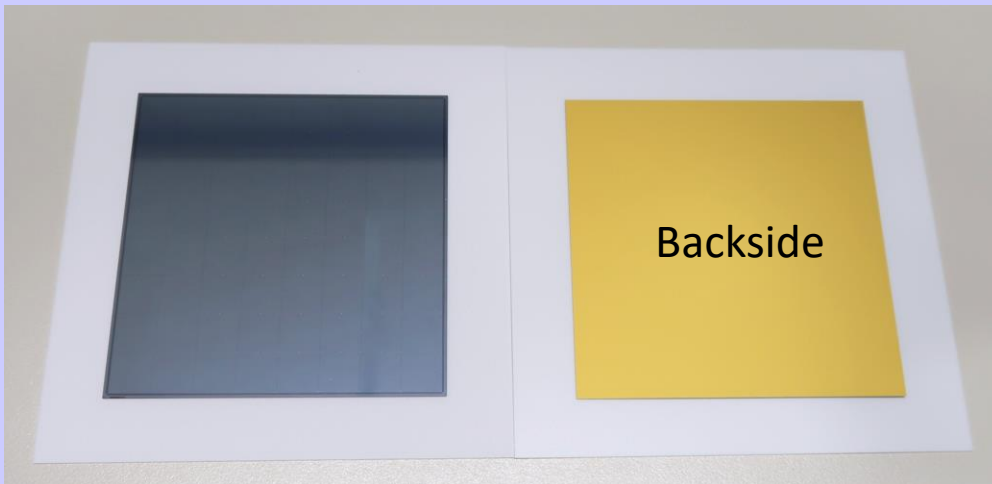
2nd version in 2017

Thinner sensors for the higher radiation tolerance.

Thickness: 500um → **320um**
(Active: 480um → **300um**).

The surface was covered with the aluminum layer in order to improve the light shielding, and 60 sensors were used for the "mini-FoCal" detector in 2018.

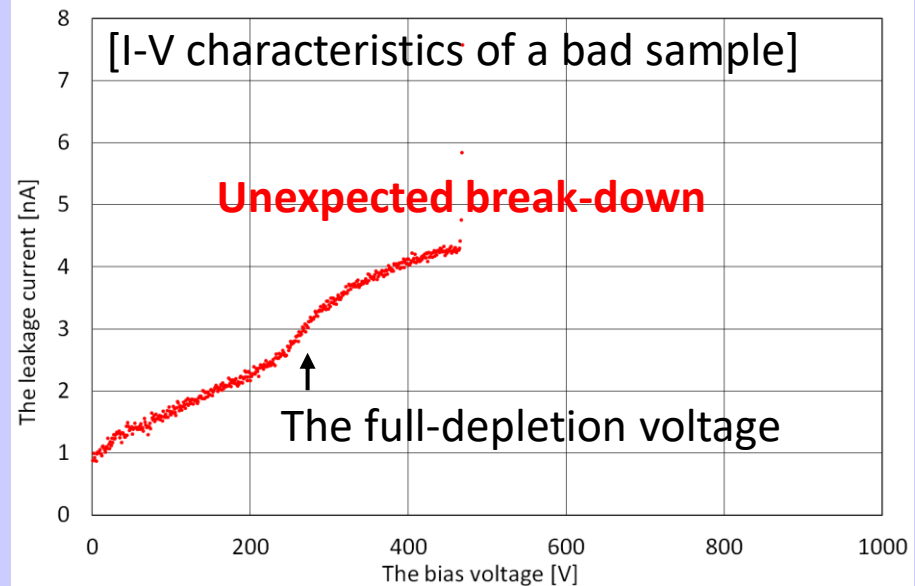
The number of pads with an unexpected higher leakage current was not zero, but it was possible to read signals of all pads.

Some sensors caused the break down at a lower bias voltage than the design value (= 1000 V) and it seemed to come from the p-stop structure.

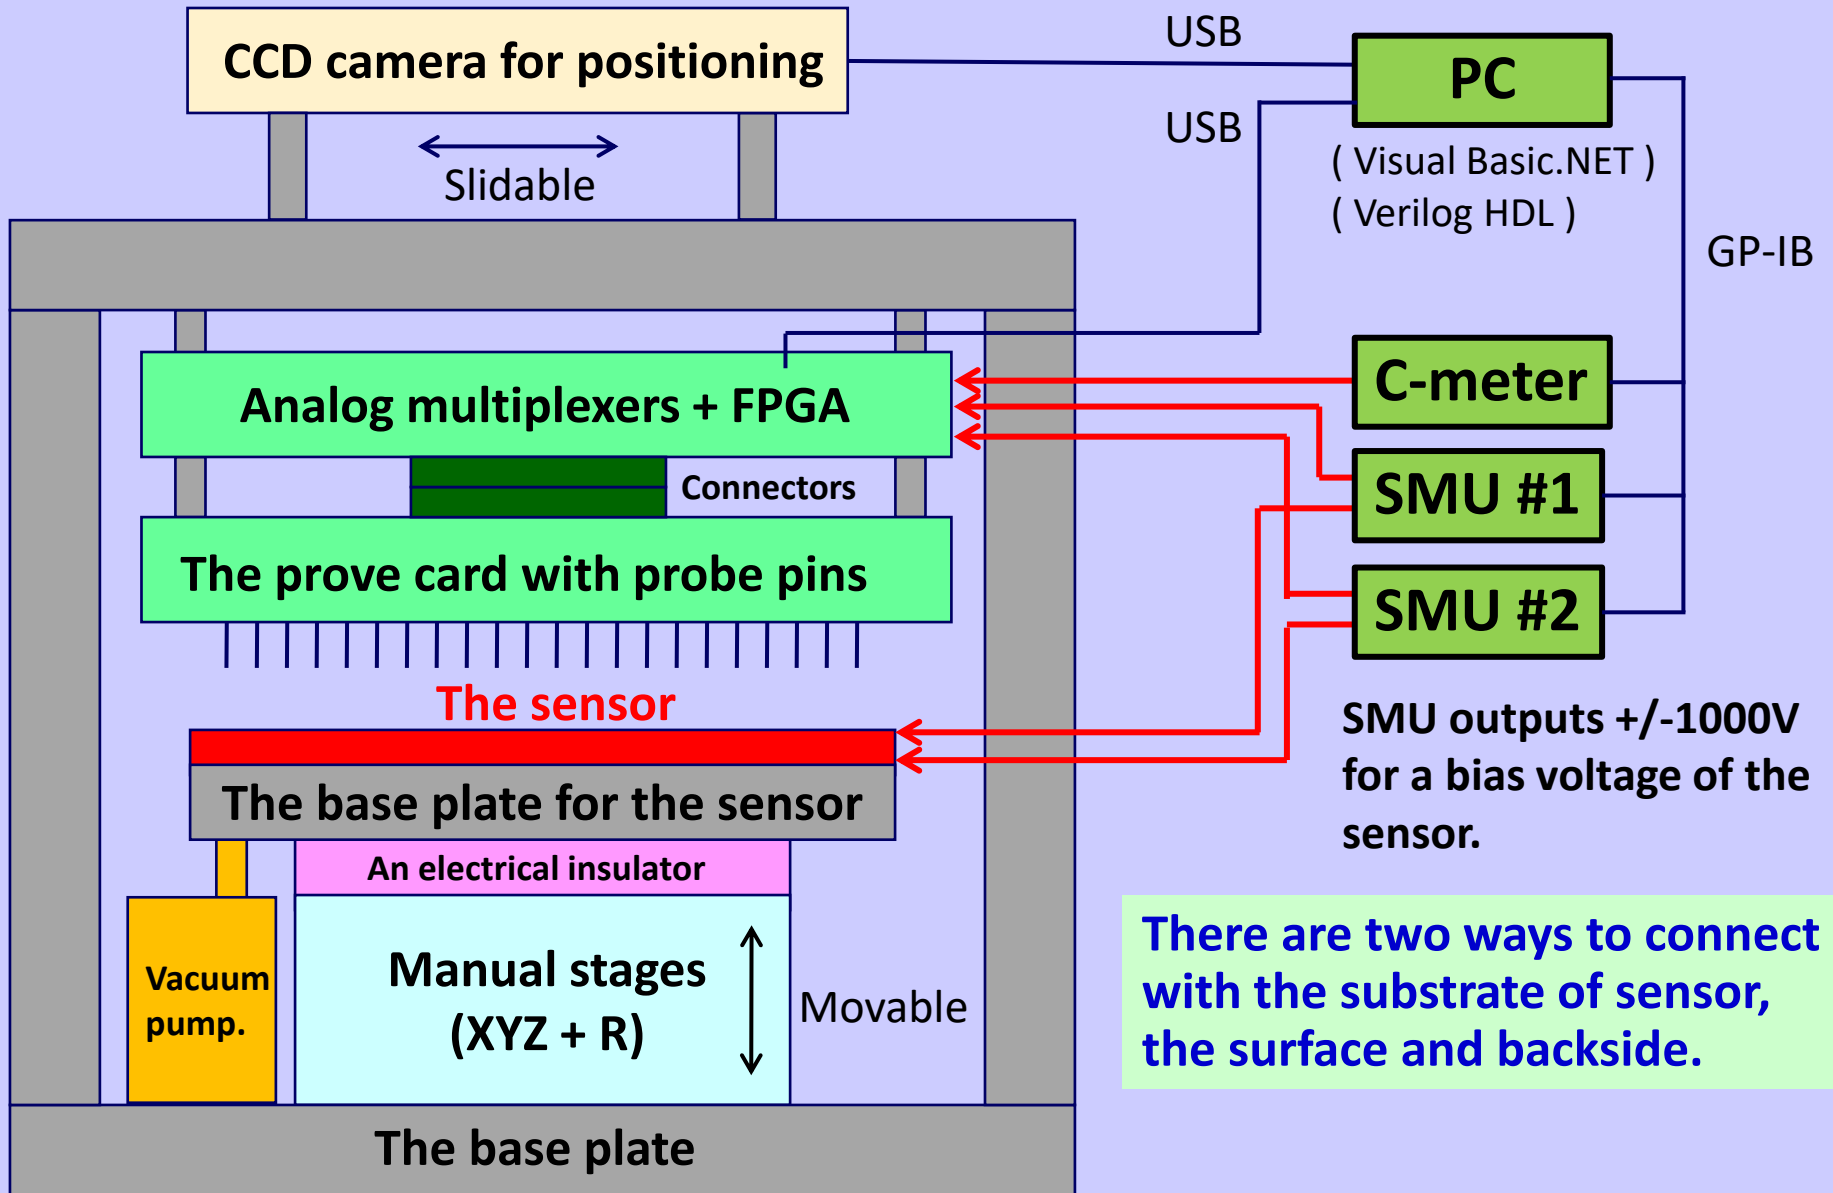
Connection to the sensor

There are two ways to connect with the substrate of sensor, the surface and backside.

<A sectioned drawing >

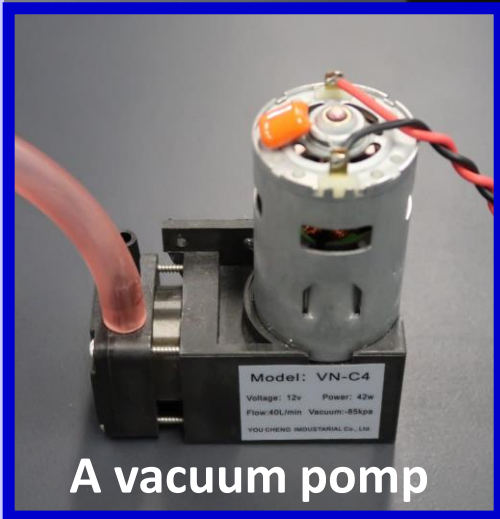
A vacuum pump

Model: VN-C4
Voltage: 12v Power: 42w
Flow: 40L/min Vacuum: 85kpa
YOH CHENG INDUSTRIAL CO., LTD

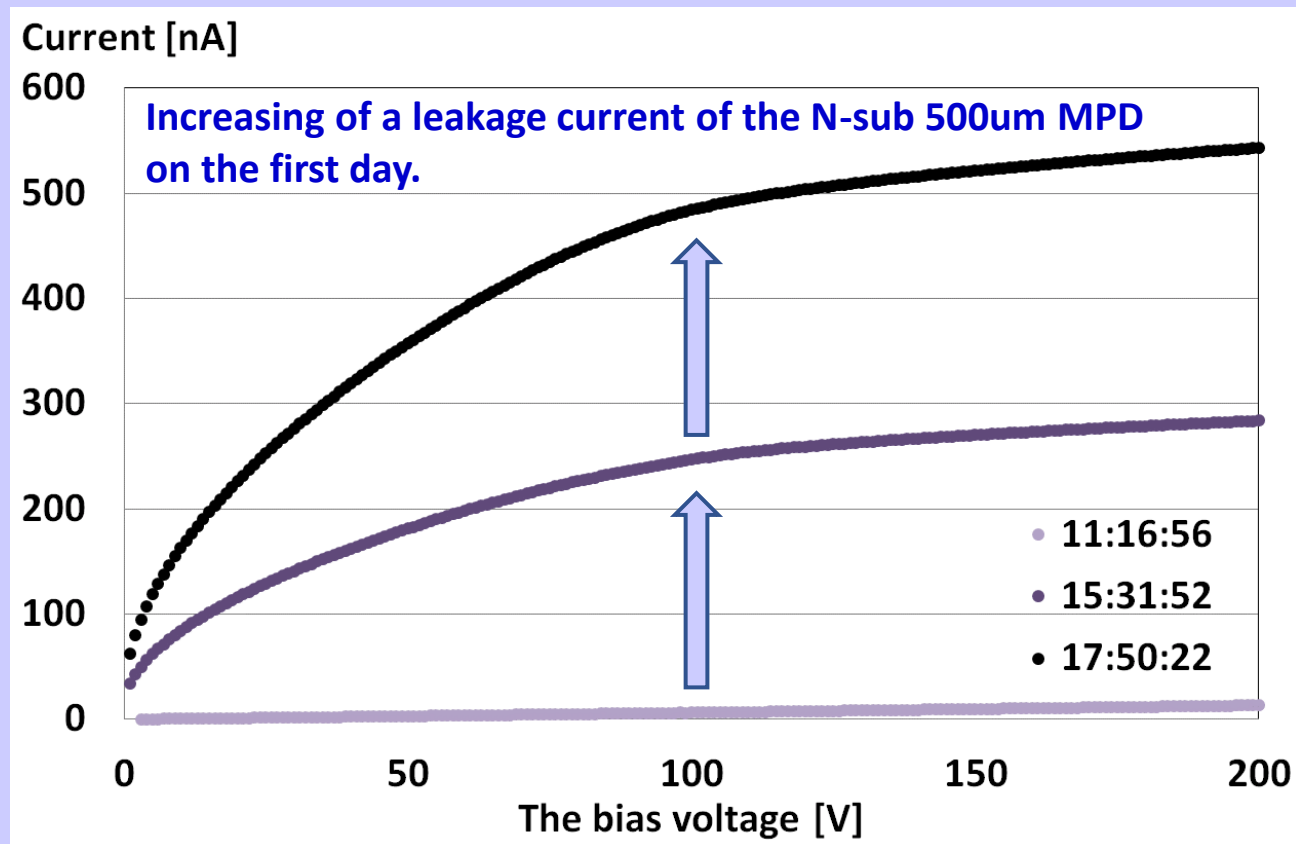
7th of March: 2 runs using a low-intensity neutron beam (1-hour x 4uA each),

8th of March: 3 runs using a low-intensity neutron beam (1-hour x 4uA each).

After removal of silicon pad sensors, other 2 runs of a high-intensity neutron beam (about 2 hours x 40uA in total).

As we expected, a leakage current was getting higher according to the irradiation.

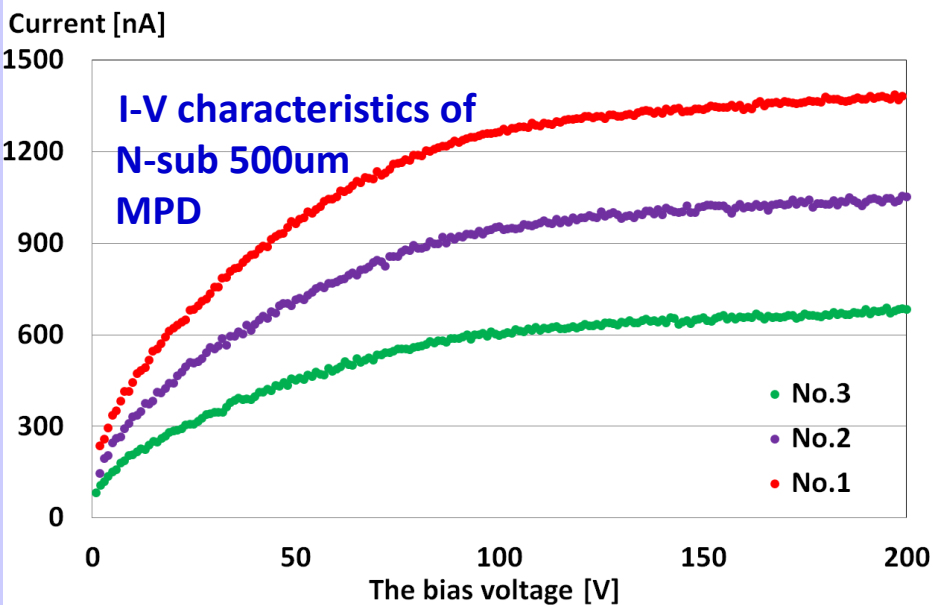
Results of the N-substrate MPD

A leakage current had increased according to the irradiation, and then it had decreased by the annealing effect. In three days, C-V characteristics were measured. Sensors on three PCBs had a different level of radiation, it comes into view as a difference of leakage currents. However, no significant difference of the full-depletion voltage among three MPDs could be found.

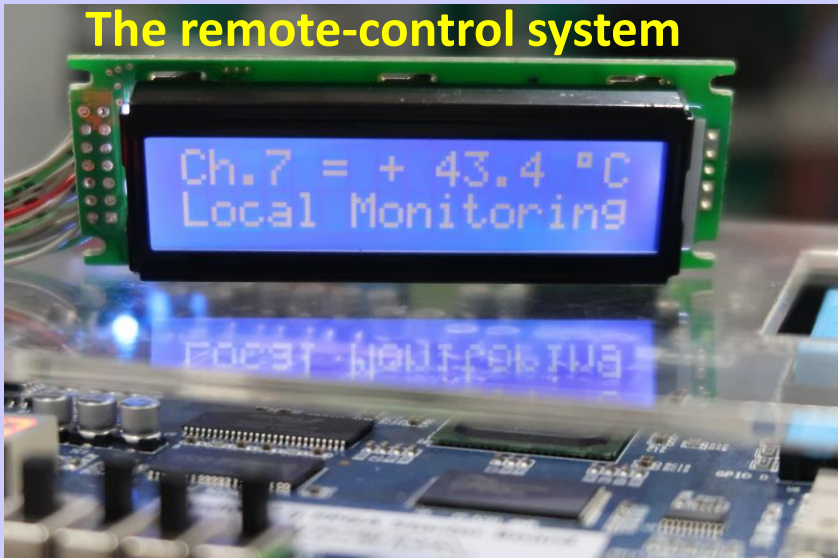
The temperature control system

In order to increase the temperature, I made a special black box with a heater.

We took the data at a room temperature, 30, 35, 40 and 45 degrees C.

45 degrees C is the maximum operation temperature of the KCU105 FPGA board and it is difficult to buy new one. No significant difference of the MIP data could be found at 45 degrees C and below.
