# Comparative Aging Studies of GEM Detectors in contaminated Environments

Jeremie MERLIN on behalf of the CMS Muon group

3<sup>rd</sup> International Conference on Detector Stability and Aging Phenomena in Gaseous Detectors

November 2023

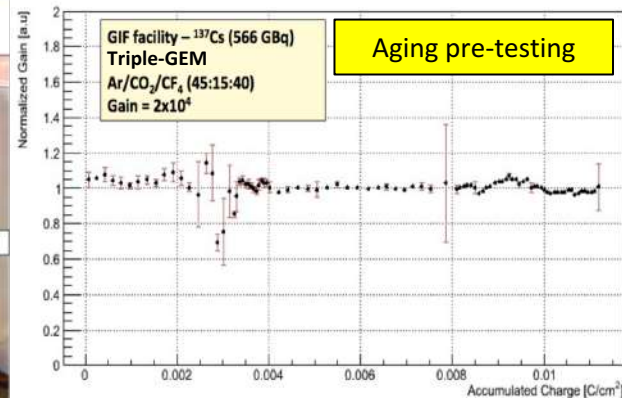
- Large triple-GEM prototype
- Ar-CO<sub>2</sub> (70-30)
- 2 wire chambers for gas purity monitoring (upstream and downstream) with low rate X-ray sources
- <sup>137</sup>Cs (662 keV photons)
- Short test period (7 months)

→ No signs of aging in the GEM prototype up to 12 mC/cm<sup>2</sup>

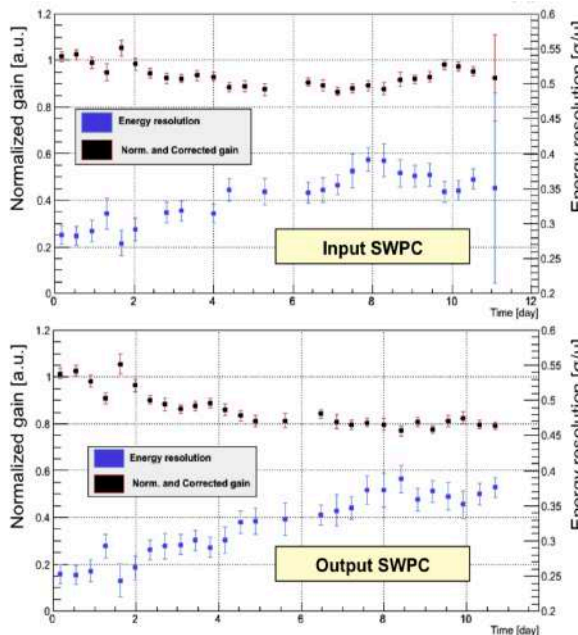
- Both input and output wire chambers show clear signs of aging after just a few days of irradiation
- Presence of Silicon deposits in the irradiated regions

→ Confirmation that the gas was contaminated even though the GEM detector did not show signs of performance degradation

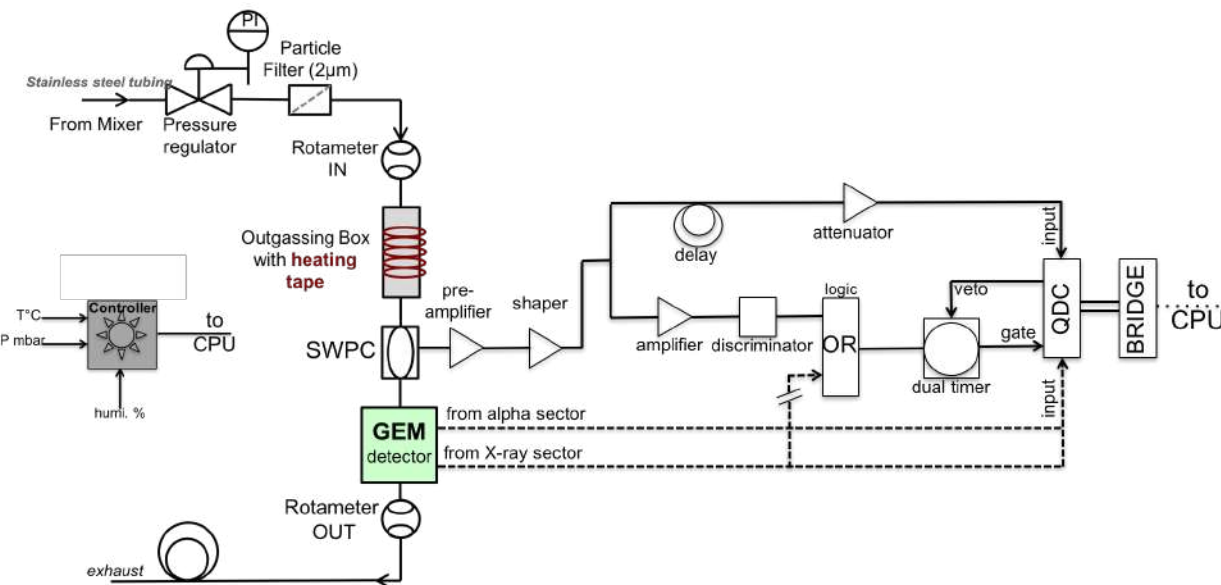
Outgassing/Aging test setup at CERN (CMS GEM Lab)

- Standalone setup at CERN previously used for outgassing studies
- 4 identical test lines with: individual gas flow control, outgassing box, monitoring wire chamber
- Common “old style” DAQ chain with NIM (trigger) +VME (ADC)
- Meteo station for T/P monitoring and recording

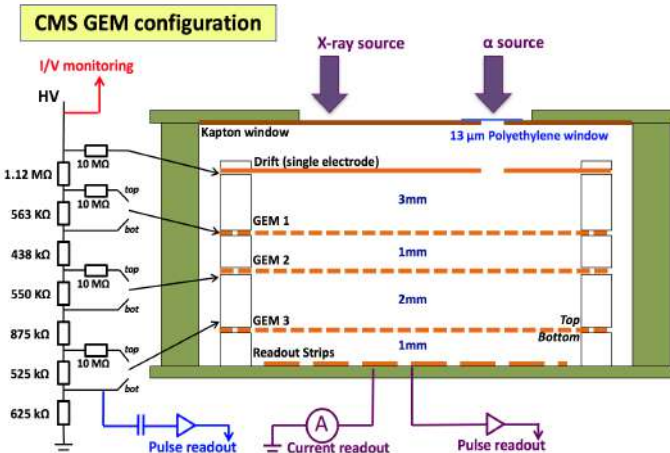
- 3/1/2/1mm configuration
- Ar-CO<sub>2</sub> (70-30%) @ 5L/hr
- Alpha sector (special opening)
  - <sup>241</sup>Am: α rate = 600 Hz
  - Primary charge ~ 12k pairs
- X-ray sector
  - <sup>55</sup>Fe: γ rate = 900 Hz
  - Primary charge ~ 200 pairs

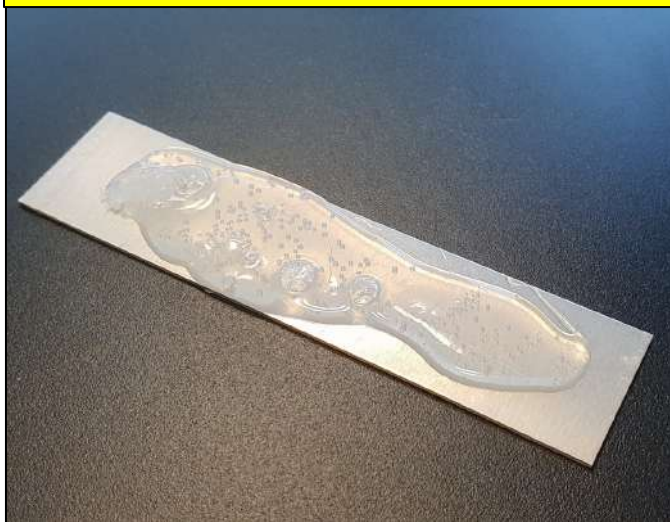
Polluting sample

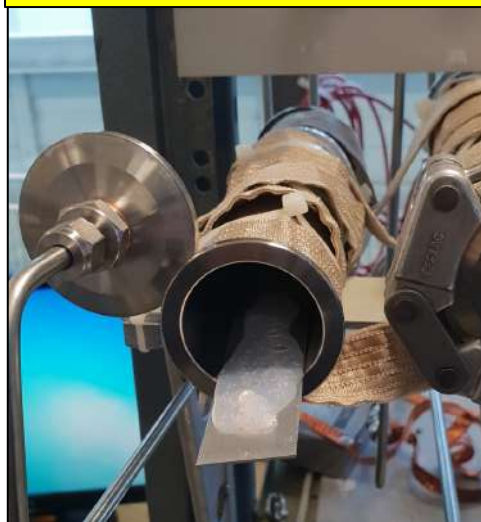
- Use of the outgassing test setup to have any material upstream the detectors under test
- Outgassing box filled with: 10g of 3140 RTV **Dow Corning** + 10 g of Acrifix 1R 0192 (**PCV glue**)
- Expected contaminants:

- Heating tape wrapped around the outgassing box to heat up the sample and enhance the outgassing

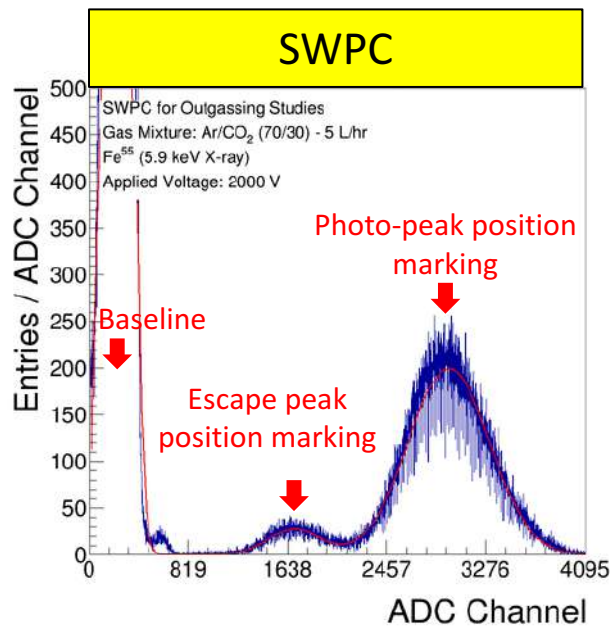
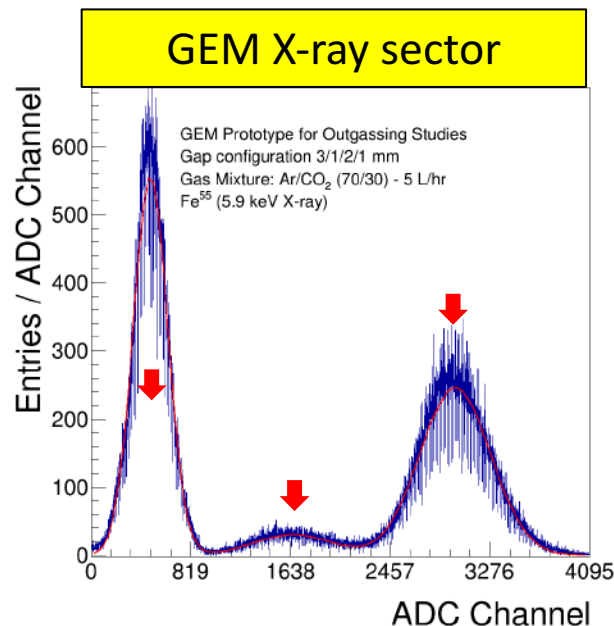
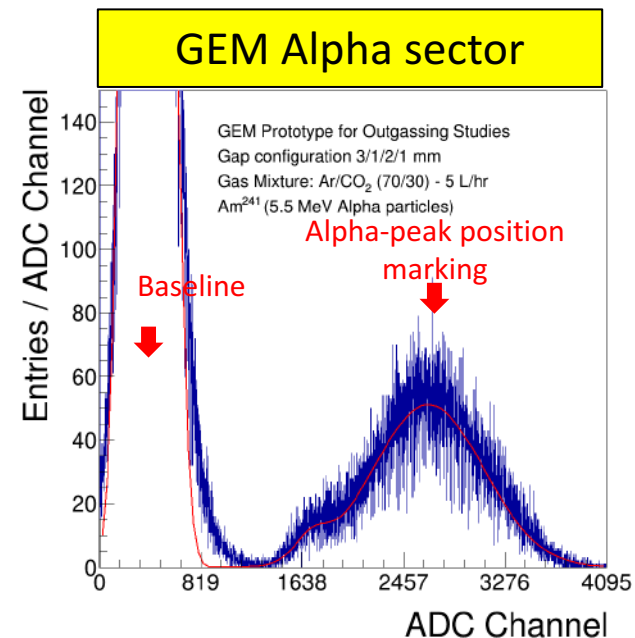
- ADC spectra recorded every 30 min during the long run for both SWPC and the various GEM regions
  - Off-line analysis to identify ADC values for: baseline, escape peak and photo peak
  - Test duration depends on the source rate and the primary charge (to reach the same accumulated value)
  - Polluting material was heated up to 50C during the second half of the irradiation period
- Total accumulated charge equ. to 170mC/cm<sup>2</sup>, i.e. > 70 days of continuous irradiation

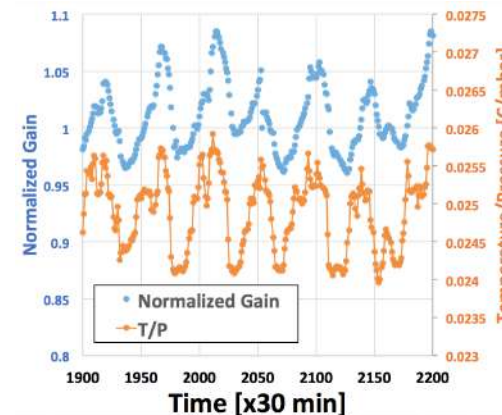
- Usual influence of T and P on the detector gain
- Environment fluctuations are recorded every 5 min during the entire irradiation test
- Data are combine with detector output to make comprehensive events

- Identify the correlation between T/P/Gain
- Apply T/P correction
- Normalize to initial gain values

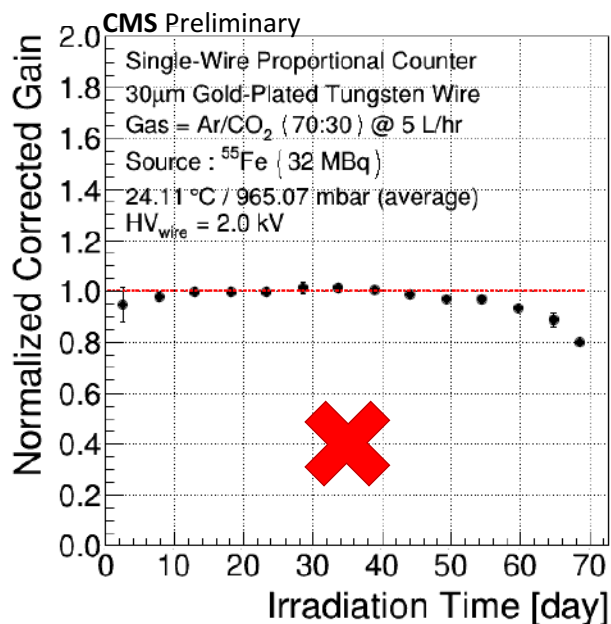
- All detector (all regions) accumulated the equivalent of 170 mC/cm<sup>2</sup> (over a period of 70-90 days)
- Permanent gain drop in the wire chamber
- No change of effective gain in the two GEM regions

**Aging**

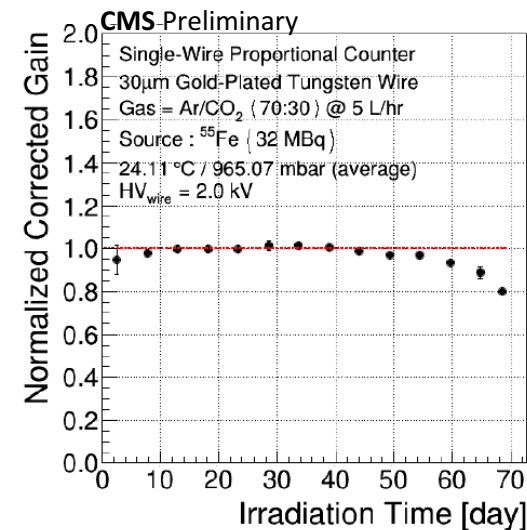
- Clear evidence of gain drop after about 50 days of operation
  - Not recovered after flushing gas without HV + neighbor (not irradiation regions) show normal gain values
  - SEM confirms the presence of 5-10 μm deposits in the irradiated region
  - EDS confirms the presence of Silicon at the level of the deposits
- Clear confirmation of aging phenomenon triggered by the upstream outgassing material

%	Au	C	O	Si	Na	+ traces
Spectrum 3	7.9	67.8	17.7	2.8	1.5	Al, Mg, K, Cl, S, F, Ca
Spectrum 4	9.6	13.2	26.4	27.3	2.2	Al, Mg, K, Cl, S, F, Ca
Spectrum 5	62.4	14.2	10.7	8.3	1.6	Al, Mg, K, Cl, S, F, Ca
Spectrum 6	78.1	4.0	13.0	4.2	0.2	Al, Mg, K, Cl, S, F, Ca

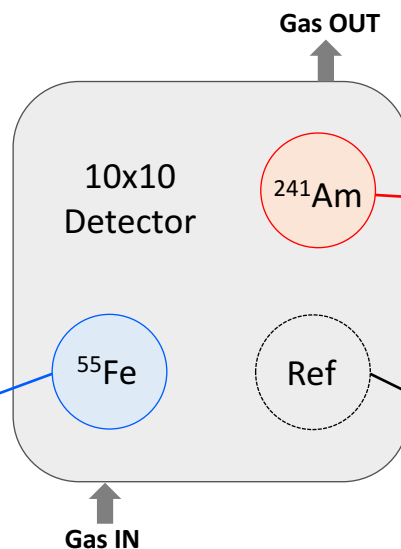
## GEM 3 – X-ray Sector

- Reference samples and X-ray samples appear clear and shiny
- Alpha samples show a dark stain with the same shape as the irradiation window
