# **IT.L8 event on 17/7/23 at 1 AM**

**(some material quickly copy-pasted from 3 meetings in the CCC)**

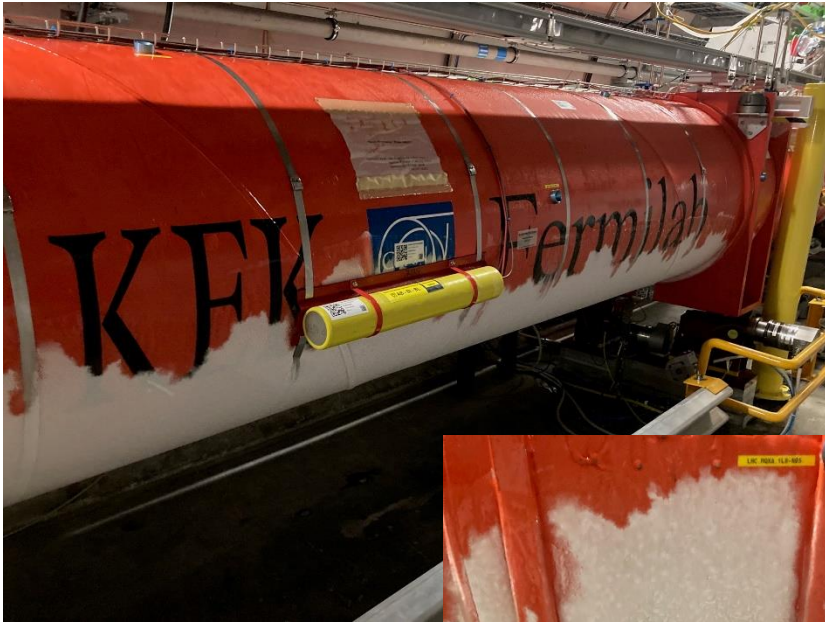
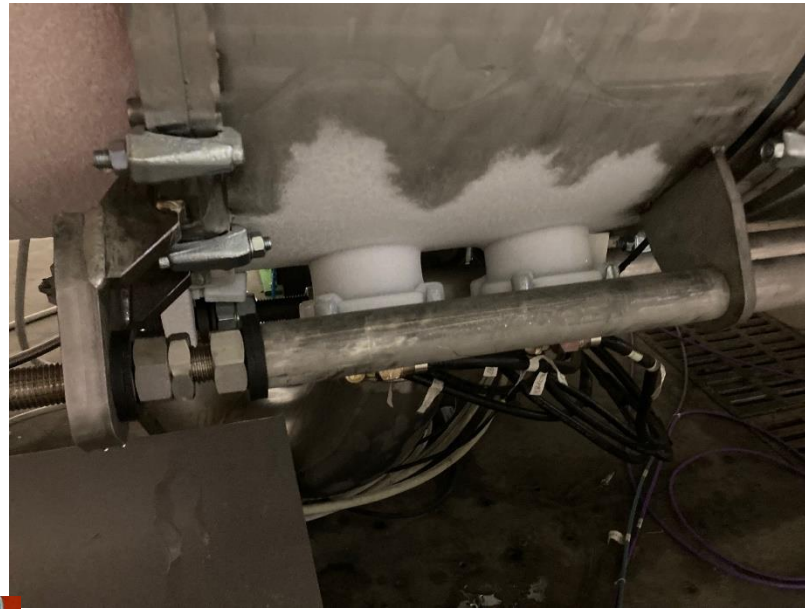
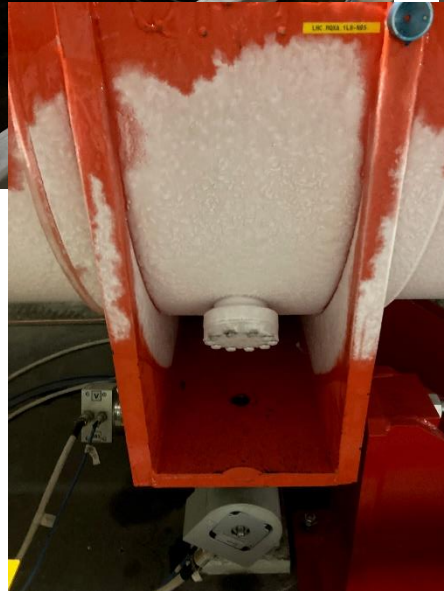
# Tunnel visit

- Condensation clearly visible on **Q1/2/3**
- Some (less) on **D1 and DFBX**

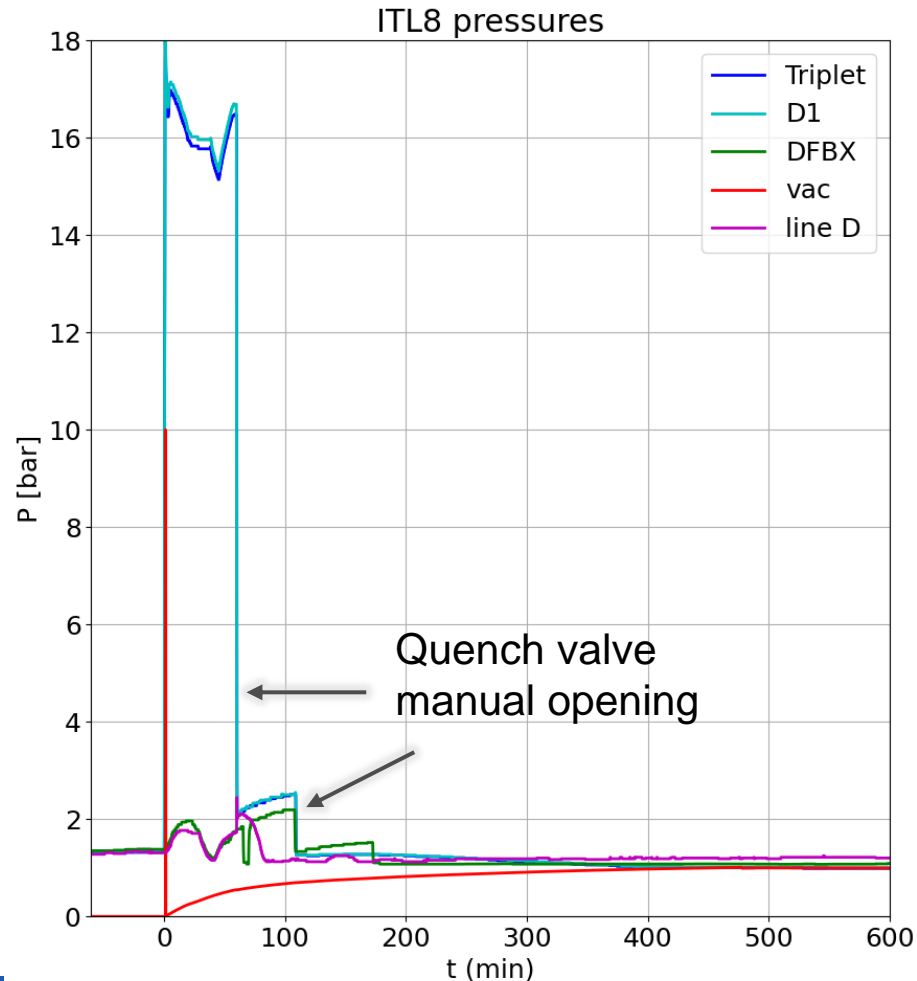
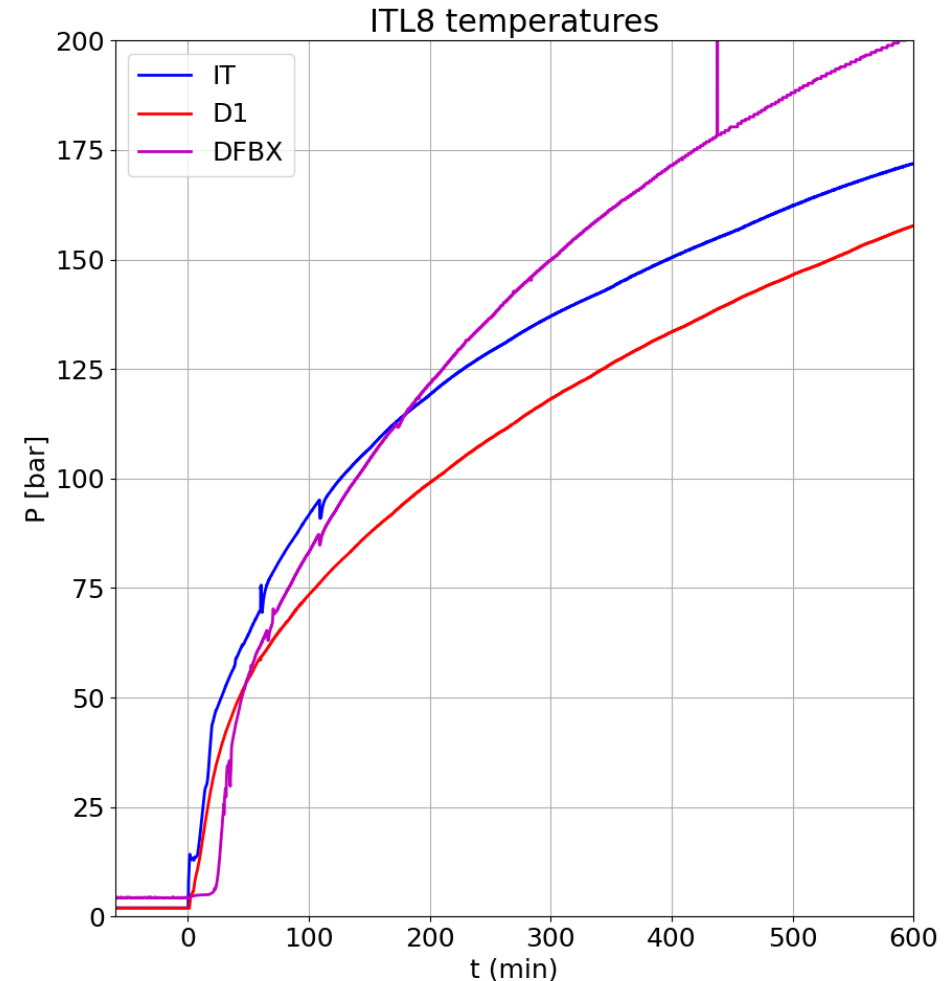
# IT-D1-DFBX L8: general cryo trends

- IT & D1 & DFBX are thermally coupled and share the same insulation vacuum
- IT & D1 share the same superfluid helium bath
