# Pressure bursts due to beam-dust interaction at SuperKEKB

Y. Suetsugu for KEKB vacuum group

KEK, Tsukuba, Japan

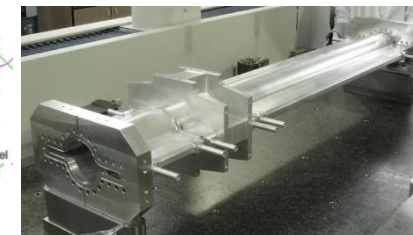
Typical beam pipe for HER

KEKB type (reuse)  
(racetrack)

Super KEKB type (new)  
(with antechambers)

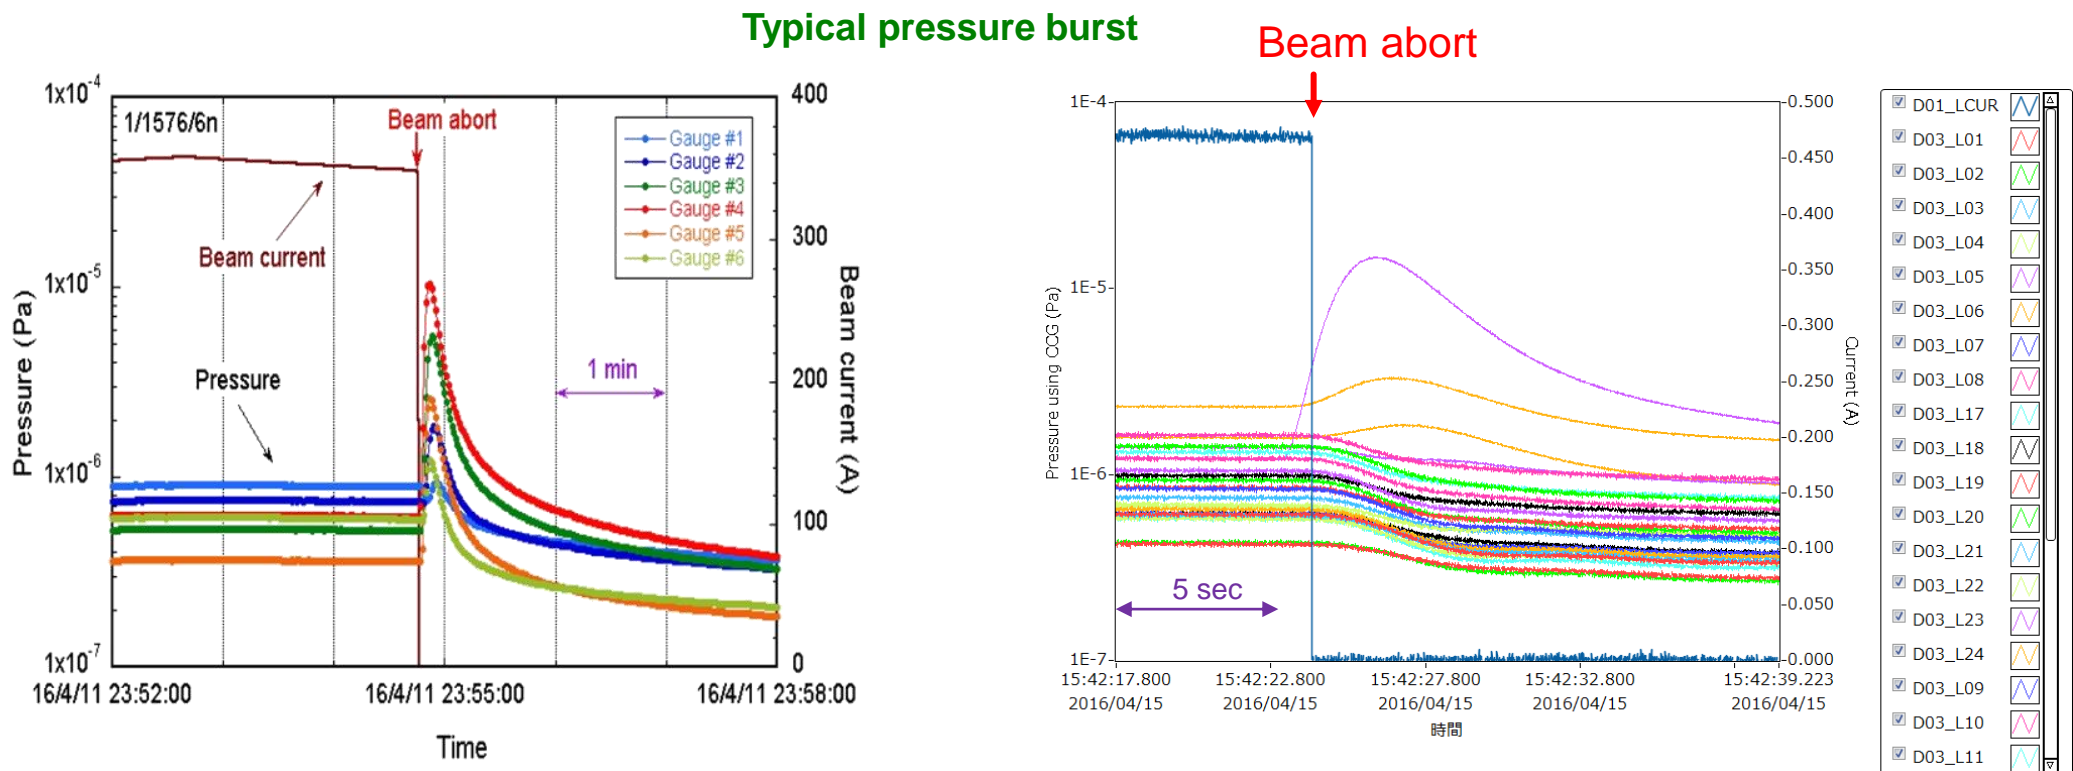
- ▶ Beam aborts accompanied by **local pressure bursts** were frequently observed in **the Phase-1 operation** (Feb. ~ Jun., 2016).
- ▶ Maximum pressure =  $1 \times 10^{-6} \sim 1 \times 10^{-5}$  Pa.
- ▶ Observed at just after beam aborts: in a few seconds.
  - ▶ Vacuum gauges are located at approximately **every 10 m in average** along the ring.
- ▶ Sometimes the pressure rose **“before”** the beam abort, which was observed by a rapid monitoring system.

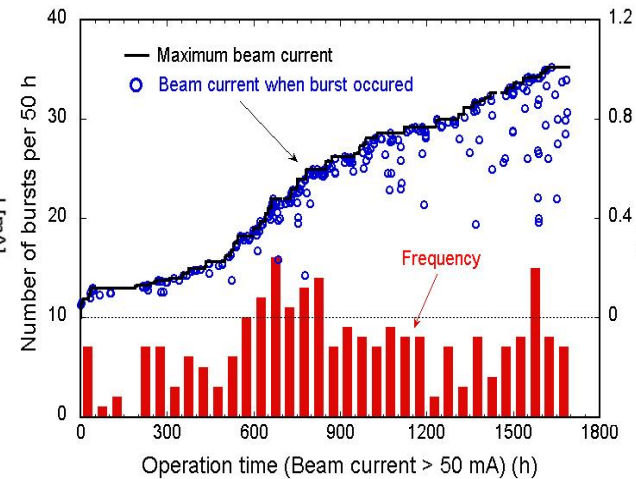
Frequency of pressure bursts for LER

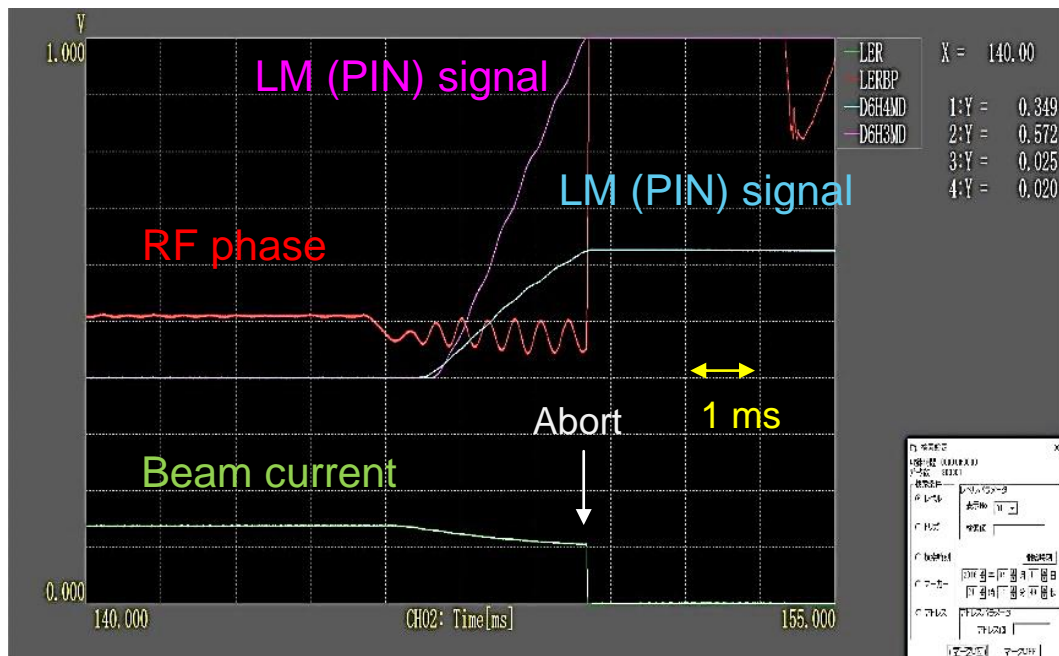
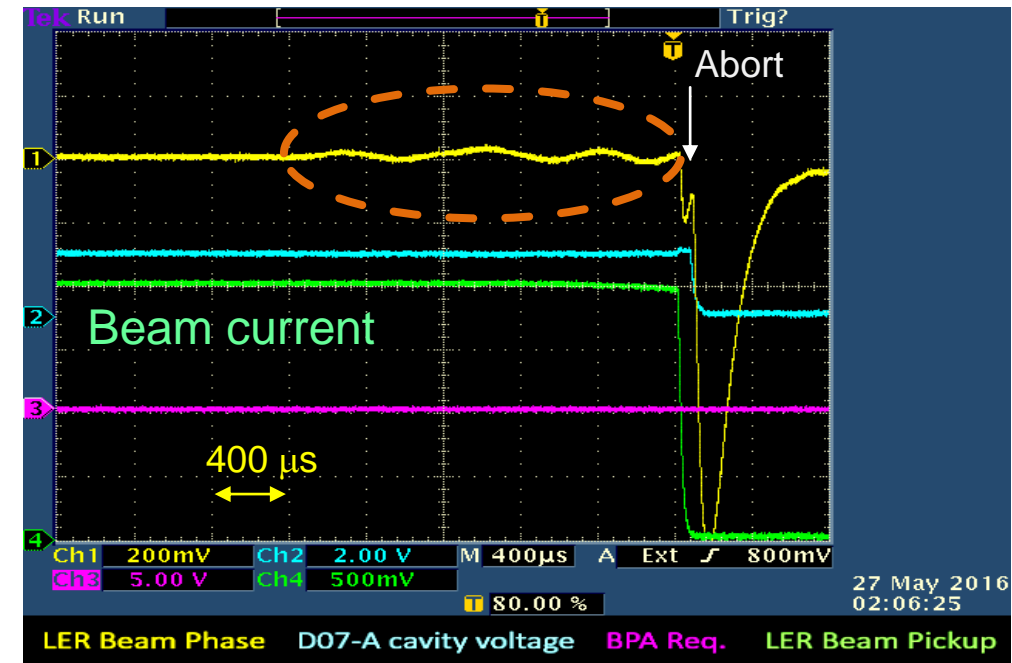
- ▶ Beam loss
  - ▶ Beam-loss monitors at collimators triggered the beam aborts.
  - ▶ The beam loss lasted for 1 ~ a few ms before the beam abort.
  - ▶ Synchrotron oscillation was observed before beam loss. → Any energy loss.

Typical abort log for the case pressure burst was observed. (H. Ikeda)

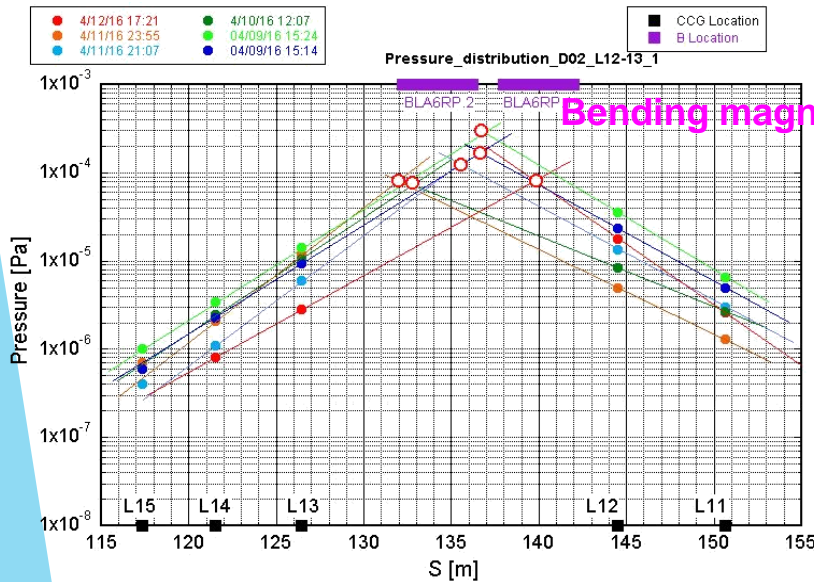
- ▶ Locations of pressure bursts.
  - ▶ Deduced from the distribution of pressure heights along the ring.
  - ▶ In most cases, the bursts were observed near the beam pipes in dipole magnets, which have a groove structure as a countermeasure for the electron cloud effect (ECE).
    - ▶ The surface at the top and the bottom of beam channel was grooved.
  - ▶ Groove structure → easy to trap “dusts”.
  - ▶ Note that the beam pipes with groove structure are also used in arc sections. But the manufacture is different from that of the beam pipes at Tsukuba straight section.

Estimated detailed locations of pressure bursts

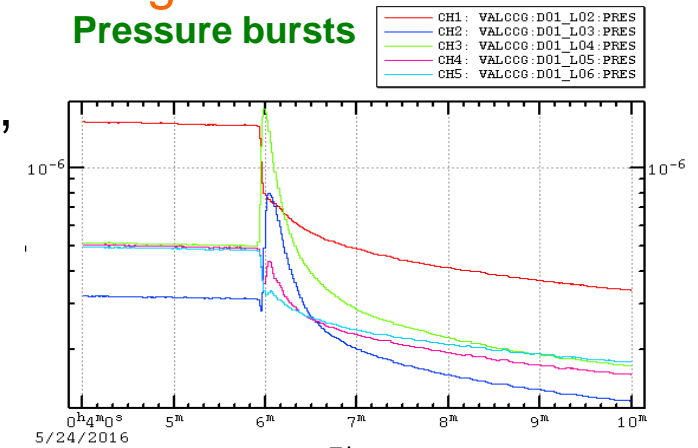
Pressure bursts

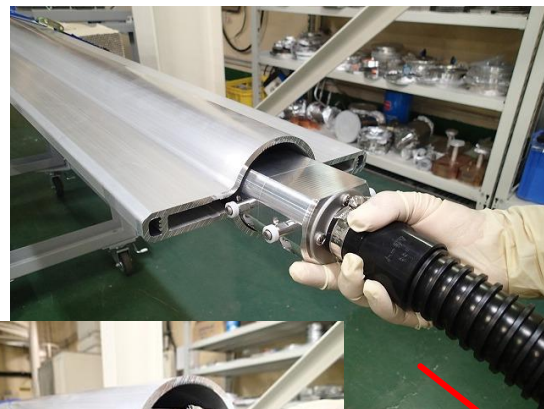
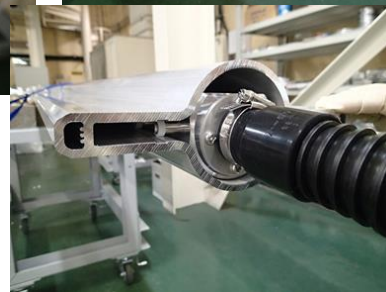
- ▶ Gathering of dusts from actual beam pipes in the ring.
  - ▶ A **special tool to cleanup the inside of beam pipes with antechambers** was developed.
  - ▶ The beam pipes where the pressure bursts had been frequently observed were used.
    - ▶ **The beam pipes have the grooved structure.**
  - ▶ After knocking the beam pipe in vacuum, the beam pipe was slowly filled with N<sub>2</sub> and the bellows were removed. Then the dusts **at the bottom** of beam channel was gathered by a powerful vacuum cleaner.

Special tool to cleanup the bottom of beam channel

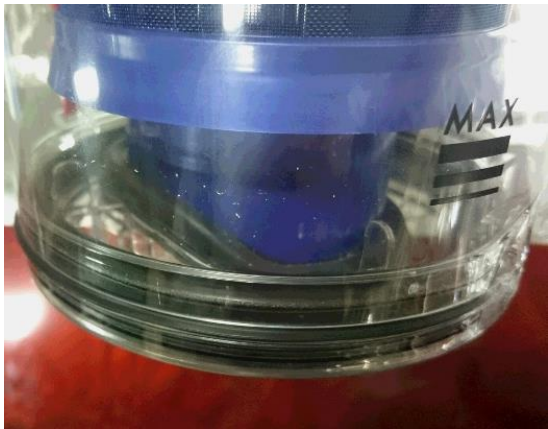
- ▶ Gathering of dusts from actual beam pipes in the ring.
  - ▶ Lots of large (in the order of one hundreds microns) dusts were found from one of the two beam pipes.
    - ▶ Small dusts could pass through the filter of the cleaner?
    - ▶ We did not check the inside of beam pipes at places where the bursts were not observed.
  - ▶ Most typical dust component were  $\text{Al}_2\text{O}_3$  (chips left after machining aluminum?).
    - ▶ Others: Zr, V, Fe, C, O → NEG material, Si, O, C →  $\text{SiO}_2$  (sand?)

## Dust obtained from the beam pipe in question

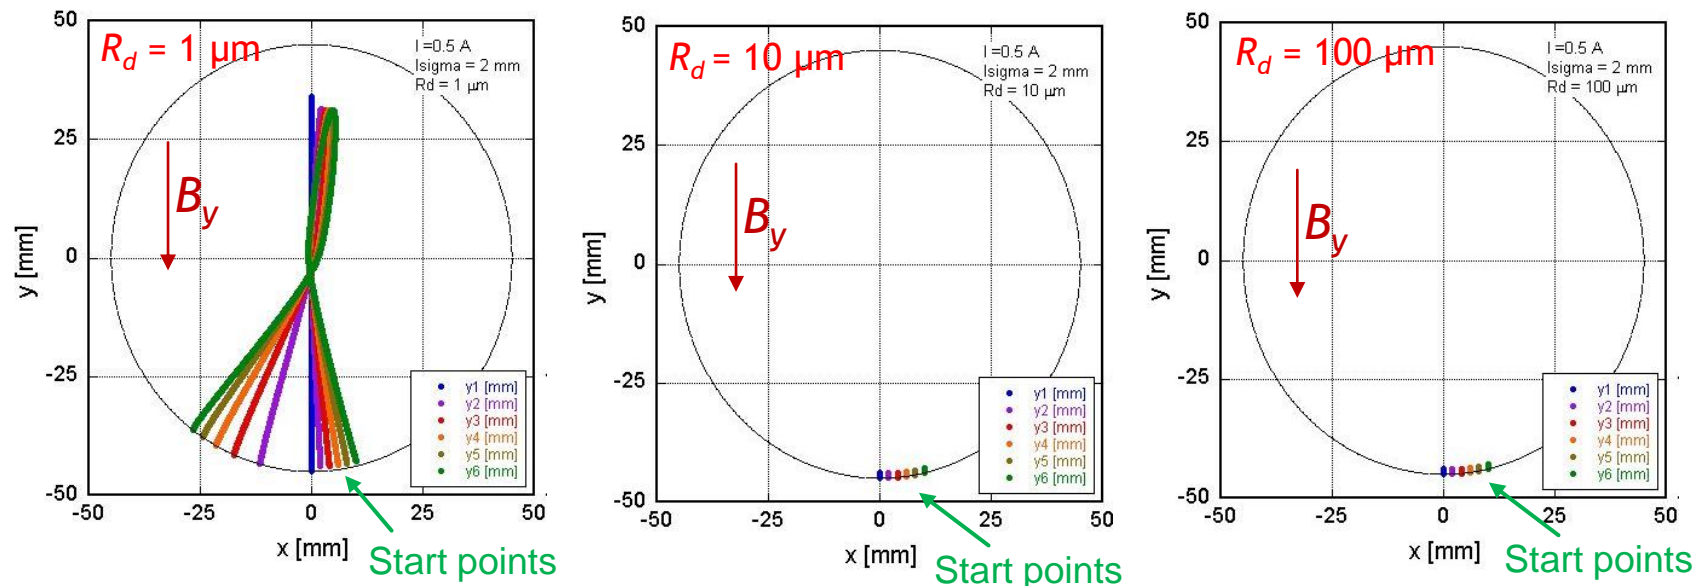
- ▶ It is hardly possible practically to cleanup the all dusts by the cleaner during the commissioning.
- ▶ **But if the sizes of dusts are large**, it is quite unlikely that the dusts are picked up from the bottom of beam channel, which might be charged up by electrons(?).
- ▶ Simple calculation showed that **a circular dust with a diameter larger than  $10\ \mu\text{m}$  cannot be lift up by the beam**. (Dust potential = 10 V, beam current = 500 mA, Initial dust location = 1 mm from the surface to remove mirror charge effect, magnetic field = 2 kG in bending magnet, smooth surface (without groove)).

Calculated orbits of dusts picked up by beam from the bottom of beam pipe

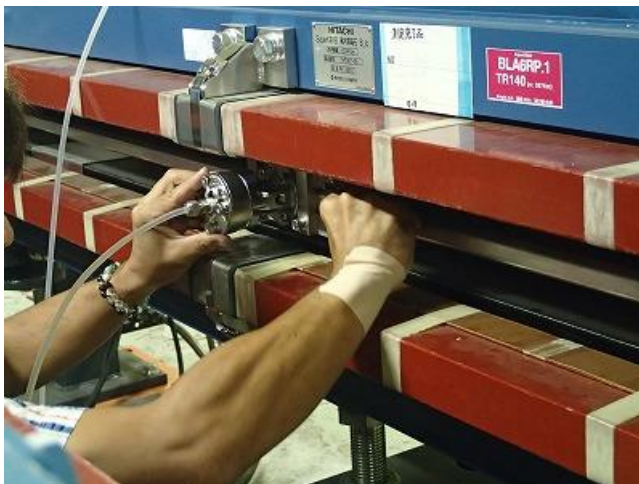
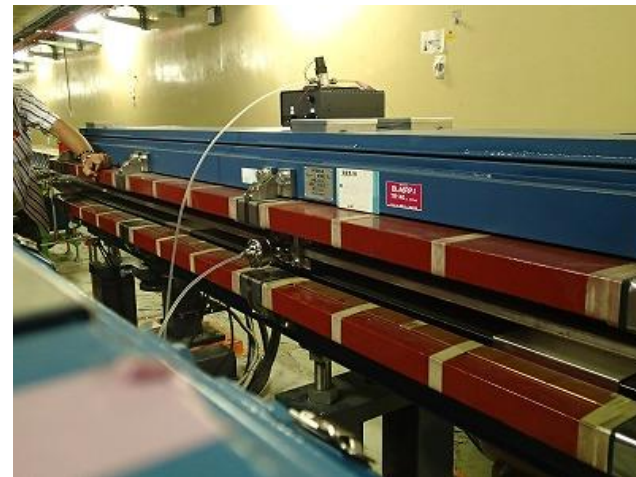
Knocking of beam pipes for bending magnets

- ▶ Under these considerations, we had **knocked 24 beam pipes for bending magnets (with groove)** around LER Tsukuba straight section for test, where the pressure bursts were frequently observed, and **dropped dusts from the top**.
- ▶ We knocked 150 times for each beam pipe (50 times x 3 locations in a beam pipe), based on the result of preliminary tests using reserved pipes.
  - ▶ The amount of dropped dust decreased by orders of magnitude in the experiment at a test bench.

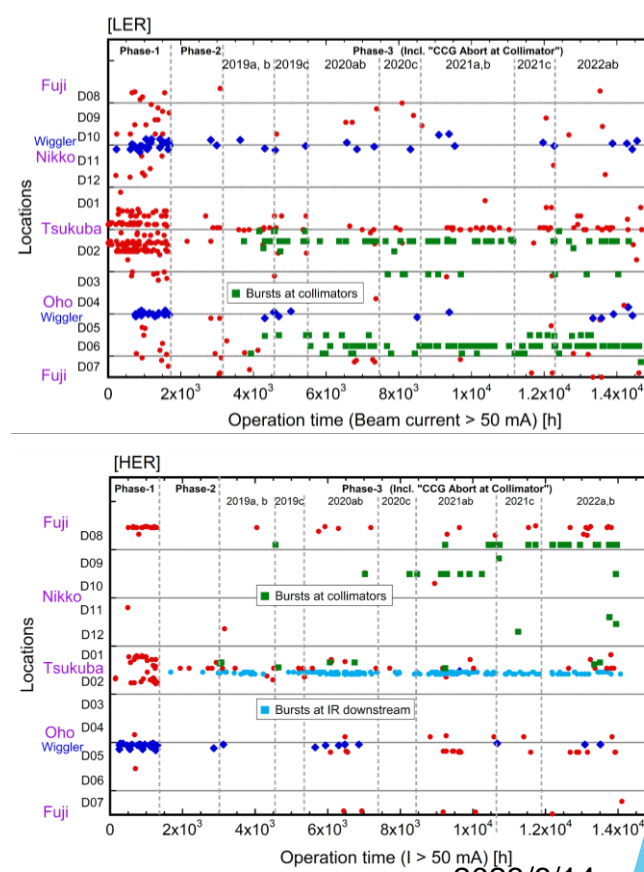
- ▶ Frequencies of pressure bursts up to June, 2022 (Mar., 2019 ~ [Phase-3])
  - ▶ Most of pressure bursts were observed at beam collimators and around IR.
    - ▶ Pressure bursts at beam collimators sometime indicated the damage of them.
    - ▶ The aperture of vertical-type collimators were very small (~ a few mm).
  - ▶ For locations other than above, the frequency is still lower than that in Phase-1 even at higher beam currents.

Location of pressure bursts

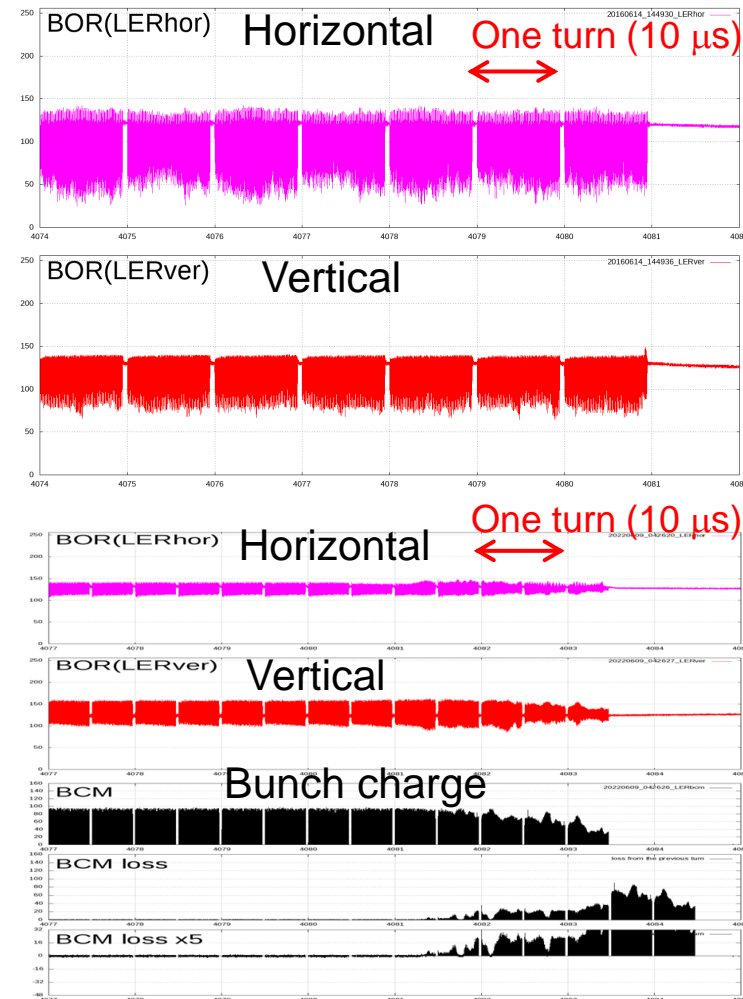
BOR data at a typical SBL

- ▶ The behaviors are different from SBL, where the beam loss starts several turns before abort.
