VeLo Tomography and plans for closing

Victor Coco (CERN) for the Velo group

PRELIMINARY, for discussion with MPP & Collimation

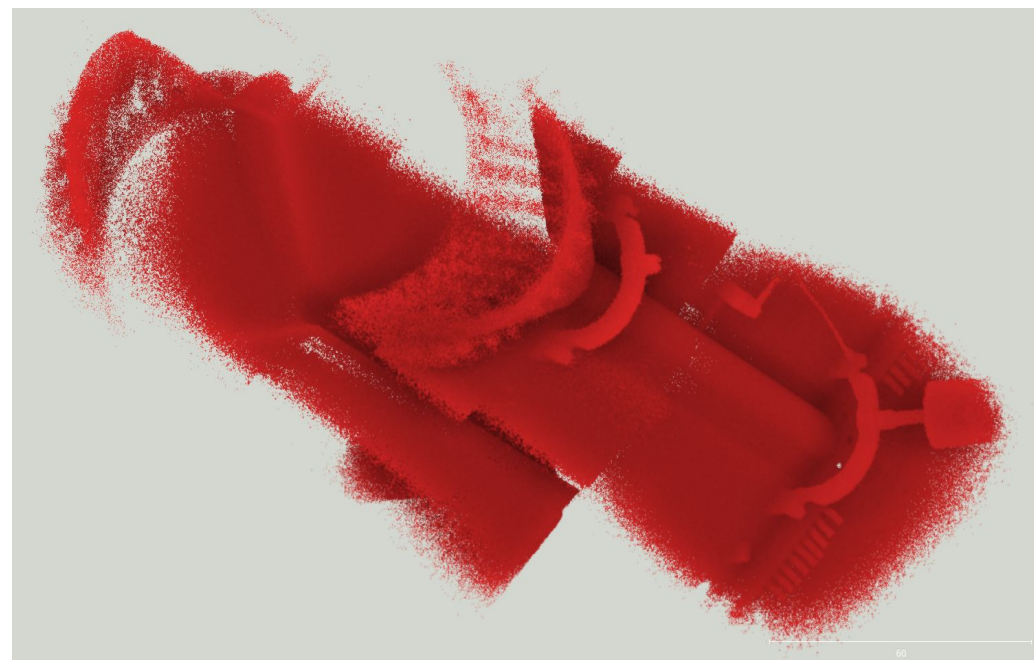
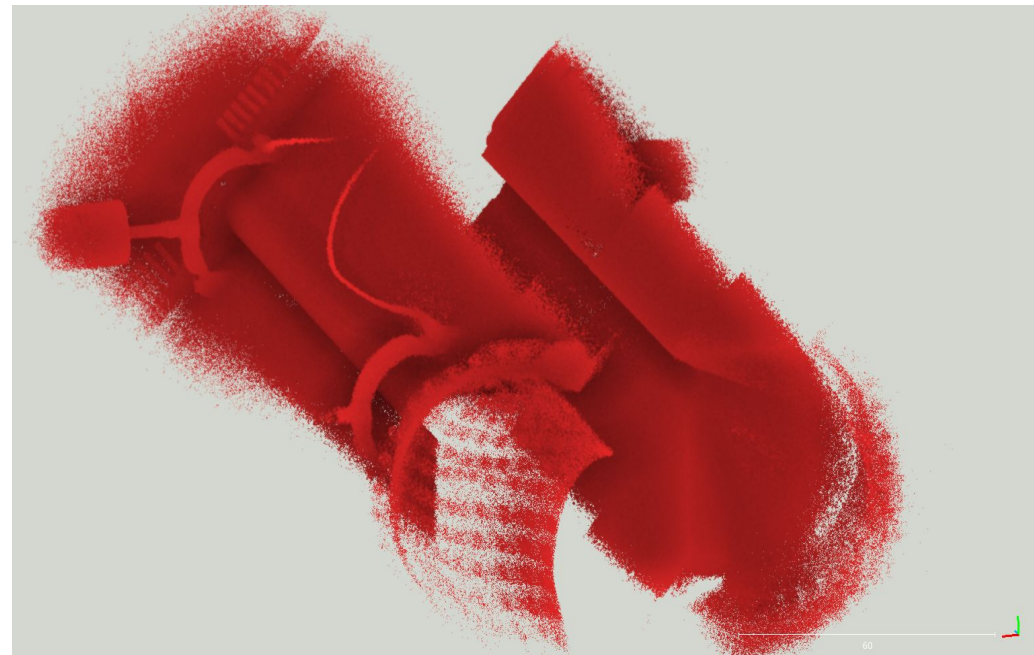
Topological inspection (1.) and (2.)

- No visible broken finger on the upstream wakefield suppressor (1.)
- No damage to the SMOG cell (2.)
- Transverse position of the cell wrt. foil identical to last year

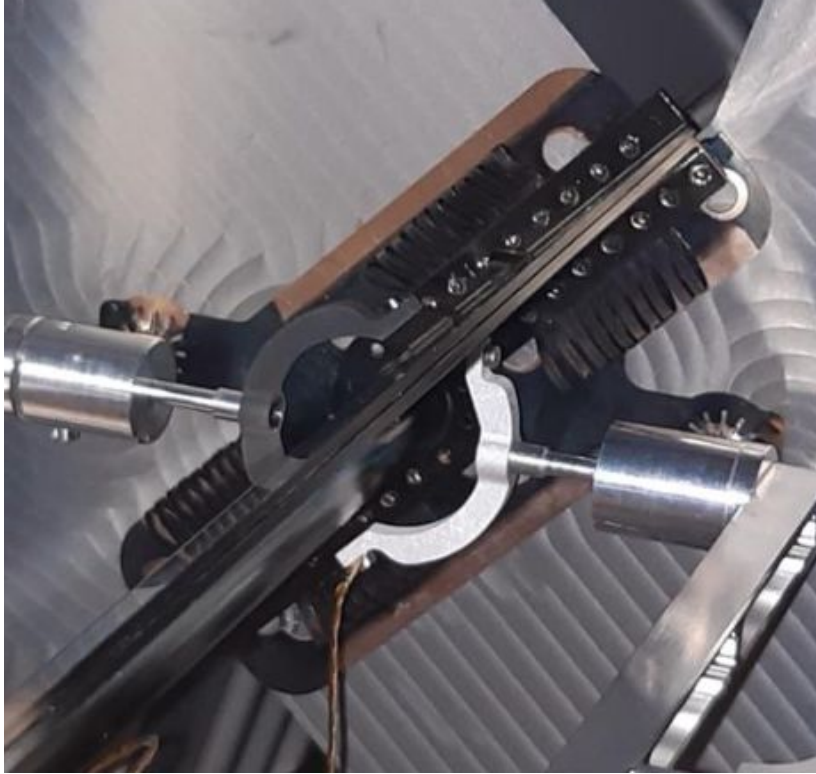
- No visible broken finger at the contact between foil and SMOG cell (3.)
- Shape of the finger as expected
- Mushroom not touching the SMOG cell

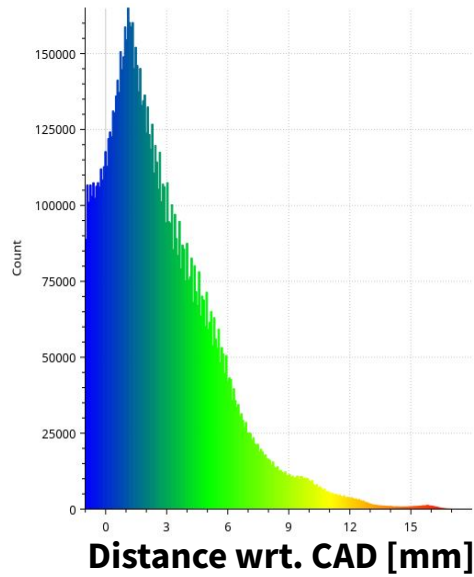
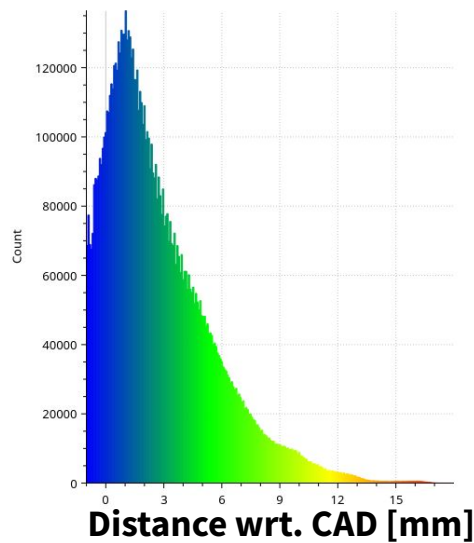
RF-foil deformation

and comparison with nominal foil

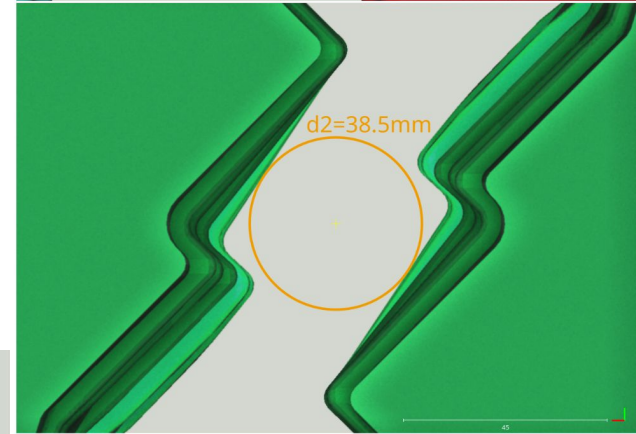
RF-foil deformation

and comparison with finite-element-simulation

- **Elasto-plastic simulation of A-side foil by M. Morrone and C. Garion (TE-VSC), used to assess the risk damage of the sensor when going back to pressure balance.**
- **Provided estimation of the aperture in open position in absence of direct observation**
- **Tomography data show 18% reduced aperture compared to simulation**
 - slightly different shape
 - in some part up to 30% more displacement

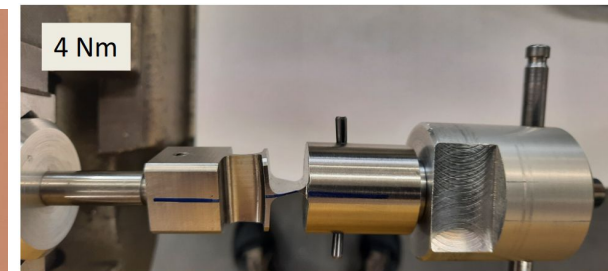
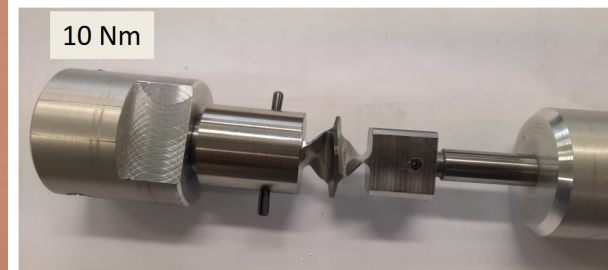
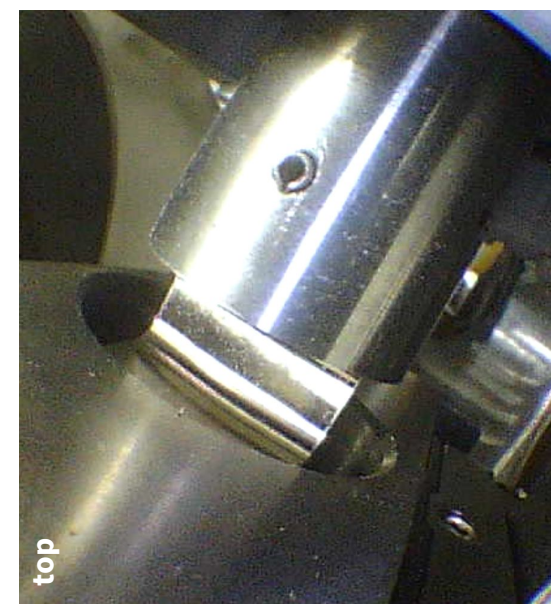
Maximal position for closing

- **Estimate maximal possible closing from the foil perspective**
 - still finalising the estimation, but somewhere between Gap of 34 and 36 mm
- **Estimate aperture at this maximum “mechanical” closing**
- **If R_{mech} closing < 3mm, increase the gap to reach 3mm**
- **Before reaching the last step will do a quick tomography to confirm the aperture (~30min, did it last year too)**

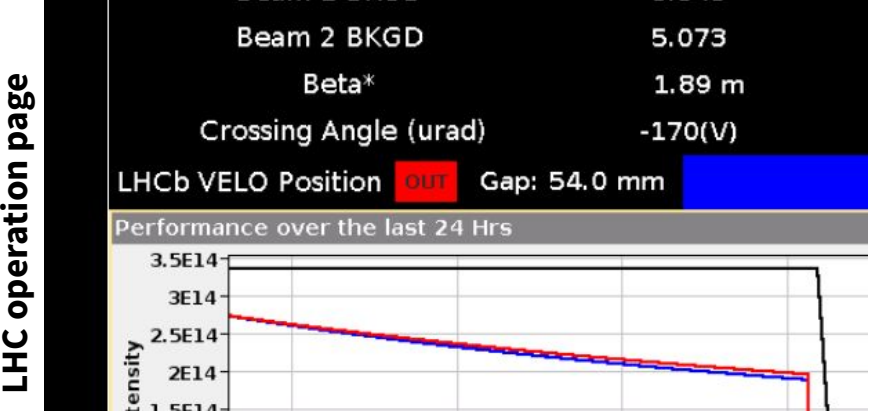
- **Half position is the distance of the half wrt. the beam position**
 - in garage position centered over reference orbit
 - while moving centered on reconstructed beam
- **The Gap is the sum of A and C side positions**

- The minimal radial aperture R , is the minimal aperture seen by the beam when the VELO is centered on the interaction point

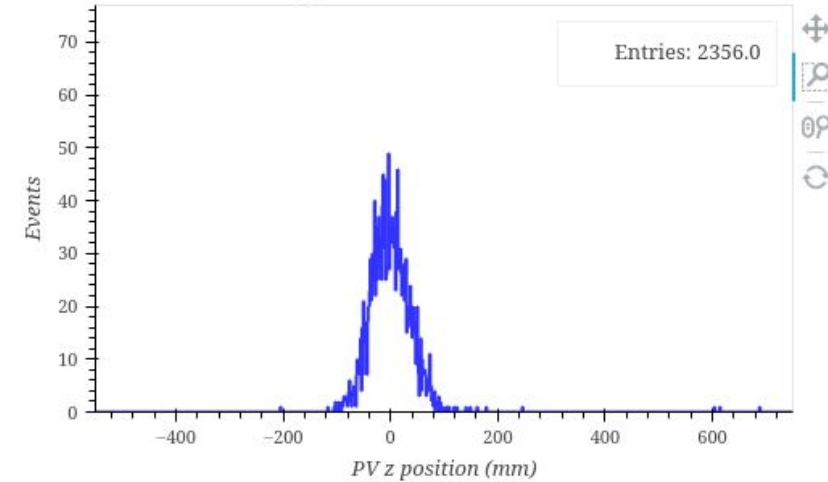
All vertices in run (Z) - VELO C side

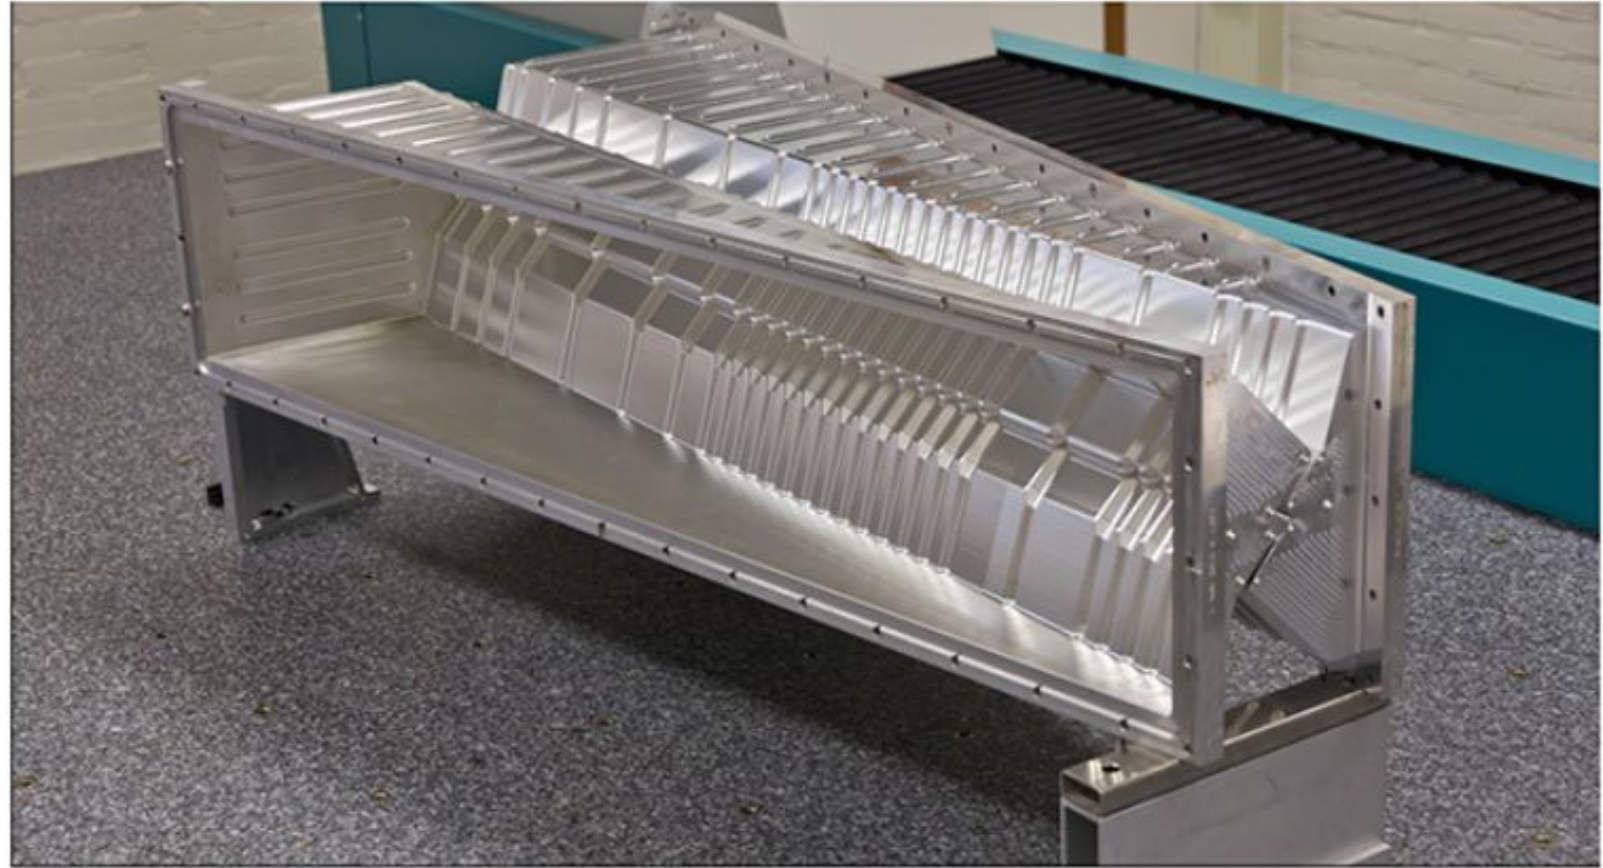
RF-foil

- **New foil shape wrt. Run1&2**
- **Same mechanical system for the motion (motors, position measurement, ...) but new control HW**

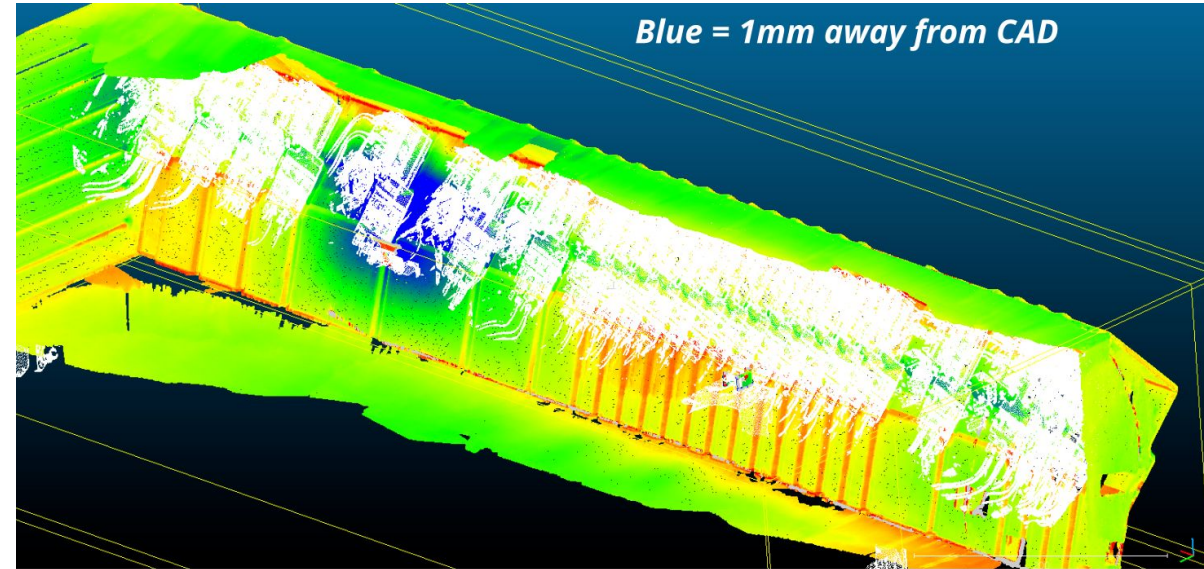
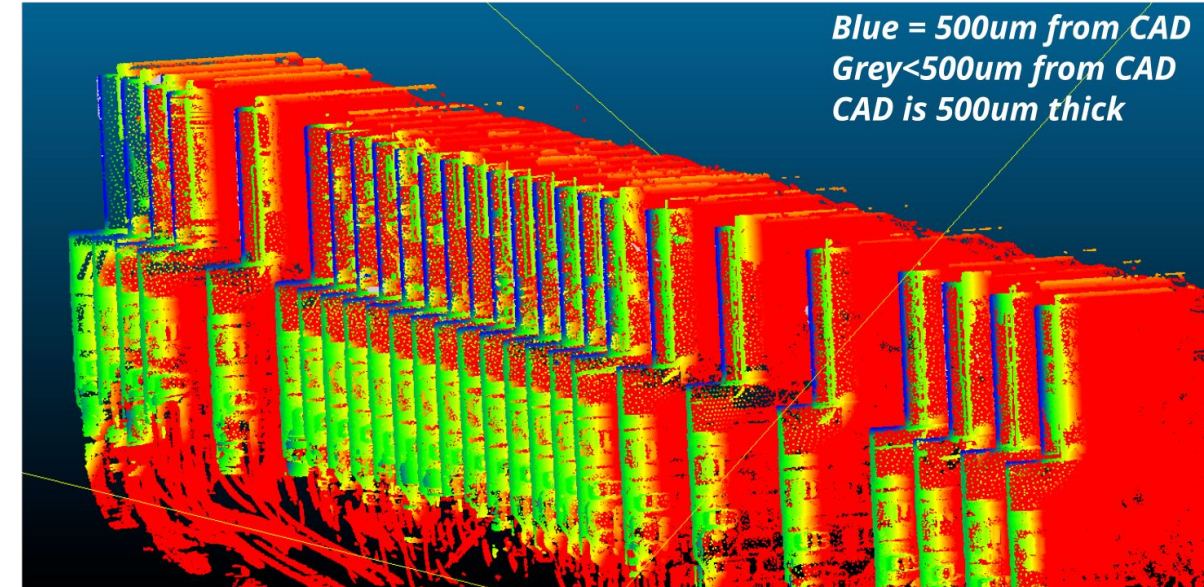
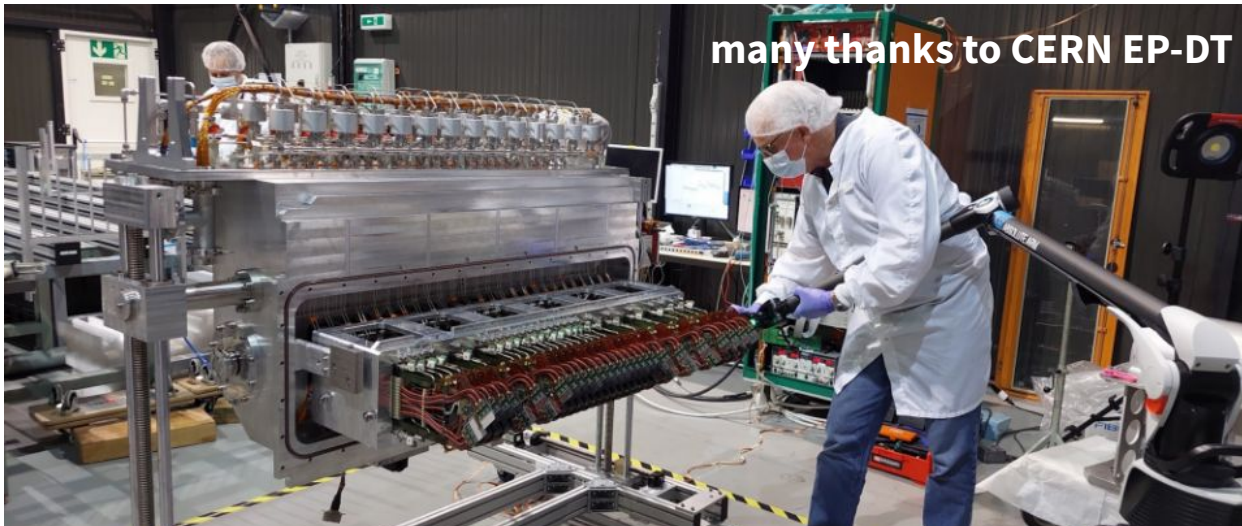
A-side surface test

- installation of removable shims
- base plate removal
- test of balancing

- 3D laser scan in horizontal position
 - ⇒ absolute position at room temperature
- check for collision with RFFoil 3D laser scan
- with Liv. metrology data provides reference for alignment
