US-AUP RFD Testing

A. Castilla, N. Huque, P. Owen – Jefferson Lab

13th HL-LHC Collaboration Meeting. – Sep. 25th–28th 2022

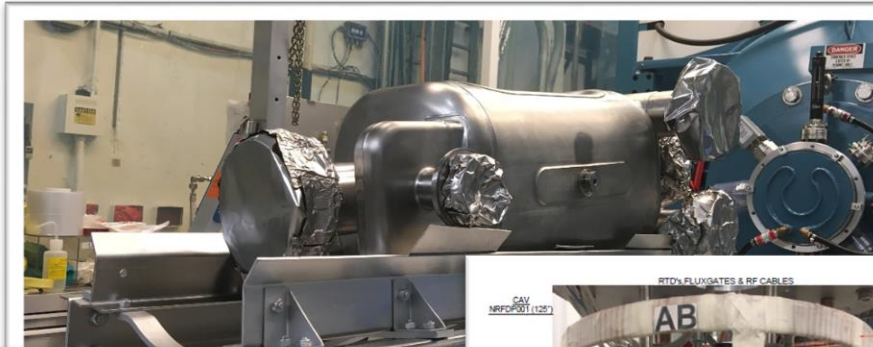
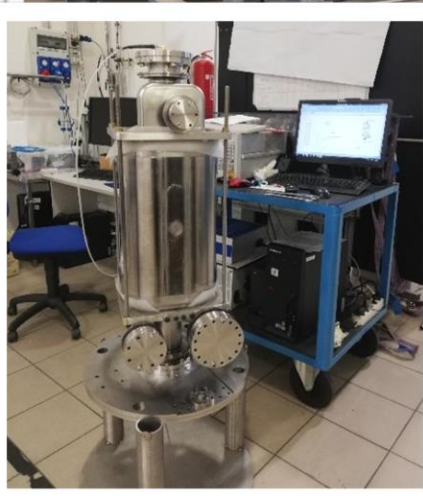
- 2 prototypes manufactured by ZRI in 2020.
- Rotational BCP at ANL/FNAL facility (ave. removal 130+40 um).
- 600 C for 10 h heat treatment performed at FNAL.
- 1st HPR+Assy.+test at FNAL.

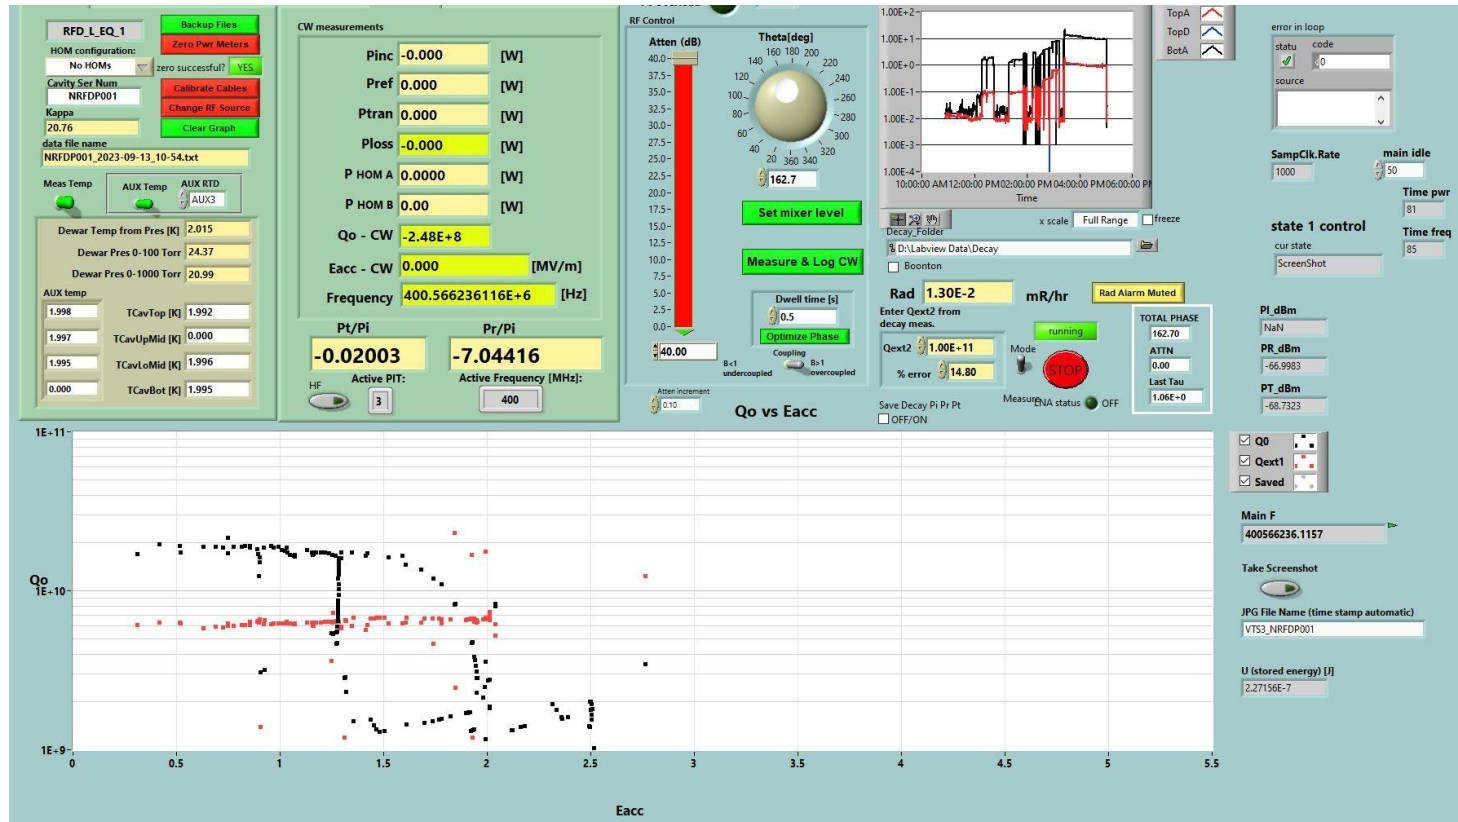
Latest NRFD001 VT: Inconclusive

- A recent test at FNAL after re-processing at ZRI, proved inconclusive due to an early FE onset and suspected multipacting.
- The cavity will be sent to Jefferson Lab to:
 - Test as is.
 - Open and inspect.
 - HPR and re-test.

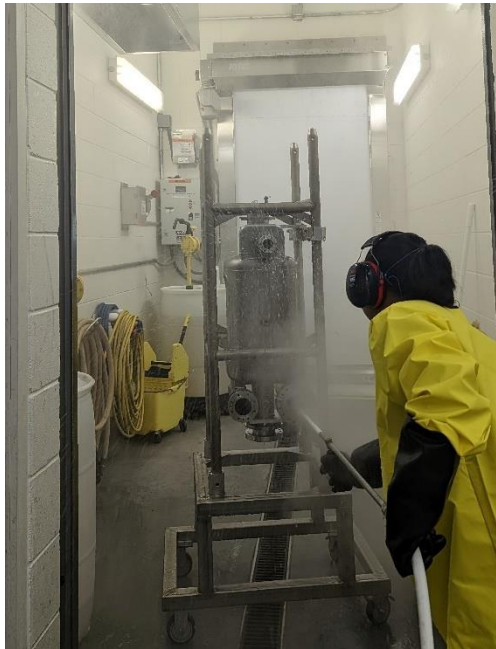
Hand port rinse
before HPR

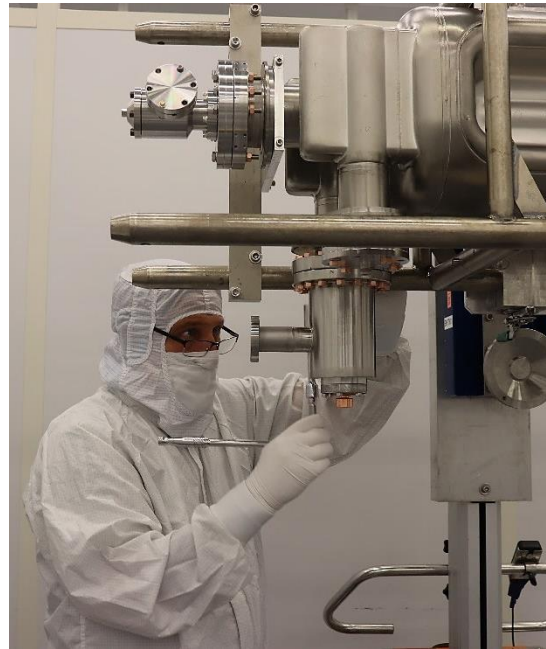
Clean room
assy.

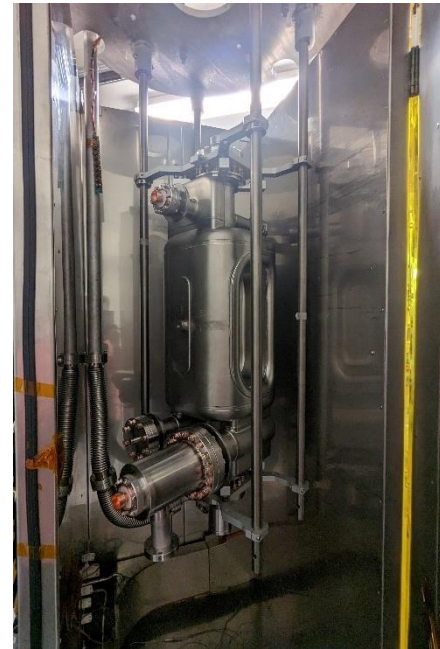
48h @120C
Bake

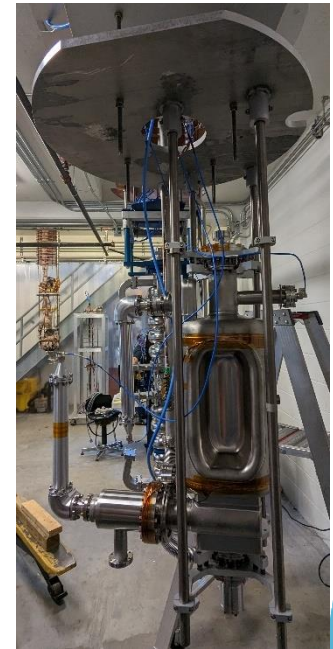
Instrumentation

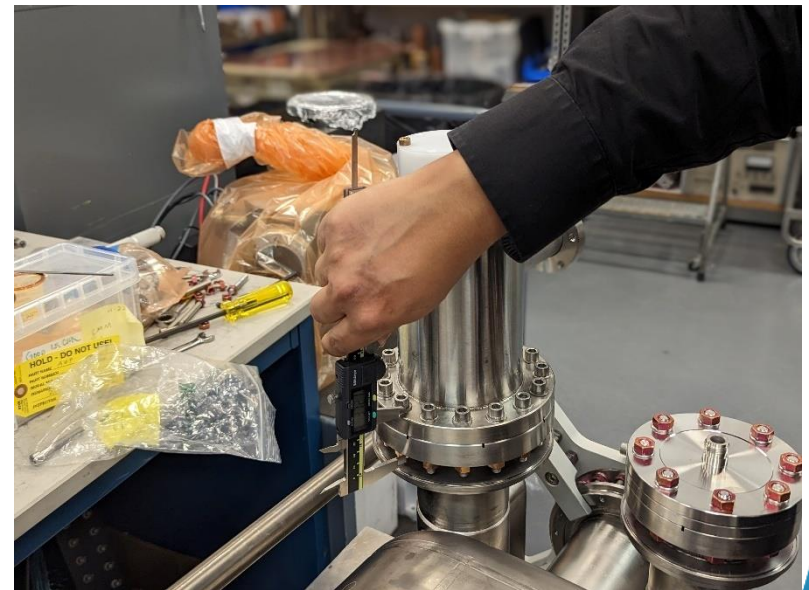
Flange Connection Measurements (1)

- Nominal values in the table.
- When the flange gap reaches zero, the lips would be compressed by 0.2mm and desirable RF contact can be achieved.

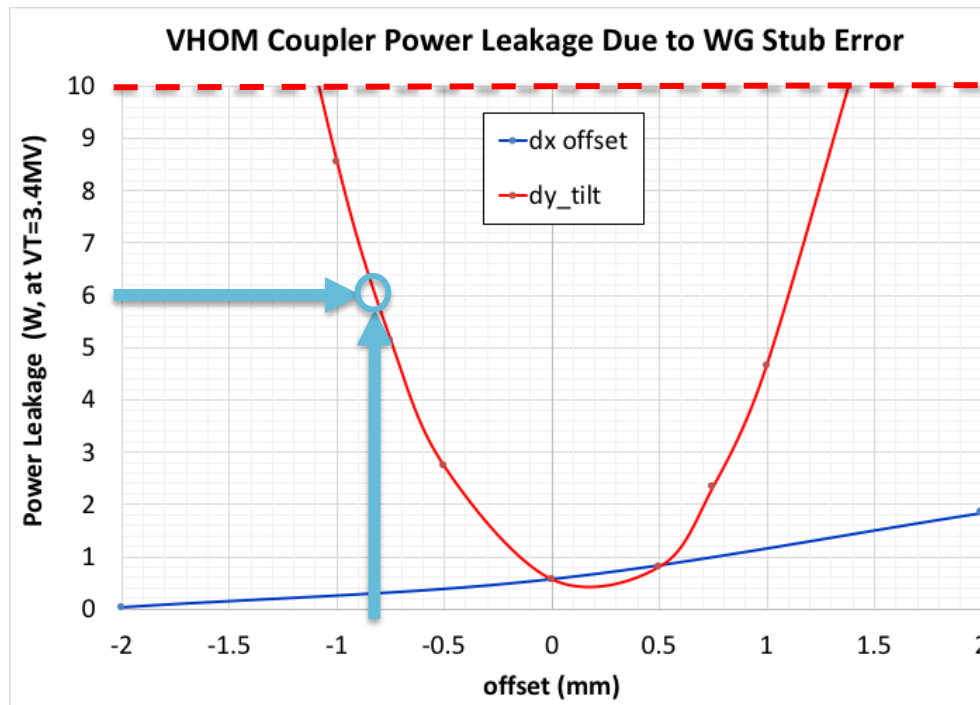
VHOM Coupler Waveguide Stub Geometry Tolerance On Power Leakage

Not sensitive to stub horizontal shift

Stub vertical tilt need be < 1 mm to limit power leakage to under 10 W

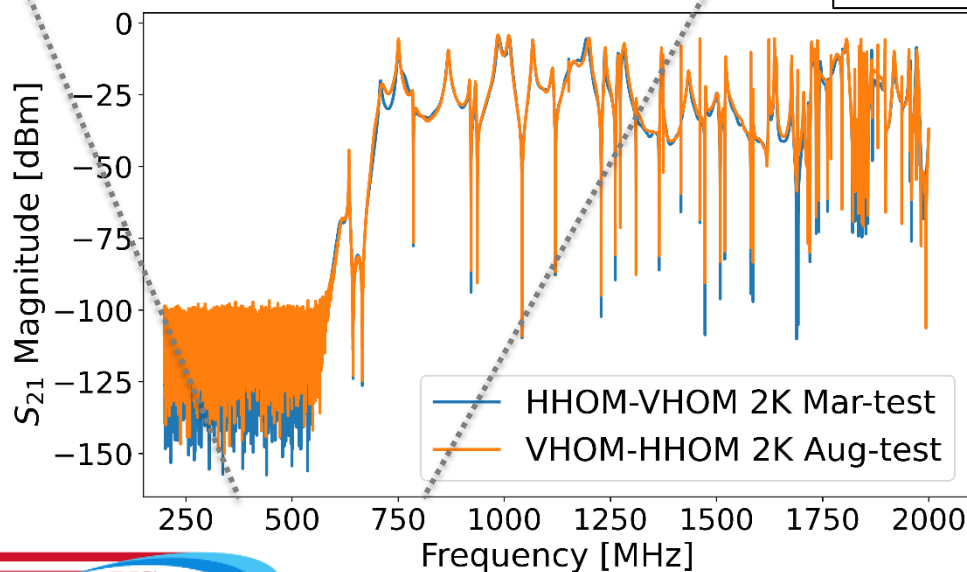
NRFDP002 2 K HOMs meas.

- Good fundamental rejection and trans. of HOMs of interest (e.g. '750 MHz').
- Q_L calculated from S_{21} at 2 K using test input and HHOM coupler.

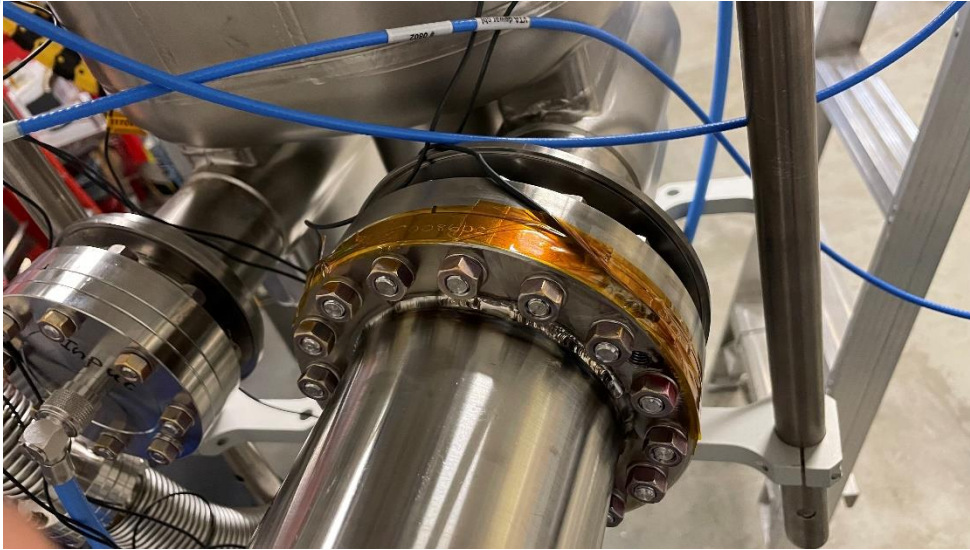
Temperature Sensors

- Some mild heating signature seen in the HHOM flange (coupler flange, next to hook weld).
- Poor RF-gasket contact is suspected (contribution to the R_{res} ?).
- Ongoing investigation

HHOM Heating Signature
