## **DQW industrial production & cavity assembly challenges**

N. Valverde, P. Kohler on behalf of HL-LHC WP4, EN-MME &  
SY-RF-SRF

13<sup>th</sup> HL-LHC Collaboration Meeting, Vancouver, 27.09.2023

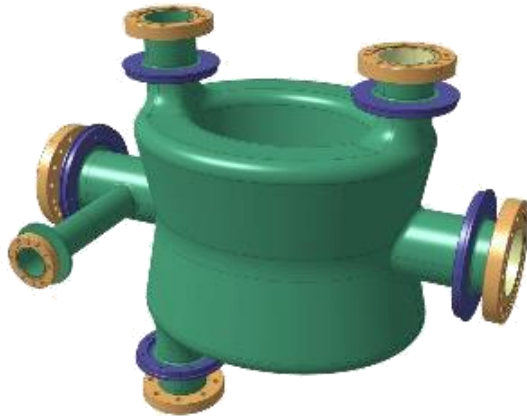
*DQW Bare cavity*

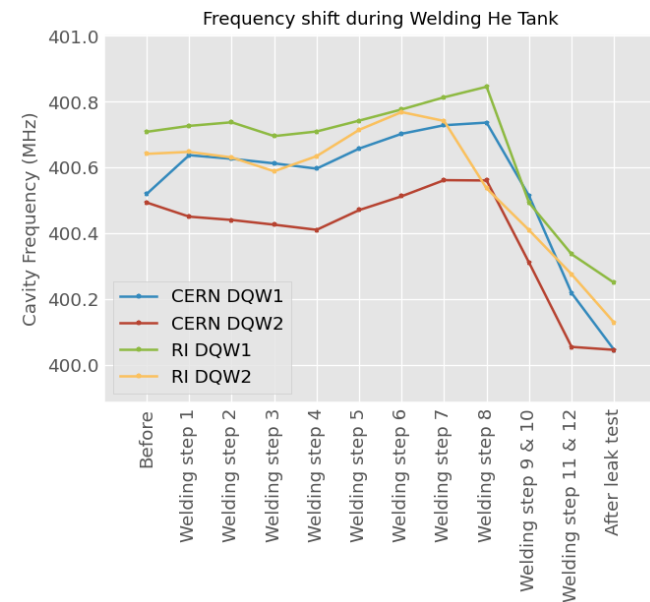
# Preseries JC RI – Freq. during He tank welding

Fundamental frequency tracking during He tank welding and comparison with CERN cavities

- Jacketing of 4 DQW cavities completed (x2 at CERN, x2 at RI)
- Consistent results
- Frequency drops during the final welds as expected from SPS- DQW experience

RI-DQW-JC1	RI-DQW-JC2	CERN-DQW-JC1	CERN-DQW-JC2
Freq. Shift (MHz)	-0.459	-0.454	-0.464	-0.459

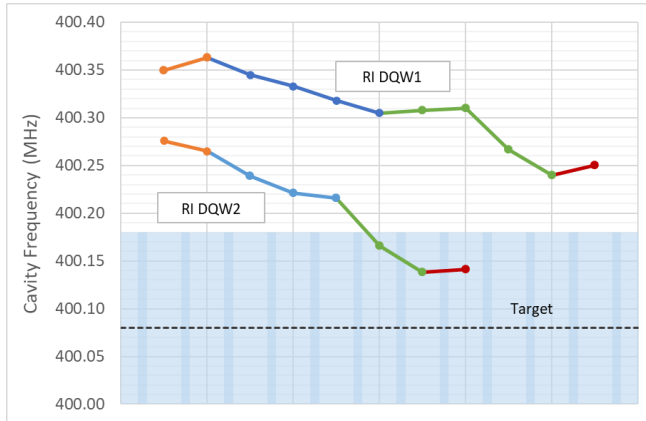
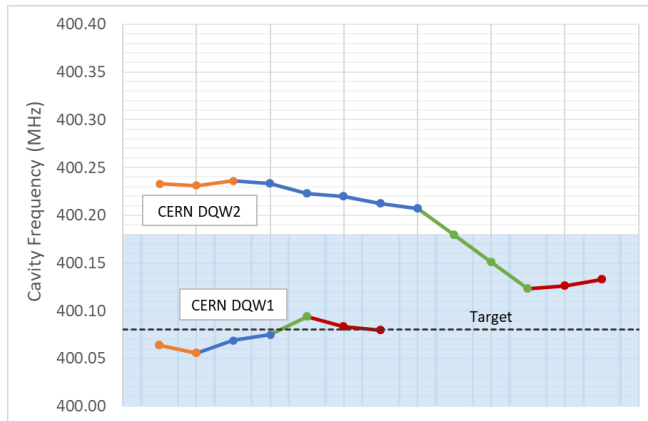
# Preseries JC RI – Pre-tuning

The freq. can be modified after welding He tank (pre-tuning).

The cavity can be deformed by applying forces to the pull and push screws and change the RF freq.

RI-JC-DQW1	RI-JC-DQW2	CERN-JC-DQW1	CERN-JC-DQW2
Target Frequency (MHz)	400.08 ± 0.1			
Frequency Before (MHz)	400.360	400.276	400.064	400.233
Frequency After Tuning (MHz)	400.250	400.141	400.079	400.133
Tuning Torque Top (Nm)	2.5 Pushing	2.0 Pushing	3.0 Pulling	2.0 Pushing
Tuning Torque Bottom (Nm)	1.5 Pushing	1.5 Pushing	3.0 Pulling	2.0 Pushing

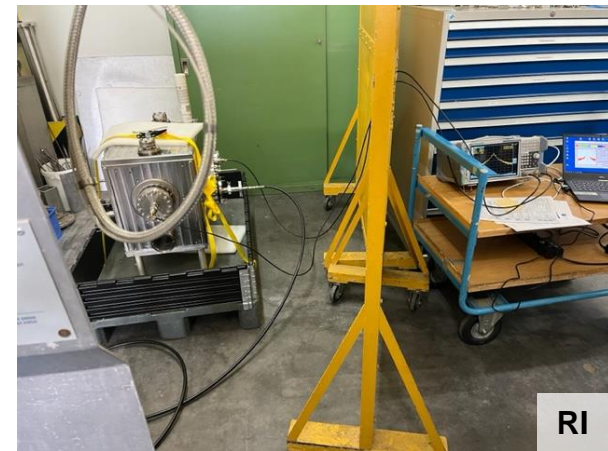
# Preseries JC RI – Pressure test

- Differential pressure of 2.7 bar across vessel walls and across cavity walls.
- The required test pressure is maintained for minimum 30 min.
- Fundamental Frequency tracked throughout.

RI-JC-DQW1	RI-JC-DQW2	CERN-JC-DQW1	CERN-JC-DQW2
Target Frequency (MHz)	400.08 ± 0.1			
Frequency Before (MHz)	400.138	400.248	400.064	400.125
Frequency After Pressure Test (MHz)	400.123	400.277	400.045	400.092
Pressure Sensitivity (Hz/mBar)	-110.85	-104.62	-82.033	-103.85
Maximum Frequency Shift @2.7bar (kHz)	-267	-281	-210	-240
Residual Frequency Shift (kHz)	-15	-21	-19	-33

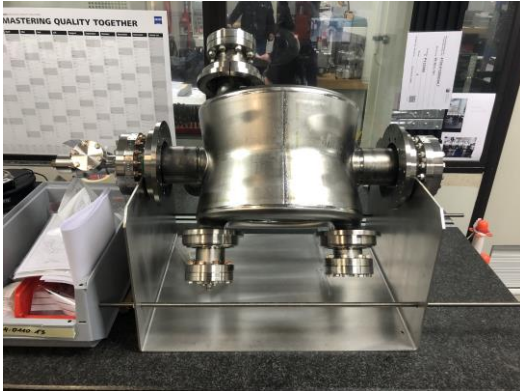
BC with transition rings

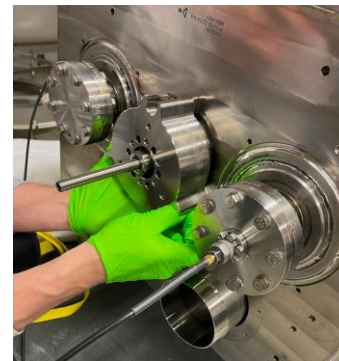
Installation pretuner

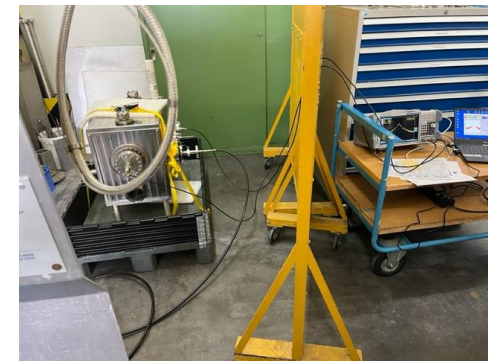
Pressure test with RF follow up

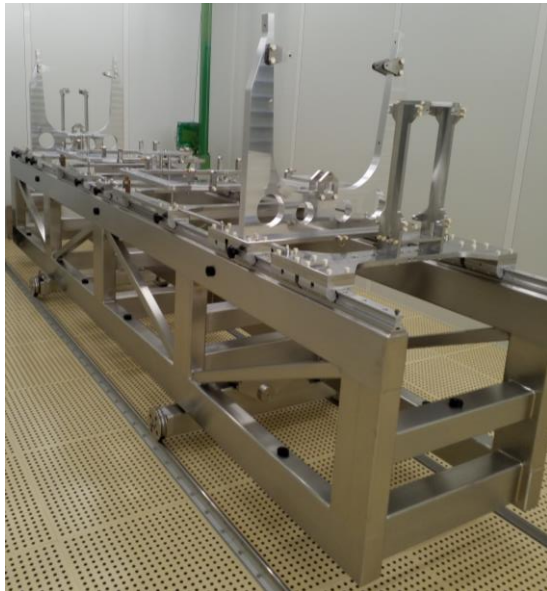
Interconnection & alignment tooling for complete string

- **Goal** : design & produce tools to interconnect & align easily the full cavities string, aiming at keeping the cavity line ISO 4 (ISO 14644 cleanroom norm)
- **Result** : complete tooling set for cavities string handling, and extremity vacuum chambers subassembly, anti-dust prepared in less than 4 weeks

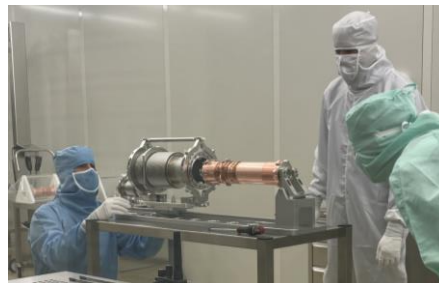
\*Parts degreased and manually cleaned outside cleanroom ; rinsed ; then assembled inside cleanroom

Inside RF fingers and inside bellow convolutions : ISO 6

Fixing area with Ag coated screws & springs : ISO 5, it was ISO 8 before a huge effort of wiping and blowing inside cleanroom

⇒ **Maintaining sub-ISO 4 is not possible** due to **complex assembly sequence** and need of **tightening coated fasteners** inside the assembly (between the bellow and the RF finger)

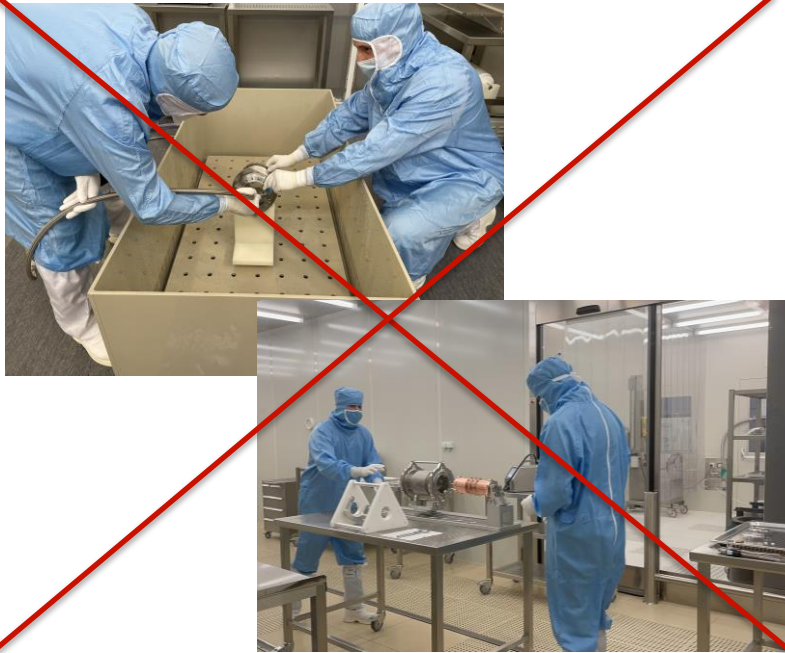
- It has been proven it is possible to dry the subassembly after rinsing. It requires a lot of care, but it is feasible without baking out.
- The inside of the subassembly went from ISO 6 for RFD, to ISO 4 for DQW.
