13th HL-WP3 MCBRD production status at CERN

Arnaud Foussat

HL LHC week annual meeting

**HL-LHC Collaboration Meeting
Vancouver, Canada,
25-28 September 2023**

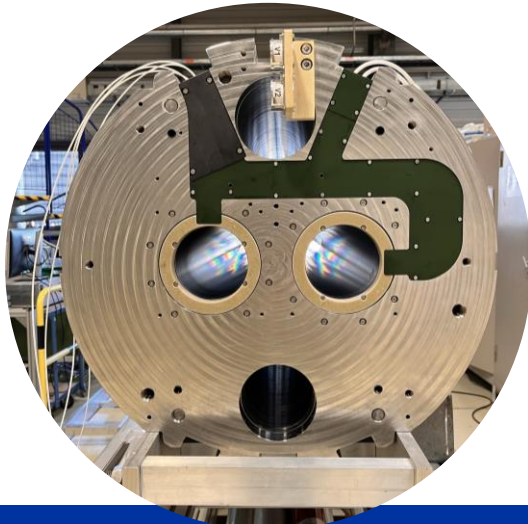
- Last MCBRDP4 built in 2022 per the series magnet requirements. (EDMS 2051870), including recent series instrumentation consolidation.
- MCBRD11,12 follow the series manufacture features

Parameters	Unit	Value
Aperture size	mm	105
Magnetic length	m	1.93
Nominal field	T	2.59
Nominal integrated field	T.m	5.0
Nominal current	A	394
Ultimate current	A	422
Short sample current at 1.9 K	A	767
Short sample current at 4.2 K	A	650
Loadline fraction at 1.9 K (WST)		53 / 47 %
Strand diameter	mm	0.825
Cu/no_Cu (WST wire)	-	1.95 (1.3)
Strand critical current at 4 T	A	700
Nominal strand current density	A/mm ²	737
Nominal superconductor current density	A/mm ²	1695
Nominal differential inductance per aperture	mH	970
Nominal stored energy per aperture	kJ	74.9
CCT skew angle	deg	30°
No. of turns per layer		365
Slot size in former (mm) (IHEP depth)		2.1 × 5.2 (4.9)
Number of CCT layers / Strands in channel		2 / 5 × 2

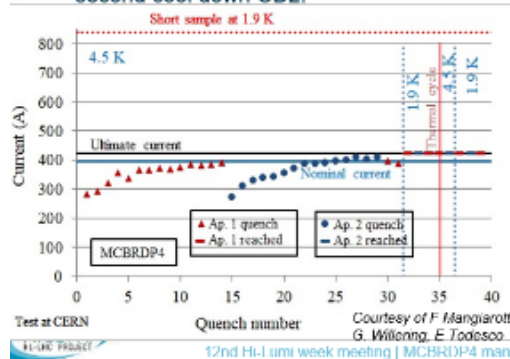
CD1 – 4.5 K single aperture - training quenches
CD1 – 1.9 K ultimate current single aperture - No quench
CD1 – 1.9 K ultimate current combined powering - No quench

CD2 – 4.5 K ultimate current single aperture – No quench
CD2 – 1.9 K ultimate current single aperture - No quench
CD2 – 1.9 K ultimate current combined powering - No quench

- Powering to **394 A nominal @ 4.5 K** with 14 training quenches in apertures during CD1. (relatively fast training in comparison with magnets constructed so far)
- Powering at **422 A ultimate current @ 1.9 K** without any quenches, before & after 😊

- After initial training at 4.5 K all cycles showed stable magnet performance, good memory at 1.9 K.

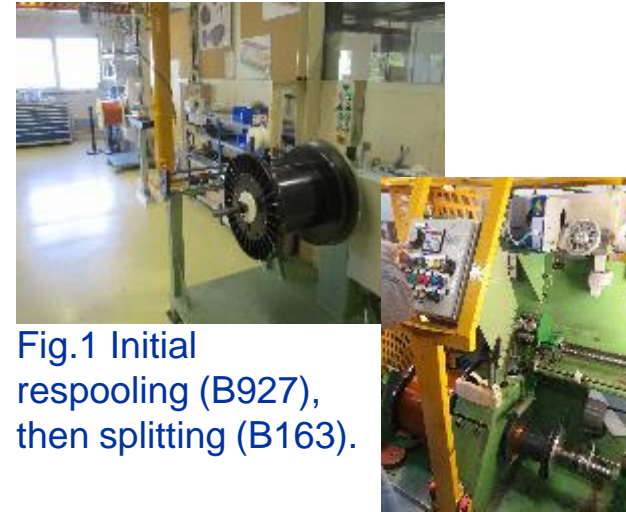
Fig.1 Initial respooling (B927), then splitting (B163).

- Spool splitting work at CERN, cleaning and rewind of **44 individual ULs spools** (480 m each) involved **Hi-pot test at 2 kV**, revealing a few more defects than marked ones by IHEP supplier
- Further re-check of the $I_c(B)$, metallographic tests to exclude risk of elongation during heavy spool respooling: no apparent I_c degradation.** (NC 2790885)

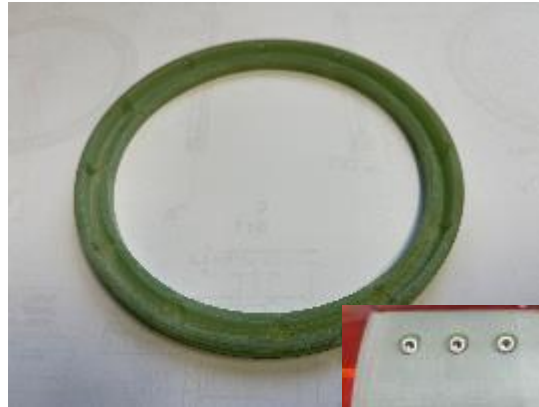
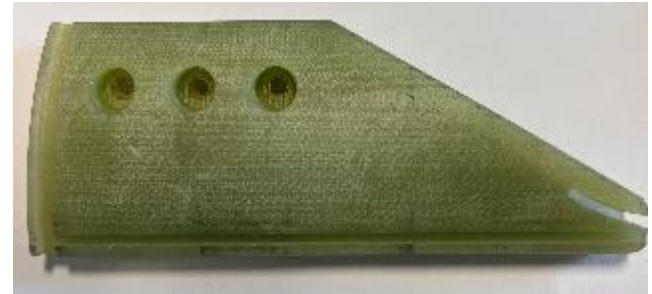
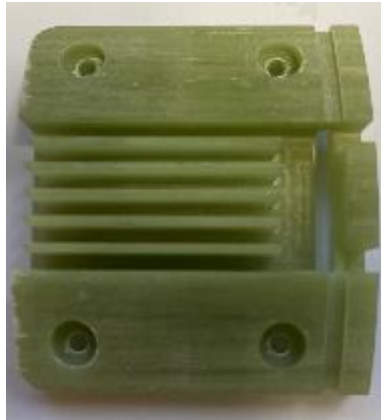
Auxiliary pieces

✓ *All GFRP pieces conform to IHEP drawings. Layer jump and connection boxes required slight outer radius correction to match insertion gaps.*

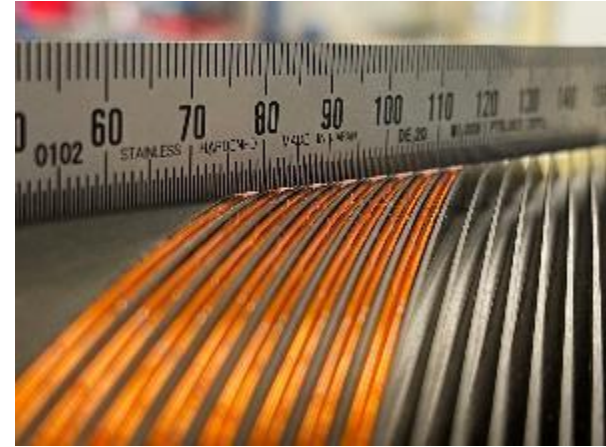
Winding activities

- Winding process still broadly manual **followed past qualified applied procedure on prototypes.**
- Validated on AP11, further setbacks on AP10,15, and AP16.

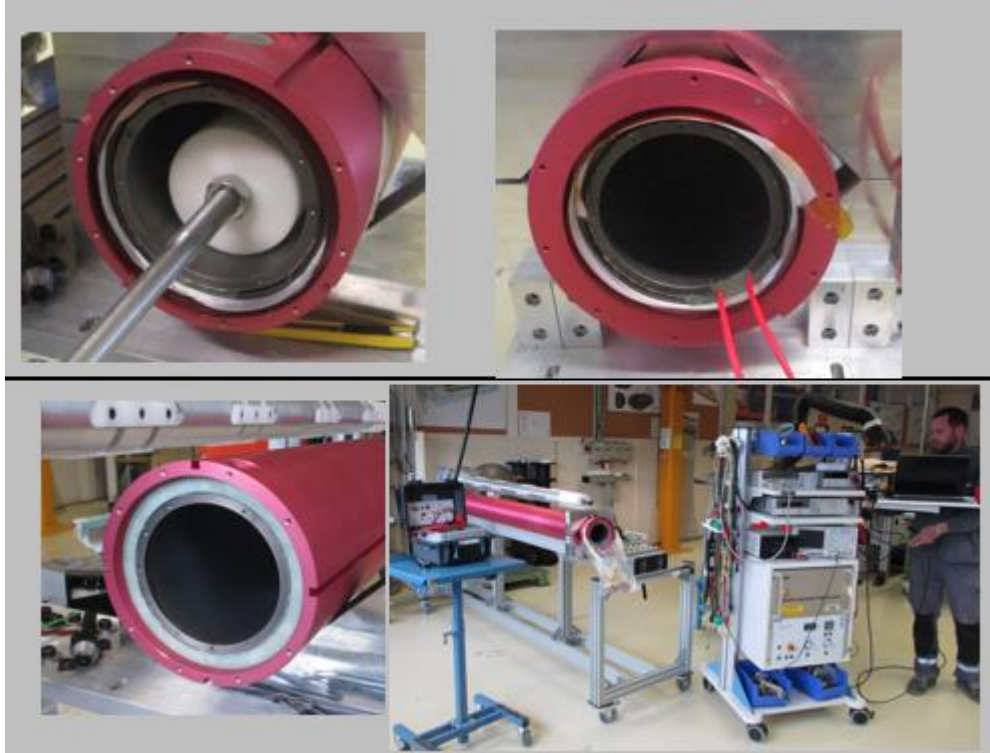
Aperture final preparation steps

- Components dimensions compatible with common series CCT assembly procedure

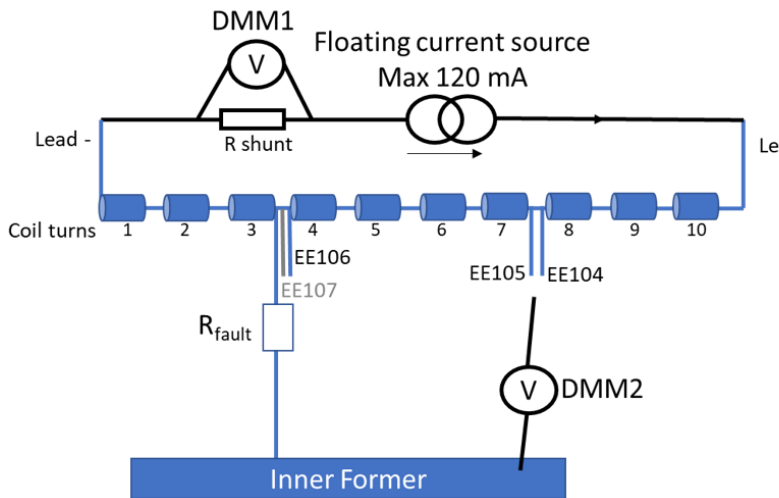
- ❑ DC voltage fault localisation method allowed to locate **direct short of 13 k Ω at about 6 cm from splicing box** entrance, close to EE106 voltage tap. (EDMS 2918370, MPE report)
- ❑ **Z frequency measurement : insight from quality factor Q measurement vs. frequency** showing clear deviations from the same coils

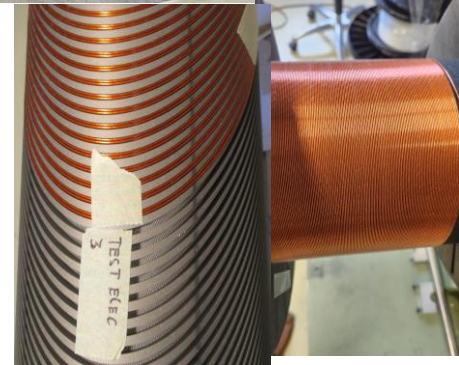
- ❑ First decision to add bottom extra 0.17 mm tck fiber glass at bottom like IHEP (extra height and electrical barrier)
- ❑ **Additional QC intermediate Hi-pot tests on the manual winding process (~ each 1/5th layer)**
- ❑ **2/3 inner layer passed Hi-pot test, last section did not.**
 - ❑ Root cause analysis report EDMS 2936245 pinpoints occurrence of damage at each tip (50 cm) under 1kV test
 - ❑ **Only two bottom wires affected due to winding process, enhanced by *low bonding of WST wire insulation (270 deg C cured, vs.400 degC on P4) and relative sharp former edge.***
- ❑ *Actions:*
 - ❑ CERN 927 team developed an **improved tooling with extra protection** (next slide).
 - ❑ **Rewind started** using SC CERN wires from **stock with best curing temperature** feature (310 degC).

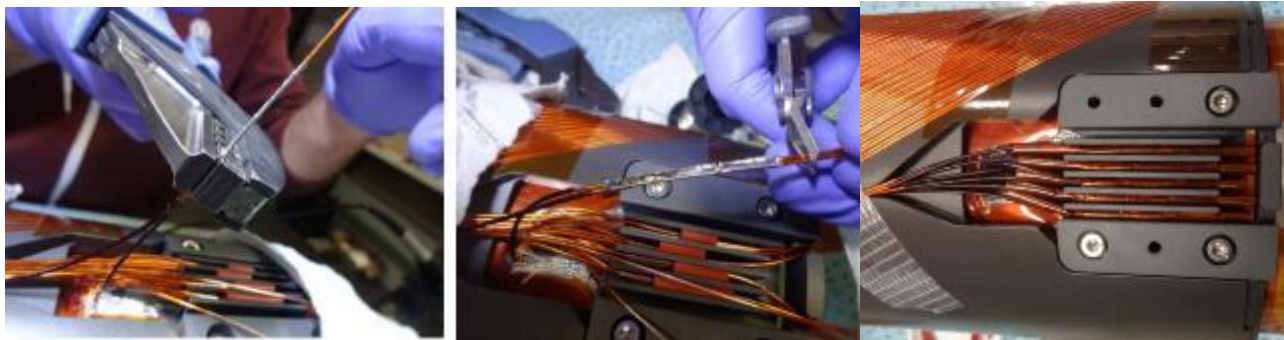
Inter layers series splicing

- ❑ Splicing executed according CERN procedure EDMS [2002873/1.1](#).
- ❑ **NC 2818415 on AP10** : Broken wire MCBRD12-V1 - HCMCBRD_C015-CR000001
 - An issue occurred due to **misalignment of crimping tool**;
 - Solution: wires connection order could be adapted:
 - ✓ outer wire 7 spliced with the inner wire 10 with 2 Vtaps.
 - ✓ outer 10 is spliced with the short inner 8 without instrumentation.

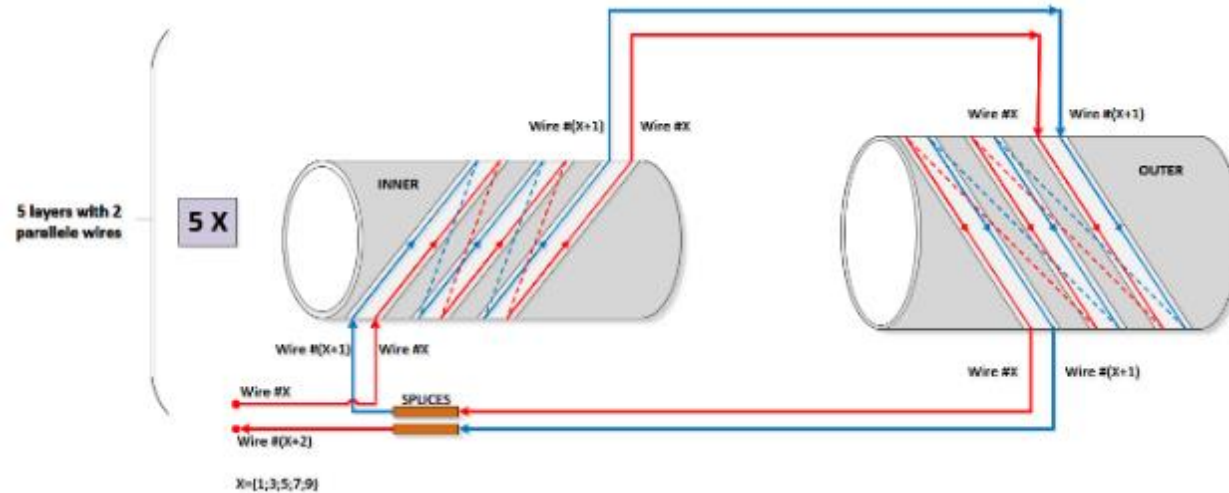
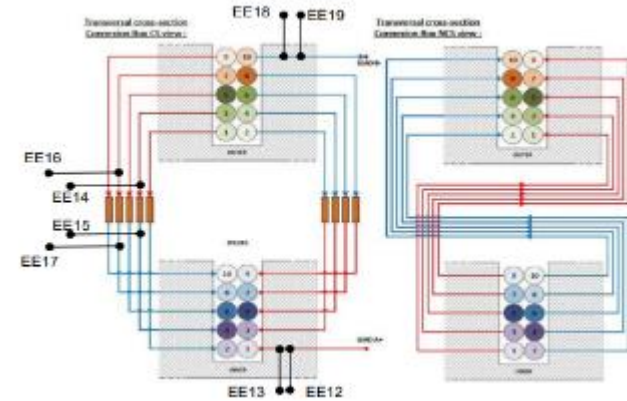
Fig.1 Series splicing terminal connection box

- 10 wires winding layers spliced in series in the connection box
- 10 voltage taps wires and 9 SC wires splicing
- Crimping, Sn96Ag4 soldering and polyimide insulating
- Current design reaches joint resistances values of 7-8 nOhms at cold when procedure is applied.

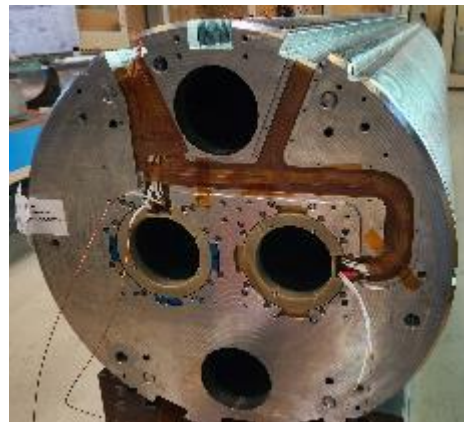
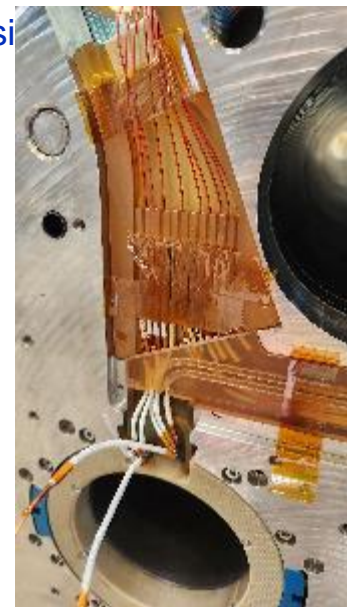
Front end wires routing

- ❑ Routing update decided of VTs and leads wires from MCBRD01, 02, 11, 12, P3, P4. localized in front end routing CERN agreed to update design to limit risk during assembly
 - In-situ local machining of end plates
 - Separation of VTs and Leads channels on double level to avoid successive crossings
 - Use of newly produced transparent Ultem® covers.
- ❑ CERN decided to apply this update to all 6 magnets incl. P3b & P4

- Local machining example on MCBRDP3b of the central channel in SS end plate for installation of new routing covers
