“SuperKEKB beam diagnostics & fast losses”

2024/6/17 FCC week

H. Ikeda (KEK)

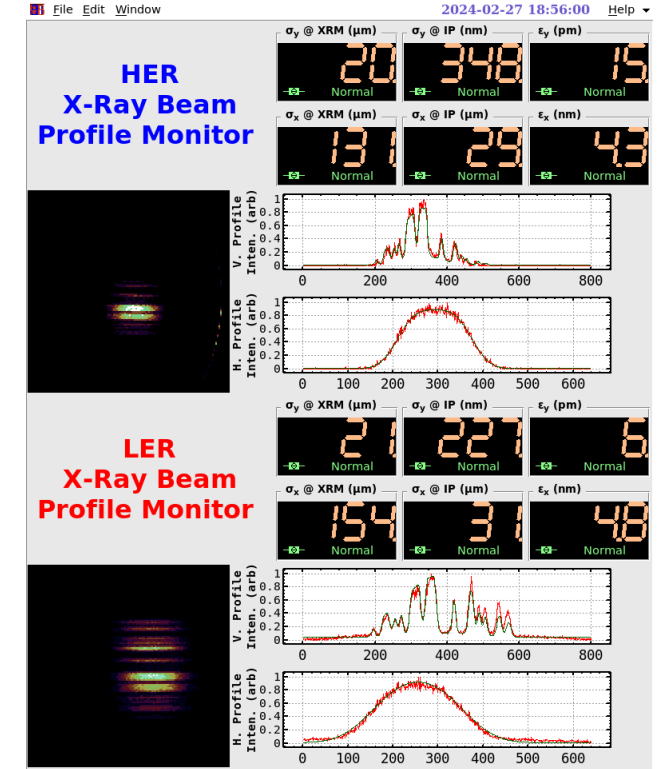
X-ray size monitor (XRM)

- Measure the beam size.
- Introduced a monitor using the short emission light of the wavelength from SuperKEKB to measure smaller beam size.
- Pinhole, URA mask, etc.
- σ_y (σ_x)

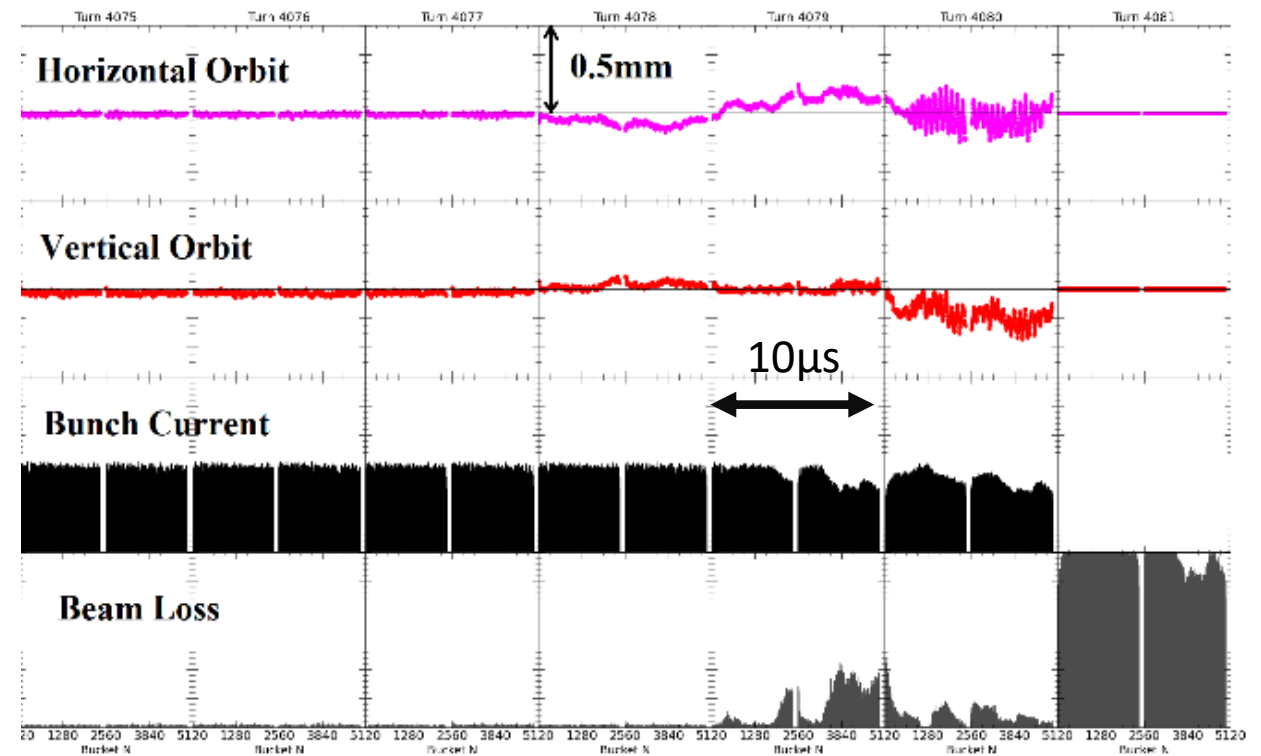
Beam signal measured by
Bunch Oscillation Recorder(BOR) & Bunch Current Monitor(BCM)

Beam loss that occurs suddenly within 1 turn (10 μ s) without precursory phenomena. = Sudden Beam Loss (SBL)

- The cause of SBL had been unknown.
 - A significant percentage of the beam is before the abort trigger is issued and stored beam is dumped
- Harmful effects of SBL;
- Damage to collimators and other accelerator components,
 - Quench of the final focusing superconducting magnets (QCS),
 - Large backgrounds to the Belle-II detector,
 - Inability to store high current due to beam abort.

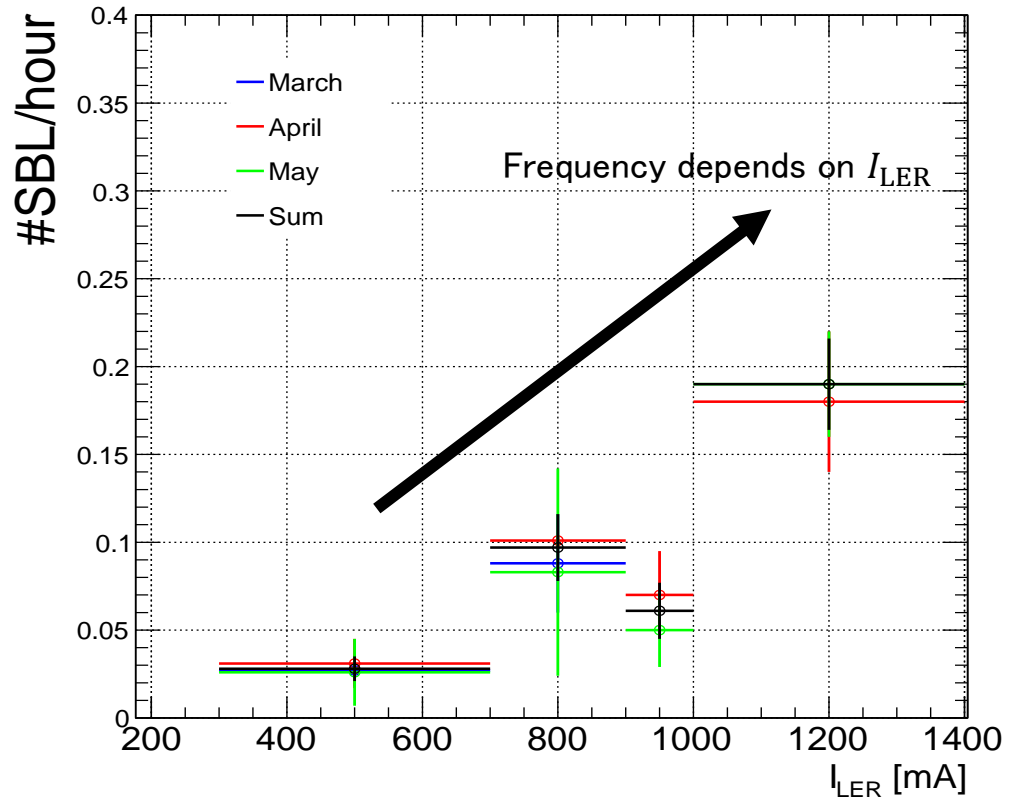
Beam current dependency

I_{LER} [mA]	[300, 700]	[700, 900]	[900, 1000]	[1000,]	
March	#LER SBL	9	10	0	0
	Operation time [hour]	331	114	0	0
	#SBL/hour	0.027 ± 0.009	0.088 ± 0.028	—	—
April	#LER SBL	5	13	8	20
	Operation time [hour]	159	120	114	110
	#SBL/hour	0.031 ± 0.014	0.101 ± 0.003	0.07 ± 0.025	0.18 ± 0.04
May	#LER SBL	2	2	6	30
	Operation time [hour]	76	24	115	159
	#SBL/hour	0.026 ± 0.019	0.083 ± 0.059	0.05 ± 0.021	0.19 ± 0.03

- Frequency (#SBL/hour) depends on the LER beam current

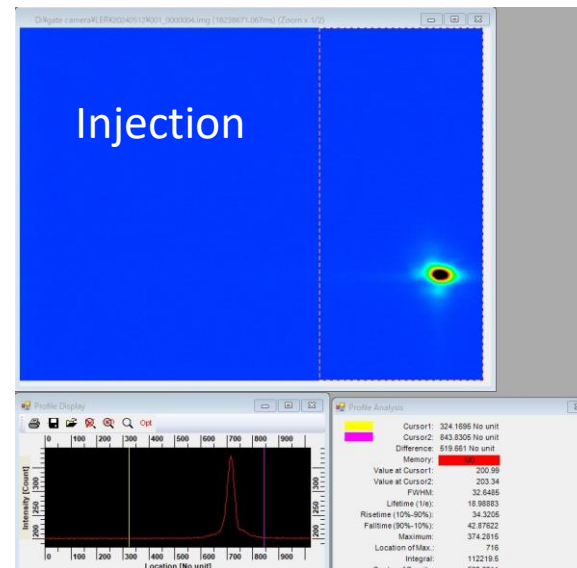
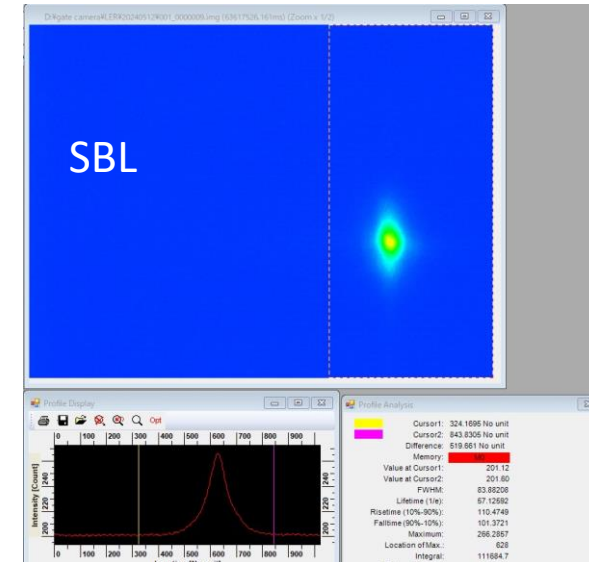
Beam size measurement @SBL

- A beam image at the abort timing was measured using a D8 SRM gated camera.
 - trigger: Abort trigger
 - Gate width: 10us
 - When the Abort trigger is sent to the kicker, a signal is also sent to D8.
 - The beam goes in the order of D8 → BOR → Abort kicker, so we should be able to see the image of the last turn.
- ↓
- Vertical Beam Size increases when SBL occurs compared to other abort.

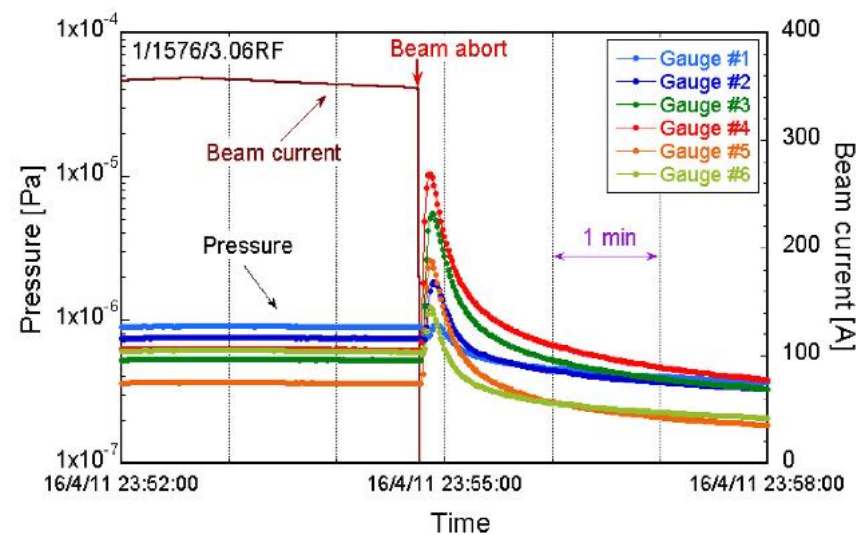
Dust event (our experience)

- At the Phase-1, pressure bursts with beam loss were frequently observed in the LER, which was an obstacle to beam current increase.
 - When a loss monitor was triggered and issued abort, the pressure momentarily jumps to the 10^{-7} - 10^{-6} Pa range in some parts of the ring at the same time.
 - The beam was lost over several 100 μ s, and oscillations in the beam phase were observed.
- Estimating the location of pressure bursts from the CCG indications, most of the pressure bursts occurred in the vicinity of the grooved aluminum beam pipes in the bending magnets.
- The beam current at which pressure bursts occurred increased with the maximum beam current at that time. The frequency of pressure bursts tended to decrease after a while of operation at the same maximum beam current (aging effect).

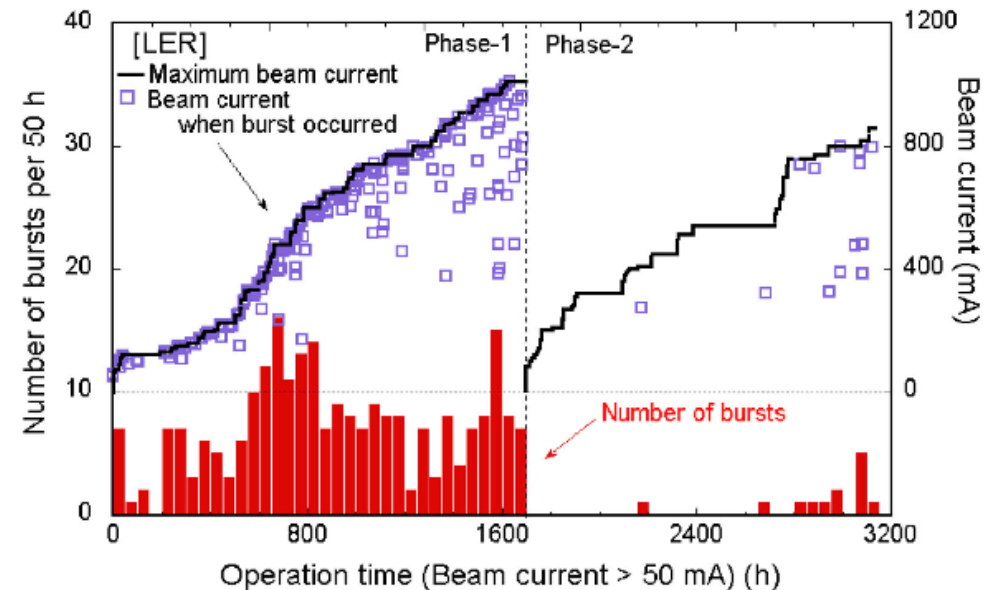
Dust event (our experience)

- We speculated that this phenomenon was caused by dusts trapped in groove structures falling into the beam. To verify this, a knocker was installed in the LER beam pipe.
- When this knocker was operated during beam operation and the beam pipe was struck, the above phenomenon was reproduced.
- As a countermeasure for Phase-2 operation, the grooved aluminum beam pipe was knocked around with a knocker during the shutdown period. As a result, the frequency of pressure bursts with beam loss was dramatically reduced.
- However, the frequency of occurrence has not been reduced to zero. Then, sometimes dust events occur even at low beam currents.

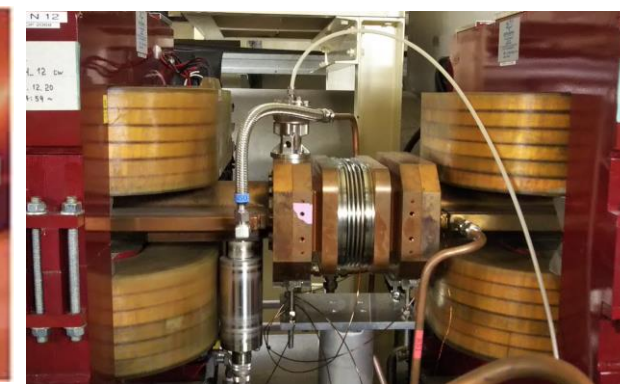
3-4. Knocker study

- We reinstalled the knocker to the beam pipe and see how the abort due to the current dust event is observed.
- Knocker installation locations
 - Where there is vacuum work during LS1 and dusts are likely to be re-trapped in the grooves. And where the collimator passes from the Belle II and QCS safety point of dust generation to the IP.
 - ✓ **Aluminum beam pipe with grooves in bending magnet in D06 arc section**
 - A location where pressure often jumps and is suspicious when SBL occurs. And where the collimator passes from the Belle II and QCS dust generation point to the IP for safety reasons.
 - ✓ **Beam pipe with clearing electrode in D10 Nikko Wiggler section** : Electrodes are formed by spraying alumina and tungsten onto copper beam pipes (electrodes are on top of the beam)

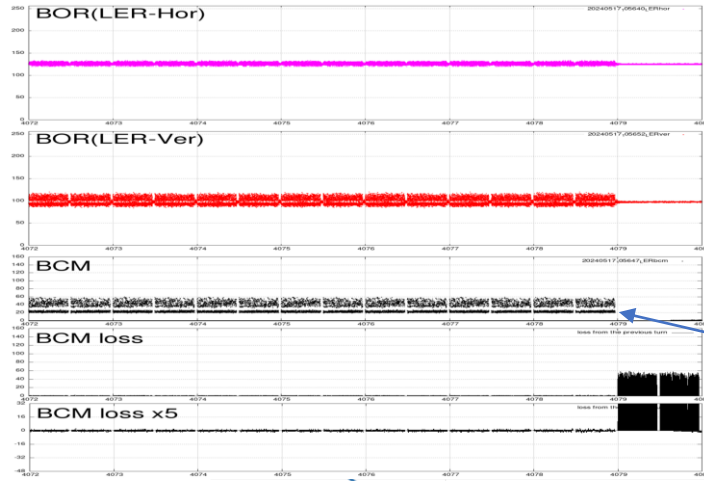
Aluminum beam pipe with grooves

Beam was aborted on the knock count =3.
However, it was not an SBL.
Pressure burst observed.

- **Aluminum beam pipe with grooves in bending magnet;**
 - **Abort occurred once but beam loss was small and only in D5V1 collimator.**
 - After continuous knocking only vacuum bursts occurred, but stopped as the knocking continued.

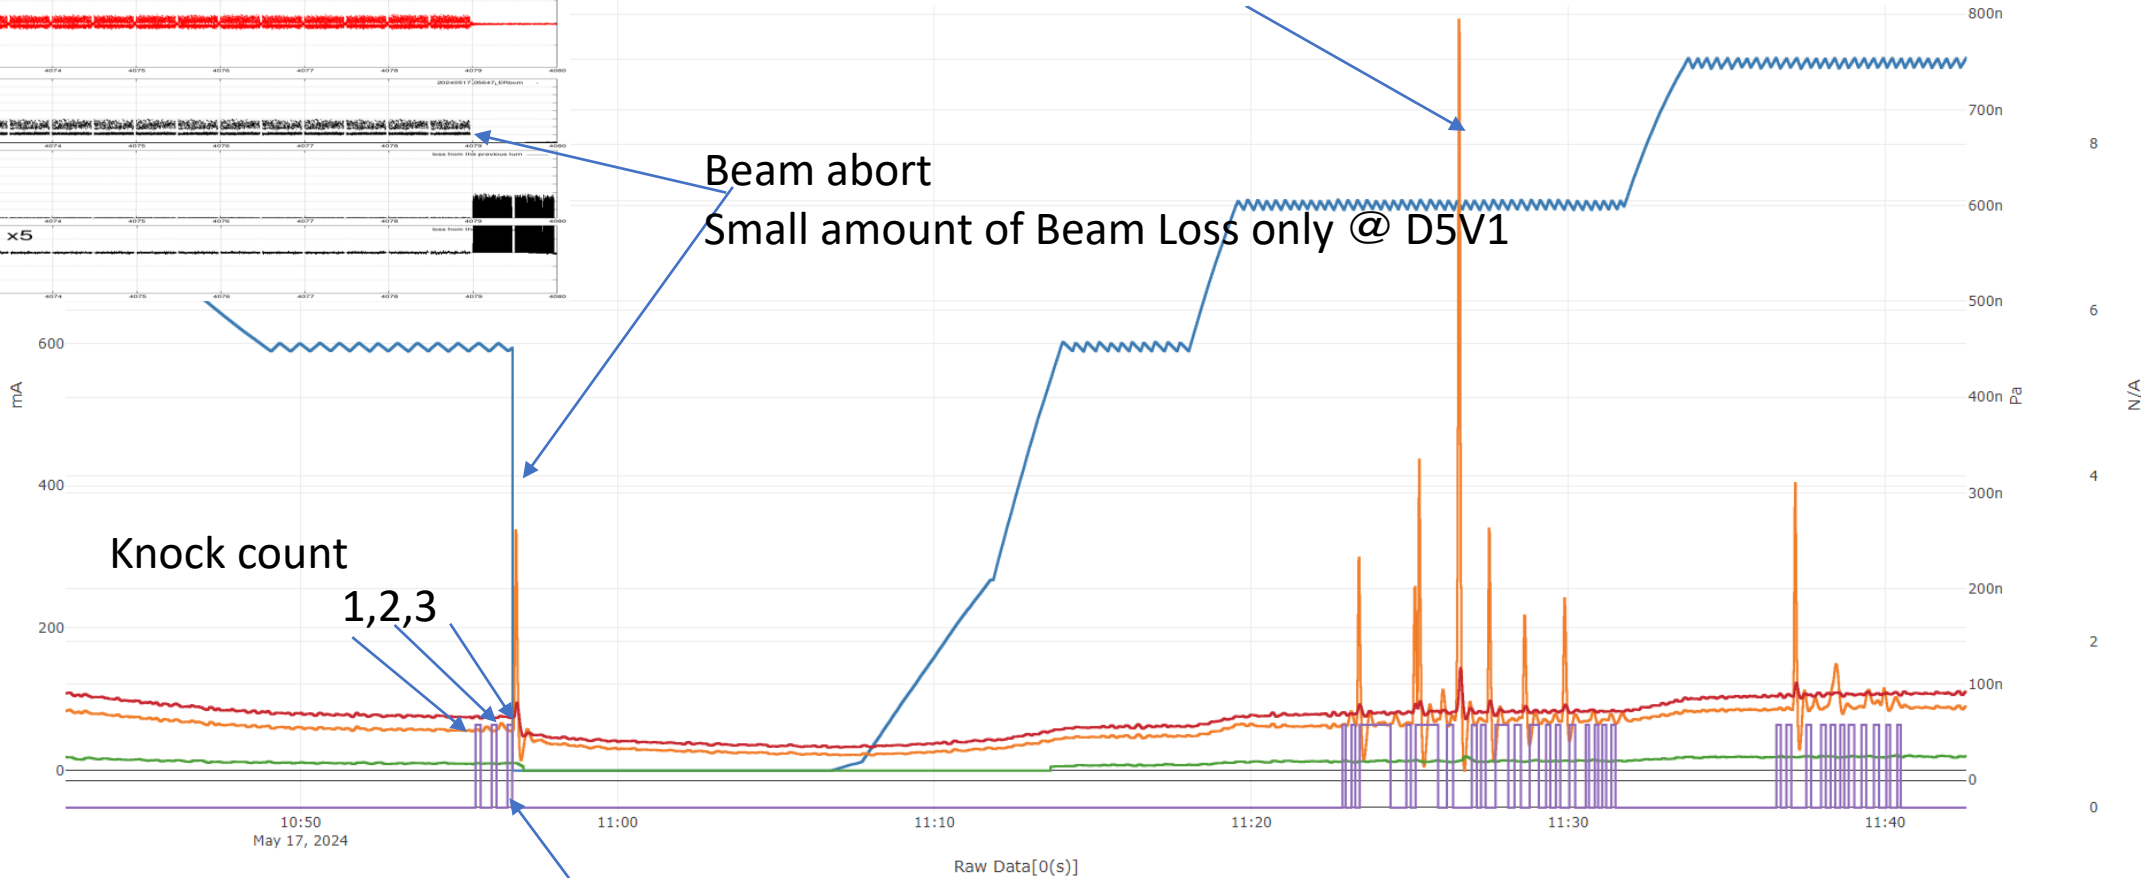
Later knocks had pressure bursts larger than the pressure burst at abort, but were not aborted.

Knock count

1->0 is Knock timing

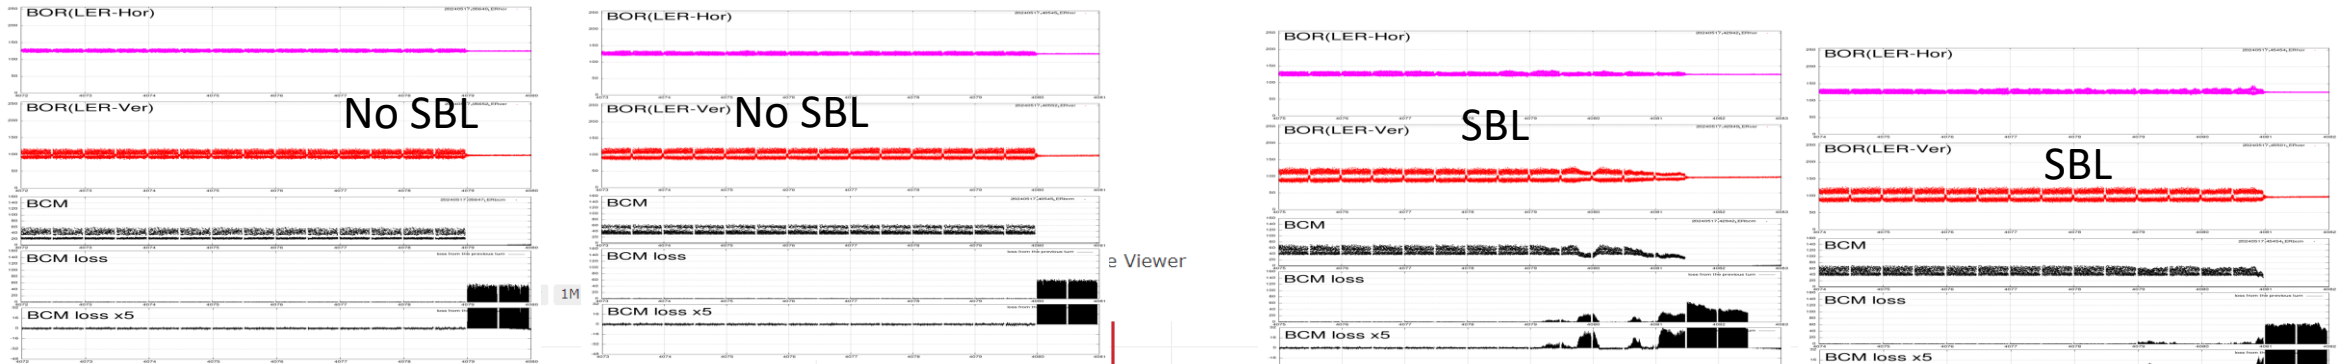
Beam pipe with clearing electrode in D10 Nikko Wiggler section

Losses are not proportional to the amplitude of the pressure burst.

We kept knocking and the abort stopped happening. Aging effect?

- No beam abort and pressure burst at knock timing @another beam pipe.
- **Beam pipe with clearing electrode;**
 - Up to 800mA, abort occurred with small amount of beam loss.

- **SBL Abort occurred with beam loss at all around in the ring by increasing to 1000mA.**
 - After that, the amount of beam loss decreased and eventually vacuum bursts no longer occurred. →aging effect?

- **When the Chamber was changed, SBL Abort occurred even at 500 mA, and then knocked several tens of times, but no aging effect was observed.**
- In both cases, the magnitude of the vacuum burst is not particularly proportional to the magnitude of Beam Loss.

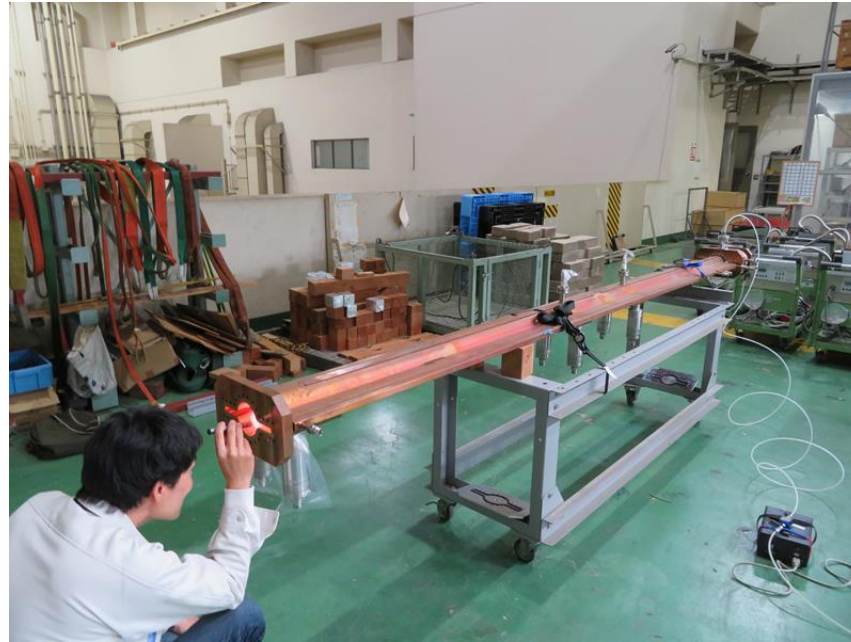
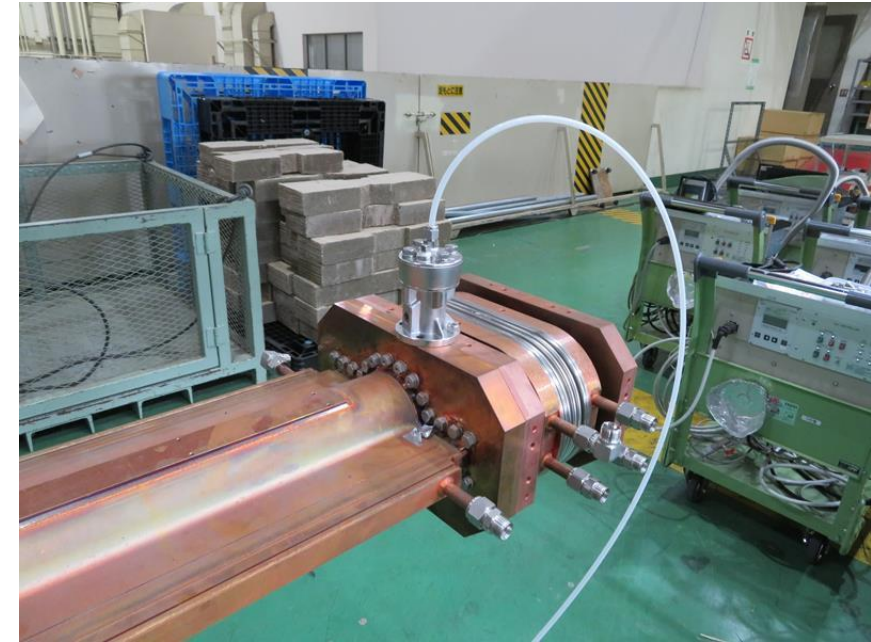
There seems to be a problem with the beam pipe with clearing electrode, so the vacuum group investigated in the experimental room with test-chamber (Chamber with electrodes taken out from tunnel at LS1).

Dust from chamber gotten by knocking was sent for chemical analysis, but no tungsten was detected in the dust.

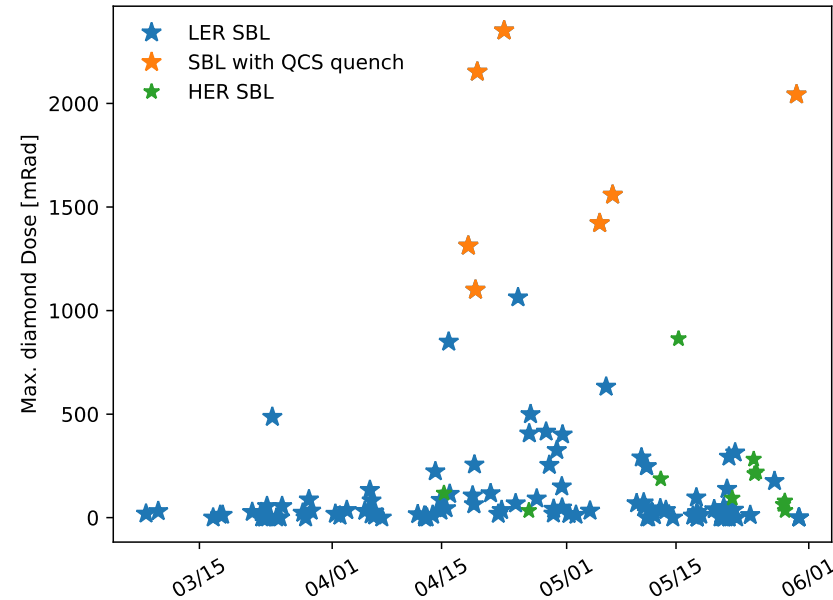
Max. Dose [mRad]	#LER SBL	May.9th* -
[0.0, 100]	87	38
[100,300]	14	6
[300,500]	7	1
[500,800]	1	0
[800, 1000]	1	0
[1000,]	8	1 ← Knocker study

* Closed LER horizontal collimators on May 9th

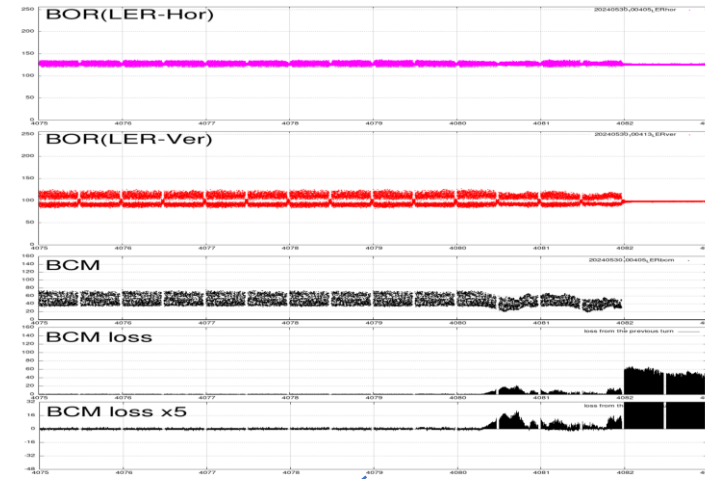
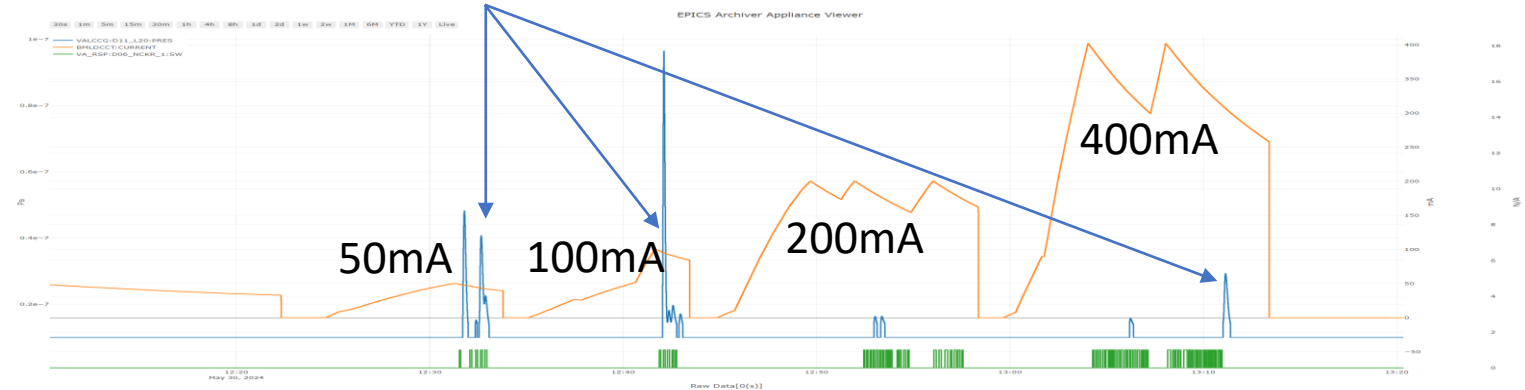
Current dependence

SBL and QCS quench occurred @1000mA .
Pressure bursts were observed at any current without beam abort request.

Maybe aging observed

Pressure burst observed
