# Single Event Burnout in thin silicon sensors

43nd RD50 Workshop  
CERN  
30/11/2023

# Introduction - Single Event Burnout mechanism

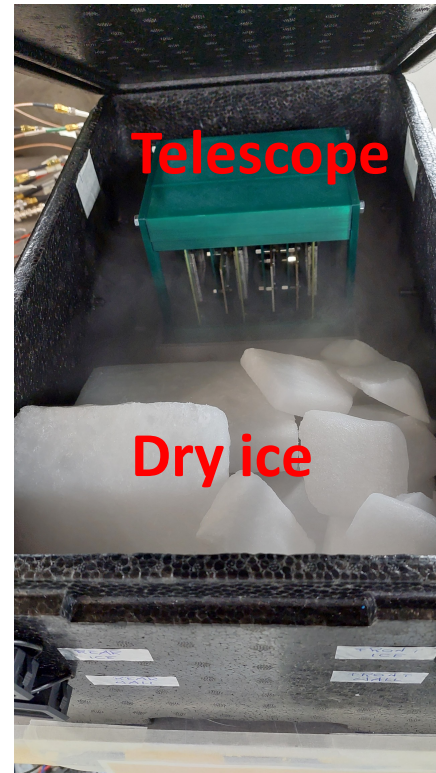
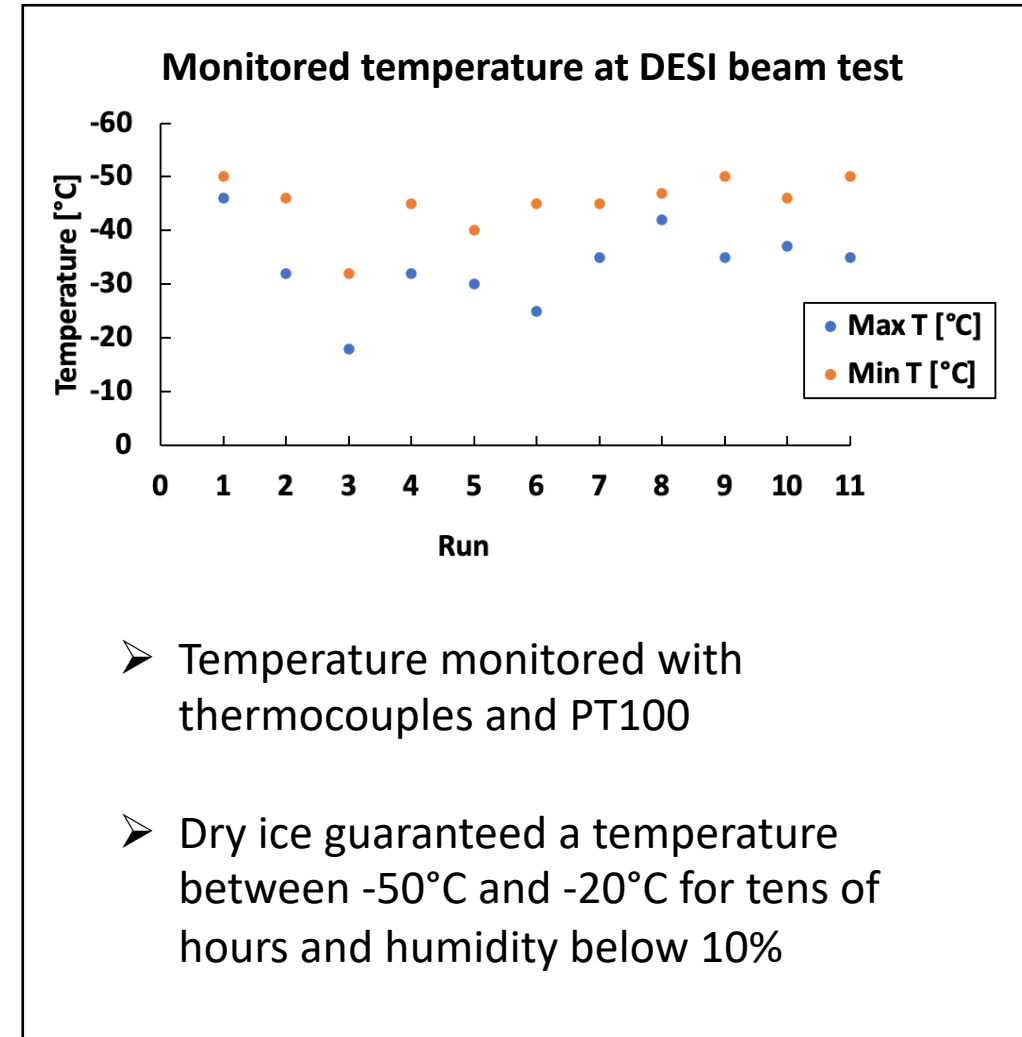
# Beam test setups

Same setup used at DESY (T22) and CERN (H6)

Cold box with dry ice to operate irradiated sensors

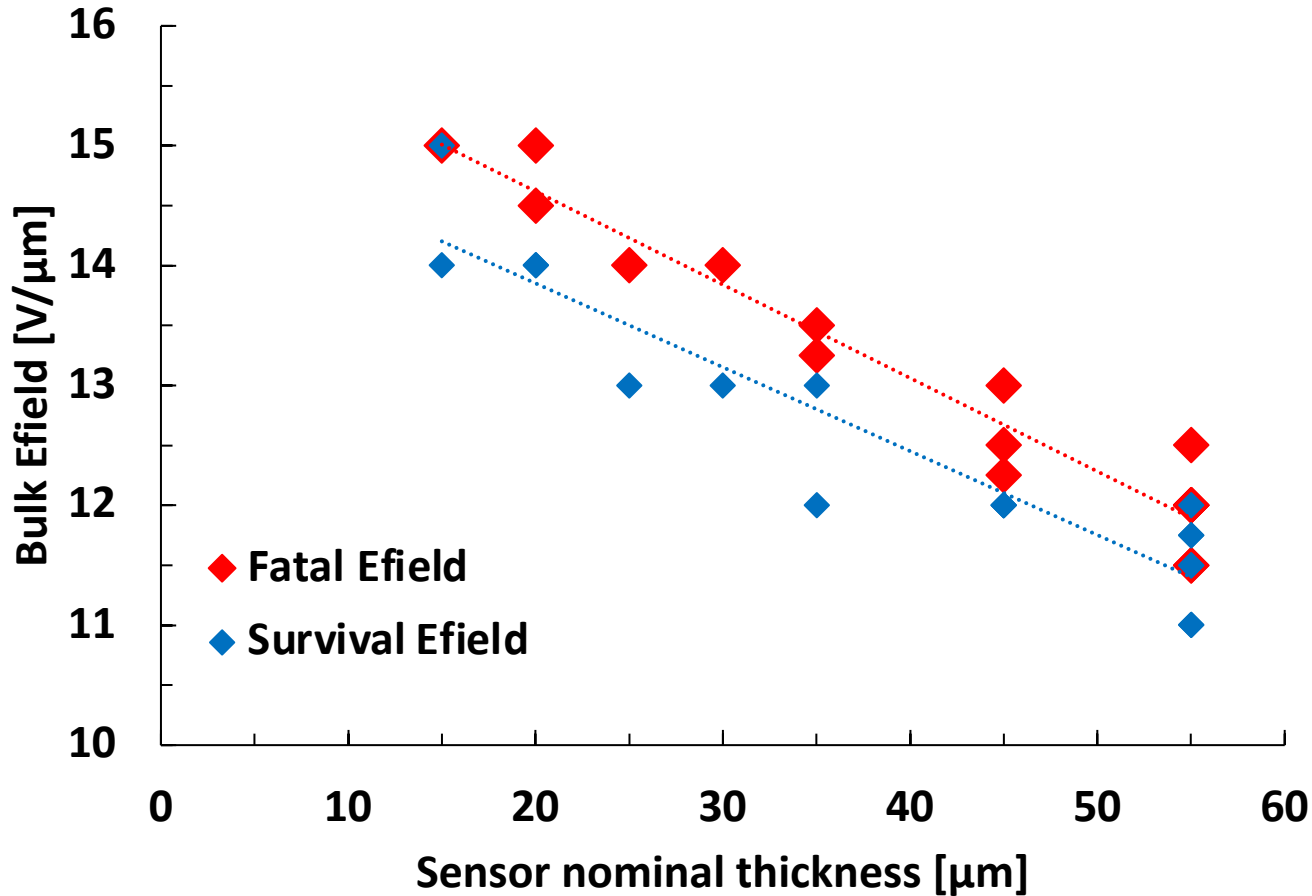
# SEB results - fatal electric field

**The thickness of the sensor determines the value of the fatal electric field**

- Almost linear relationship between fatal electric field and sensor thickness
- Almost linear relationship between survival electric field and sensor thickness
