Limitations from LHC RF Fingers

Presenters: Chiara Antuono and Patrick Krkotić

Joint Accelerator Performance Workshop, 6 December 2023

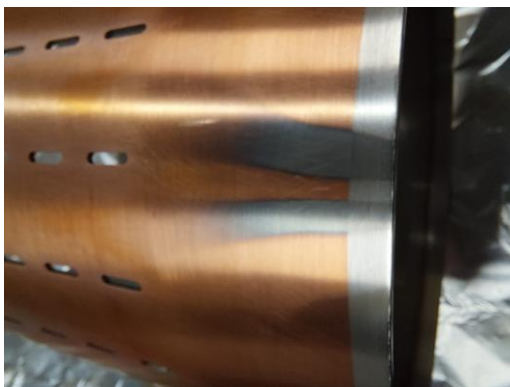
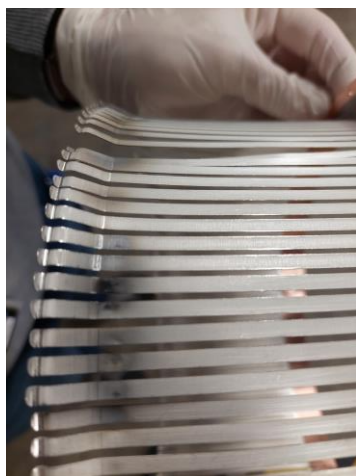
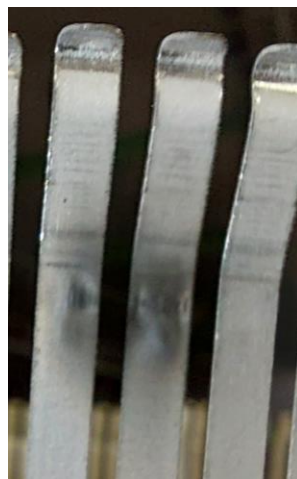
Visual inspection:

- annealed/plasticised spring → localized temperature increase to more than 500°C
- localised extremely high temperature producing debris, sputtering and sublimation of austenitic stainless-steel spring
- cascade of failure with consequent loss of electrical contact of RF fingers on the transition tube perimeter

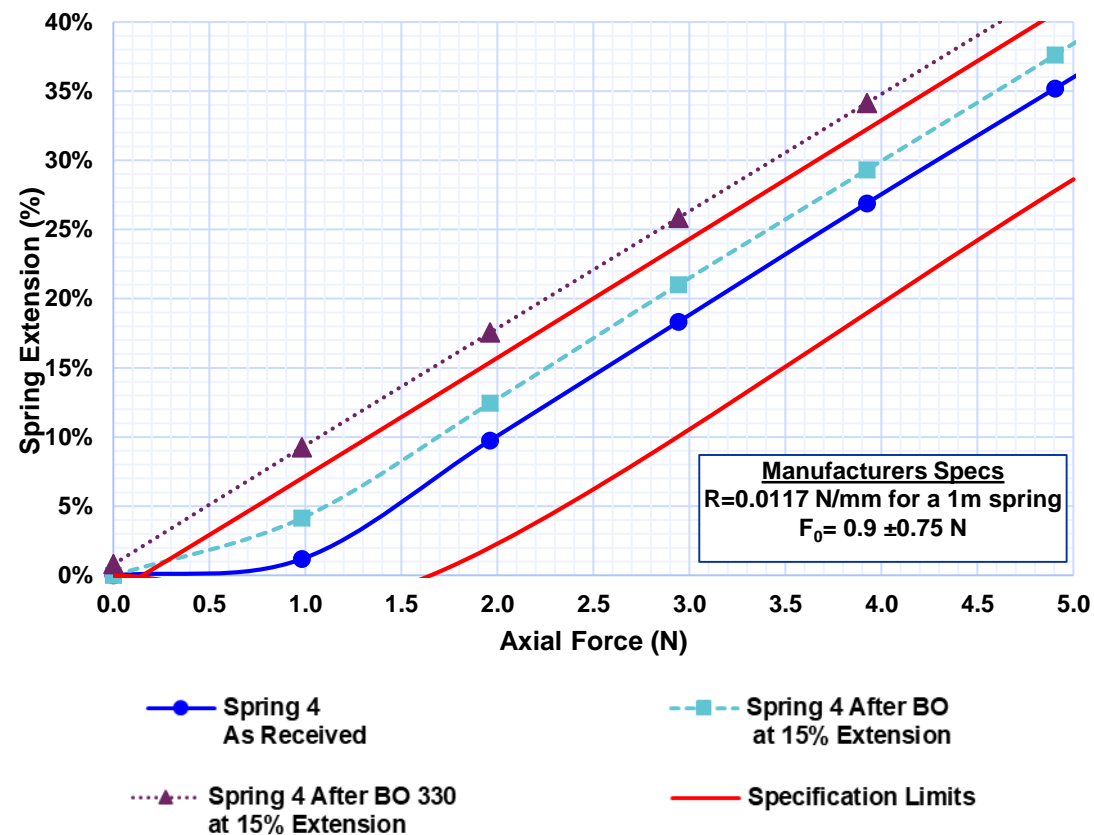
Traction Tests Before and After Bake-Out

Effects of the bake-out cycle: elasticity of the spring versus different elongations (**EDMS**)

- As received: compatible with specifications
- **8 days 250°C** bake out: no degradation
- **8 days 330°C** bake out: removal of pre-load and length increase

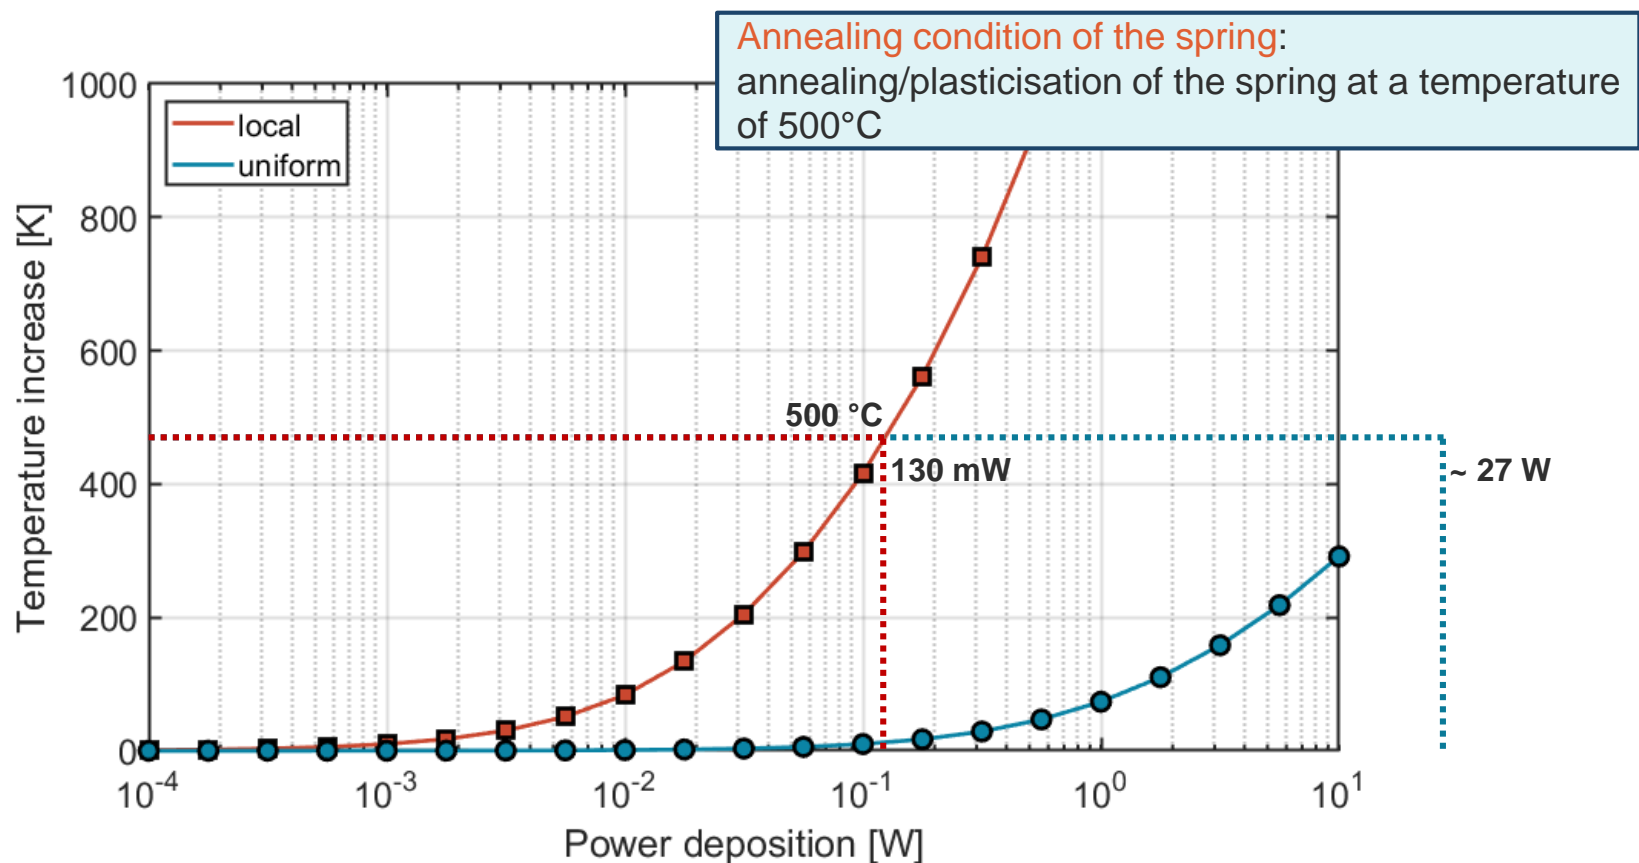
Thermal simulations

- Visual inspection and radiography indicate that heating of the spring is the triggering mechanism of the first module failure
- Finite Element Method simulations via COMSOL were conducted to determine the power deposition necessary to heat the spring in a steady state (**EDMS**)

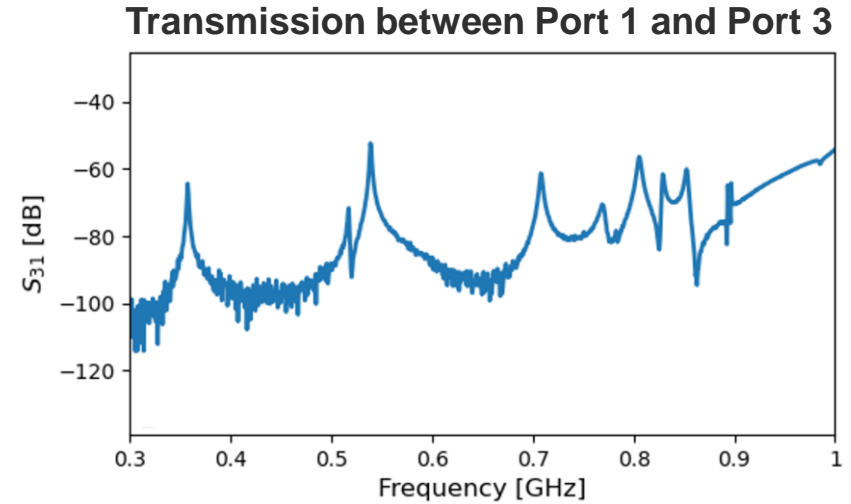
Impedance measurements - field leakage

- Low frequency resonances (below vacuum pipe cut-off frequency)
 - **Field leakage** through RF fingers / transition tube

➤ It is the mechanism that allows some of the beam induced power to be dissipated on the spring

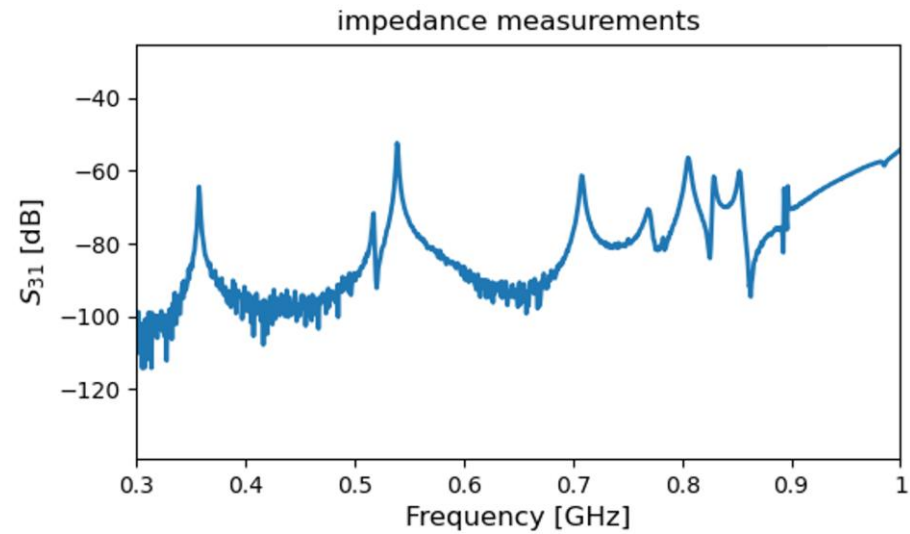
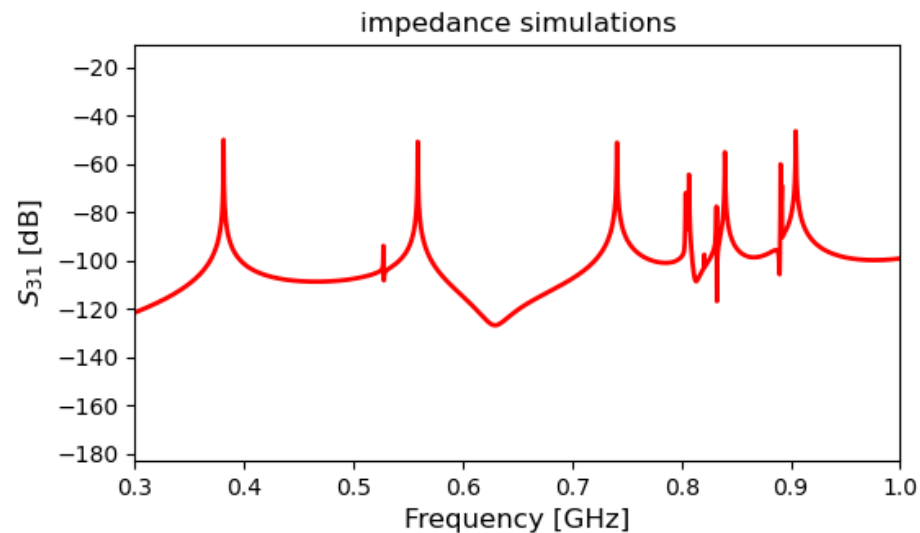
Simulations vs Measurements : validation of the model

- Virtual measurement setup reproduced in e.m. simulation

- Very **similar frequency response** between simulation and measurements
 - First resonance below 400 MHz
 - Several resonances below pipe cut-off frequency

The **simulation model is used for impedance assessment**

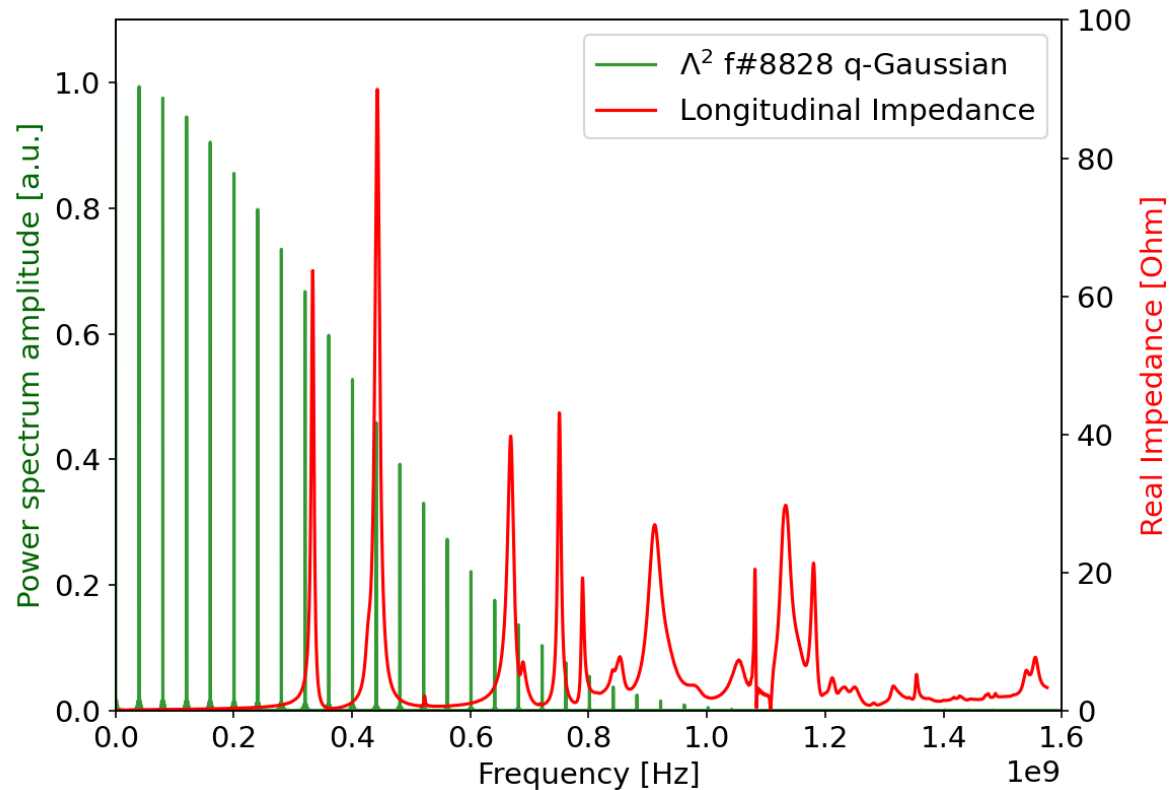
Beam induced power assessment

Λ : beam spectrum
 ω_0 : angular revolution frequency
 Δy_1 : offset of beam 1 from center
 Δy_2 : offset of beam 2 from center
 $Z_{||}^{0,1}$: longitudinal impedances of orders 0 and 1
 τ_s : delay between arrival times of the two beams

Two beam power loss

$$\Delta W(s) = \left(\frac{\omega_0}{\pi}\right)^2 \sum_{p=0}^{\infty} |\Lambda(p\omega_0)|^2 \{ \text{Re}[Z_{||}^0(p\omega_0)] + [\Delta y_1(s) + \Delta y_2(s)] \text{Re}[Z_{||}^1(p\omega_0)] \} (1 - \cos p\omega_0 \tau_s)$$

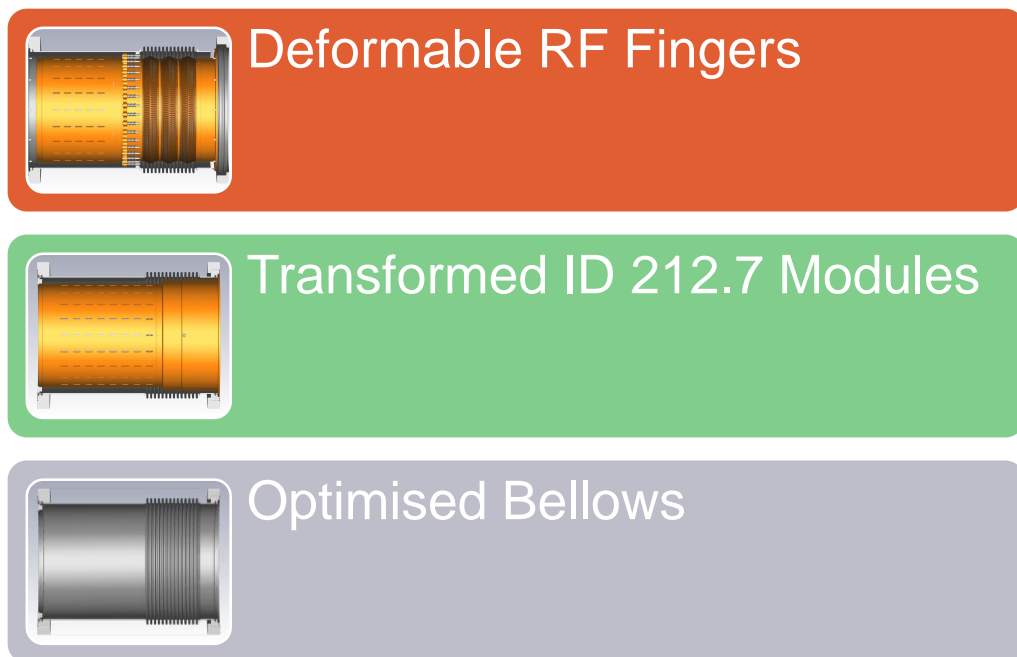
Two-stages approach

Replace and transform the current 71 modules in the ID212.7 RF contact **with newly designed modules** wherever it is possible to implement such a substitution.
Anchor 'unnecessary' ID212.7 modules (EDMS)

Full consolidation in YETS 24/25

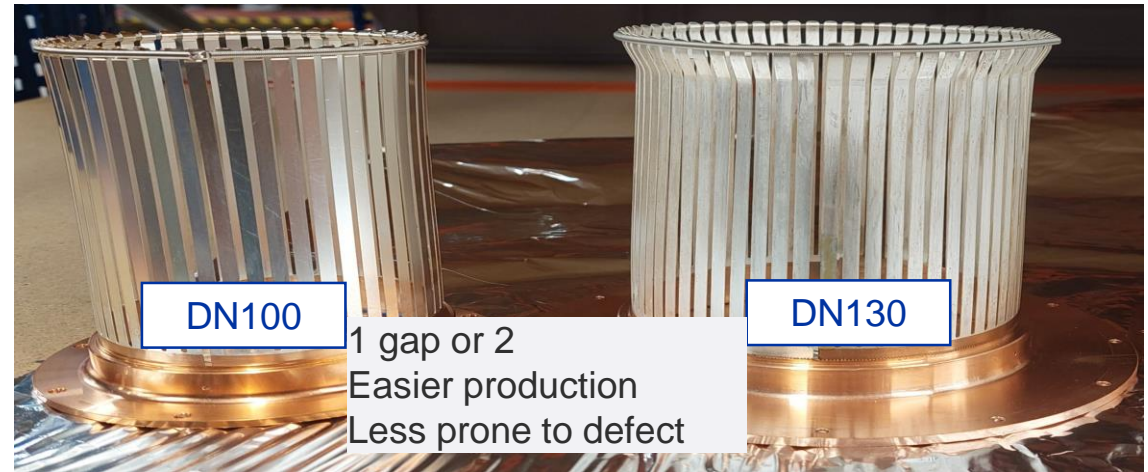
Smaller transition in terms of diameter

Smaller diameter modules are expected to be less critical

- higher frequency modes
- Only 1 beam
- smaller beam offset
- less production defects
- lower impact of the machine layout

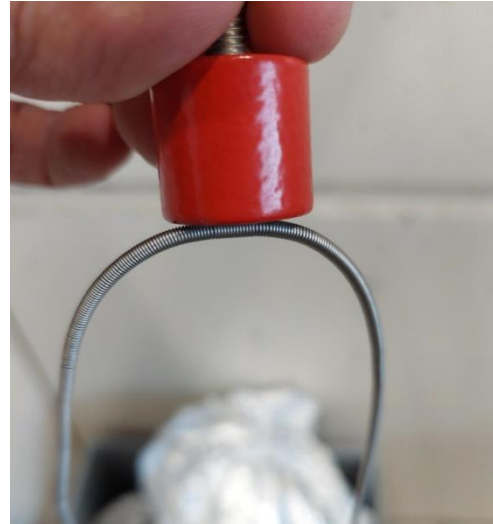
Spring of module 5

...but most of it is totally amagnetic

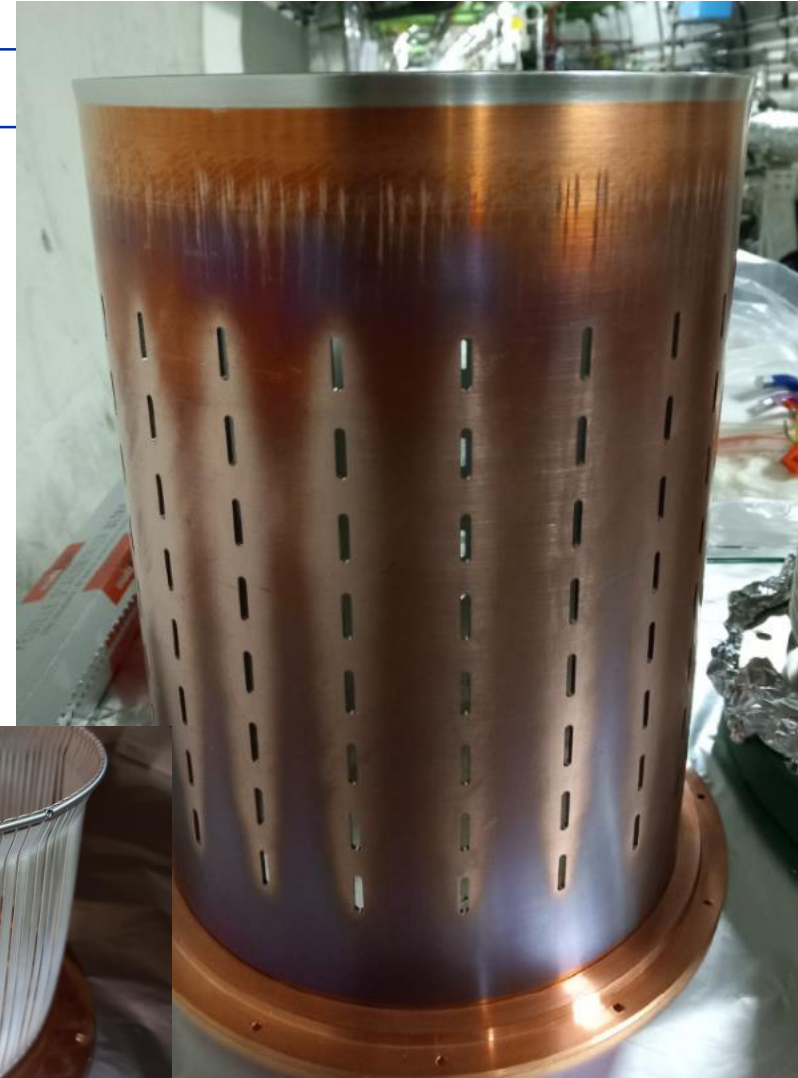
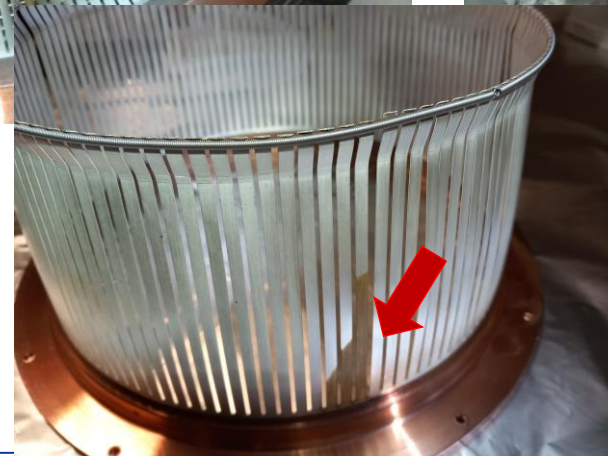
B4R8.X - VMBGC.E5R8.X

No spring coil degradation detected
