#### RD50-MPW3 - Lab measurements

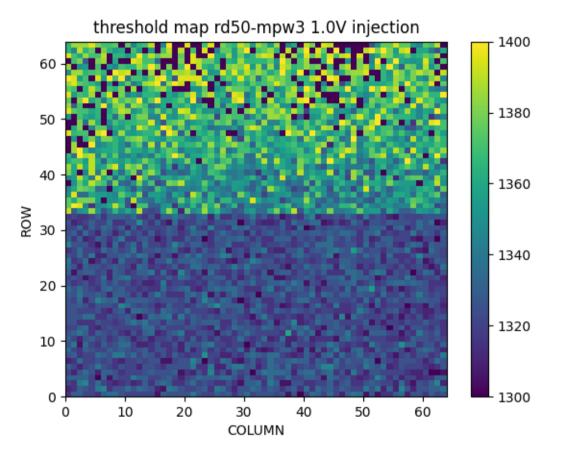
• Distinct difference between top and bottom of matrix suspected to be due to a TrimDac config being applied unknowingly

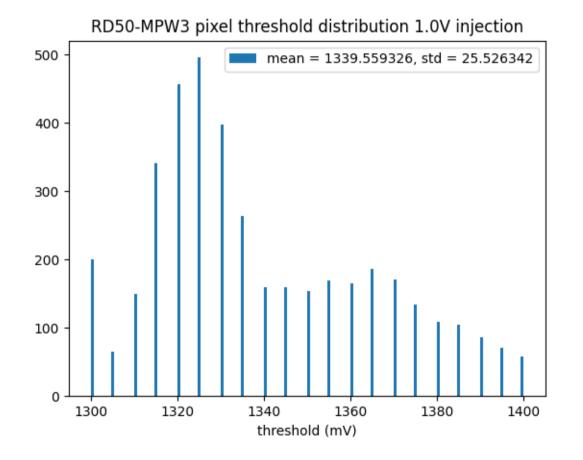
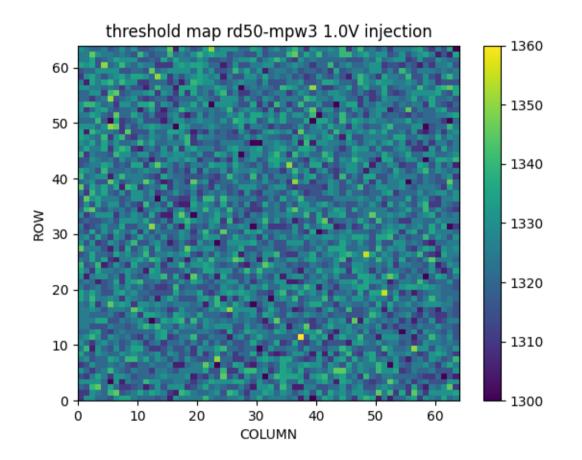
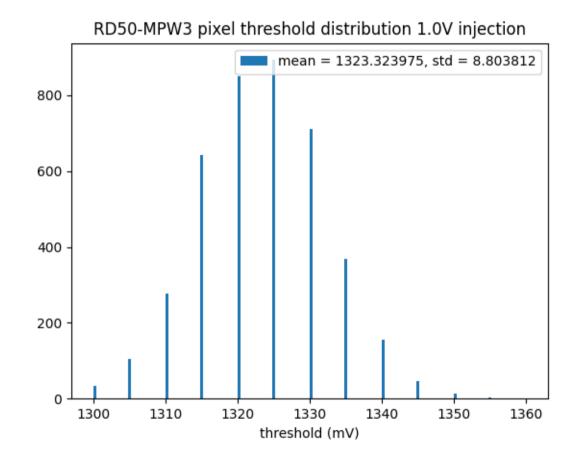
• Modifying the trimDac Config file has solved the issue. Scans ongoing...
